# **National Trust Purbeck: Swan Brook NFM Opportunities**

## **Feasibility Assessments**

**Dr Peter Stone**

**May 2024**

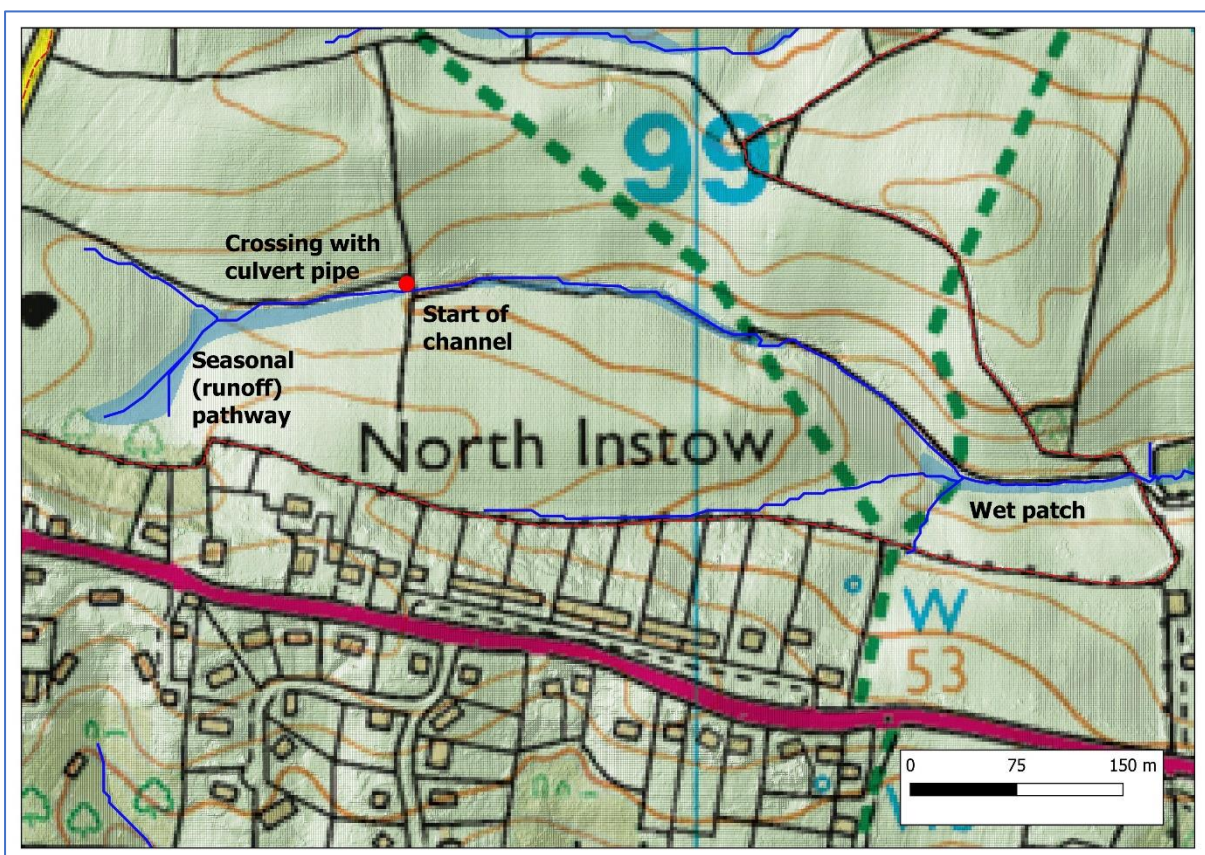
The channel initially flows through a relatively narrow valley form with steep slopes. A further analysis is provided from the Environment Agency LiDAR DTM to define areas that are regarded as flat and can be regarded as the valley floor (blue areas in the map above). The flatness is defined as a combination of low slope combined with relative elevation to surrounds. Flat areas can be regarded as potential floodplain or wetland, and represent the natural topography where water might flow or accumulate.

The catchment area draining to the tributary channel at Westwood Farm concentrates surface flow from two runoff pathways that generate from southern slopes. During a site visit in June 2023, the runoff pathways were dry and there was only a minor groundwater (base) flow in the tributary channel. The runoff pathways are likely to only flow in response to rainfall which generates a surface runoff flow. The channel flowing through the National Trust land is supported by emerging groundwater with a clear start of the channel as a spring type emergence.

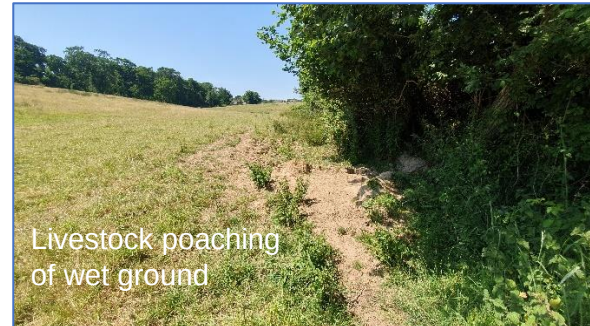
Upstream of the start of the formal channel, runoff clearly originates in response to rainfall-runoff generating events in a field which is currently used for livestock farming. The topography analysis shows that there is flatter land where water may accumulate and observation from June 2023 noted evidence of seasonal wetness within an area of the field.

There are two potential issues to address. The land use may lead to accelerated runoff generation and delivery, but secondly, livestock poaching will help to increase fine sediment delivery to the downstream Swan Brook and on to Poole Harbour.

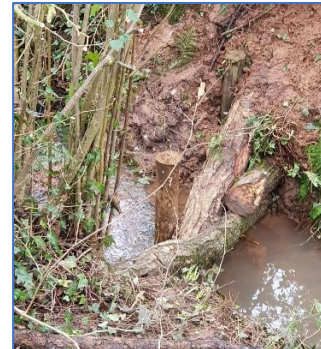
Structure configuration and Securing options

A basic design of woody debris in the channel is shown below, along with an example. Given the incised nature of the channel the structure will be secured into the banks of the channel rather than sitting on top.

The leaky woody debris dams will be installed manually. Works will be undertaken using a chainsaw and debris manually manoeuvred into place. Any fixings will be manually installed.

- Fell and lever the entire tree partially or entirely into the watercourse from the riverbank, with the branches facing either upstream or downstream;
- Fell with :
  - no hinge so that the tree is detached from the stump (requires staking of the trunk or securing to other trees on bank); or
  - (if possible) a hinge to enable the tree to carry on living, and to naturally secure it to the bank;
- Secure the head of the tree (main branches) and the trunk, with stakes made from local durable wood;
- Stakes securing the tree should be on the downstream side, angled so the top of the stake is pointing upstream and >0.1m above the top of the felled tree;
- Where stakes are used to secure the tree to the river bank and retain in-channel, the wood will be attached to the stake to minimise the risk that the tree floats away.

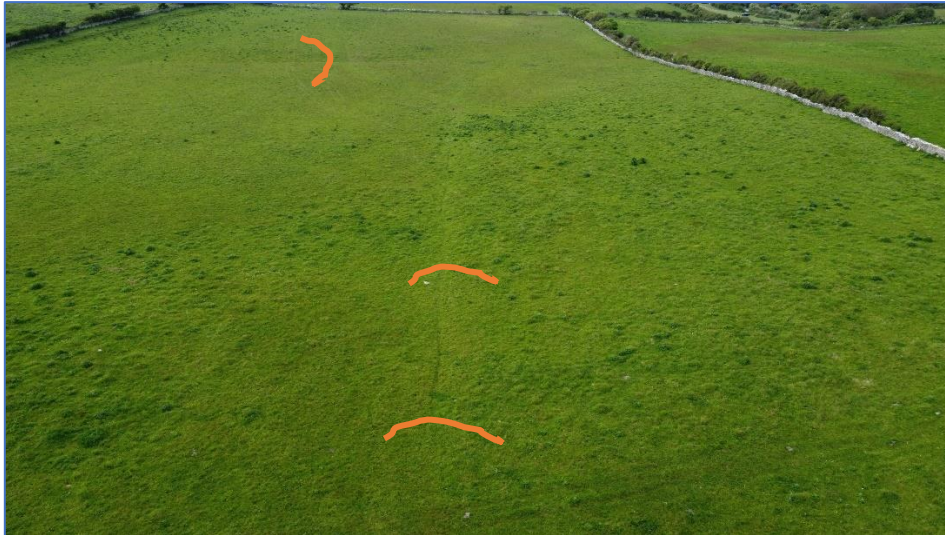
Modification to slow the delivery of runoff from the upstream field sources can initially be achieved by creating shallow bunds across the pathway using the available topography depression along the pathway. The cross-pathway features need only be ca. 30cm high and take the form of a curved “speed bump”. Material from upstream can be scraped from the surface and compacted to create the shallow bund. It is intended that flow will overtop the feature and a further flow control will not be required.

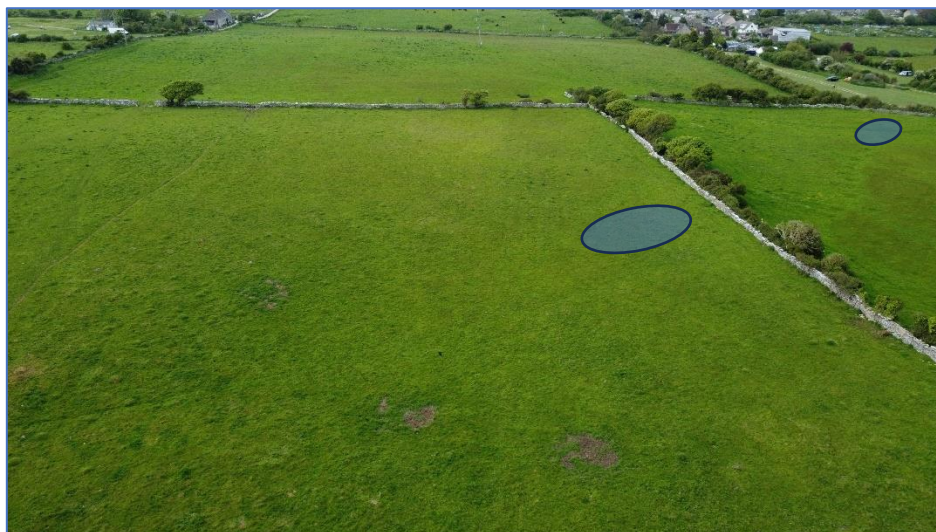
The flatness analysis suggests that there are two natural depressions which can be expanded to create temporary storage in scrape features within the fields. Both locations identified in the figure above are close to field boundary walls which will help control downstream flow. The scrape features can be created using a digger to remove a shallow depth of top soil ca. 20-30cm to enhance the depression feature. Removed material can be used to define the feature but also to infill the upstream runoff pathway that feeds into the scrape feature.

The two features suggested will both be in the order of 30m in diameter.

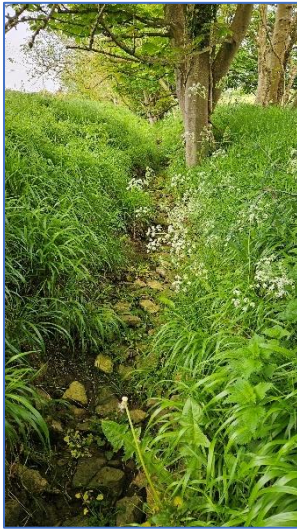
## Natural Flood Management Opportunity – In-channel slow flow

The incised form of the channel downstream of the campsite is part of the reason that the floodplain has been disconnected. There is a limited width of floodplain but reducing channel incision will increase the cross section width of the channel, slowing delivery and increasing storage. Addition of woody debris to the channel is proposed specifically with the intention to trap sediment and raise the bed level of the channel. The woody debris as a leaky dam will also raise water level but at the locations proposed there is a limited floodplain space.

Within the reach are proposed, addition of up to 3 to 4 dams is proposed.

The leaky woody debris dams will be installed manually. Works will be undertaken using a chainsaw and debris manually manoeuvred into place. Any fixings will be manually installed.
