Liskeard Cattle Market, Liskeard, Cornwall Heritage Assessment

Liskeard Cattle Market, Liskeard, Cornwall

Heritage Assessment

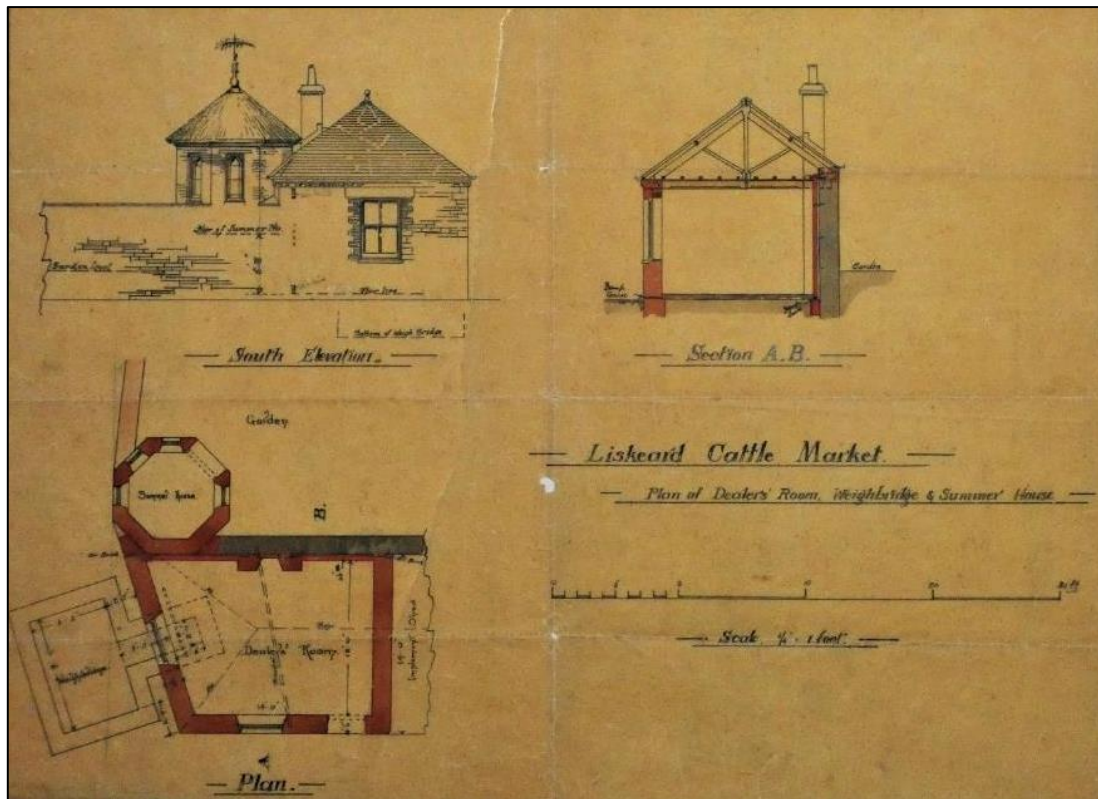
Fig 14 John Sansom's designs c 1905 for the Dealers' Room and weighbridge forming part of the building range on the north side of the cattle market (3), and a summerhouse located in the adjacent garden to Rosedean House.

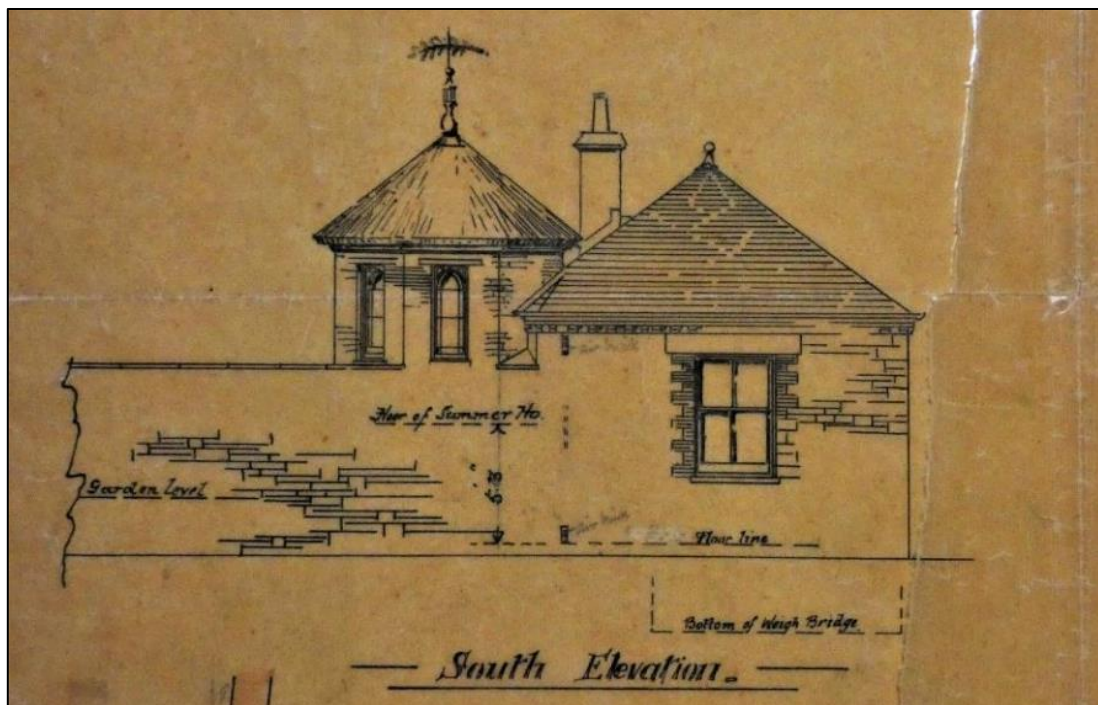
Fig 15 South elevation of the cattle market Dealers' Room and summerhouse, c 1905, indicating the difference in levels between the market surface and that of the garden to the north.

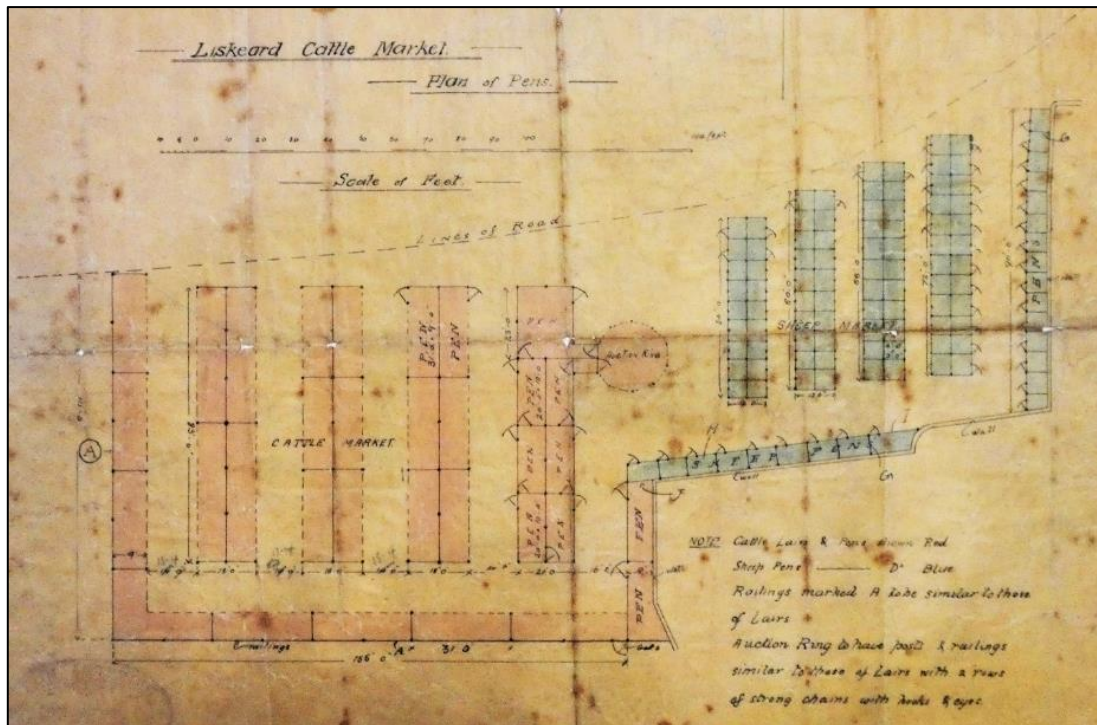
Fig 16 Plan for the original layout of the auction ring, cattle pens and lairs (in red) and sheep pens (blue) in the cattle market area, c 1905.

The auction ring was marked out with 'post & railings similar to those of Lairs with 2 rows of strong chains with hooks & eyes' (Courtesy Liskeard & District Museum).

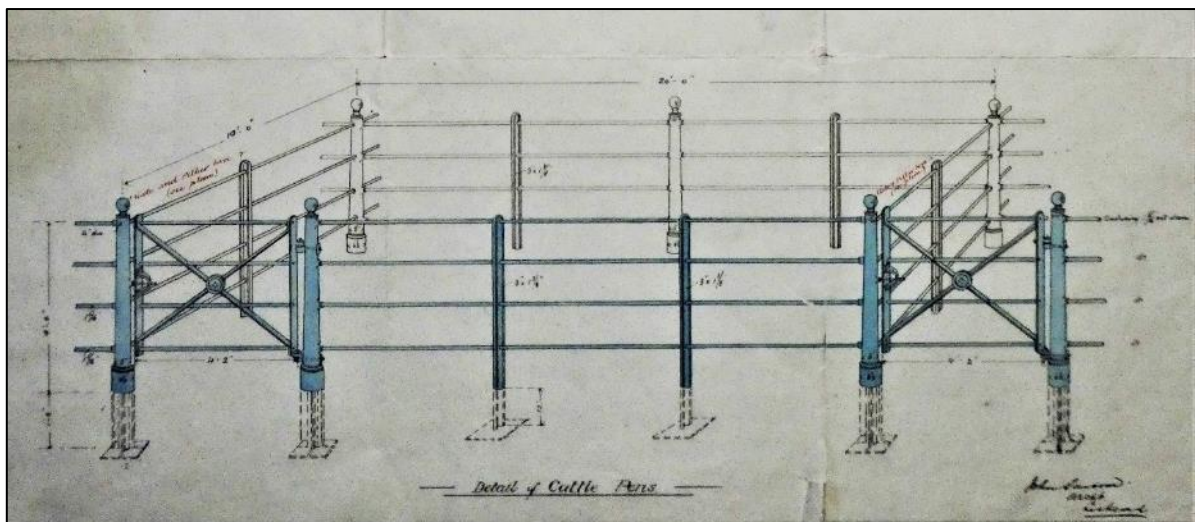
Fig 17 Sansom's designs c 1905 for the cattle pens, some of which survive on the site.
(Courtesy Liskeard & District Museum).

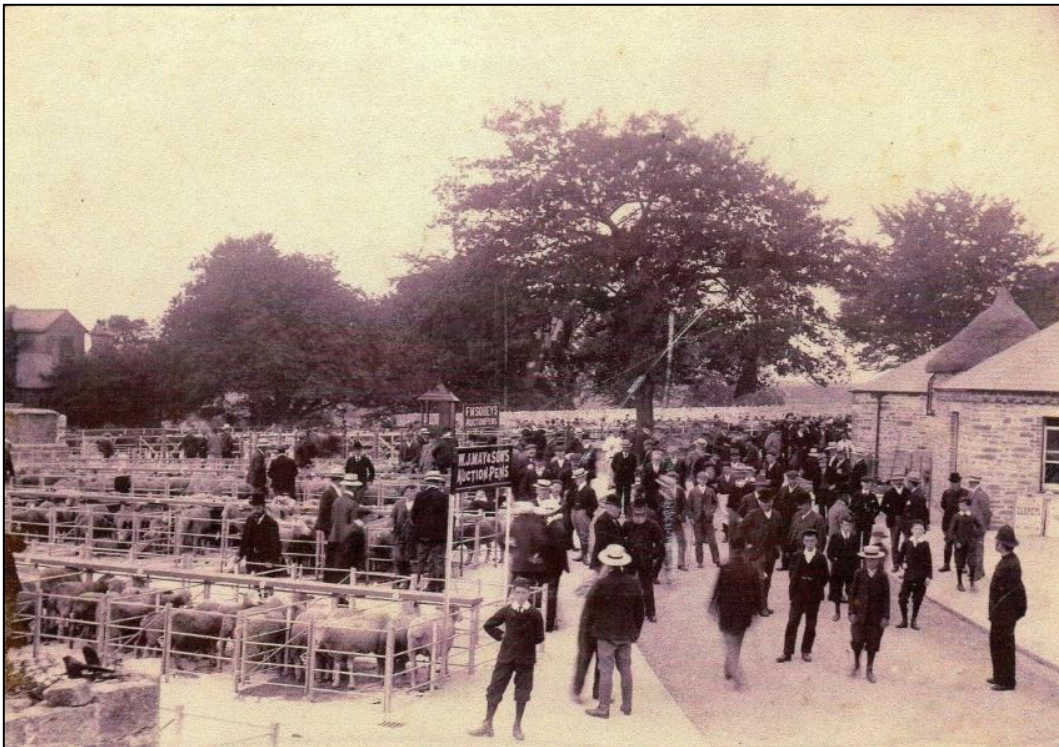
Fig 23 An early photograph of the cattle market in operation, probably on the opening day.

The Dealers' Room and summerhouse are visible to the right and a small auctioneer's booth beside the auction ring in the centre, with sheep pens to the left. Many of the trees formerly in the grounds of Trehawke House had clearly been left in situ in both the cattle market and Fair Park areas (Courtesy Liskeard Old Cornwall Society).

A wall running north-south dividing the cattle market from the Fair Park is shown on the Ordnance Survey 2nd edition 25-inch map (surveyed 1905) (Fig 9). Early photographs (Figs 23 and 24) show it as a stone wall with a capping of close-set vertical killas slabs. The boundary appears to have been removed by 1946 – it is not visible on an air photograph of that date (Fig 32) – and was not shown on the 1969 1:2500 Ordnance Survey map. Traces of the boundary may survive below the present surfacing.

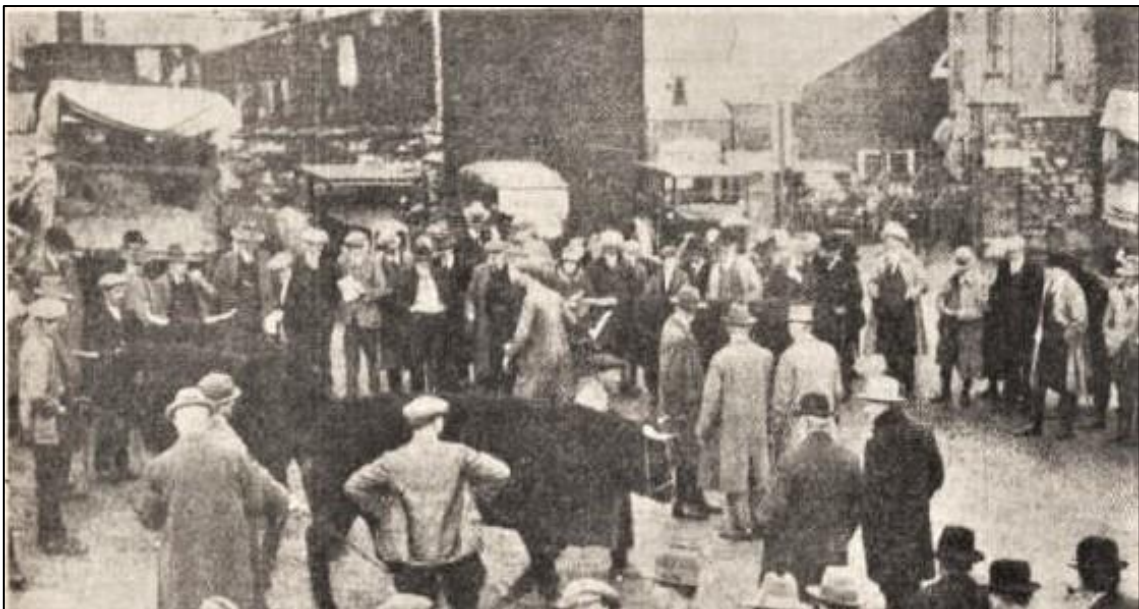
Fig 25 Liskeard Fat Stock Show, November 1927. The gates and ornamental piers to the Fair Park Road entrance to the site are visible at upper right, together with the gable of the Girls' Friendly Society clubroom (now Gilbert's Outfitters).

The housing formerly on both east and west sides of Fair Park Road is also visible. (WMN, 24 November 1927, p10).

Gates were an important element of a market site in that they were symbolic of the market operation being regulated by an authority. Designs by the local architect John Sansom for gate piers and ornamental gates for the entrance to the cattle market and Fair Park site survive in Liskeard & District Museum (Fig 19) and the original position of the gates is shown on the Ordnance Survey 2nd edition 25-inch: 1 mile map surveyed in 1905 (Fig 9). The gates and piers are shown *in situ* in photographs of 1927 and 1936 (Figs 25 and 27), which also show a flanking wall to the east and a pedestrian gate on the west.

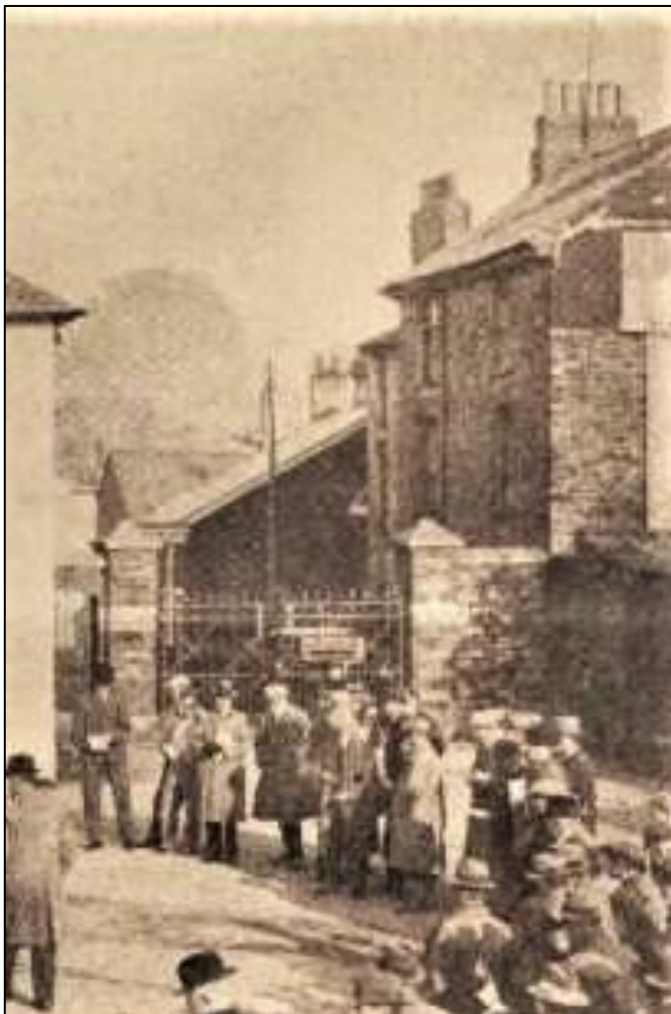
Fig 27 The Fair Park Road entrance in 1936, showing the gates, gate piers, Girls' Friendly Society clubroom and three courtyard houses.

The building partly visible on the left is the recently constructed St John's Ambulance headquarters (WMN, 26 November 1936, p12).

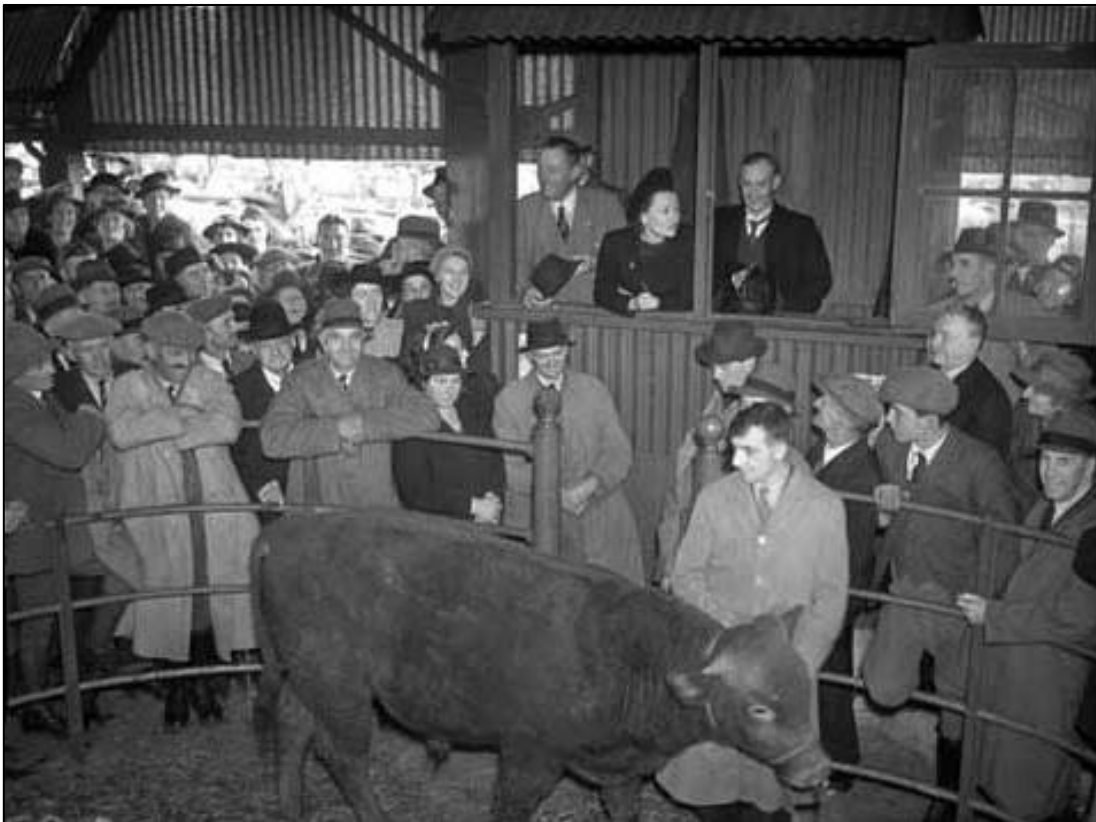
Fig 29 The interior of the auction ring (10A) during a sale in aid of the Red Cross on 9 November 1942, conducted by Mrs Beatrice Wright, MP for Bodmin.

The ring was part of the original 1905 market with the covering structure added before 1942 (cf Fig 29).

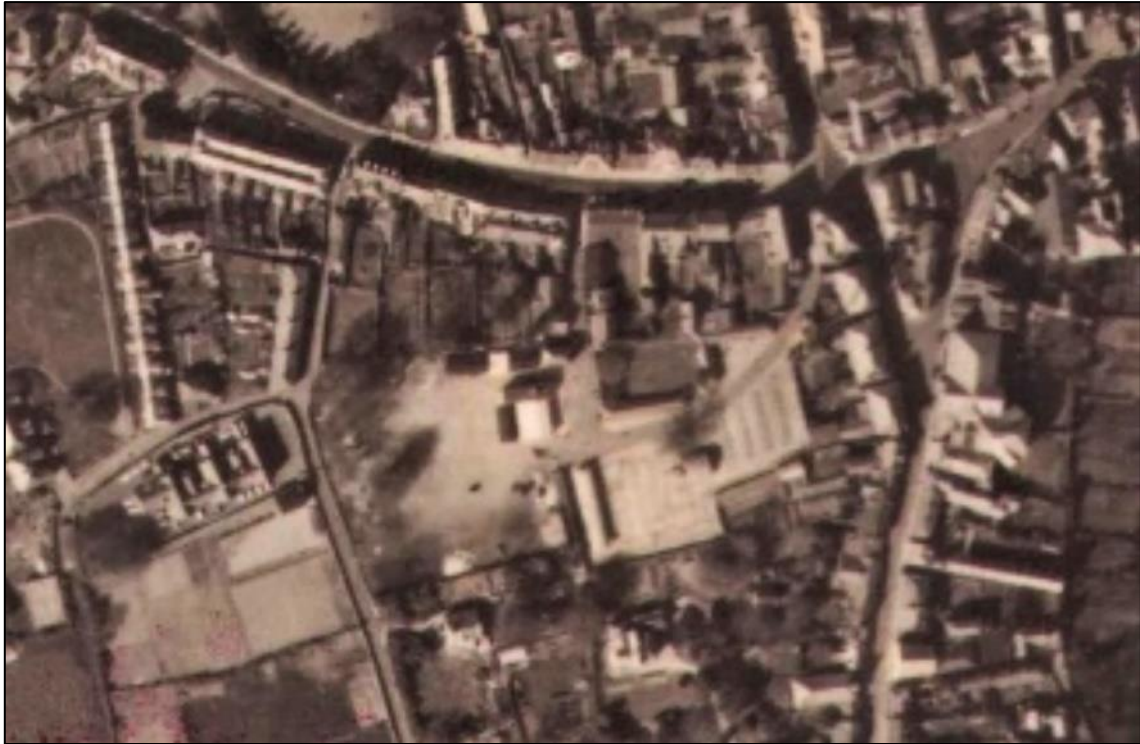
Fig 32 Detail from Royal Air Force 1:10,000 vertical air photograph, 13 April 1946. (3G/TUD/UK 144. Part II. 511). (Copy held by Cornwall Council).

A building of broadly similar dimensions appears on this site in the 1946 air photograph (Fig 32) and on the 1969 Ordnance Survey 1:2500 map. However, it is not clear that these represent the present café building, which appears to be of relatively recent date.

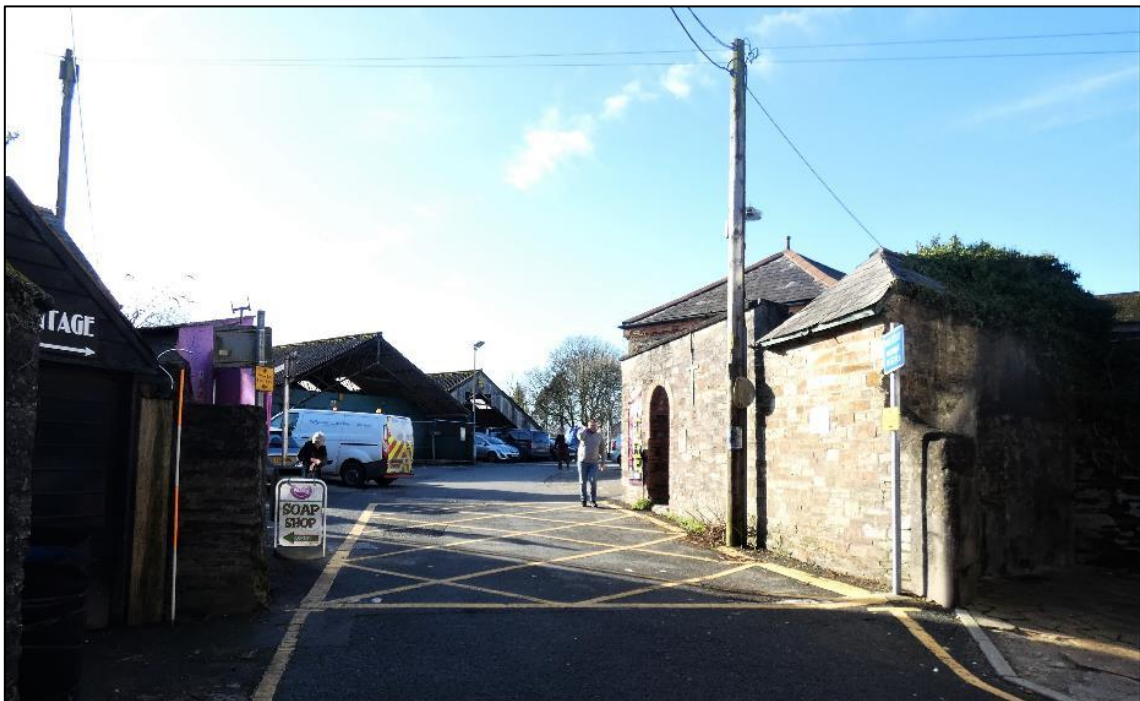
Fig 33 The market approach looking south west, with, on left, a surviving stub of historic walling against which one of the market gate piers (1) formerly stood.

The gate piers have been removed but a stub of wall on the east side of the entrance is likely to be that to which a pier was formerly attached (Fig 33). No information has been found on the fate of the ornamental gates.

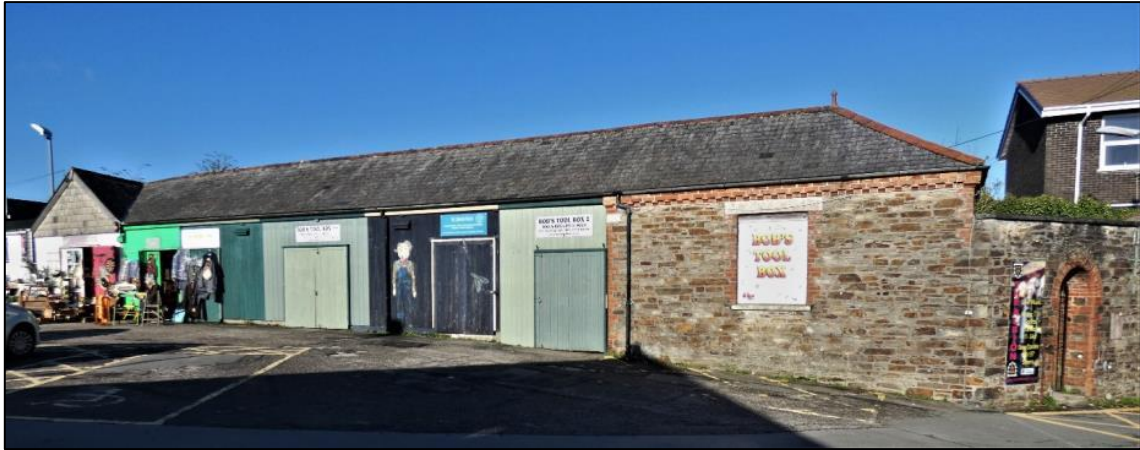
Fig 34 The surviving market building and range of formerly open-fronted structures (2) with, at left, the truncated range (3) which formerly formed an L-shape with these buildings.

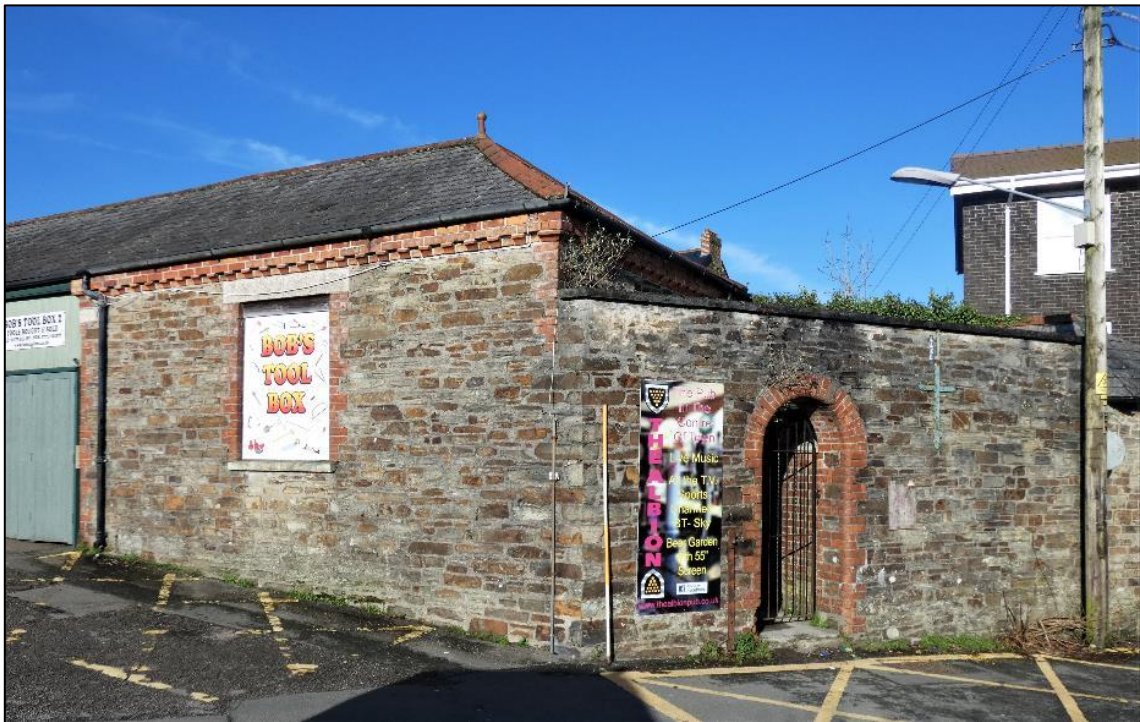
Fig 35 Detail of the surviving original market building (east end) (2).

The market building at the east end is of a single storey, built in semi-coursed local killas with red brick surrounds to the single window in the south elevation and the arched doorway in the attached wall to the east, and rounded bricks to the south-west corner (Fig 28, 34 and 35). The lintel over the south-facing window is of dressed granite; the sill is concrete and is presumably a replacement. The range is covered by a pitched slate roof, hipped to the east and on the surviving northern end of the demolished portion (below), with red ceramic ridge tiles and a decorative terracotta finial on the eastern ridge-end.

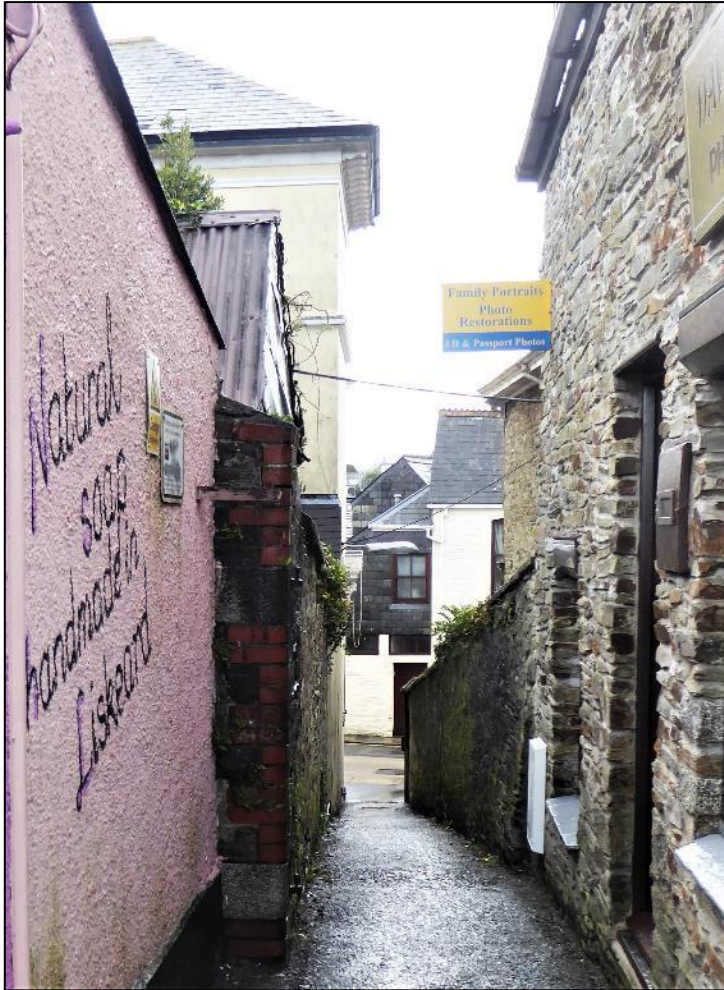
Fig 36 The alley (5) linking the cattle market to Barn Street with, at left, the pier for the original gate.

The alley between the cattle market and Barn Street was shown on the Ordnance Survey 2nd edition map (surveyed 1905) and was labelled 'Right of Way to Cattle Market' on an undated plan (c 1910) associated with the sale of the site of Trehawke House. A gate to the alley was included in the designs for the market site by John Sansom (Fig 21) and its position marked on the previously noted undated plan. The gate pier on the north side survives, constructed of shaped bricks and large dressed granite blocks in which the upper and lower pintles on which the gate swung remain *in situ* (Fig 36).

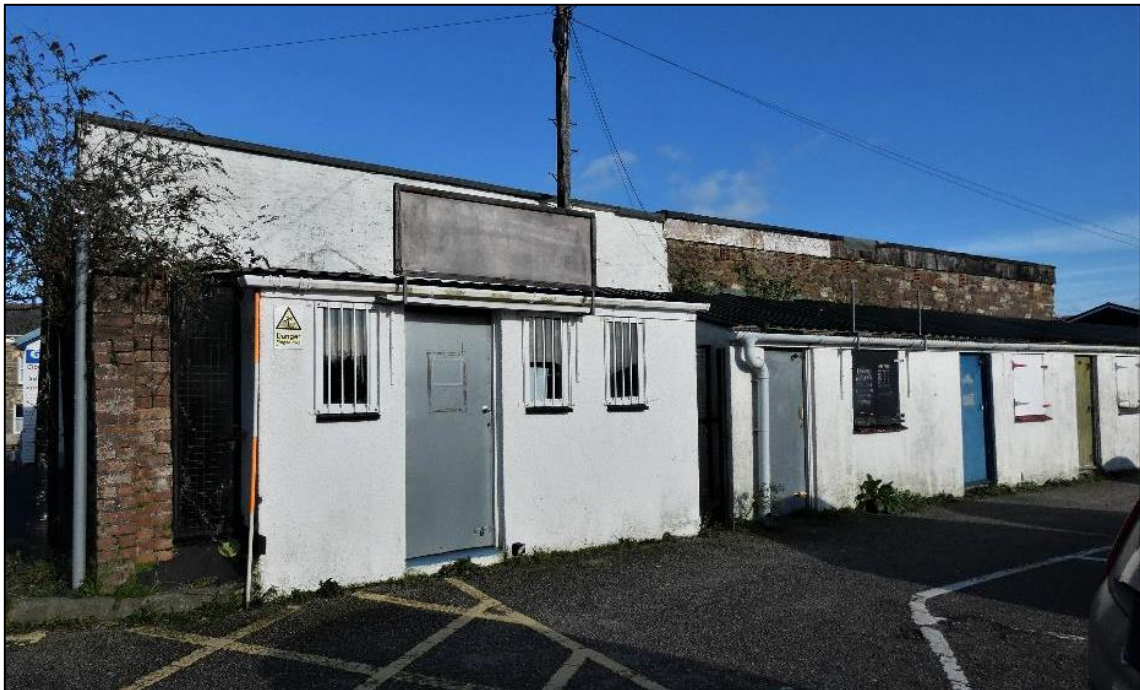
Fig 37 The range of lean-to units (7) along the north side of the market area dating to the period 1946-69.

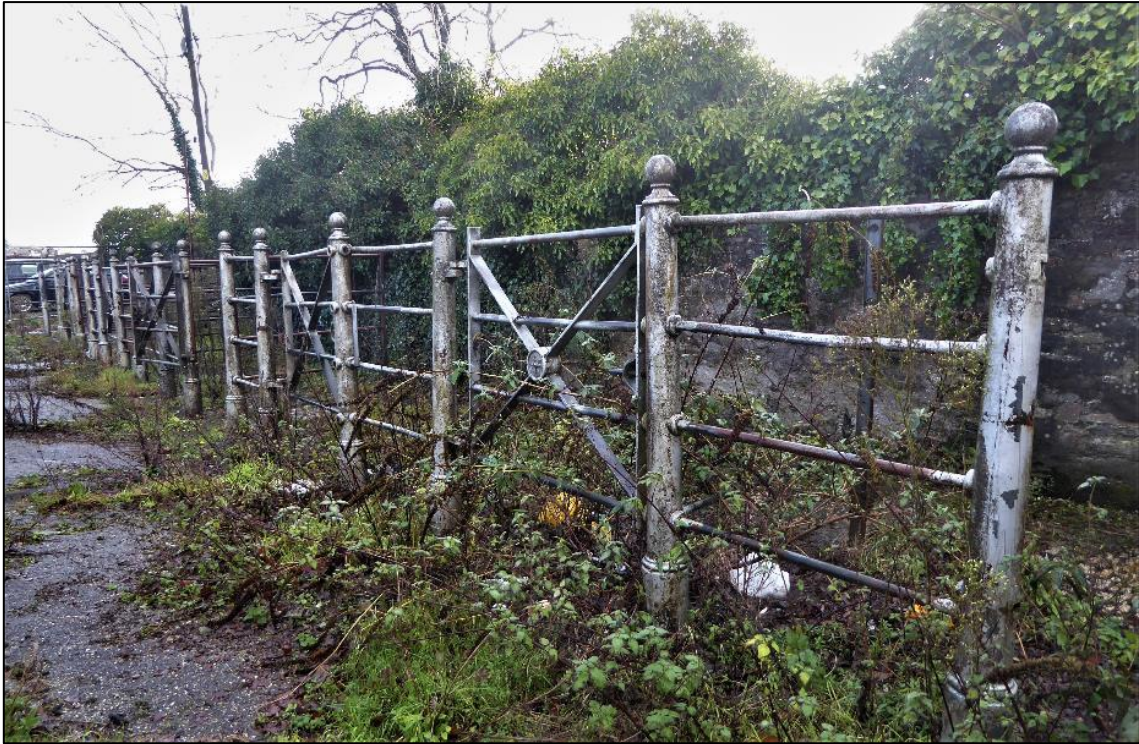
Fig 38 Original 1905 cattle pens along the southern boundary wall (8) of the cattle market in the sales area for stirks and store cattle (10).

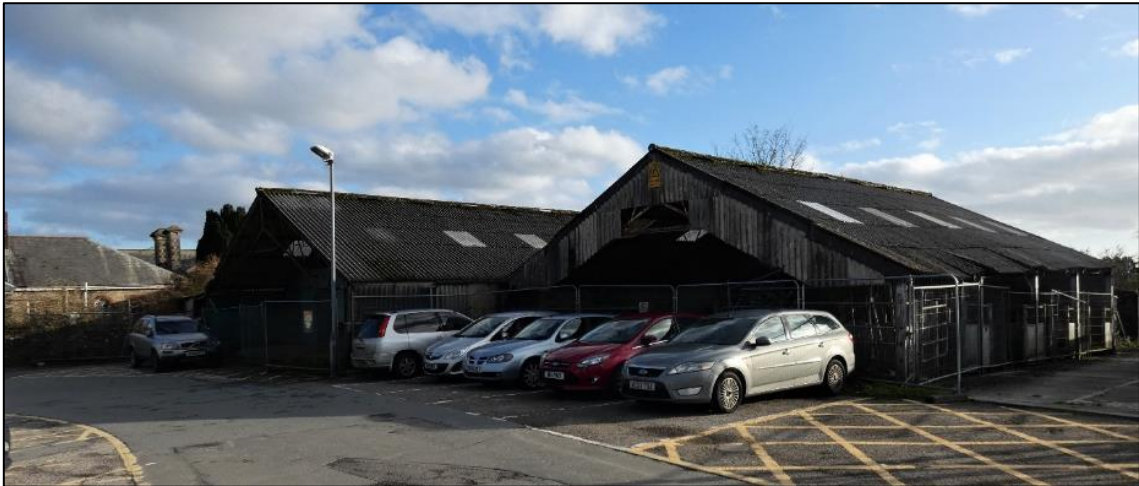
Fig 39 The sales complex for calves and pigs (9), looking south east.

The view at left to the roof and ornamental chimneys of the paired town houses at 1 and 8 Windsor Place (Listed Grade II) emphasises the proximity of the site to the historic core of the town and the potential of changes on the site to impact on the setting of designated heritage assets.

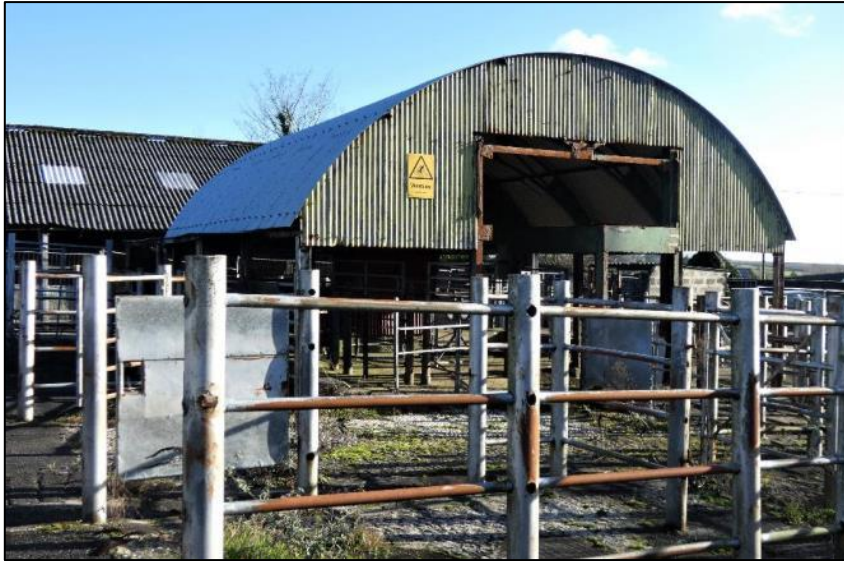
Fig 40 Auction ring (10A) with modern cattle pens in the foreground, looking east. The buildings for calves and pigs (9) are visible to the left.

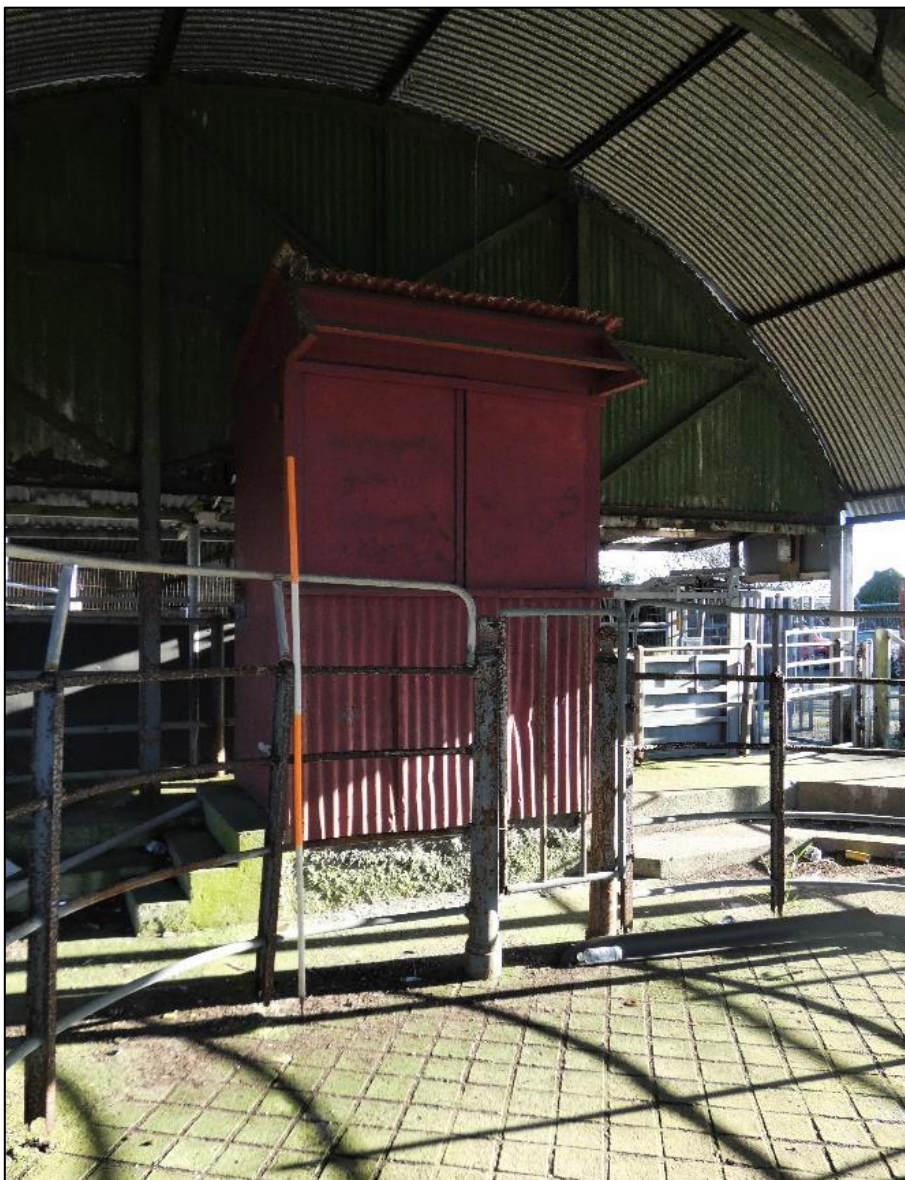
Fig 41 Interior of auction ring (10A), looking east.

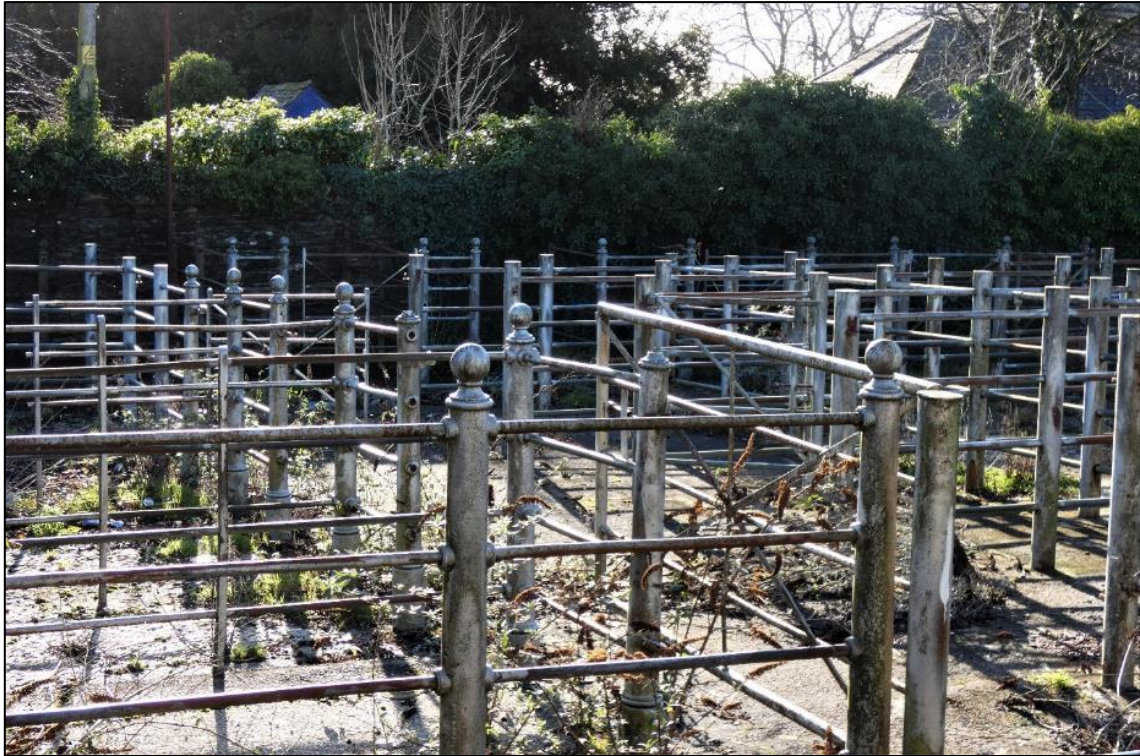
Fig 42 Cattle pens within the sales complex for stirks and store cattle (10). Original 1905 pens are to the left and rear, modern pens to the right.

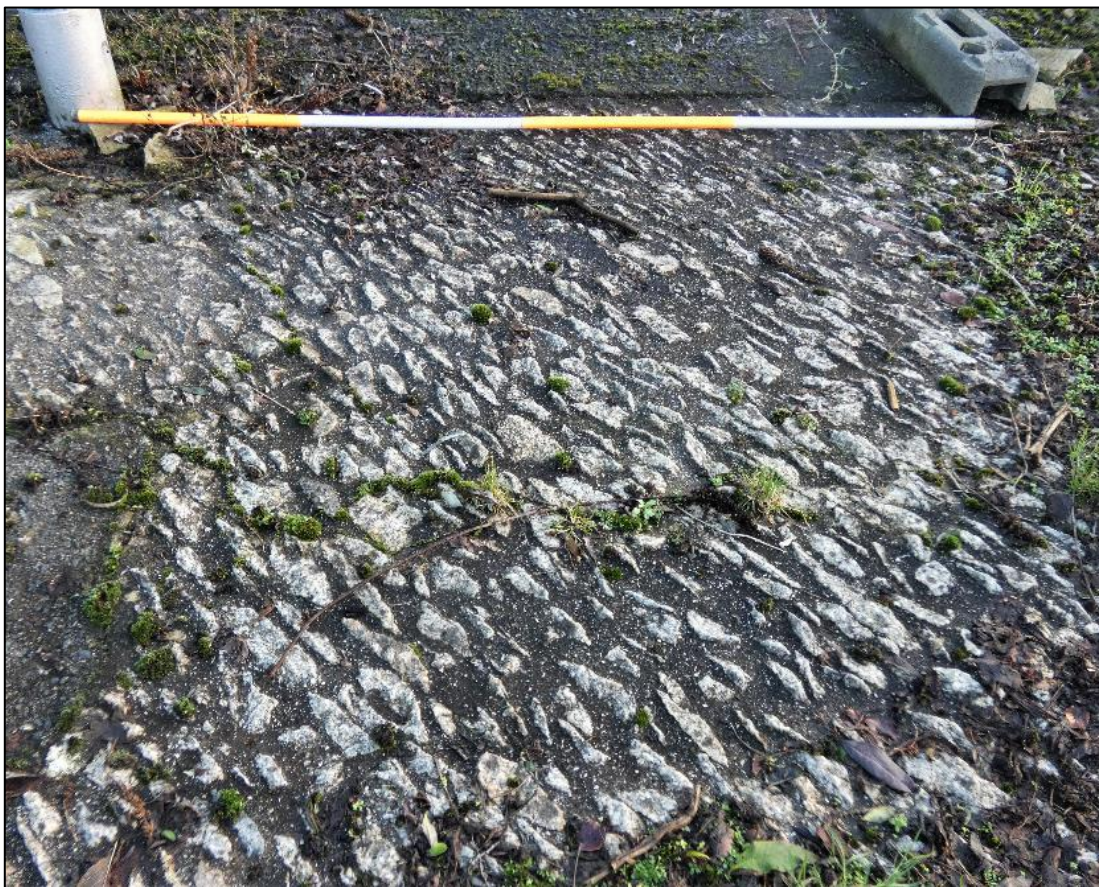
Fig 43 Historic 'non-slip' surfacing in the sales area for stirks and store cattle (10).

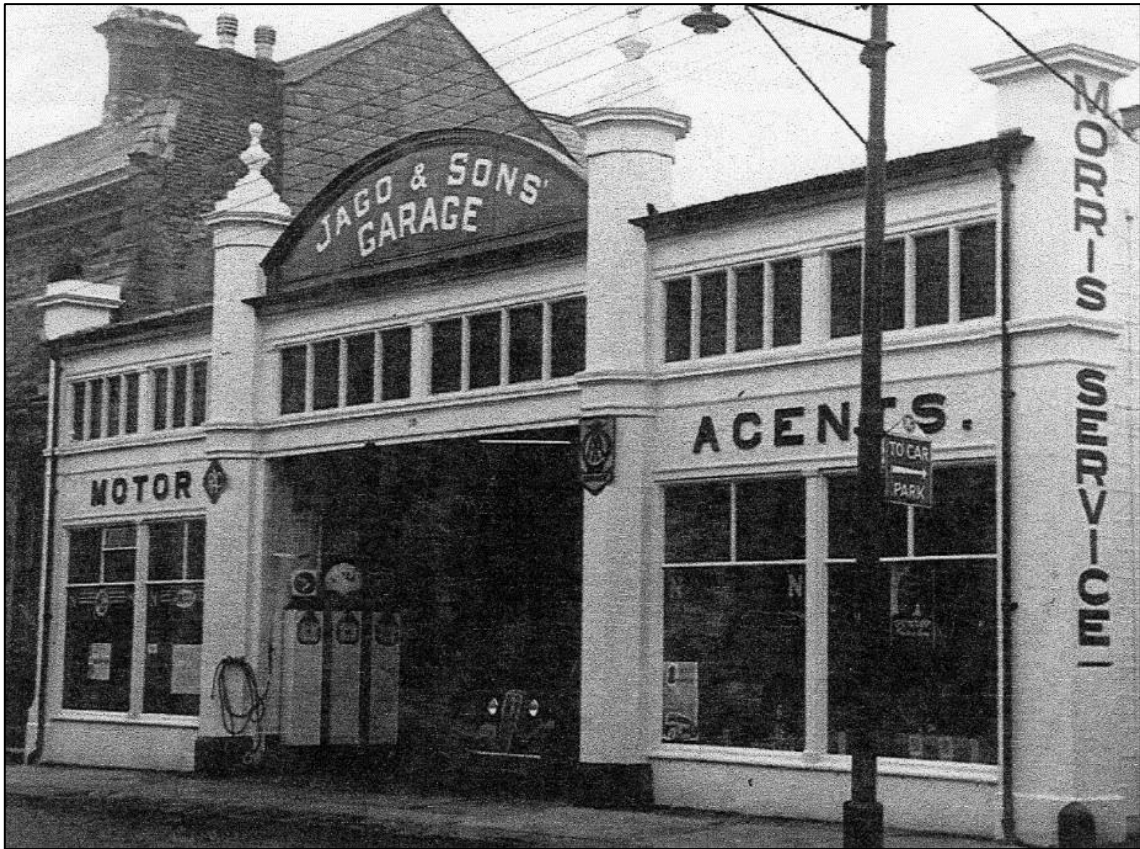
Fig 48 The former Jago's Garage (13), Dean Street, probably in the 1940-50s. (Photograph courtesy Liskeard Old Cornwall Society).

- Surviving boundary walls (**1, 8, 27, 32**);
- The original auction ring (**10A**); perhaps preservation/re-use of the original signage, gated entrance/exit
- Surviving 1905 cattle pens and surfacing (**10**) (perhaps preservation of a small 'sample' against the southern boundary wall (**8**) of the site?);
- Coronation (Welfare) Centre (**15**) (remove post-war extension and refurbish?);
- Façade of ATS garage (**13**) (restore original decorative elements and fenestration; cf Fig 48).

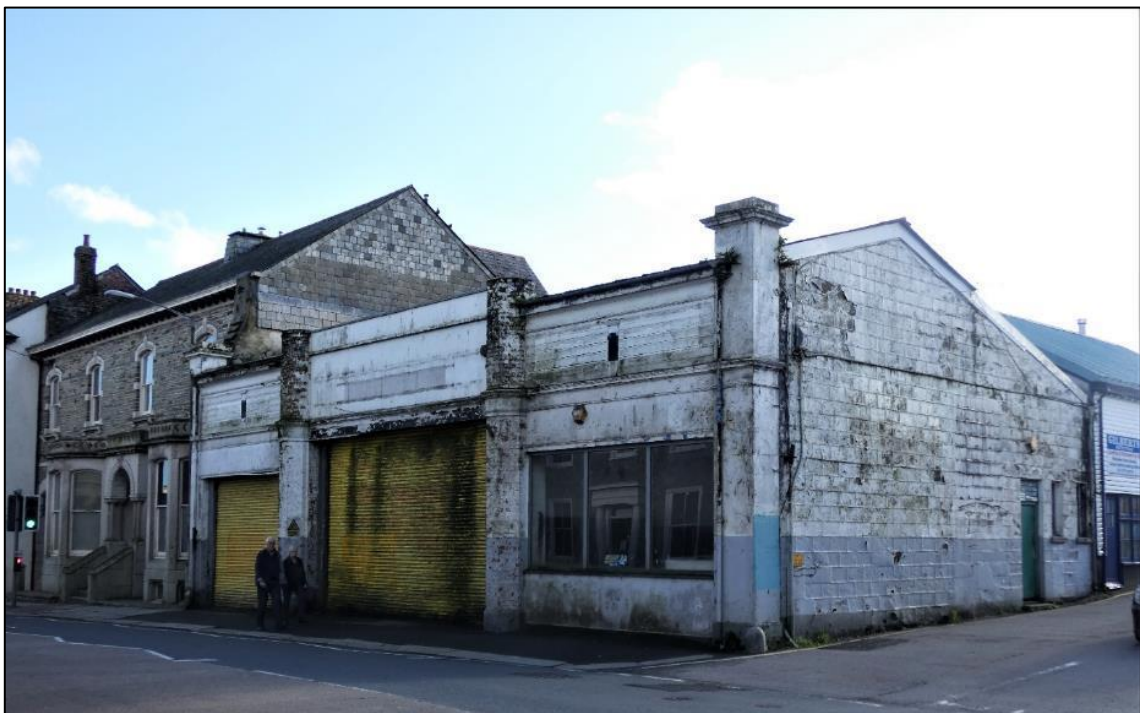
Fig 49 The ATS garage (former Jago & Sons) (13), Dean Street, with Rosedean House to the left.

- If the façade of the ATS garage is not to be preserved (above) the opportunity should be taken to move the front elevation of the replacement on the site backwards (south) to reinstate the historic street line and enhance appreciation of the front elevation of the adjacent Rosedean House and the designated buildings adjacent.
- Consideration should be given to views into the proposed development along the historic axis of Fair Park Road, including from the front elevations of nos 17 and 19-21 Dean Street (NHLE 1281818, 1206506).

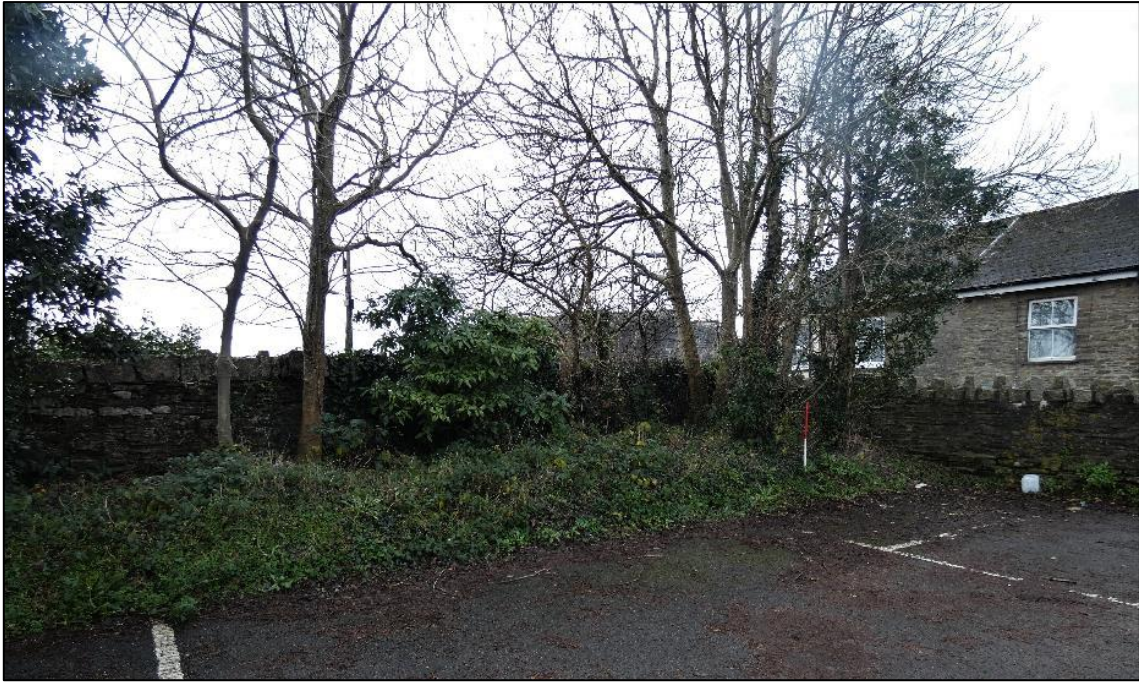
Fig 54 A surviving length of the 1905 northern boundary to the Fair Park (27).

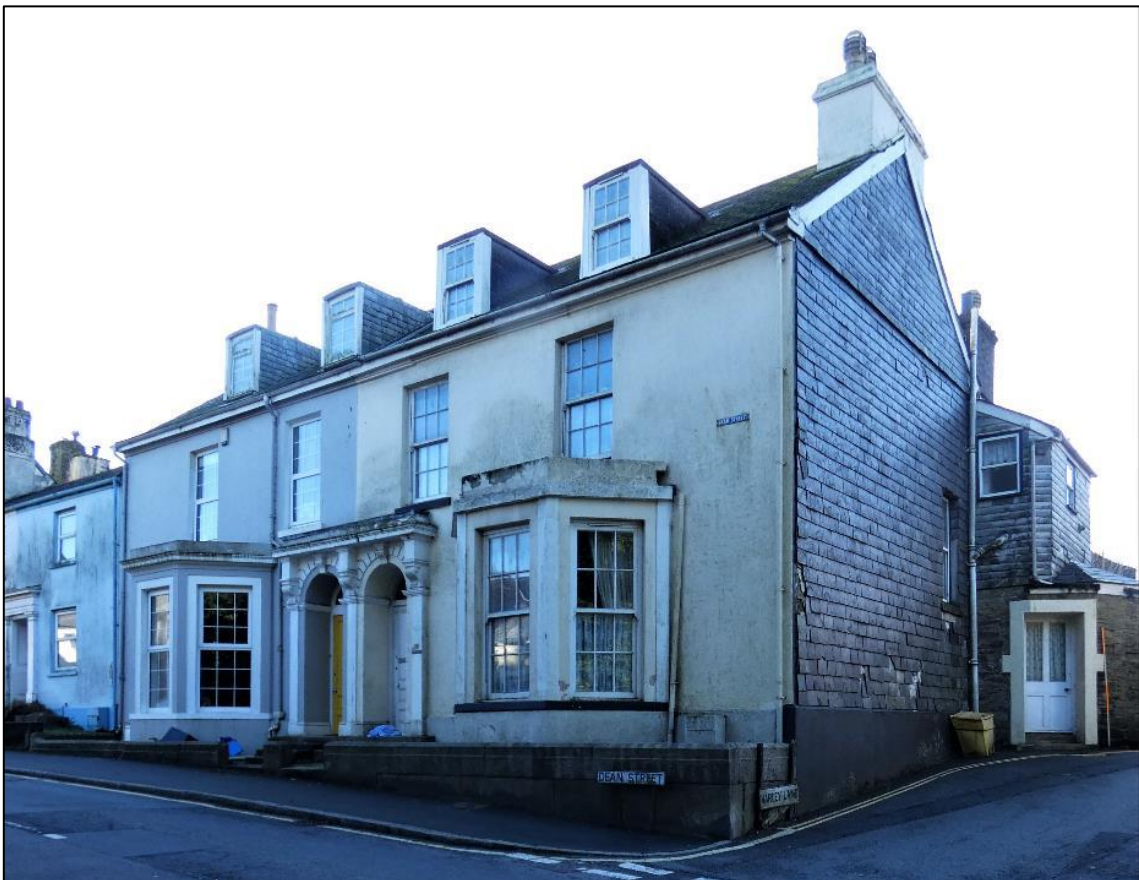
Fig 55 Nos 26 and 28 Dean Street (28), looking south east, with Varley Lane at right.

No 28 Dean Street is one of a pair of single-fronted villas (Fig 55) suggested to have been designed by local architect Henry Rice and built c 1850 (Vaughan-Ellis *et al* 2010, 24; MCO 55980). In the context of the almost total designation of other Rice buildings in Dean Street they are unaccountably not Listed. They were, however, classed as 'Other significant buildings' by Gillard (2005, fig 5).

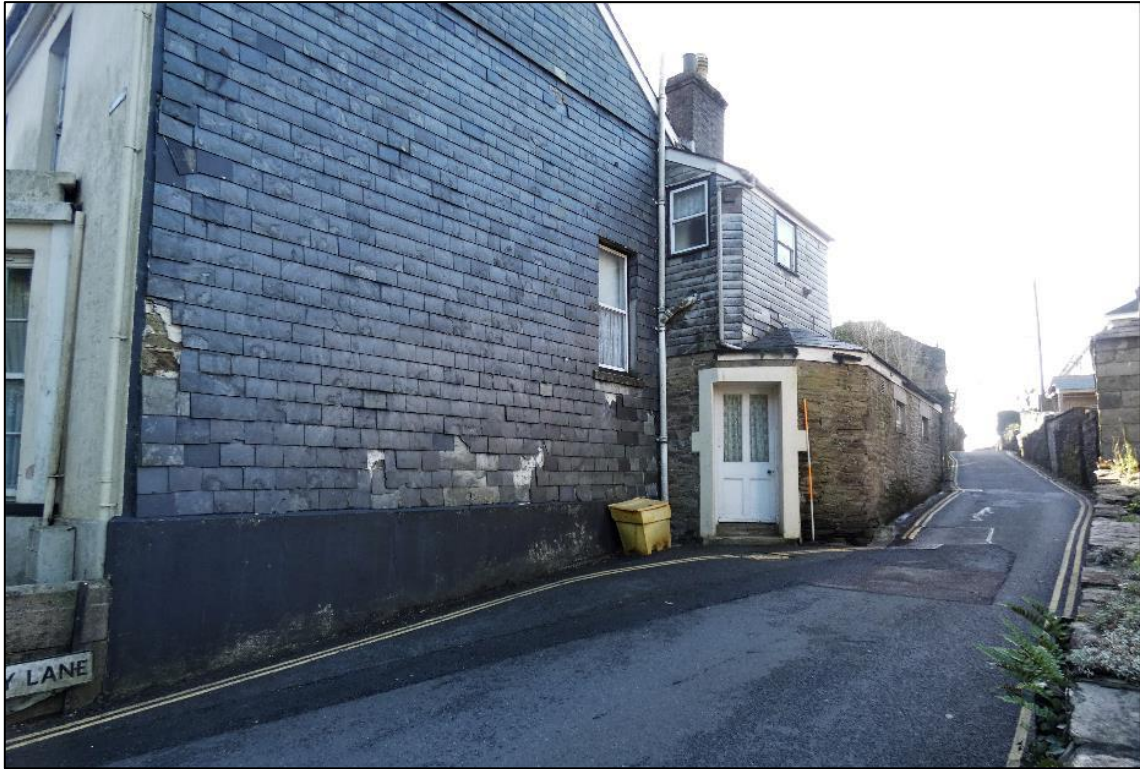
Fig 56 Varley Lane looking south, with the slate-hung gable and projecting side block of 28 Dean Street (28) on the left.

The western gable of no 28, facing onto Varley Lane, is slate hung (Fig 56) and forms a prominent landmark on the approach along Dean Street from the west, signalling the transition from the quasi-suburban zone of trees, gardens and terraces set back from the road to the properly urban character of the historic core of Liskeard (*cf* the boundary between Character Areas indicated by Gillard (2005, fig 7). The slate hanging on the gable is in need of appropriate conservation work.
