Liskeard Cattle Market, Liskeard, Cornwall Heritage Assessment

Liskeard Cattle Market, Liskeard, Cornwall

Heritage Assessment

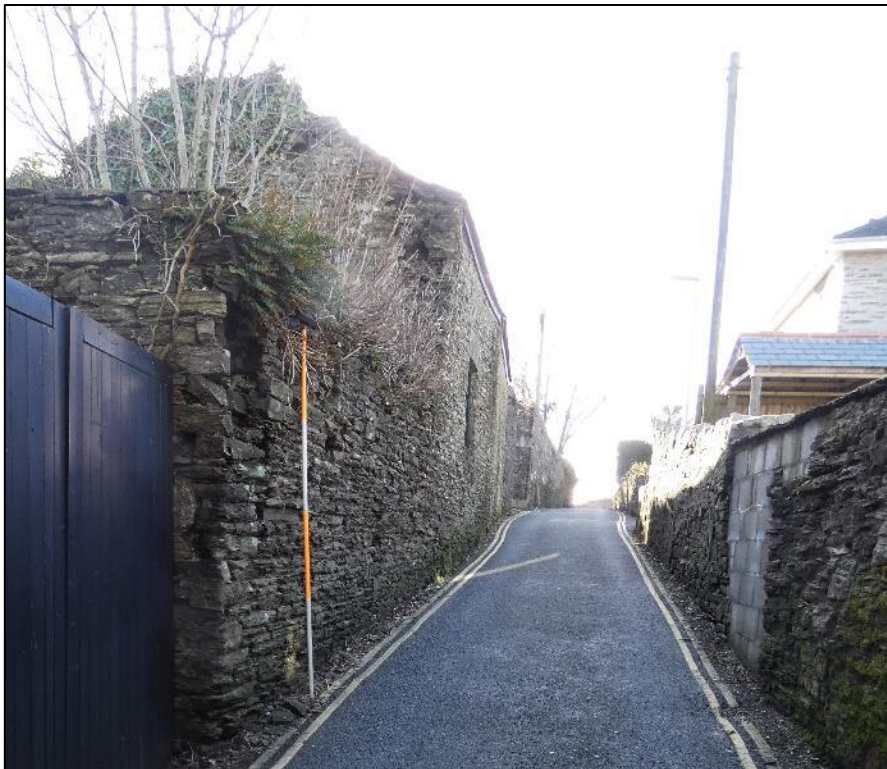
Fig 57 Varley Lane looking south, with the boundary wall and buildings (29) to the rear of 28 Dean Street at left.

To the rear of 28 Dean Street a long boundary wall runs south along the east side of Varley Lane (Fig 57). Much of this wall is more than 2m high and, where it forms the western wall of a range of buildings it is more than 3m high; it is built of mortared local killas and parts are now in poor repair.

To the south of the gateway the wall has been repaired and granite 'crenellation' added, most probably at the time the land to the east was taken into the enlarged cattle market site during the 1970s. Towards the southern end of this length is a blocked entrance, probably formerly providing pedestrian access via steps to the Fair Park. A wall extending east along the present northern boundary of the Fair Park area is likely to have been refurbished and crenellations added at the same time.

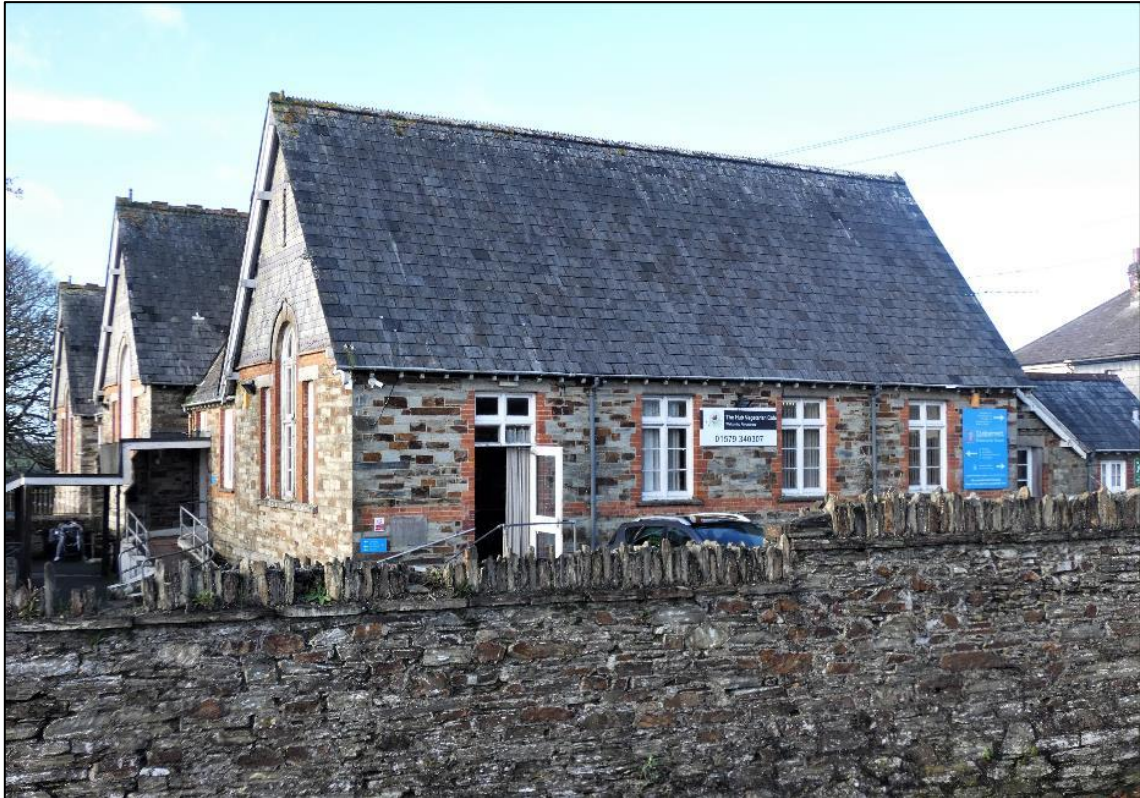
Fig 58 The Liskerret Centre (**30**), looking west. It was originally a Board School for 400 children, opened in 1882.

The building is a substantial structure in local killas with brick detailing and prominent steeply pitched roofs on the three main north-south blocks (Fig 58). The roofs are slated (asbestos?) and the upper parts of some gables have decorative slate hanging. There are a number of extensions, almost all in keeping with the original and probably early in its history, including a two-storey block on the west end added before 1905.

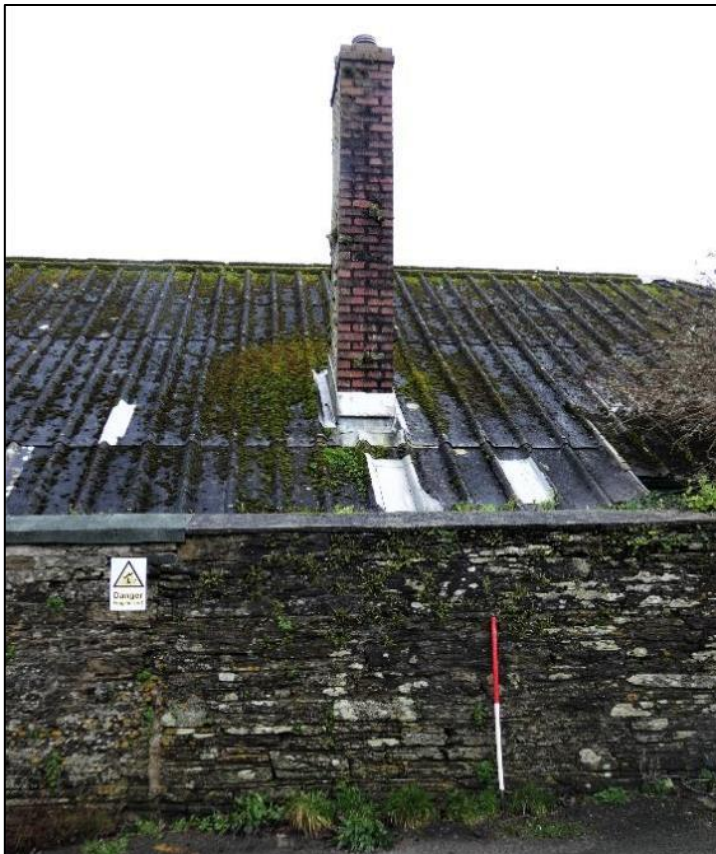
Fig 59 The boundary wall (**32**) to the rear of the Welfare Centre (**15**) with prominent brick stack).

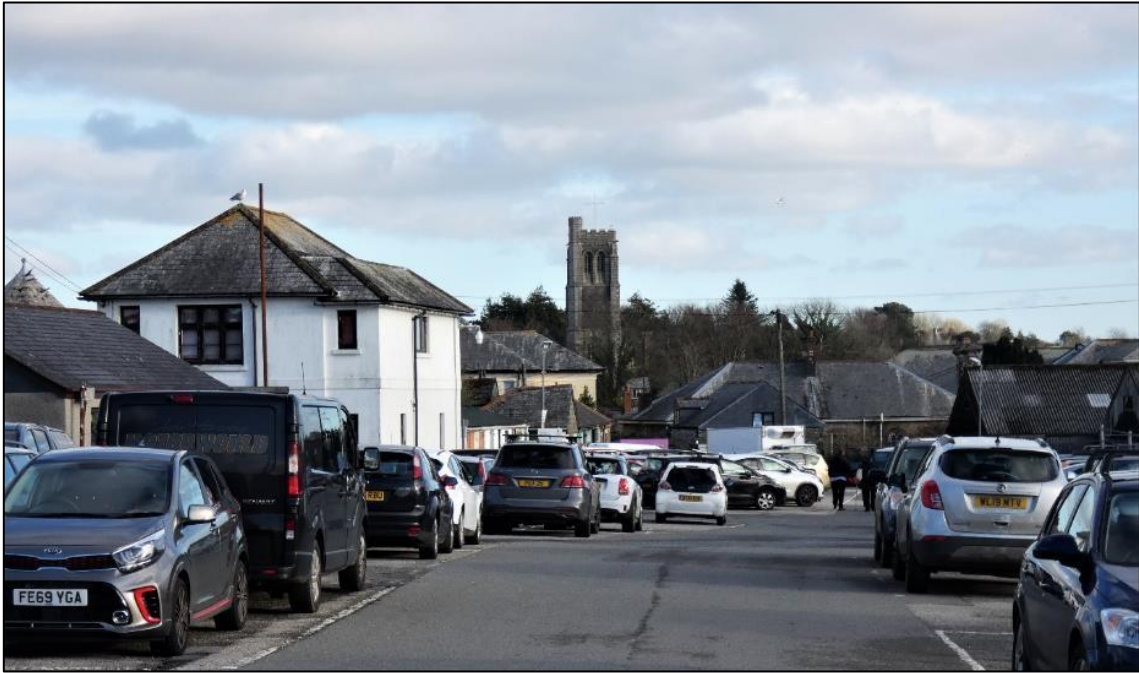
Fig 60 A key view east from the historic market site towards the tower of St Martin's church and skylined trees.

- East from most of the site to the skylined tower of St Martin's church (NHLE 1206300) and adjacent trees (Fig 60);
- West across the site to the prominent roofs of the Liskerret Centre (HER MCO 53212) (**30**) (Fig 63);
- North to the rear elevation of Rosedean House (NHLE 1281817) (Fig 62);
- North along Fair Park Road to 17 and 19-21 Dean Street (NHLE 1281818, 1206506) (Fig 66);
- South to the roof turret and lantern on Hollywood (local designation) (Fig 64)
- East to the roof and ornamental chimneys on 1 and 8 Windsor Place (NHLE 1187319) (Fig 61);
- East to the turret on the former National Westminster Bank on the corner of Dean Street and Windsor Place (NHLE 1281795) (Fig 65).

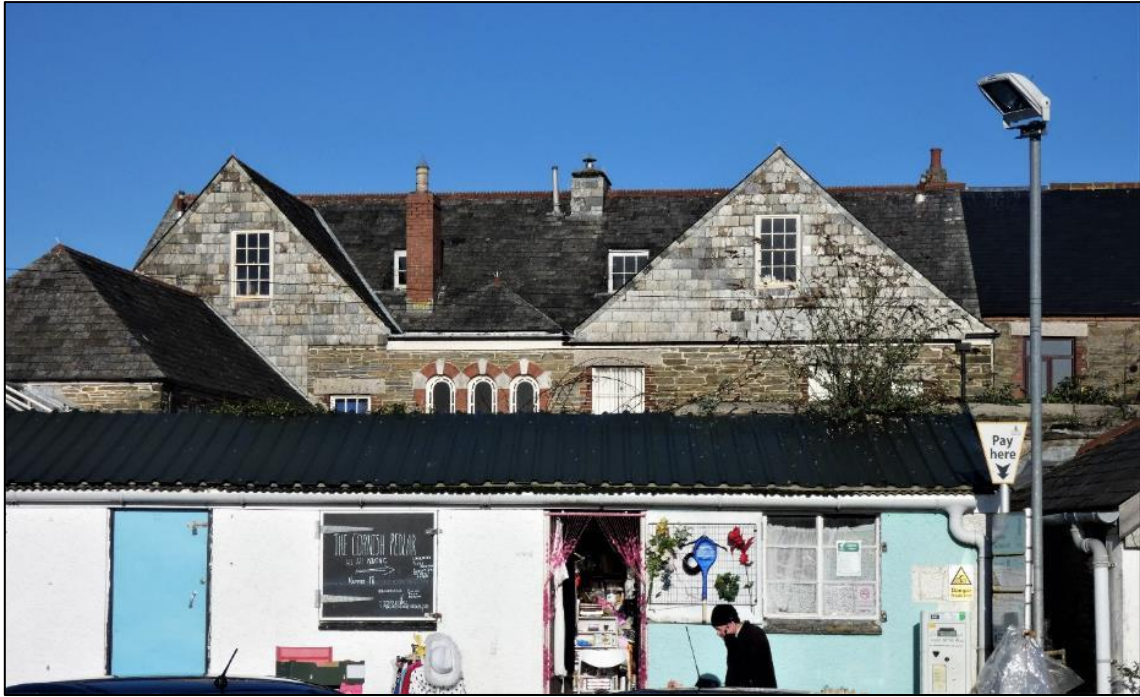
Fig 62 View north from within the cattle market site to the rear elevation of Rosedean House (Listed Grade II).

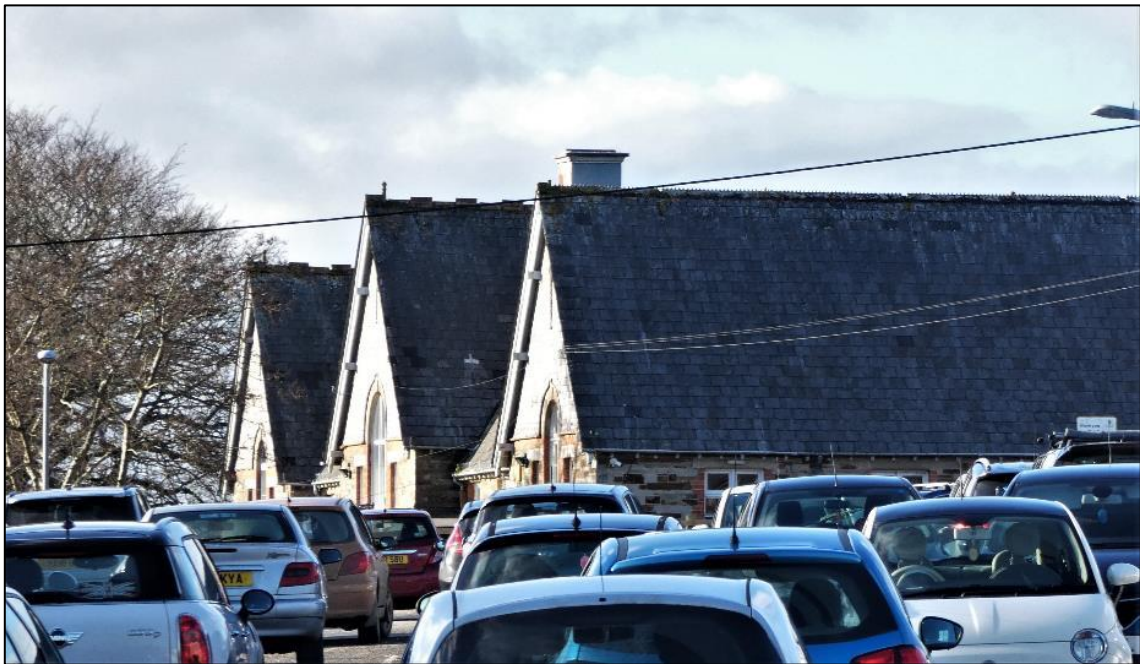
Fig 63 The view west from within the cattle market site to the steep roofs and prominent decorated gables of the former Board School, now the Liskerret Centre (30).

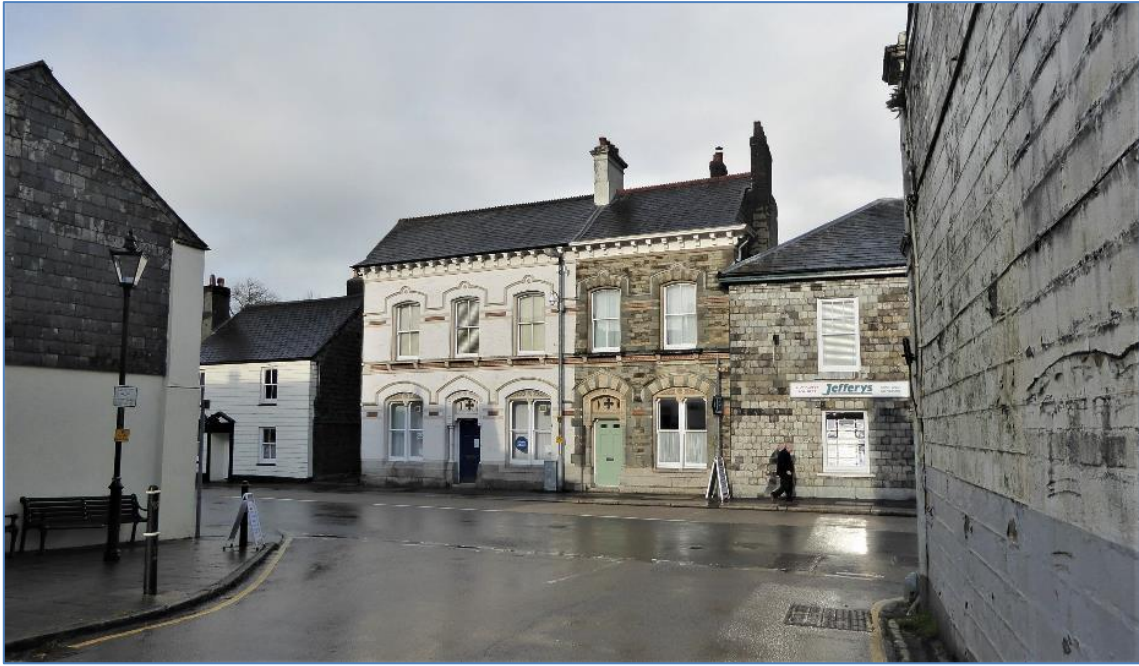
Fig 66 The view north from Fair Park Road to a series of Listed Buildings on the north side of Dean Street (from right to left, nos 17, 19 and 21, and 23).
