**Preliminary Ecological Appraisal  
for  
Liskeard Cattle Market & Community  
Centre,  
Liskeard,  
Cornwall**

17 September 2019

**Prepared for:**  
CORMAC

**Prepared by:**  
Cornwall Environmental Consultants (CEC Ltd)  
Five Acres  
Allet  
Truro  
TR4 9DJ

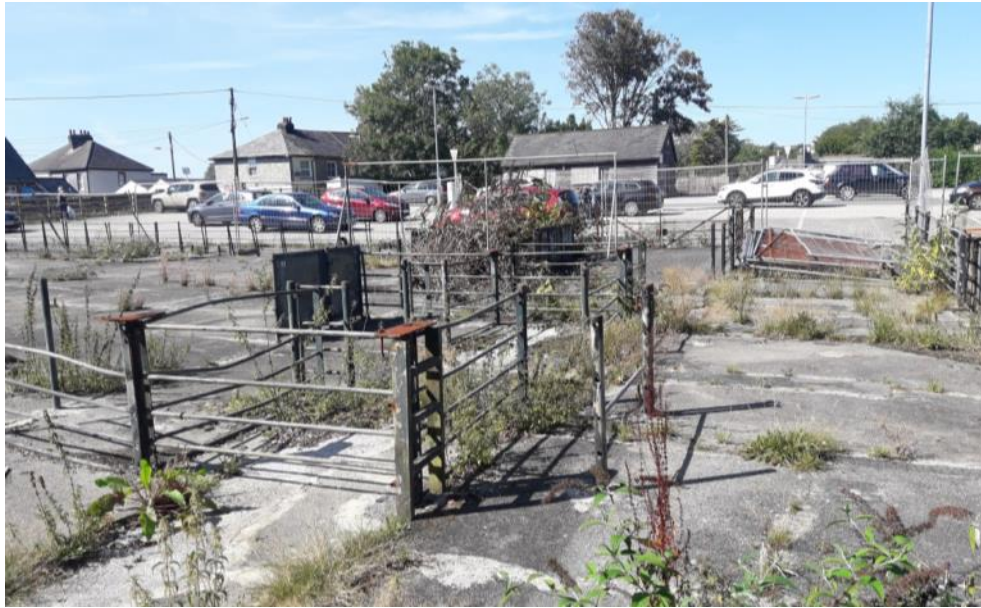
**Figure 4: Site overview**

As previously described, this 1.87ha urban site is dominated by hard-standing and buildings; aside from this, there are numerous scattered mature broadleaved trees, introduced shrubs, dense scrub, tall ruderal, scattered scrub, ephemeral grassland and a species-poor hedge. See Figure 4 below, showing the overall character of the site.

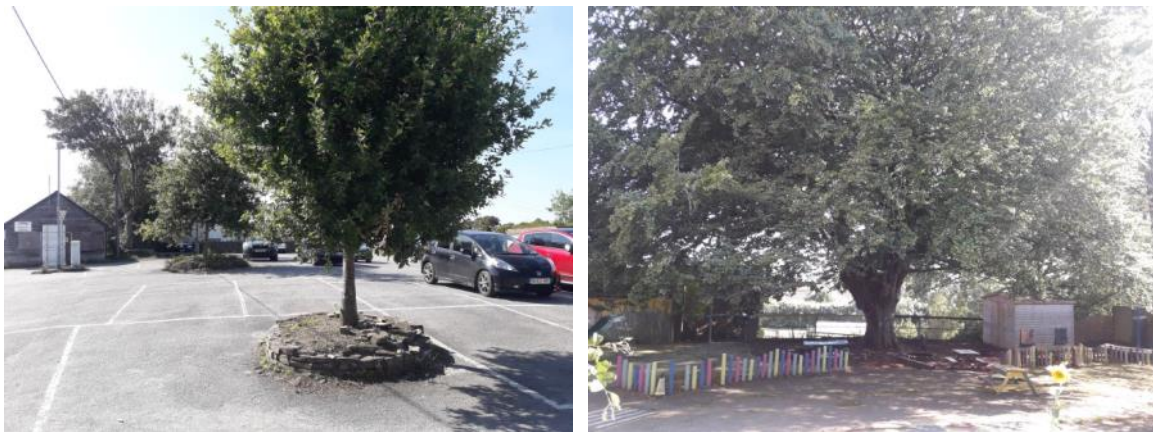
**Figure 5: Scattered broadleaved trees**

There are numerous broadleaved trees scattered throughout the Cattle Market and Community Centre; this includes mature trees such as TN4 shown in Figure 5, which is a beech tree with a diameter of c. 1.5m. Sycamore is the most common species present, other species include: ash, sessile oak, field maple, beech, cultivated apple, alder, hazel, copper beech, holly, cultivated cherry, pear and grey willow. It is not known which trees will be retained and which will be removed at the time of writing.

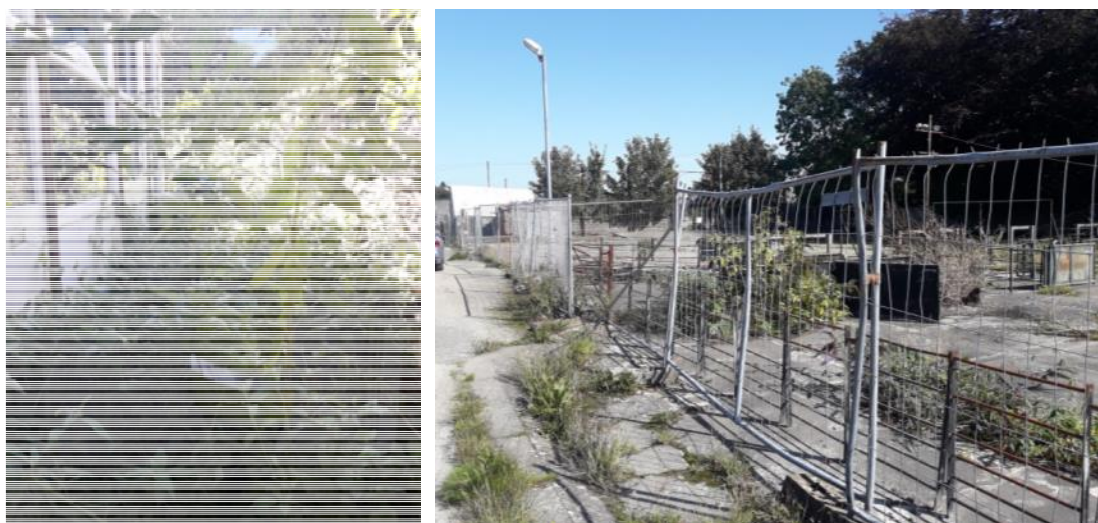
**Figure 6: Dense & scattered scrub**

Scattered scrub is present in several locations on site; often in areas of ephemeral grassland that have grown through areas of hard standing, as shown in Figure 6 below. There are also three areas of dense scrub across the site (see locations in Map 1). Species present here are dominated by buddleja, with bramble, grey willow, pheasant berry, hawthorn, rose and the invasive non-native montbretia.

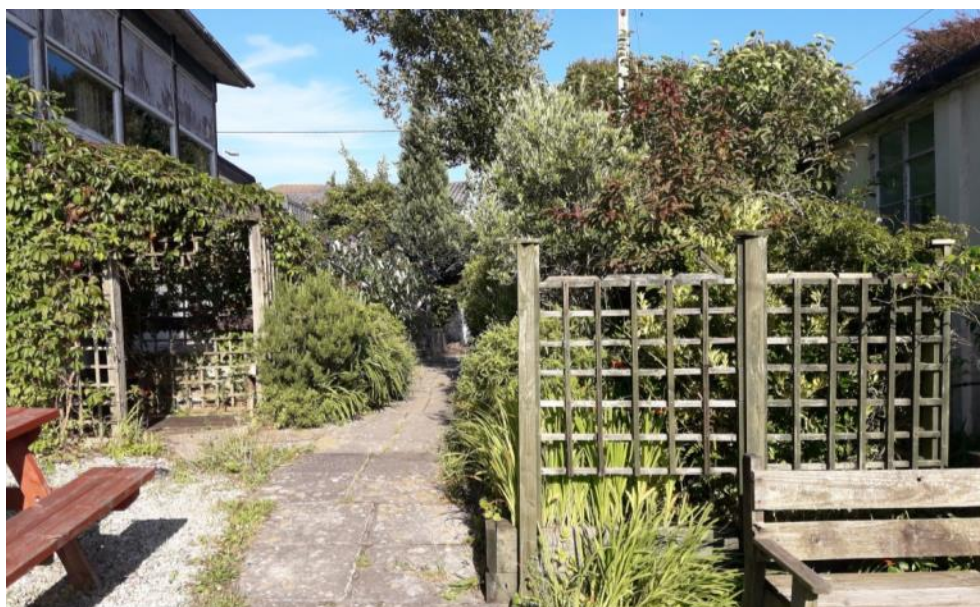
**Figure 7: Introduced shrub**

There are several areas of introduced shrubs on site, which have been planted up as garden borders as shown in Figure 7 below. In addition to this, there is also a species-poor hedge planted behind one of the properties on the northern border of the Cattle Market site.

Species present here include: hedge bindweed, Russian vine, pheasant berry, dogwood, leylandii, eleagnus species, euonymus, fuchsia, cherry laurel, rosemary, rose, berberis, elephant-leaved saxifrage, New Zealand cabbage palm, foxglove, escallonia, euphorbia, fig, treasureflower, tree mallow, lithodora, oleander, penstemon, New Zealand flax, pieris, castor oil plant, raspberry, common comfrey and great mullein. In addition, both Schedule 9-listed non-native invasive montbretia and cotoneaster are present.

It is assumed that some of this habitat will be lost to the new development. As a result, suitable mitigation measures for the partial loss of this habitat will need to be adopted. See Section 5.2.2.

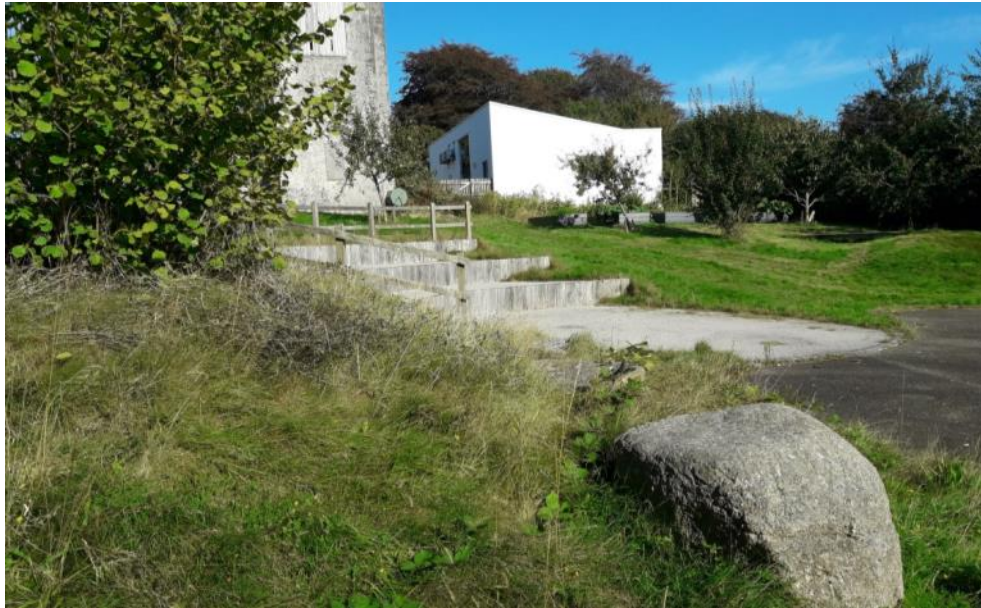
**Figure 8: Amenity grassland**

There are several areas of amenity grassland across the site. These vary in species composition and structure, as shown in Figure 8 below. Species present include those which are commonly associated with this habitat in an urban location: Yorkshire fog, common bent-grass, sweet vernal grass, cock's-foot, broad-leaved dock, common knotgrass, common cat's ear, perennial rye-grass, ribwort plantain, dandelion, white clover, daisy and greater plantain. Again, it is not known how much of this common habitat will be lost to the new development of the site. Possible mitigation measures for the loss of some of this habitat have been suggested in Section 5.2.2.

If amenity grassland is to be partially removed, and amenity grassland is proposed, an enhanced seed mix should be sown. These could be planted with either Emorsgate Seeds ELI or ENI which would be considered as suitable. Details regarding the management of these seed mix can be found at <https://wildseed.co.uk/mixtures/view/56> and <https://wildseed.co.uk/mixtures/view/61>, respectively. Once established, management should comprise mowing from late June, and cut again after 4-8 weeks.

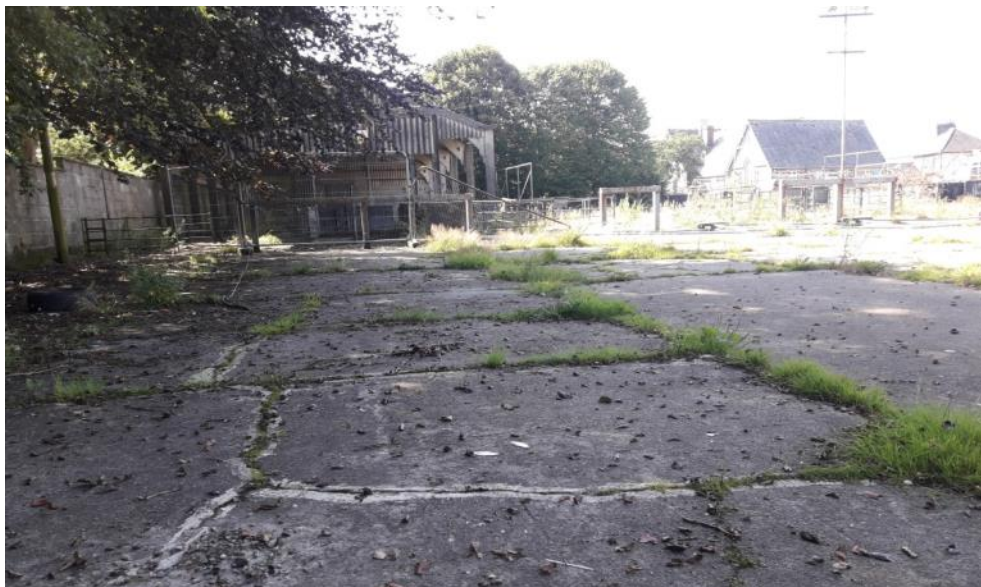
**Figure 9: Ephemeral grassland**

Ephemeral grassland is present in several areas across the site. This has arisen due to a lack of weed management of the areas of hardstanding. Species present in this common and widespread habitat include: dandelion, common nettle, marsh willowherb, common bent-grass, procumbent pearlwort, common knotgrass, stonecrop, thyme-leaved speedwell, broad-leaved dock, common cat's ear, white clover, bramble, false oat-grass, red valerian, ragwort, Yorkshire fog, perennial rye-grass, daisy, greater plantain, grey willow, creeping buttercup, lesser stitchwort and moss species.

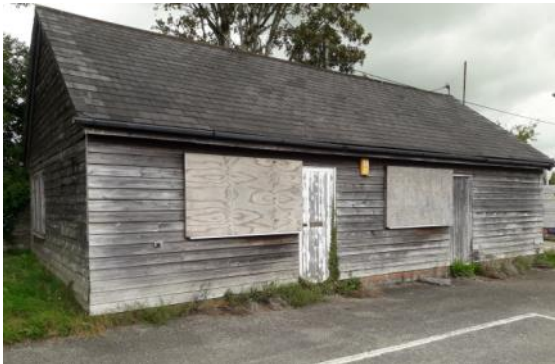
**Figure 10: Building 1**

- *Building 1* is the former market office and is single storey with timber walls and a pitched roof of timber covered with roofing felt which has been covered again with fibre cement slates. There is a false ceiling and enclosed roof void. No evidence of bats was found, however the batten space beneath the slates could not be searched.

**One emergence survey** is recommended for **Buildings 1, 2, 3, 4, 6, 19 and 22 but see below.** These buildings were assessed as offering some, albeit low, potential for roosting bats therefore further surveys will be required if the proposed work will impact on these buildings (e.g. demolition or works to the roofs and ceilings).

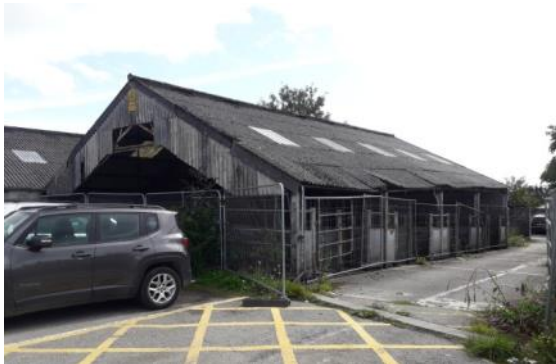
**Figure 18: Building 9**

- *Building 9* is similar to Building 8 but is open along the north and west sides. This building could not be accessed but the interior could be seen from the Heras fencing. No evidence of bats was found.

**No further surveys are recommended for Buildings 5, 7, 8, 9, 10, 11, 12, 13, 14, 15, 16, 17, 18 and 20.** These buildings were assessed as offering negligible potential for roosting bats and no further surveys will be required. Some of these buildings could be accessed and no evidence of bats was found; for the buildings that could not be accessed they were assessed as offering negligible potential due to their construction, the absence of external gaps where bats could gain access and the surrounding habitat.

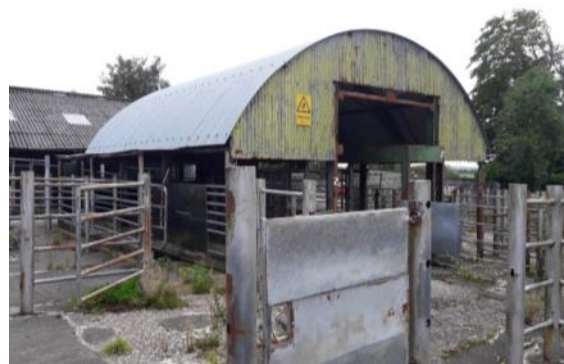
**Figure 19: Building 10**

- *Building 10* is a cattle ring and has a domed roof of galvanised steel and no walls. No evidence of bats was found.
- *Building 11* is single storey with walls of single row concrete block and a pitched roof of corrugated fibre cement sheets. No evidence of bats was found.

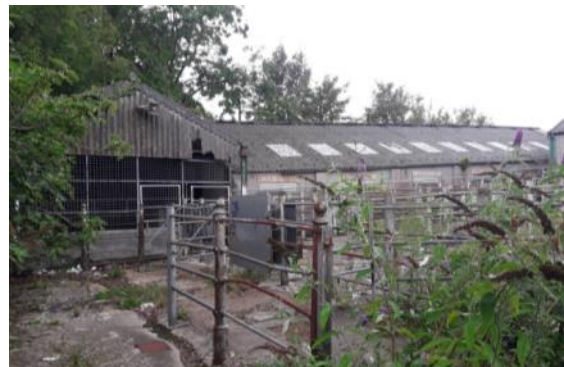
**Figure 21: Building 12**

- *Building 12* is single storey with walls of single row concrete block and a pitched roof of corrugated fibre cement sheets. No evidence of bats was found.

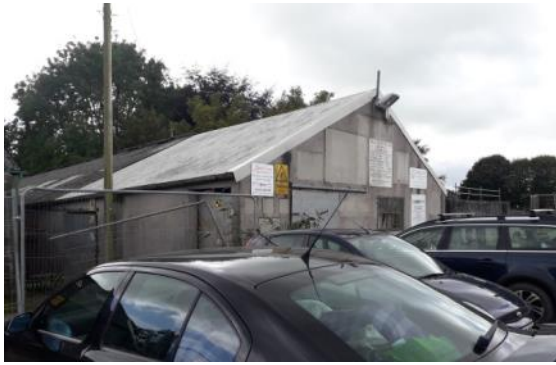
**Figure 22: Building 13**

- *Building 13* is single storey with walls of single row concrete block and a pitched roof of corrugated iron and galvanised steel. No evidence of bats was found.

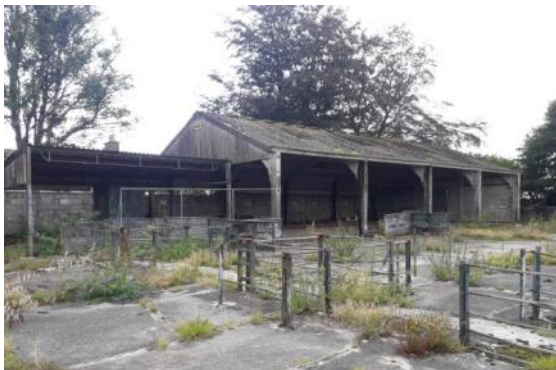
**Figure 24: Building 15**

- *Building 15* is a shed with two walls of single row concrete block (open along the north and east sides) and a pitched roof of corrugated fibre cement sheets. No evidence of bats was found.
- *Building 16* is owned by Western Power and is single storey with walls of single row concrete block and a sloping roof of natural slate. This building could not be accessed.

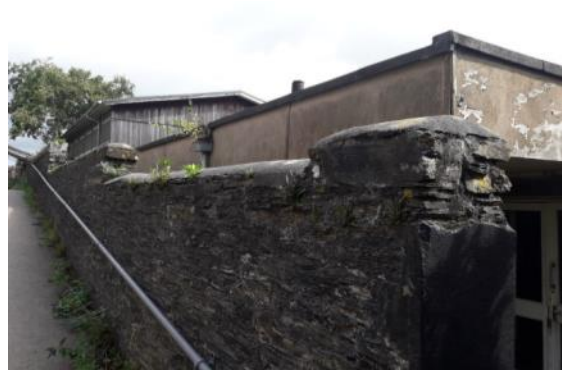
**Figure 27: Building 18**

- *Building 18* is a hall and workshops, and is single storey with a flat roof at the western end and a pitched roof covered with roofing felt at the eastern end. There is a false ceiling beneath the pitched roof with an enclosed roof void c. 1m in height but no loft hatch therefore this area could not be accessed. No evidence of bats was found within the areas that could be accessed.

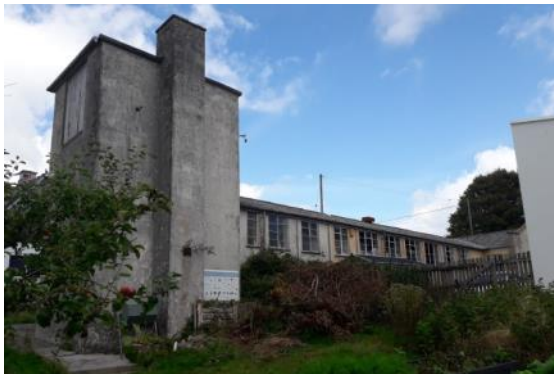
**Figure 28: Building 19**

- *Building 19* is a single storey dance school with a pitched roof of corrugated fibre cement sheets and vaulted ceilings. There is a water tower at the western end. No evidence of bats was found but the batten space between the roof and vaulted ceilings could not be searched.

As buildings 4, 19 and 22 are proposed for demolition, further surveys are recommended to ascertain how bats are using these two buildings. see Section 5.3. The findings of these surveys will recommend site and species-specific mitigation measures. The development must take into account the presence of bats and retain access and suitable roosting site/s for bats. An European Protected Species (EPS) licence or a Bat Mitigation Class Licence (BMCL) may be required from Natural England before the planned work can lawfully commence.

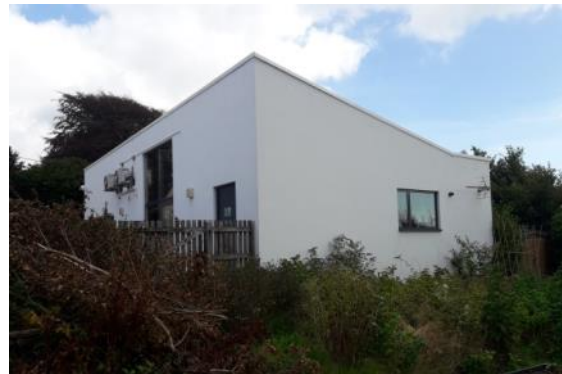
**Figure 29: Building 20**

- *Building 20* is single storey with a sloping roof, assumed to be either metal or concrete (the top of the building could not be seen from the ground). This building could not be accessed.

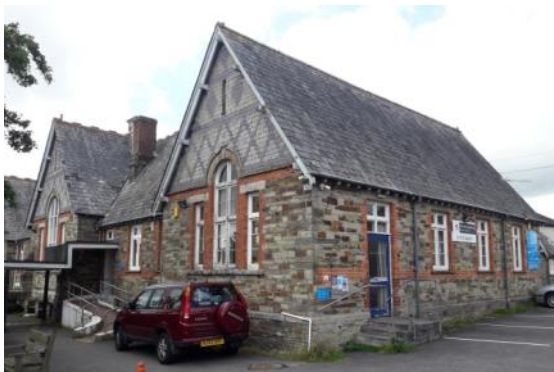
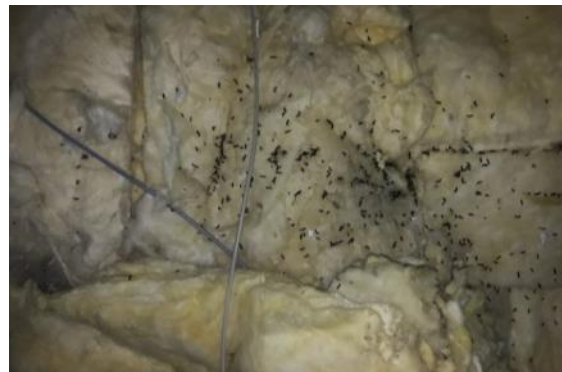
**Figure 30: Building 21**

**Figure 31: Long-eared bat droppings in Building 21**

- *Building 21* is the community centre and is single storey with a lower ground floor at the western end. It has stone walls and pitched and hipped roofs of natural slate underlined with bitumen felt. There are false ceilings and enclosed roof voids: the original ceilings are still in place and newer ceilings have been installed beneath, creating upper voids c. 3m in height with voids beneath c. 2m in height. The roof spaces at the eastern end were accessed and searched, however the voids at the western end could not be accessed. Long-eared *Plecotus* sp. bat droppings were found

Evidence of bats was found within **Building 21** therefore further surveys will be required if the proposed work will impact on this building. **Two emergence surveys and a week of remote monitoring** during the active bat season (May to September) are recommended for Building 21; the majority of these surveys should be completed during the optimal survey season (May to August).

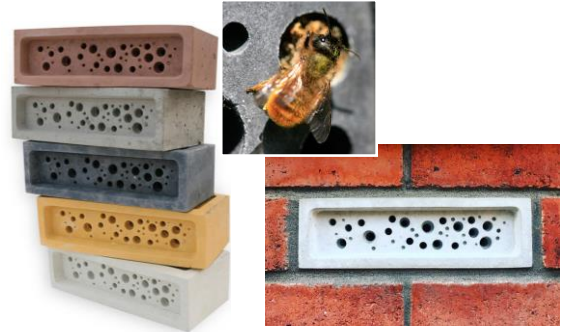
- The bee brick provides a stylish nesting site for red mason bees and leafcutter bees, amongst others, and makes a real design statement in any garden, allotment or within the external walls of building.
- Available in a range of colours.
- **Measurements:** 215 x 105 x 65mm; 2.9kg.

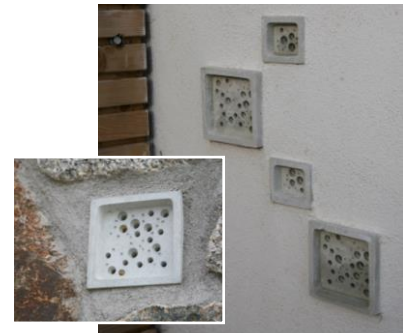
- A freestanding bee nest which can be placed in your garden or which can also be built into walls to provide additional habitat for solitary bees.
- Available in two sizes and in a range of colours.
- **Measurements:** **Large:** 105 x 105 x 105mm; 2.8kg & **Small:** 65 x 70 x 105mm; 1.1kg.
