PHASE II GROUND INVESTIGATION REPORT

**OUTREACH COMMUNITY HUB, STATION ROAD, SHOTTON COLLIERY,
CO. DURHAM, DH6 2JL
PREPARED FOR D3 ASSOCIATES**

Project No.	GEOL23-7823	Client	D3 Associates
Report Type	Phase II Ground Investigation Report		
Project Type	Proposed New Youth Club		
Site Address	Outreach Community Hub, Station Road, Shotton Colliery, Co. Durham, DH6 2JL		
NGR	439180, 541320		
Date	30/06/2023		
Prepared by Qualifications Position	William Howells BSc (Hons) MSc Graduate Geoenvironmental Engineer

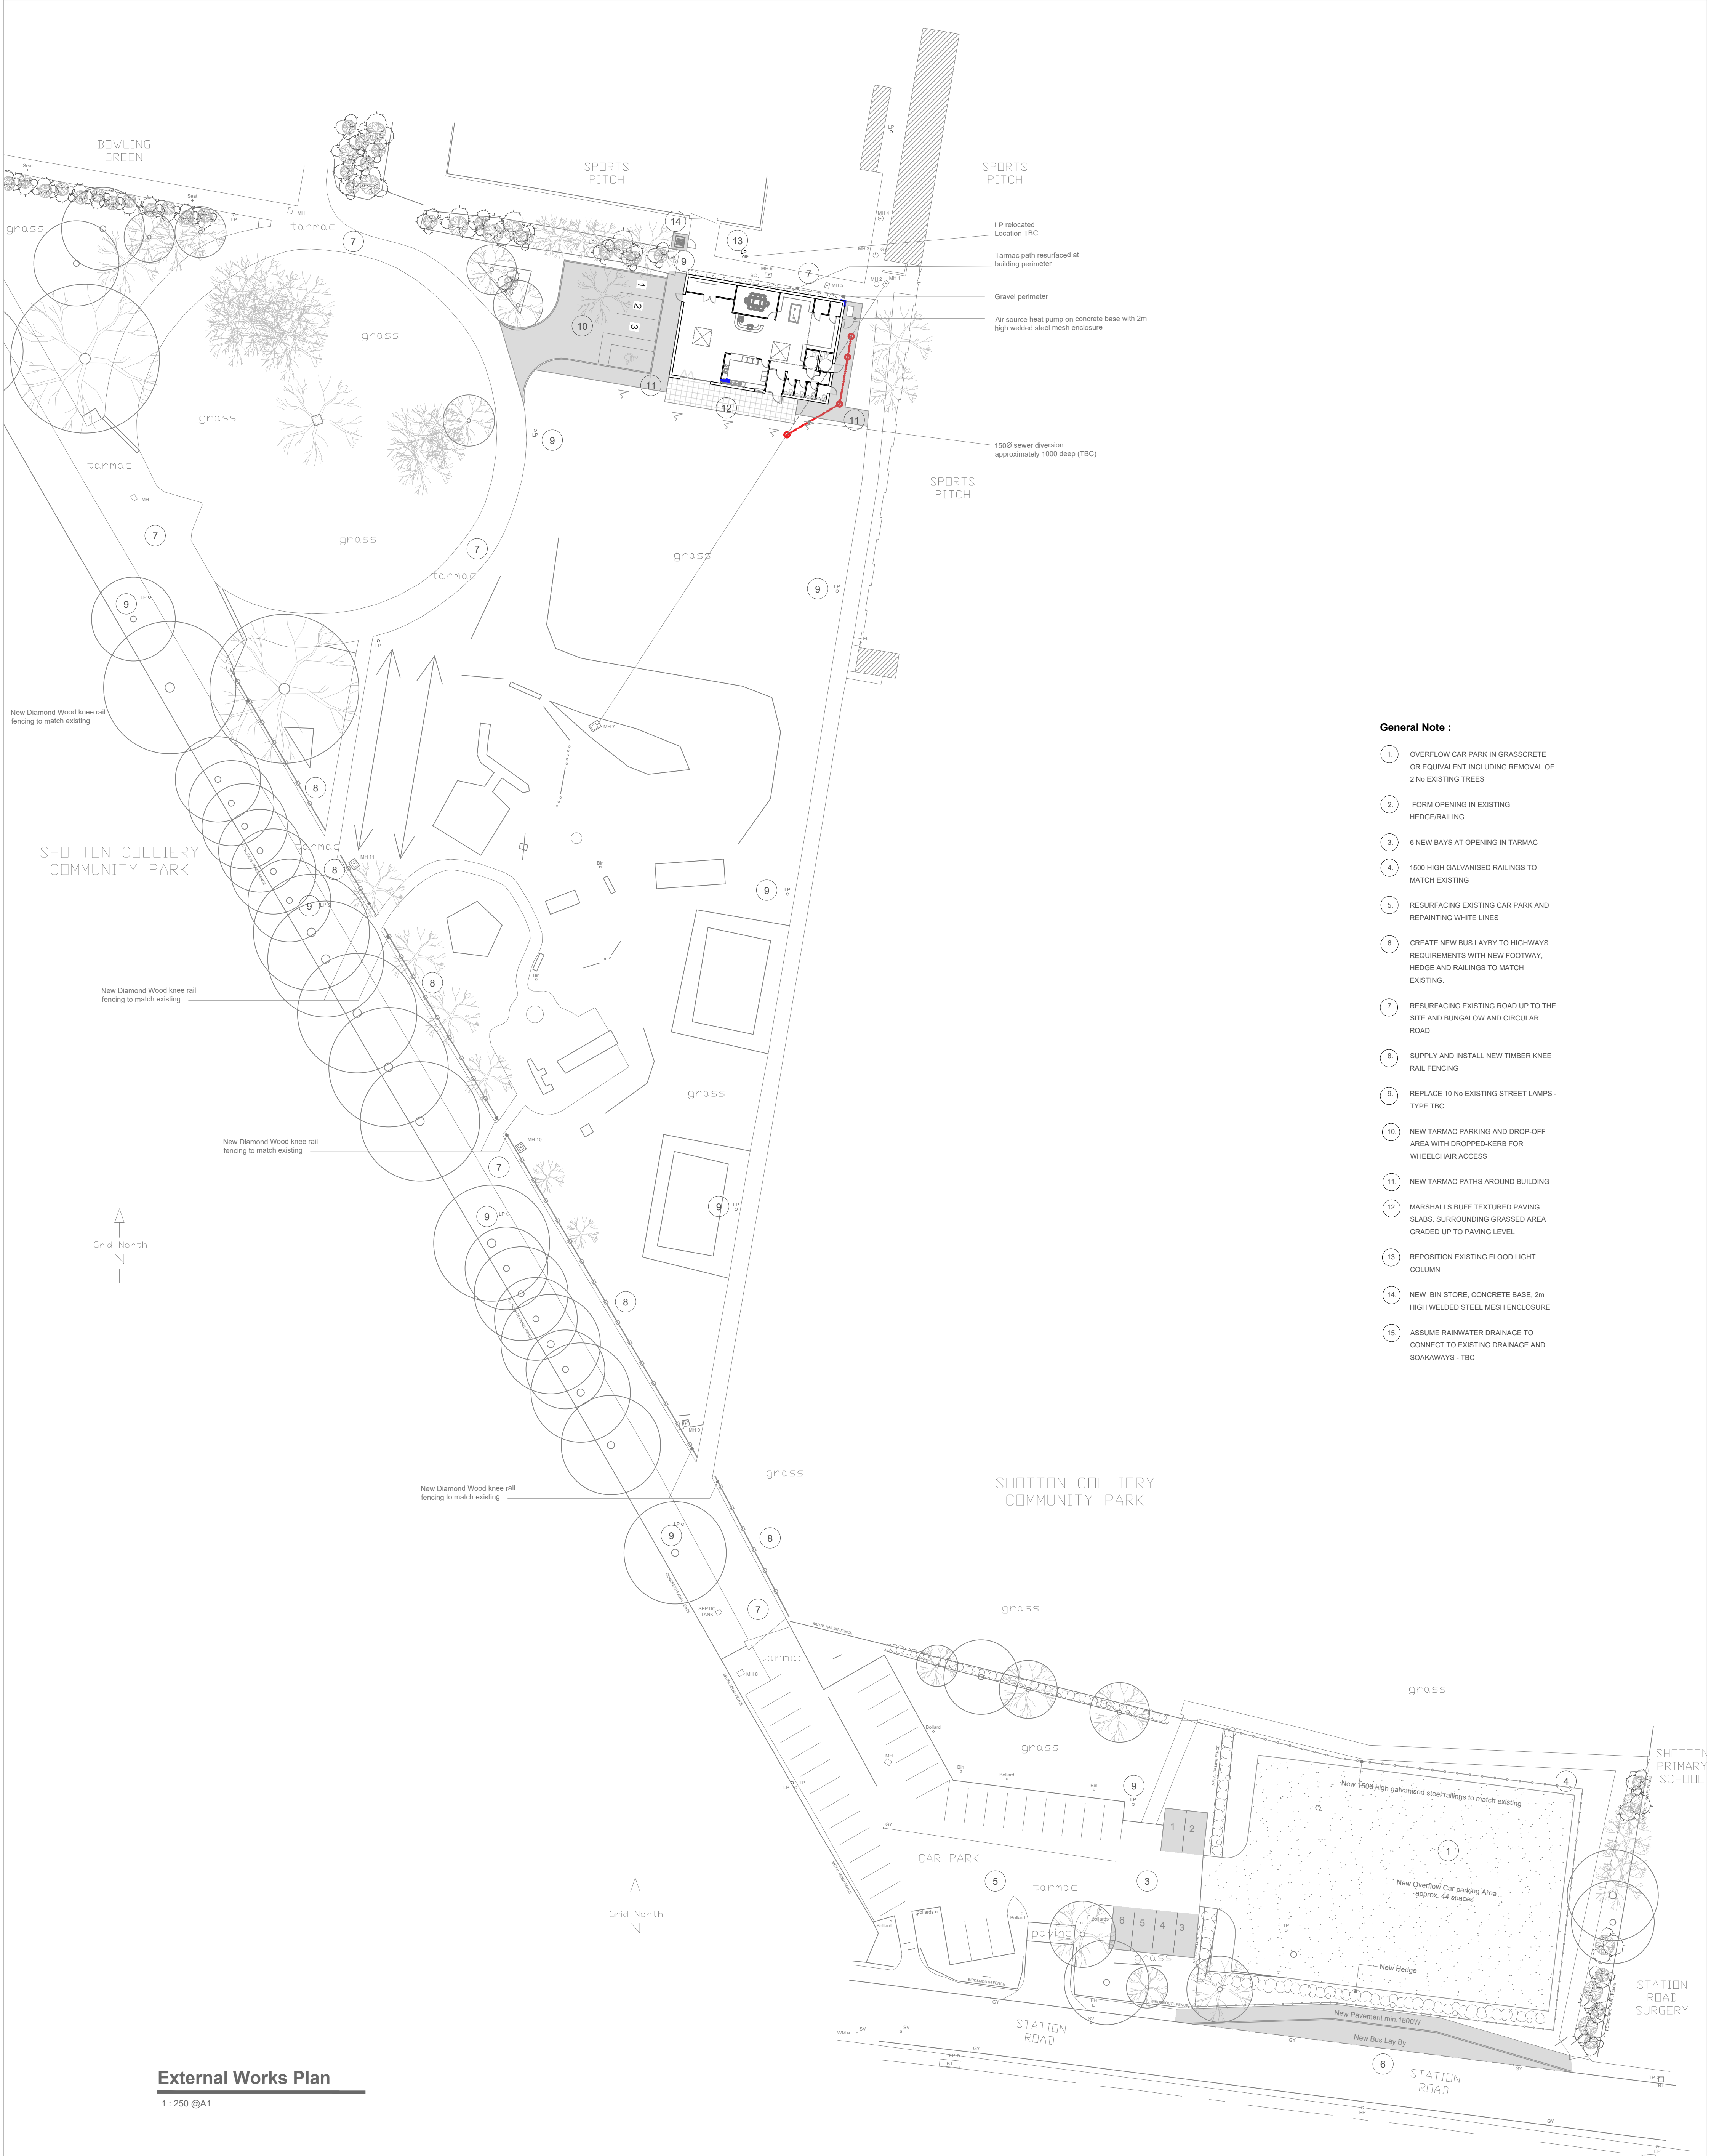
Geol Consultants Limited (GEOL) were instructed by D3 Associates to undertake appropriate ground investigation works to facilitate a proposed new Youth Club building and overflow car park at Shotton Parish Community Park, situated off Station Road in the Co. Durham village of Shotton Colliery. The Youth Club building is to replace an existing changing room facility once demolished and the overflow car park will adjoin the existing car park sited in the south of the Community Park.

A copy of the External Works Plan provided by D3 Associates can be seen attached in Appendix I. A Phase I Preliminary Contamination Risk Assessment (PCRA) was completed for the site, and considers the new development proposals, by GEOL, reference GEOL23-7823, dated April 2023. The PCRA should be read in conjunction with this Phase II Ground Investigation Report (GIR).

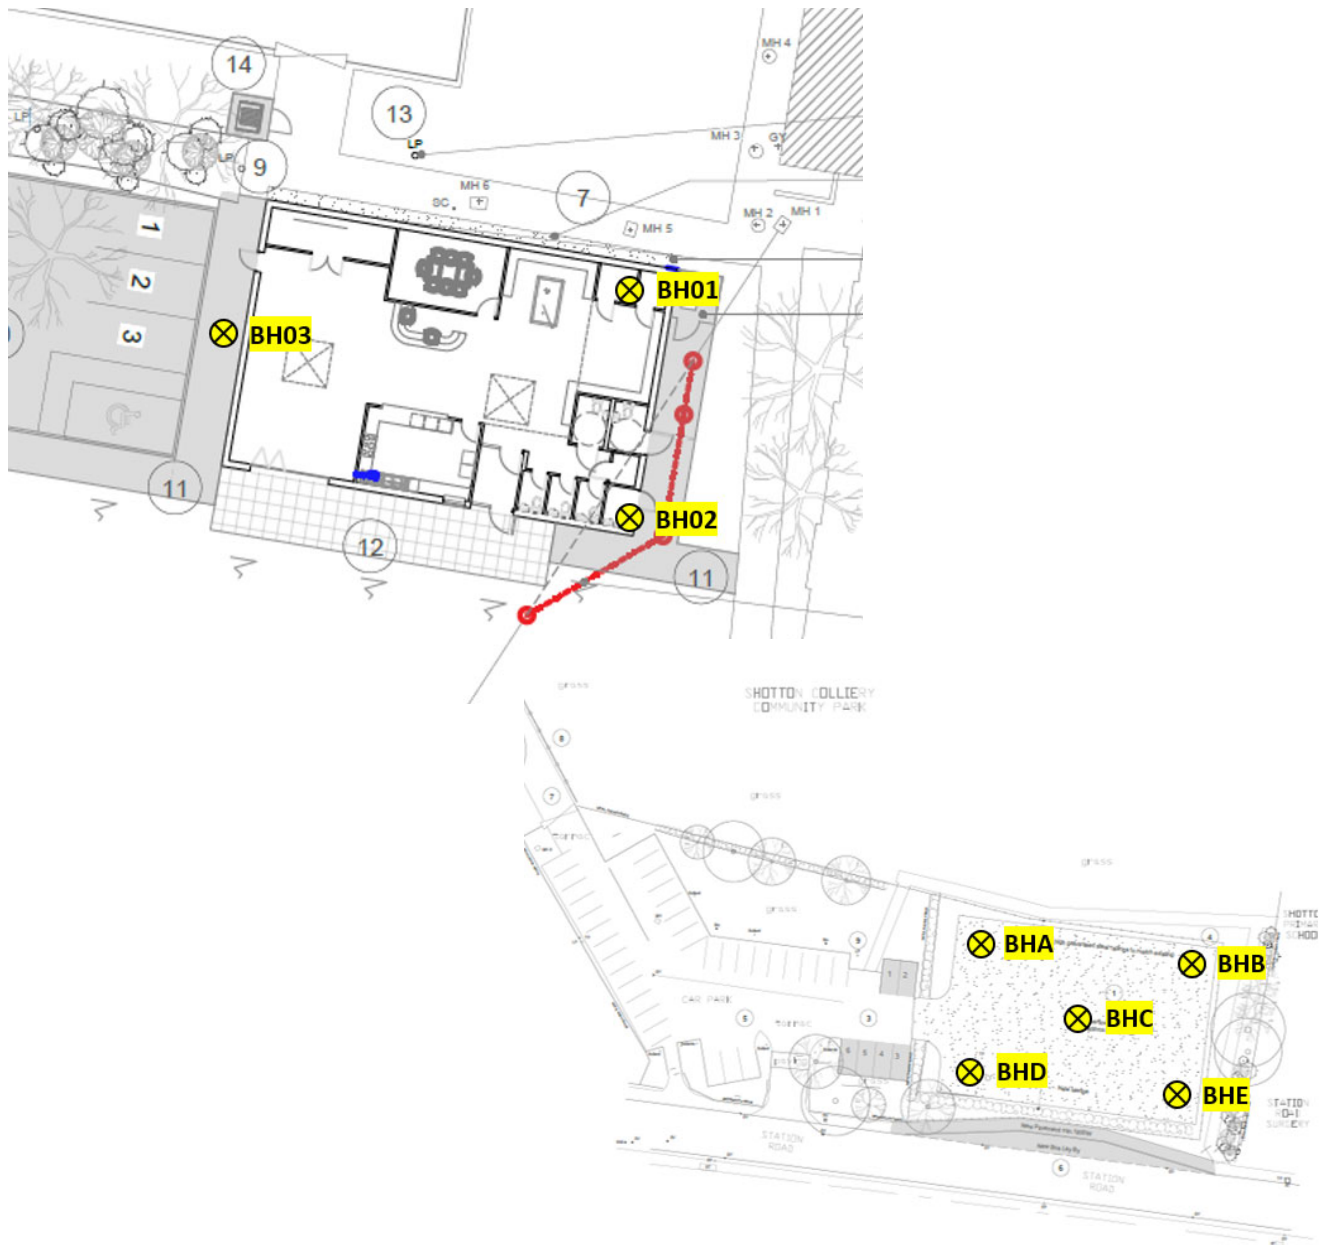
BOREHOLE LOCATION PLAN

To determine the ground conditions below the site area, the ground investigation works completed by GEOL comprised the sinking of 8 no. windowless sampling boreholes, labelled BH01 to BH03 and BHA to BHE. Detailed descriptions of the strata encountered during the investigation works, together with the results of all insitu field testing, are presented on the borehole record sheets attached in Appendix II. The investigation positions can be seen on the borehole location plan attached in Appendix II.

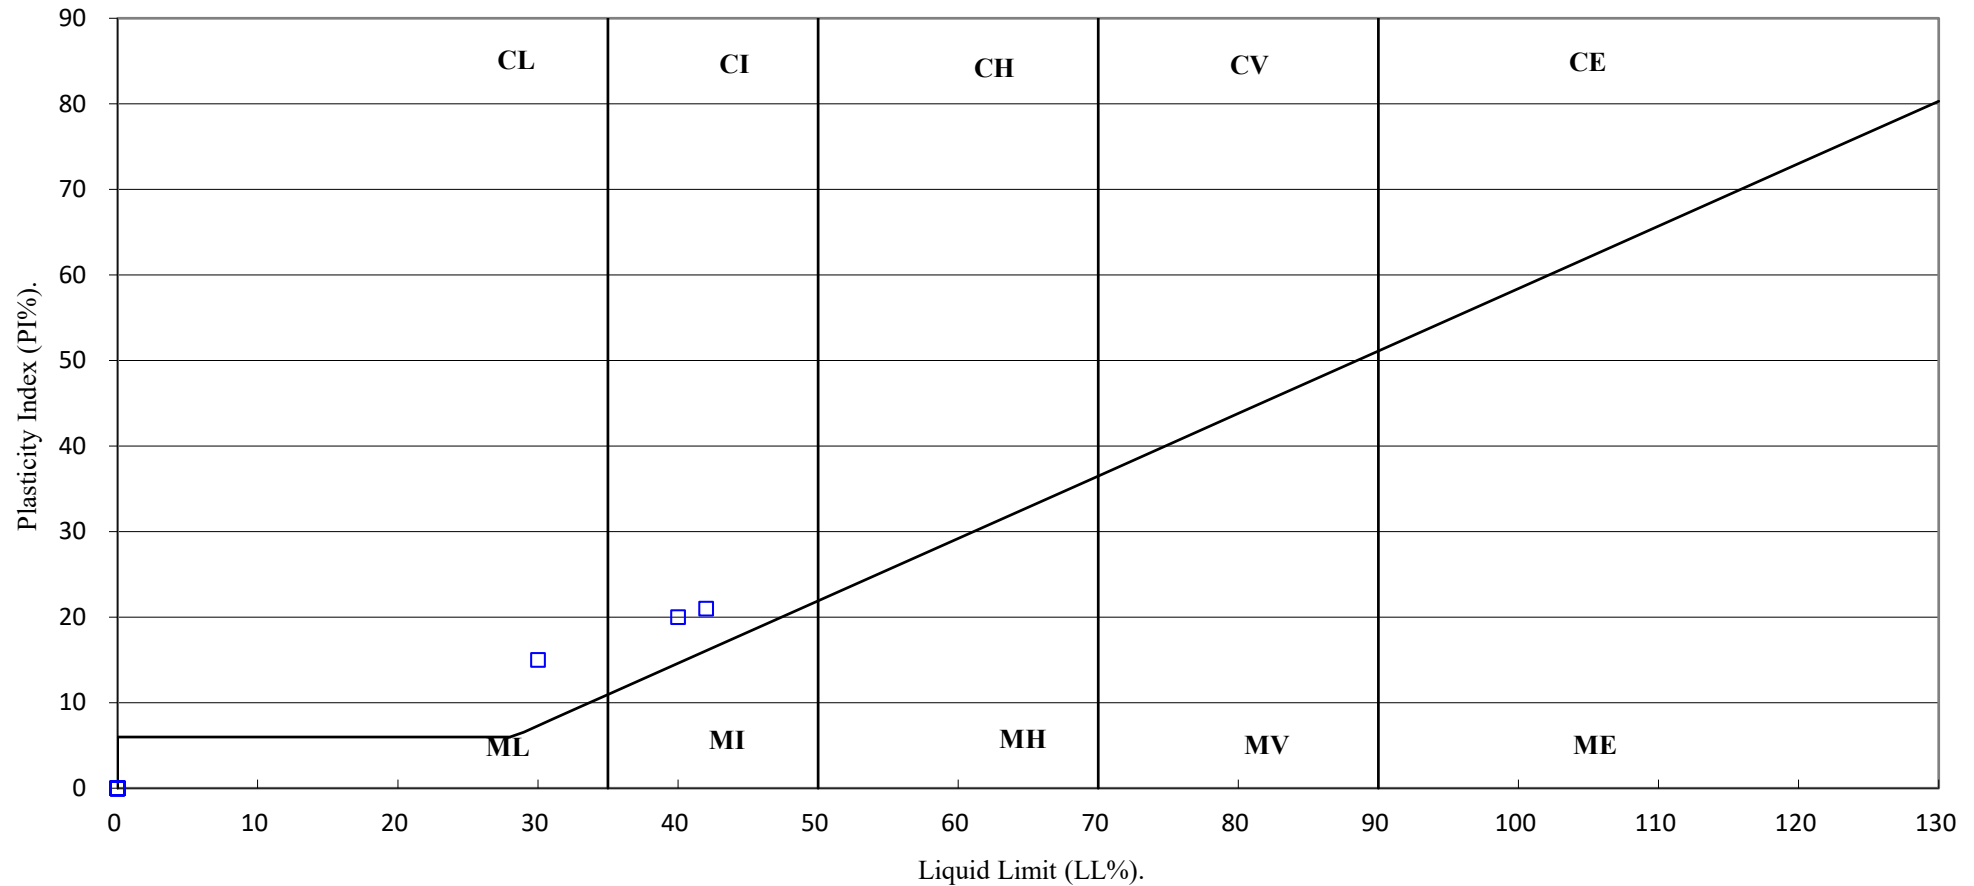
PLASTICITY CHART FOR CASAGRANDE CLASSIFICATION.

The results of the tests are contained in the Professional Soils Laboratory (PSL) Laboratory Report, report reference PSL23/4006 a copy of which can be seen attached in Appendix III. The natural clay deposits tested fall within the low and intermediate plasticity ranges, and when considering the amount passing the 425um sieve they display a low volume change (shrinkage or swelling) potential. Therefore, the natural clay deposits present below the site are unlikely to undergo significant changes in volume if large changes in their natural moisture content were to occur due to seasonal variations or the like, and as such if new foundations were to be based within the natural chalk deposits, they should be placed at a minimum depth of 0.75m below finished ground levels. Consideration should be given to the presence of existing, proposed or recently removed vegetation to avoid the effects of future shrinkage and swelling of the natural deposits, and as such minimum foundation depths may need to be increased to take this into account. Reference should be made to the NHBC Technical Standards guidance, Part 4.2 Building Near Trees, and BS5837:2012 – Trees in relation to design, demolition, and construction – Recommendations.
