# Agglestone Mire, Knowle Valley

## Historic Environment Assessment

Project	Dorset Peatlands Project
Site NGR (centre) between areas	402630, 83100
Site area (combined)	15.31 ha.
Client	The Dorset Peat Partnership
Client contact	Grace Herve, Andrew Norris
Document Author(s)	Matthew Williams MIfA
Document date	November 23

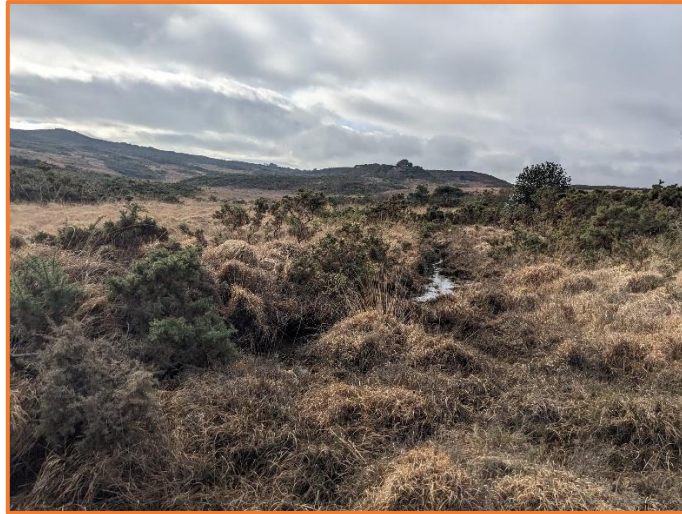
*Figure 2 - Looking east along (4) restoration area*

The channel (4) is part of a squatter enclosure boundary and is also one of the ditches to be used in the restoration. It is considered of low importance. The excavation of peat at each side to create the blocks will impact the channel, but most of the feature will not be affected and the overall course will be preserved. The impact is therefore considered very low and no mitigation is recommended. The feature is recorded in existing sources and the GIS data from this report will be sent to the DHER.

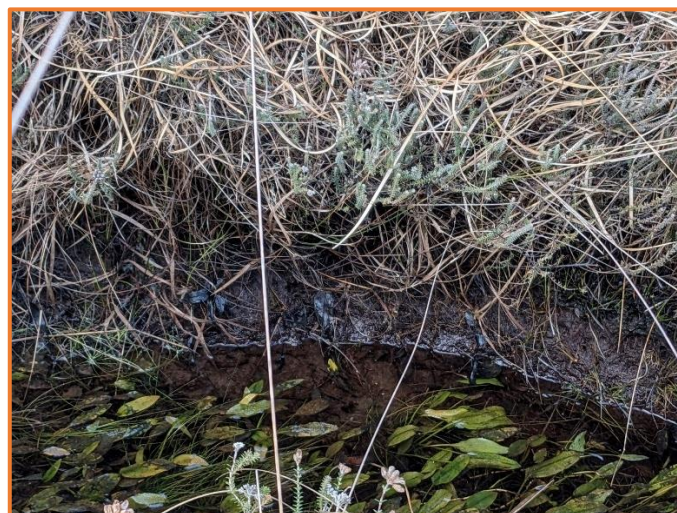
*Figure 4 - Exposed deposits along ditch*

The visit confirmed that the Site is very wet and tussocky; access onto the restoration areas was very difficult. The Site conditions did not allow proper examination for finds, although all exposed areas, e.g. eroded edges of ditches, were checked (Figure 4). No finds or archaeological deposits were noted.
