PHASE 2 CONTAMINATION ASSESSMENT REPORT FOR POWICK PAVILION, HAMILTON CLOSE, POWICK WR2 4NH

PREPARED FOR
POWICK PARISH COUNCIL

Report No. 4043/2

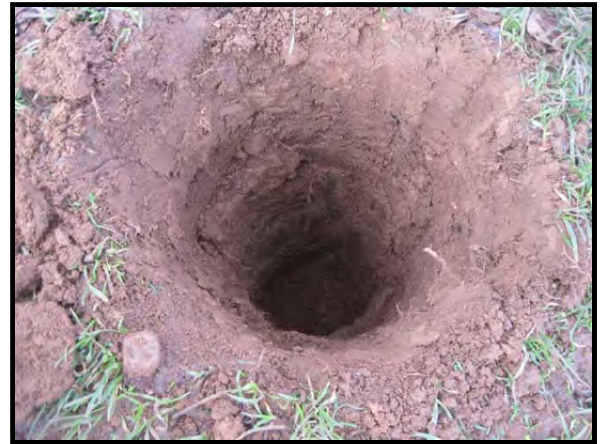
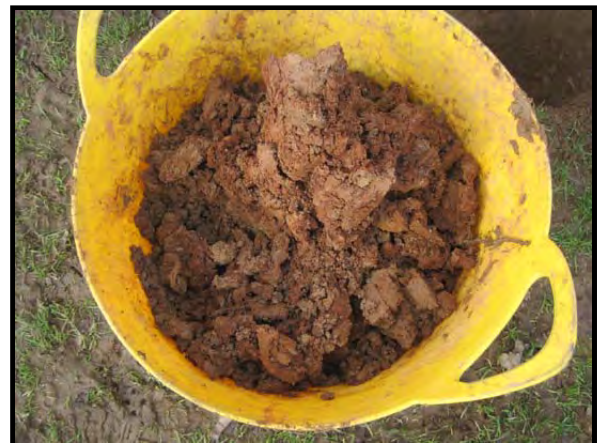
Site: POWICK PAVILLION, HAMILTON CLOSE, POWICK, WORCESTER, WR2 4NH				TRIAL PIT No. TP1
Job No. 4043/2	Date 17-02-17	Ground Level (c.m, AOD) c 47m	Co-Ordinates (c.) E 382,317 N 250,934

- A TOPSOIL: grass over mid brown, silty/sandy TOPSOIL with fine rootlets and occasional quartzite gravel
- B SAND: probable firm/medium dense, reddish brown mottled greenish grey, sandy clay/clayey SAND with occasional quartzite gravel
(BUSHLEY GREEN MEMBER)

- 1 Pit logged from surface
- 2 Pit dry and stable
- 3 Soil sample taken at 0.5m depth

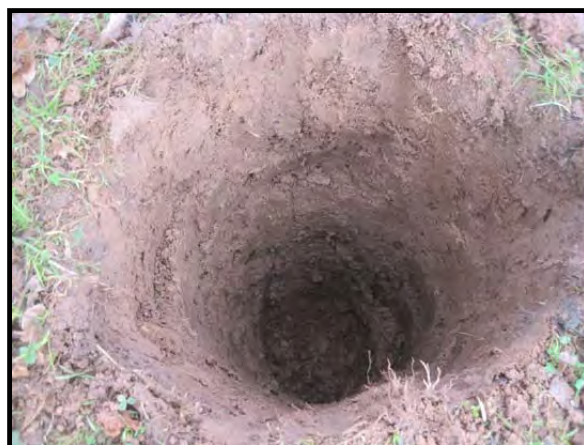
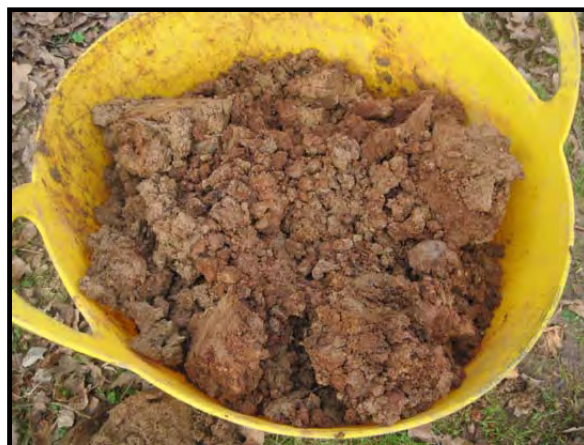
Site: POWICK PAVILLION, HAMILTON CLOSE, POWICK, WORCESTER, WR2 4NH				TRIAL PIT No. TP2
Job No. 4043/2	Date 17-02-17	Ground Level (c.m, AOD) c 47m	Co-Ordinates (c.) E 382,319 N 250,963

- A TOPSOIL: grass over light brown, silty/clayey TOPSOIL with roots/rootlets
- B SAND: probable loose, light greyish brown, clayey, slightly gravelly SAND. Gravel is sub to well rounded, medium quartzite (*BUSHLEY GREEN MEMBER*)
- C SAND: probable loose to medium dense, reddish brown, mottled grey, clayey, gravelly SAND (*BUSHLEY GREEN MEMBER*)

- 1 Pit logged from surface
- 2 Pit dry and stable
- 3 Soil sample taken at 0.65m depth

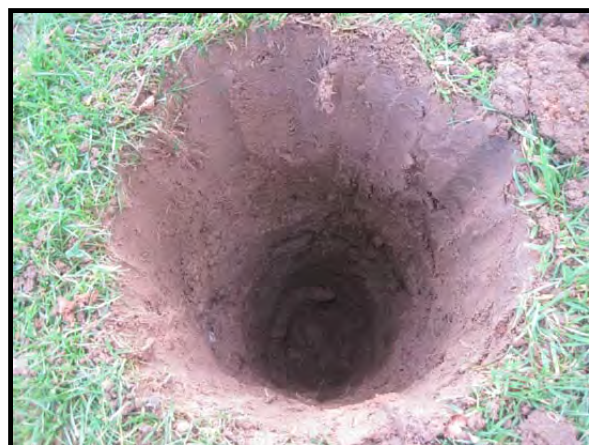
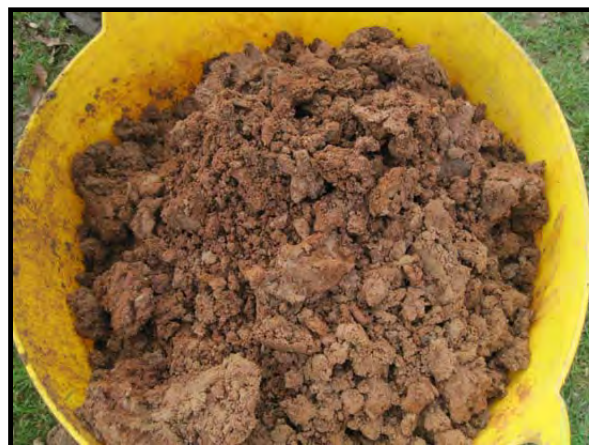
Site: POWICK PAVILLION, HAMILTON CLOSE, POWICK, WORCESTER, WR2 4NH				TRIAL PIT No. TP3
Job No. 4043/2	Date 17-02-17	Ground Level (c.m, AOD) c 47m	Co-Ordinates (c.) E 382,334 N 250,963

- A TOPSOIL: grass over light brown, silty, sandy clay TOPSOIL with fine rootlets and occasional quartzite gravel
- B CLAY: probable soft to firm, pinkish brown, slightly gravelly, very sandy CLAY. Gravel is subangular to rounded, fine to coarse quartzite; locally recovered as clayey sand
(BUSHLEY GREEN MEMBER)
- C CLAY: probable firm, reddish/orangish brown, silty/sandy, slightly gravelly CLAY. Gravel is sub to well rounded, fine to medium quartzite with occasional siltstone
(BUSHLEY GREEN MEMBER)

- 1 Pit logged from surface
- 2 Pit dry and stable
- 3 Soil sample taken at 0.1m depth

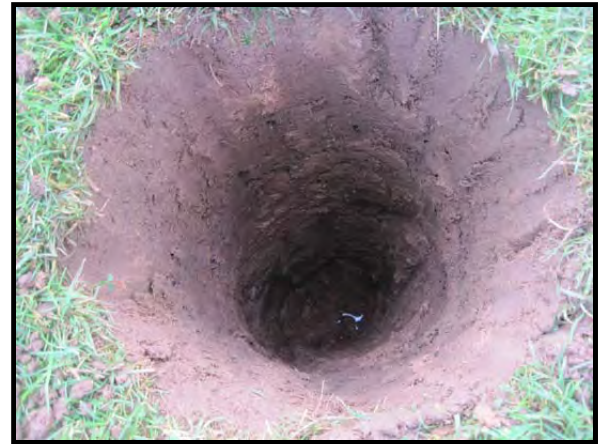
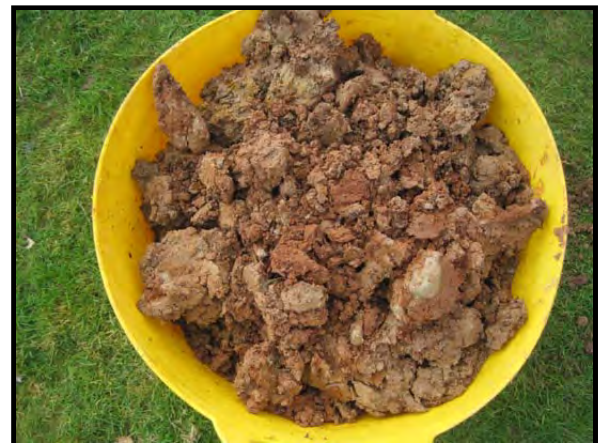
Site: POWICK PAVILLION, HAMILTON CLOSE, POWICK, WORCESTER, WR2 4NH				TRIAL PIT No. TP4
Job No. 4043/2	Date 17-02-17	Ground Level (c.m, AOD) c 47m	Co-Ordinates (c.) E 382,339 N 251,008

- A TOPSOIL: grass over light brown, slightly silty, sandy TOPSOIL with fine grass rootles and occasional quartzite gravel
- B CLAY: probable soft to firm, very sandy and slightly gravelly to gravelly CLAY. Gravel is sub to well rounded, medium to coarse quartzite; moist at base of horizon
(BUSHLEY GREEN MEMBER)
- C CLAY: firm, reddish brown, slightly gravelly, very sandy CLAY. Gravel is subrounded, medium to coarse quartzite
(BUSHLEY GREEN MEMBER)

- 1 Pit logged from surface
- 2 Pit dry and stable
- 3 Soil sample taken at 0.4m depth
