PHASE II GEO-ENVIRONMENTAL SITE ASSESSMENT

CHINLEY, BUXWORTH & BROWNSIDE PARISH COUNCIL

CHINLEY & BUXWORTH CENTRE

G20232P2R0

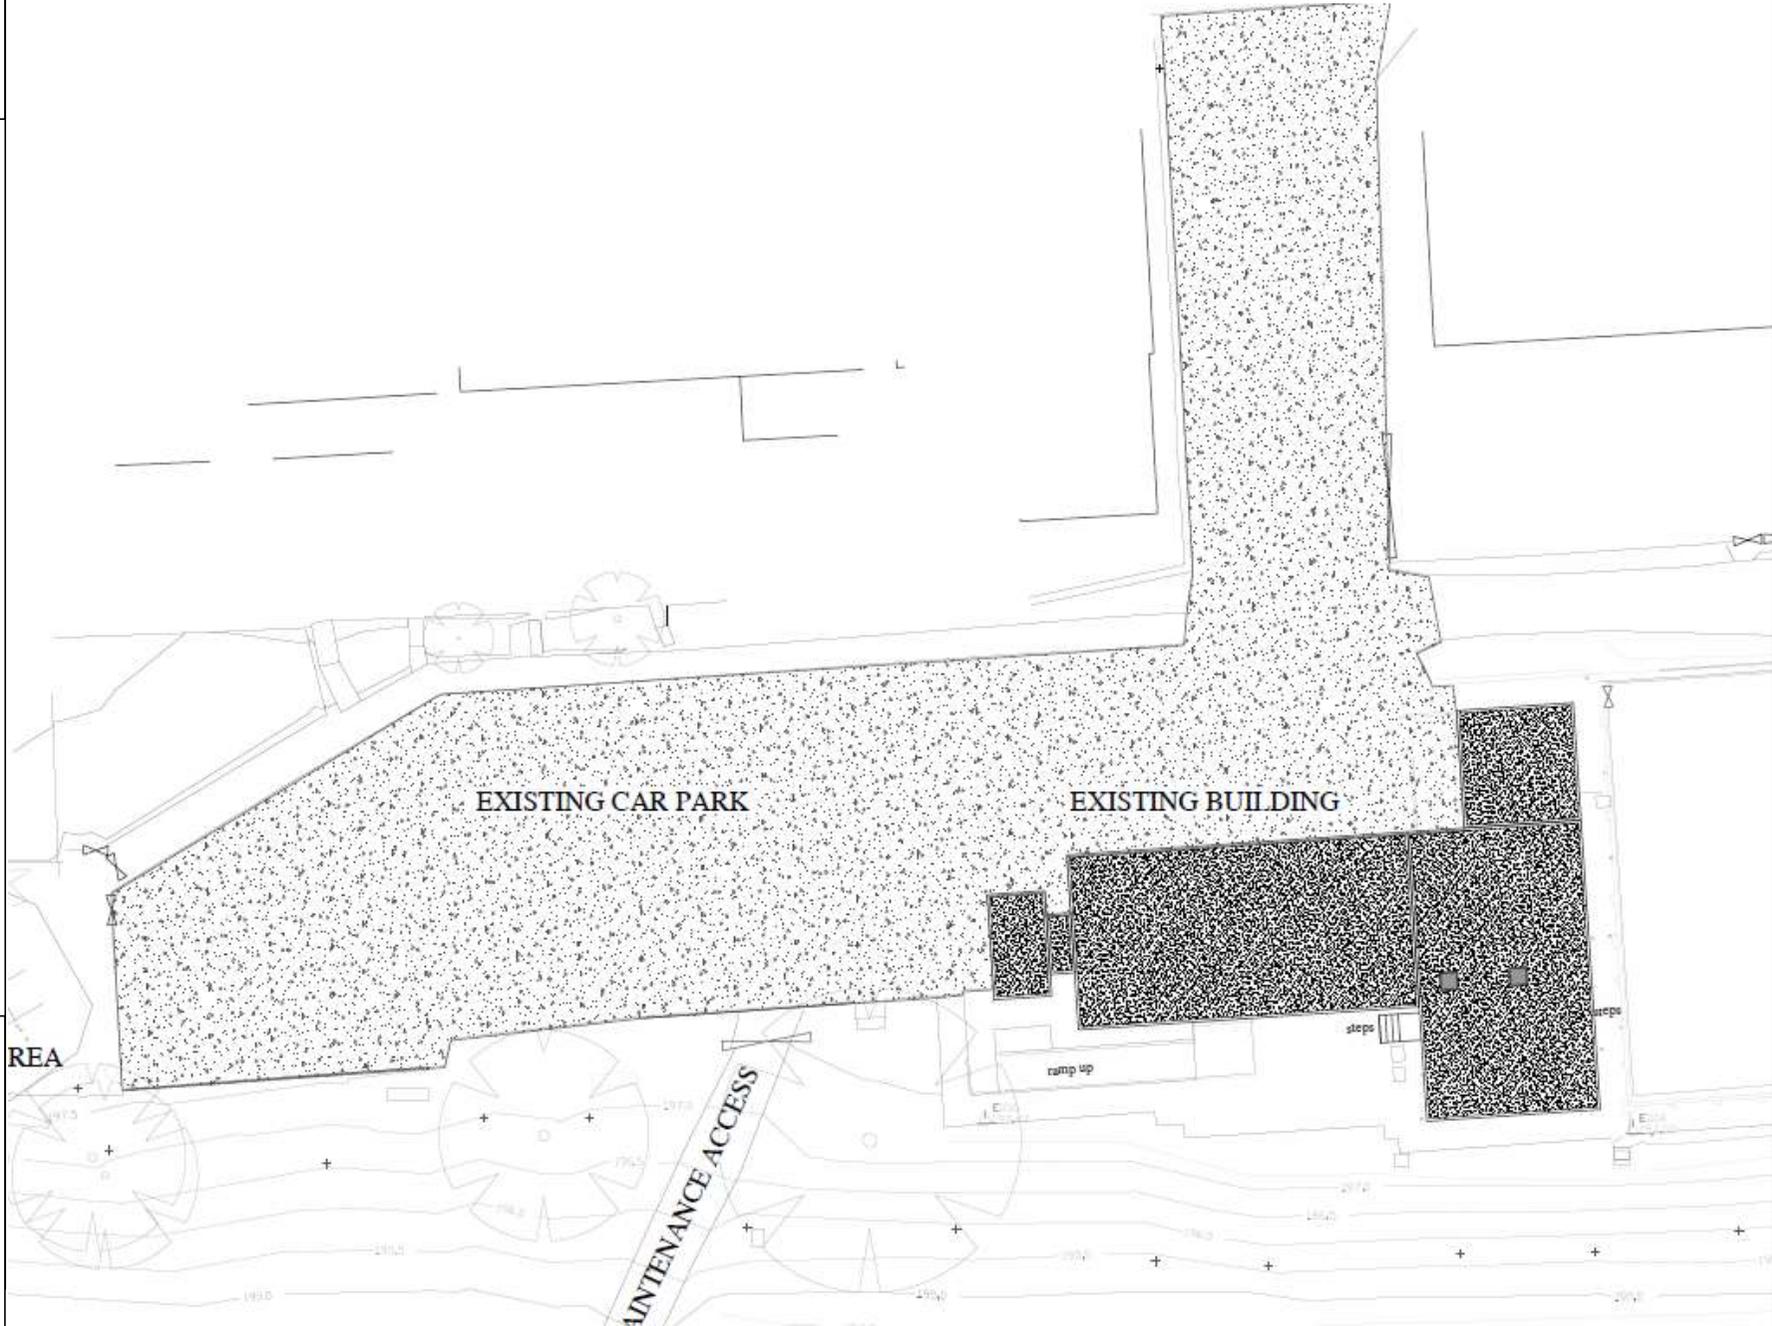
G20232 001 Site
Location Plan

A Site Location Plan (reference G20232-001) is presented in Appendix III.

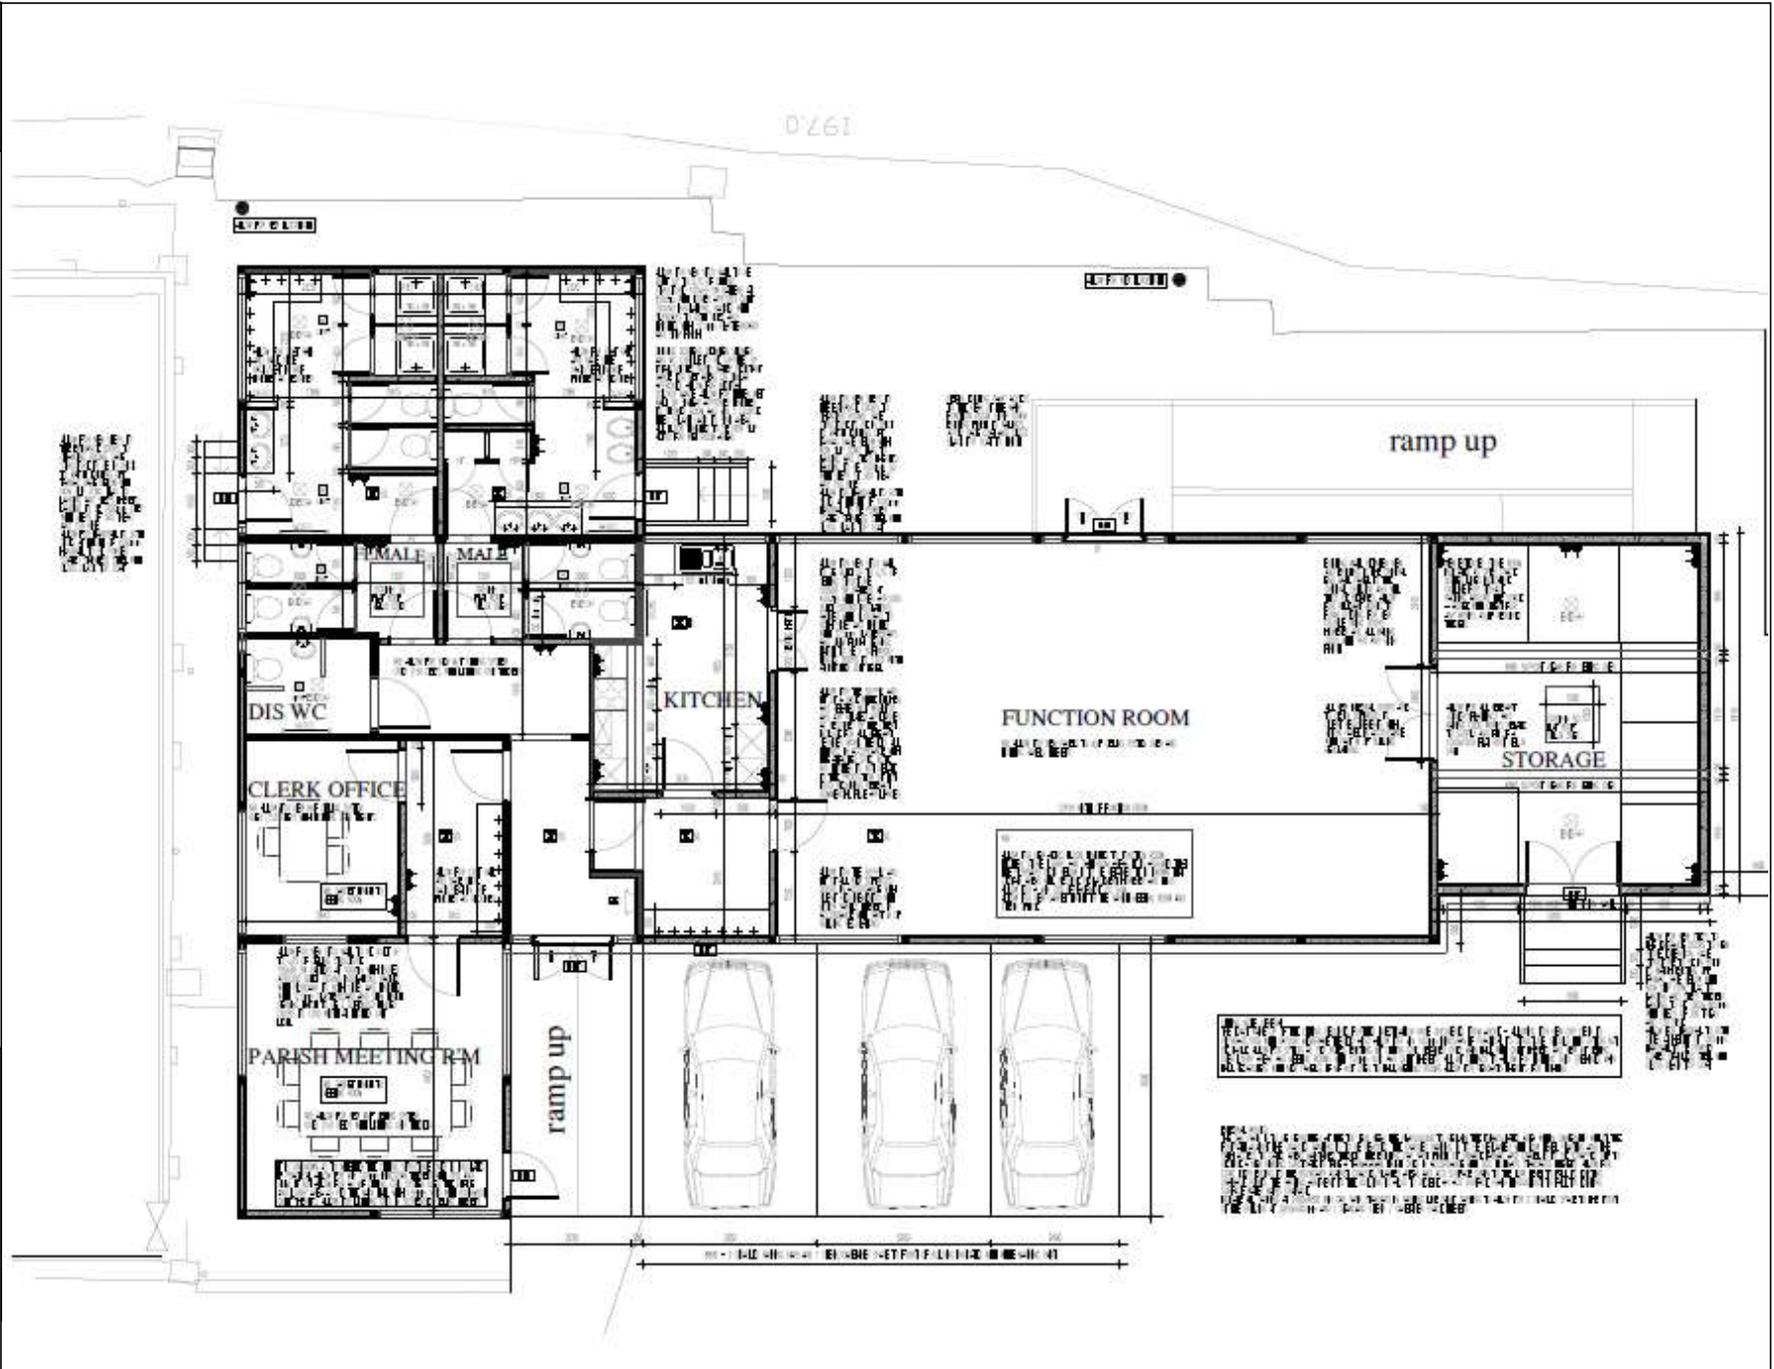
Drawing Title:
 G20232 003 Proposed
 Development Plan (1)

It is understood that proposals include for the development of a new Community Centre, located within the footprint of the existing building and construction of associated parking to the west and north.

A Proposed Development Plan (G20232-003) is provided within Appendix III.

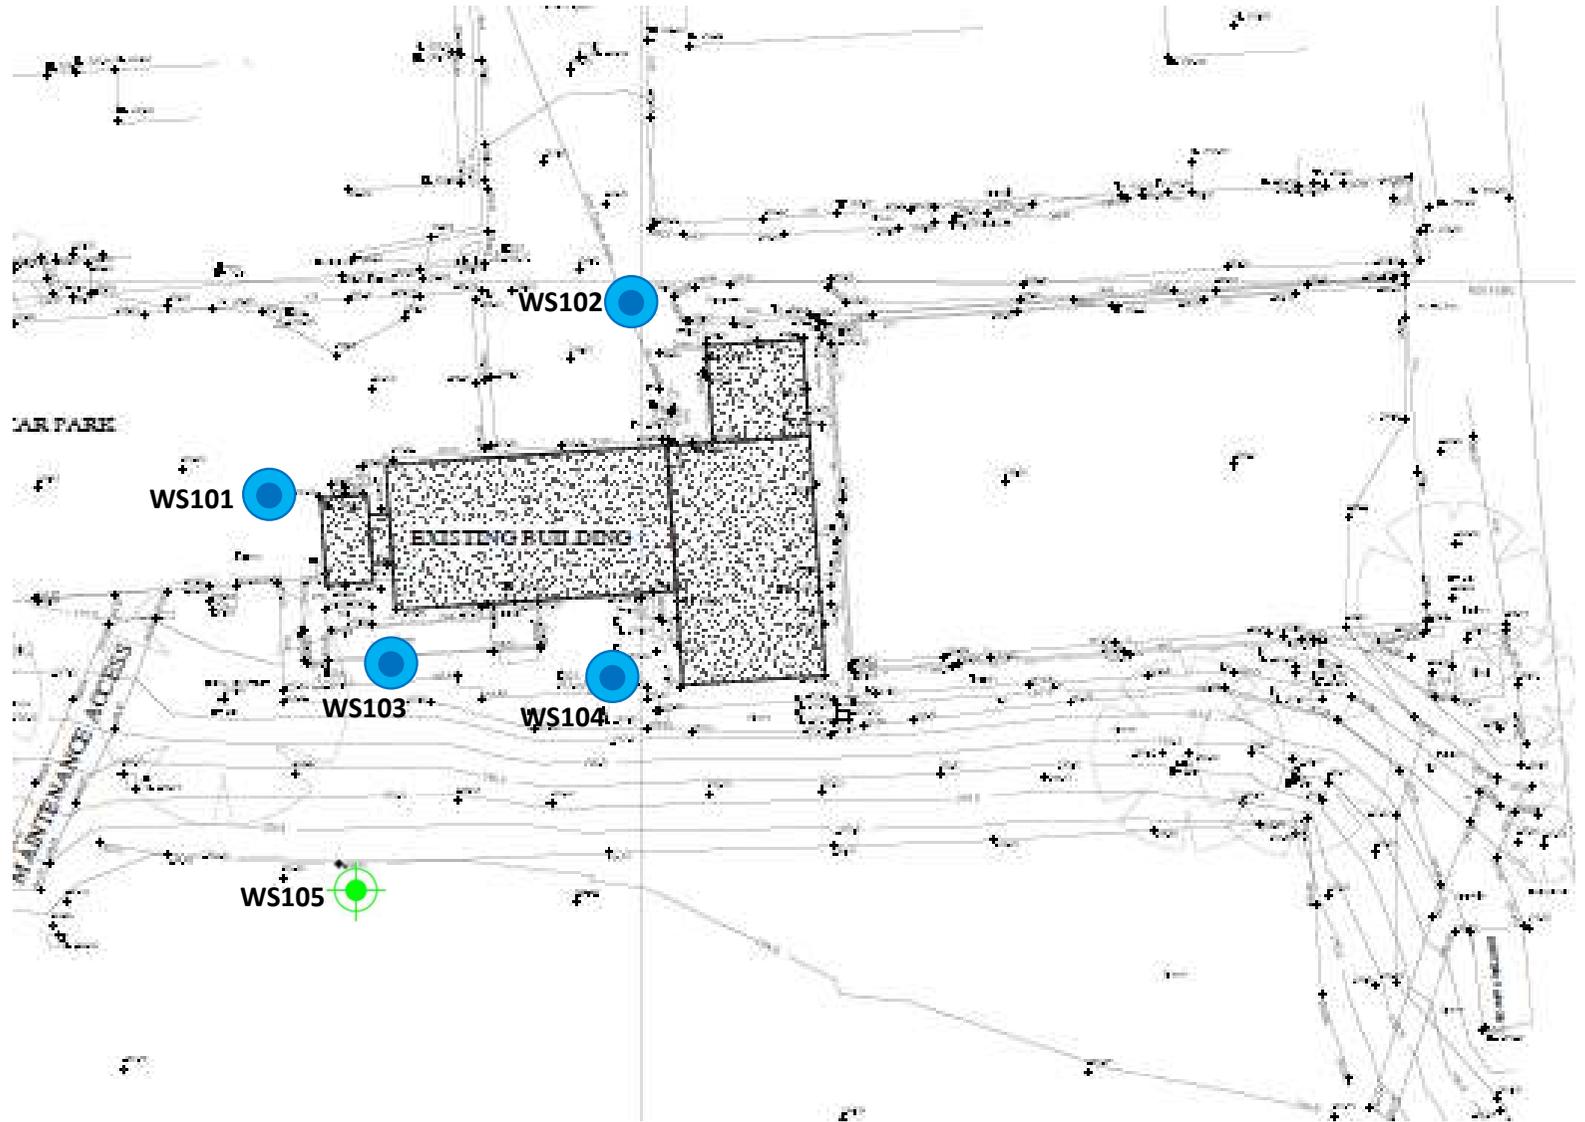
Window
Sample
Location
(Installed)

The exploratory hole locations are shown on the Exploratory Hole Location Plan (G20232-003) presented within Appendix III.

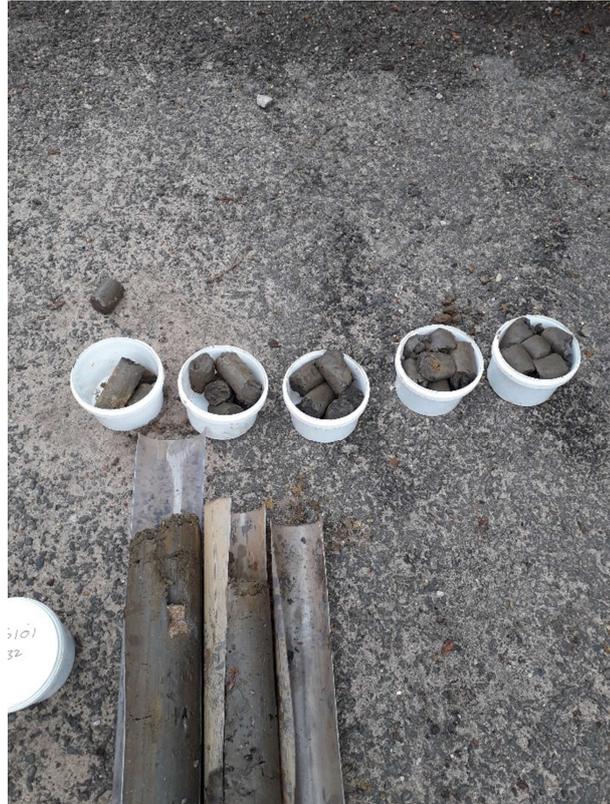
Made Ground was encountered in all exploratory hole locations from ground level to a maximum depth 1.30mbgl (WS103). Made Ground within WS101 comprised Asphalt over limestone subbase, which was underlain by gravel and clay. Within WS102 Made Ground comprised Asphalt over limestone subbase and ash. Within WS103 – 105 this stratum typically comprised topsoil, this was underlain by gravelly clay within WS103 and WS104.

PLATE 1 - MATERIALS RECOVERED FROM WS101

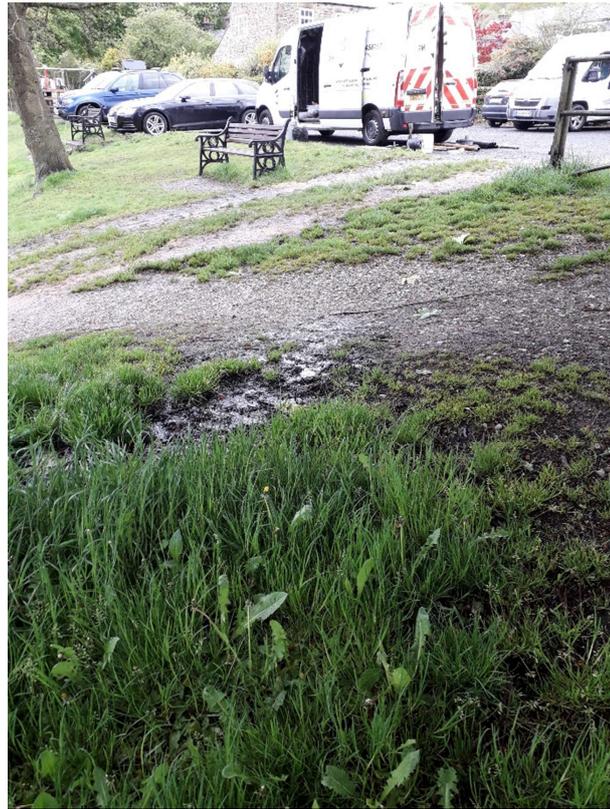
To the south of the development platform was a steep bank ~3.5m high, dropping onto a playing field with a small skate park. The steep slope from the development platform to the sports field below is the result of levelling works undertaken to facilitate the playing field and skate park, initially the site gently sloped from the upper level for the full extent of the playing surface. It is understood that field drains have been installed near the foot of the bank and in the middle of the playing field. At the time of the investigation the land at the foot of the bank was saturated, with obvious boggy areas. One area had been recently re-seeded.

PLATE 5 – BANKING SOUTH OF CARPARK

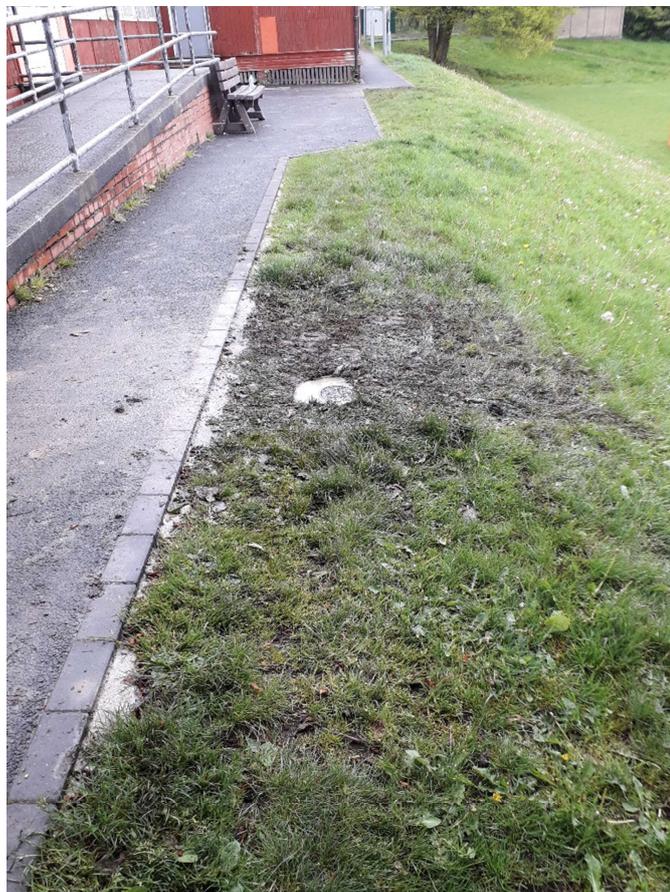
Groundwater was not encountered during the investigation. Water was identified in the installed wells at depths between 0.27mbgl and 0.95mbgl during return monitoring visits. However, this is believed to be perched surface water, given that the water was contained within fine grained material and absent during the ground investigation.

PLATE 6 – WELL INSTALLED WITHIN WS103

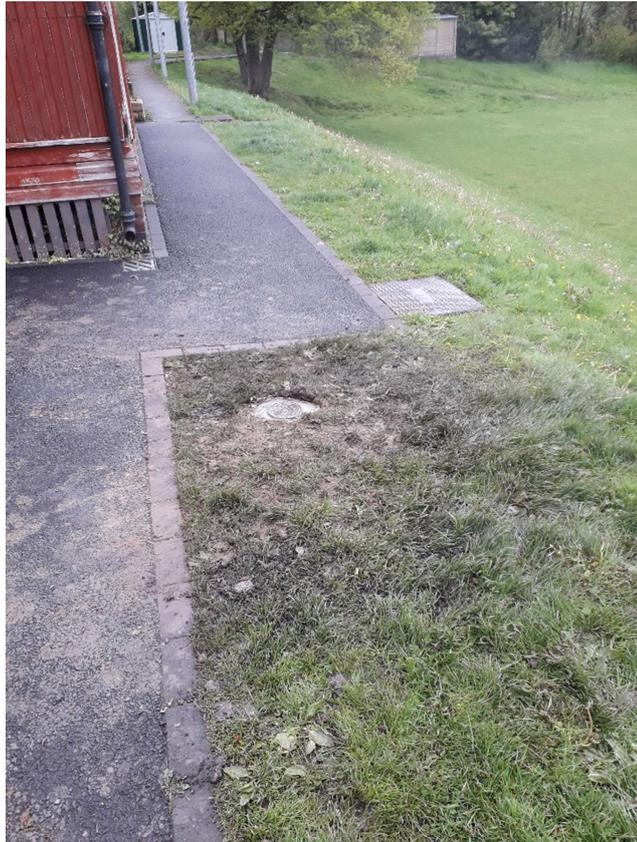
PLATE 7 – WELL INSTALLED WITHIN WS104

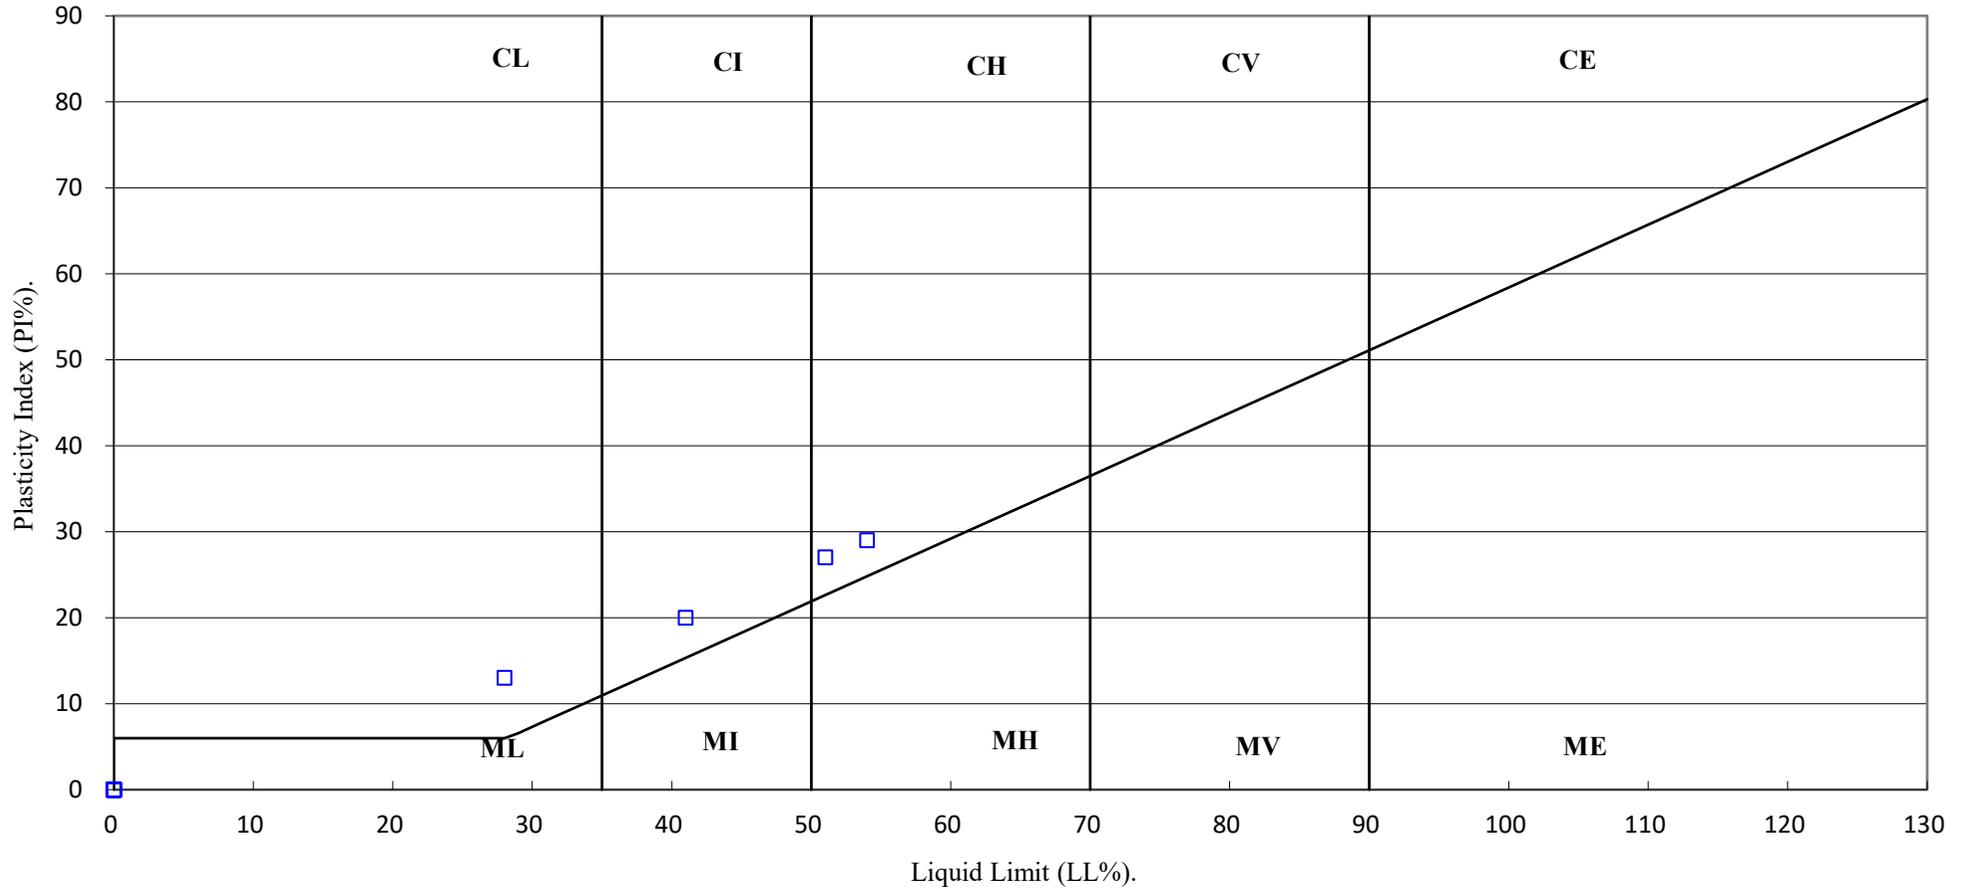
Location	Strata	Depth (m)	Moisture Content (%)	Liquid Limit (%)	Plastic Limit (%)	Plasticity Index (%)	Passing 425µm Sieve (%)	Modified Plasticity Index	Vol Change Potential
WS101	GT*	1.50	22	51	24	27	100	27	Medium
WS103		1.60	26	54	25	29	100	27	
WS104		1.30	13	28	15	13	93	12	Low
WS104		1.40	18	41	21	20	88	18

PLASTICITY CHART FOR CASAGRANDE CLASSIFICATION.

The plasticity testing results indicate the soils on site to be of low to medium volume change potential. A modified plasticity index of over 20% was identified within WS101 and WS103, indicating a medium volume change potential, and therefore these soils are deemed to be susceptible to frost. It is likely that these soils will change volume as moisture content fluctuates seasonally.

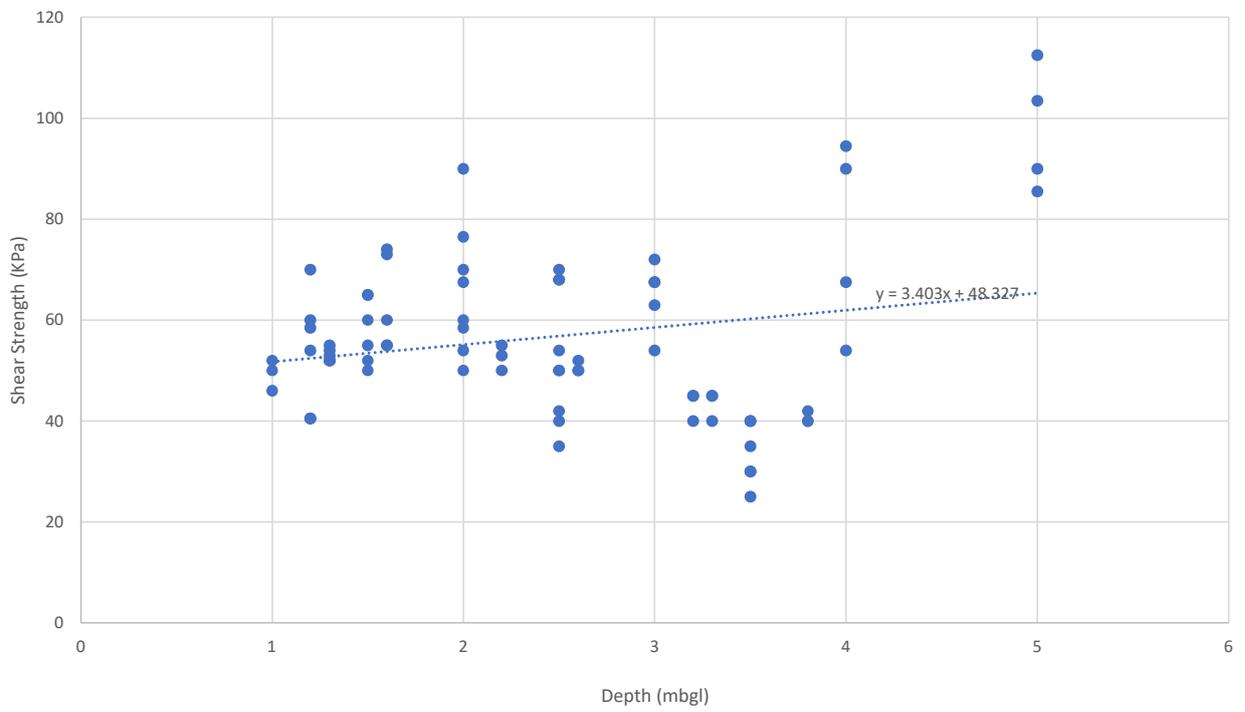
Shear Strength vs Depth

Undrained shear strength values of the underlying natural soils were calculated using in situ SPT results and hand shear vane testing. Given that the underlying geology comprised primarily fine grained material, hand shear vane tests have been used to calculate allowable bearing pressures as their results are likely to be more representative of true geotechnical conditions.

APPENDIX IX – SHEAR STRENGTH VS DEPTH PLOT

Based on average undrained shear strength value in fine grained soils for a strip foundation with a width of 0.6m, the following allowable bearing pressures have been calculated with a factor safety of 3:

Conventional standard strip foundations can be applied to natural fine-grained strata encountered at an average depth of 1.20mbgl where an Allowable Bearing Pressure in order of 122kN/m² can be achieved.
