# **NON INTRUSIVE SURVEY AND INTRUSIVE INVESTIGATIONS FOR UNEXPLODED ORDNANCE AT TITCHWELL MARSH 2<sup>nd</sup> PHASE**

Prepared for: Lancaster Earthmoving

Project Number: 3216

Report Number: 3216/30

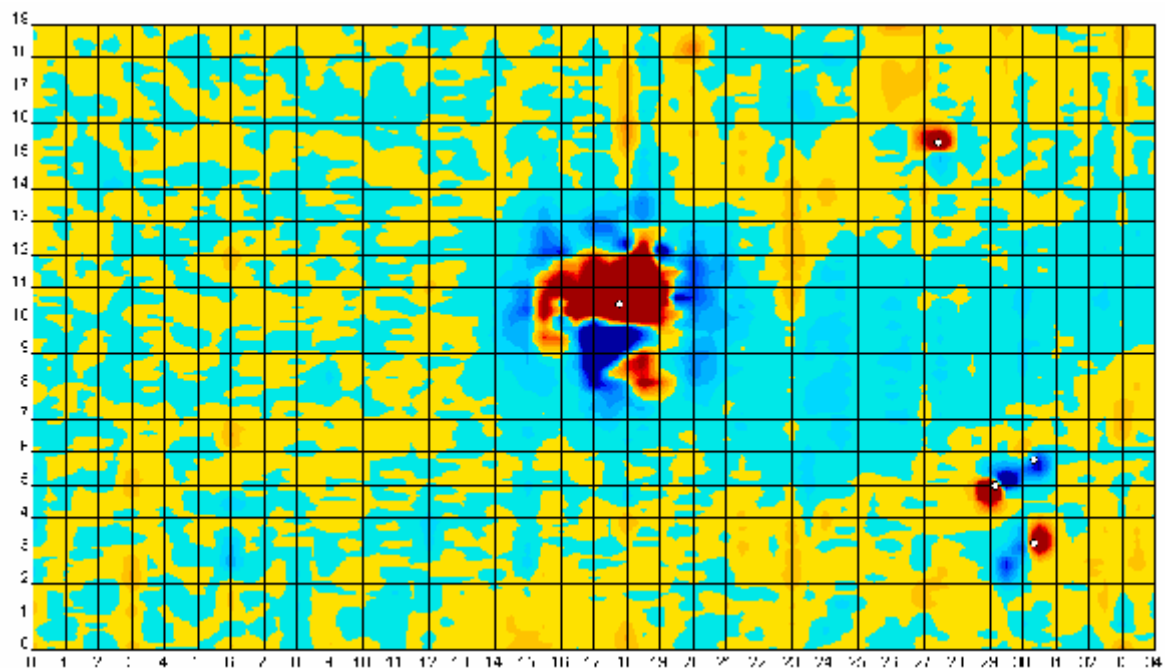
## Area 1 Box 3

Nbr.	X m	Y m	Depth m	Diam. m	Volume Litre	Remarks
1	27,48	15,39	0,40	0,09	0,3	<b>Projectile 76mm</b>
2	29,19	4,99	0,44	0,13	1,2	Steel Pin
3	30,35	3,24	0,39	0,09	0,3	Steel Pin
4	30,37	5,74	0,55	0,11	0,7	Steel Pin
5	17,82	10,50	1,15	0,66	151,5	Foundations

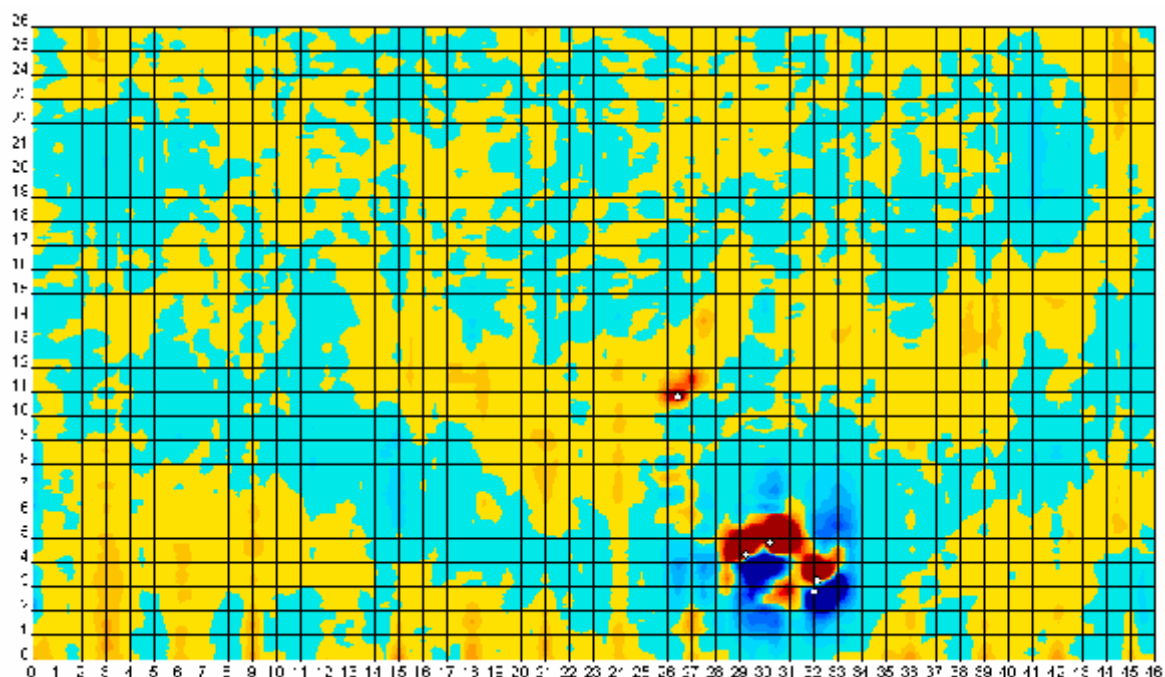
## Area 1 Box 11

Nbr.	X m	Y m	Depth m	Diam. m	Volume Litre	Remarks
1	26,50	10,80	0,46	0,10	0,5	Red brick foundation
2	29,26	4,32	0,66	0,24	7,1	Red brick foundation
3	30,29	4,77	0,95	0,53	77,9	Red brick foundation
4	32,20	3,27	0,72	0,31	15,7	Red brick foundation
5	32,11	2,80	1,07	0,41	35,5	Red brick foundation

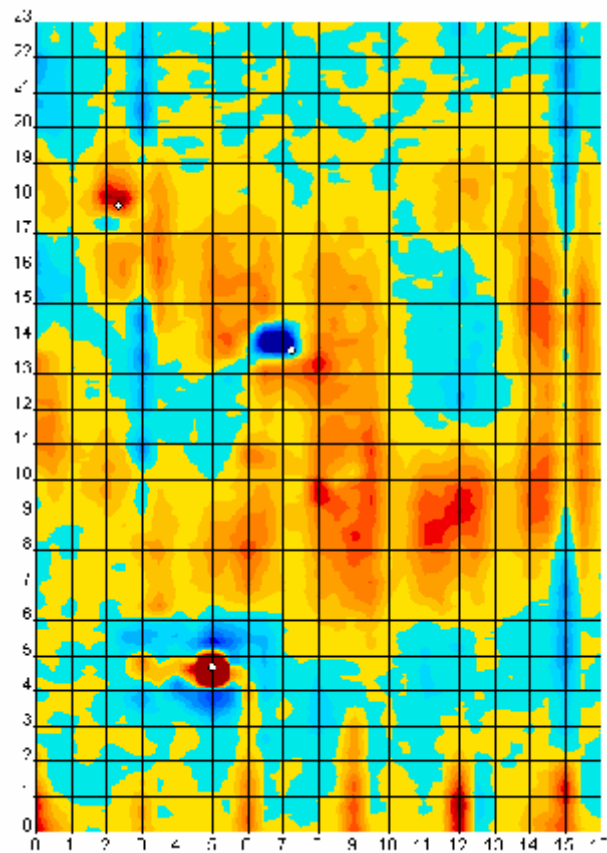
## Area 2 Box 1

Nbr.	X m	Y m	Depth m	Diam. m	Volume Litre	Remarks
1	5,00	4,69	0,38	0,12	0,9	Pigtail post
2	7,30	13,66	0,78	0,19	3,4	<b>37mm TPT</b>
3	2,35	17,82	0,61	0,10	0,5	Iron scrap

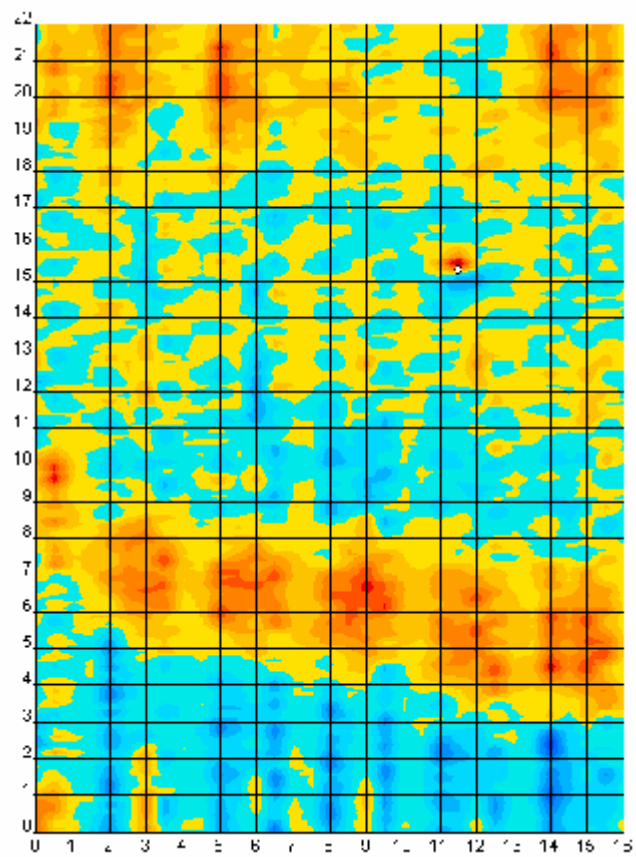
Area 2 Box 2

Nbr.	X m	Y m	Depth m	Diam. m	Volume Litre	Remarks
1	11,51	15,33	0,40	0,05	0,1	Tin scrap

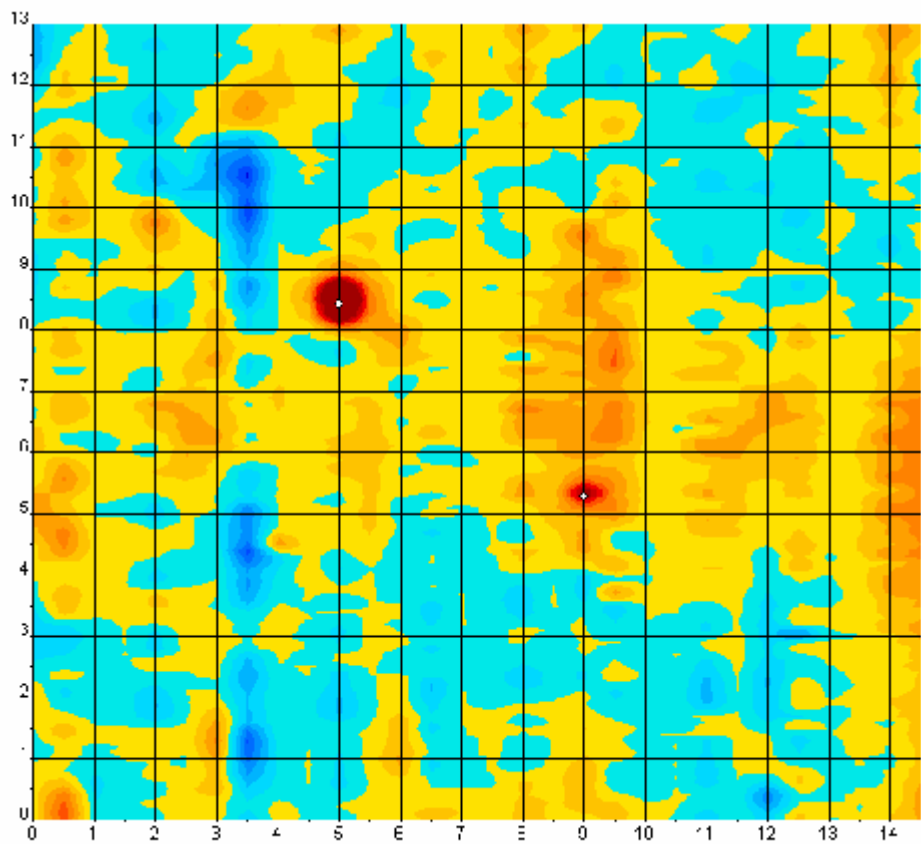
Area 2 Box 4

Nbr.	X m	Y m	Depth m	Diam. m	Volume Litre	Remarks
1	5,00	8,45	0,49	0,09	0,4	Projectile 37mm
2	9,00	5,30	0,47	0,07	0,1	3" nail

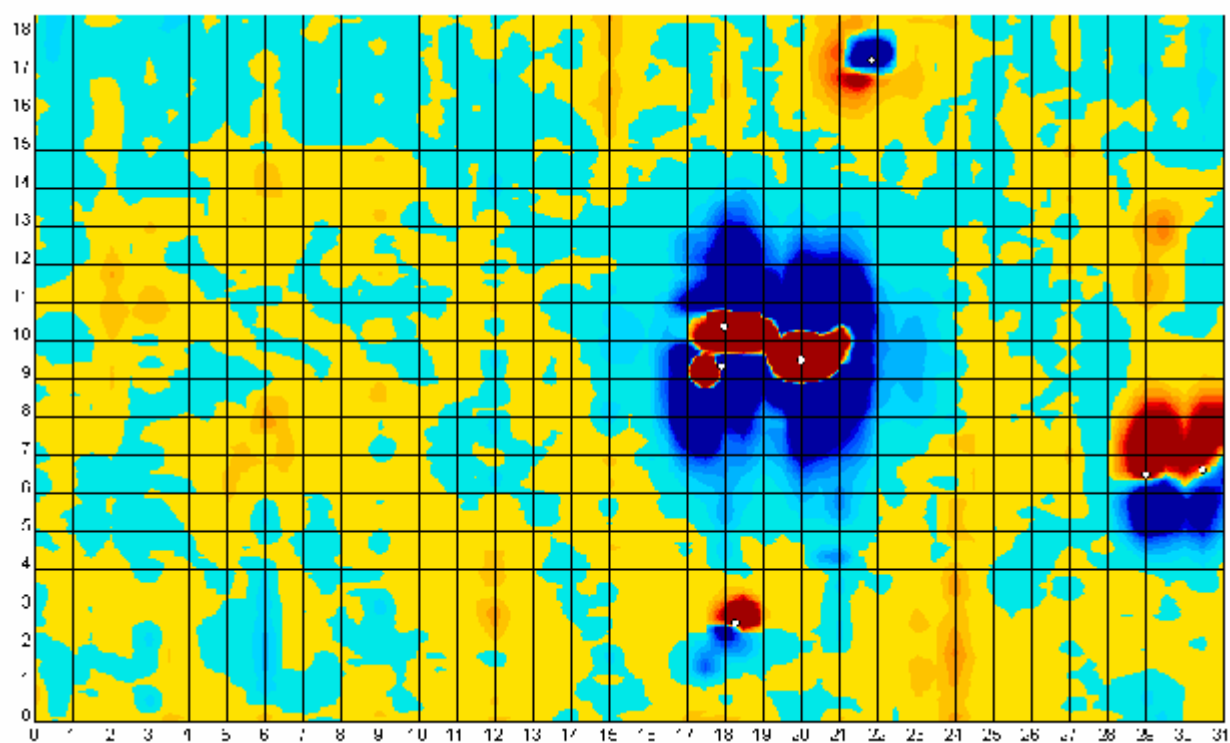
### Area 3 Box 1

Nbr.	X m	Y m	Depth m	Diam. m	Volume Litre	Remarks
1	18,32	2,59	0,45	0,14	1,4	Post (left in situ)
2	17,94	9,29	0,78	0,48	56,9	Post (left in situ)
3	20,03	9,45	0,58	0,50	65,6	Post (left in situ)
4	18,03	10,34	0,50	0,45	49,2	Post (left in situ)
5	21,87	17,32	0,61	0,21	5,2	<b>Projectile 37mm</b>
6	29,00	6,47	1,08	0,48	57,7	Post (left in situ)
7	30,50	6,60	1,23	0,48	56,8	See Area 3 Box 2 (Nbr 1)

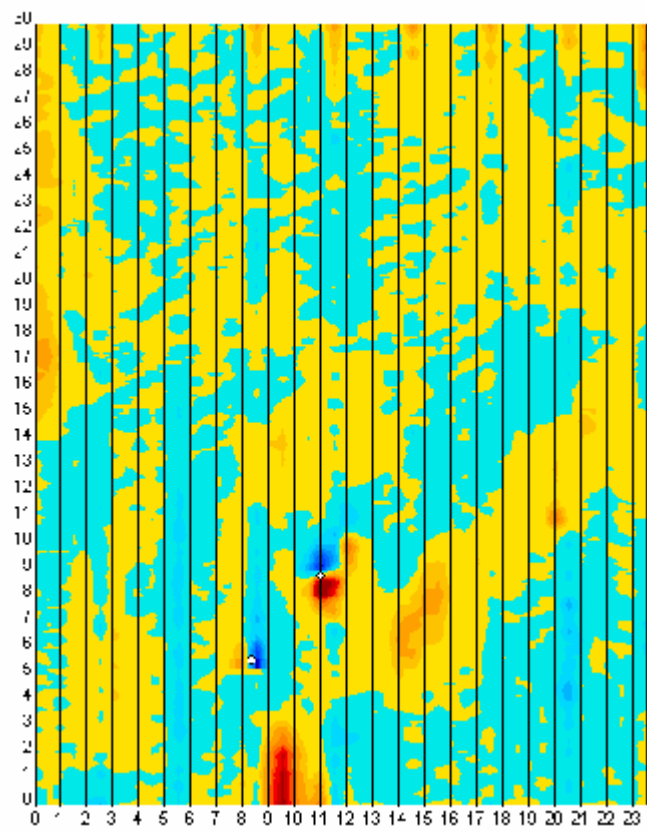
Area 5 Box 1

Nbr.	X m	Y m	Depth m	Diam. m	Volume Litre	Remarks
1	10,98	8,79	0,56	0,14	1,3	Cast iron scrap
2	8,34	5,56	0,38	0,07	0,2	Too small

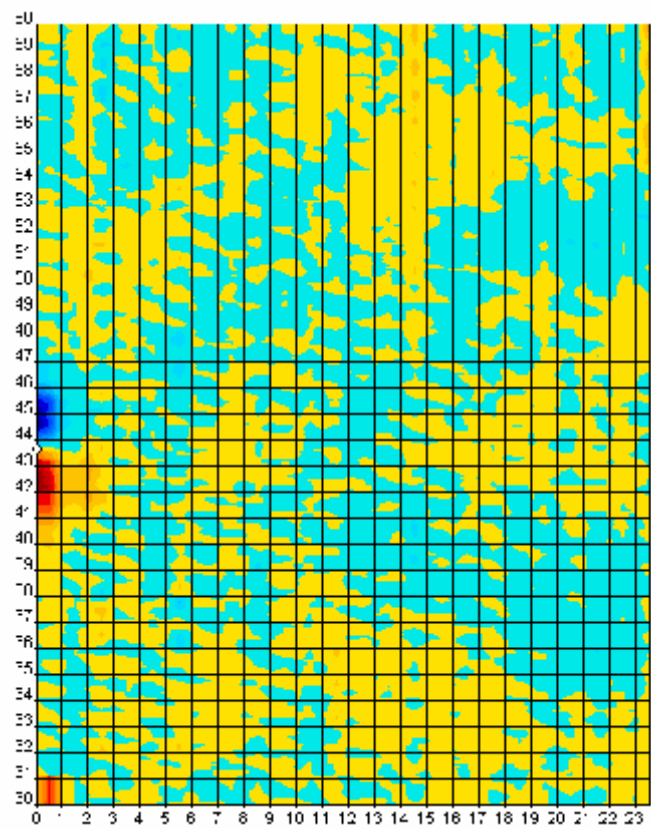
Area 5 Box 2

Nbr.	X m	Y m	Depth m	Diam. m	Volume Litre	Remarks
1	0,00	43,71	1,54	0,61	119,3	Too deep in water logged area

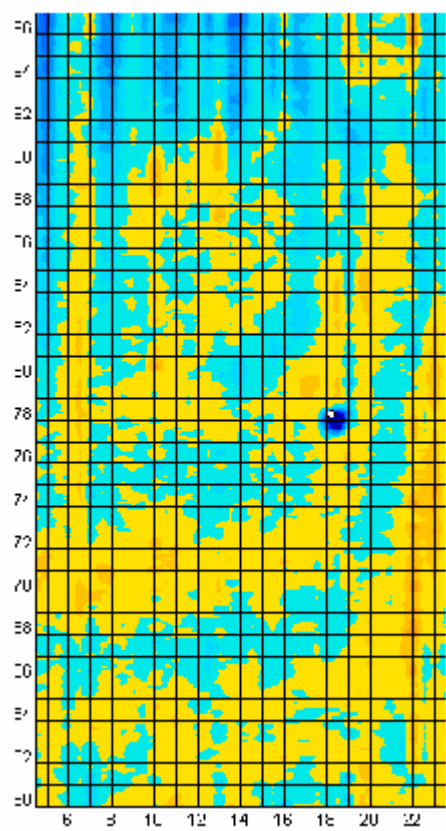
Area 5 Box 3

Nbr.	X m	Y m	Depth m	Diam. m	Volume Litre	Remarks
1	18,23	78,35	1,41	0,38	29,5	Iron scrap

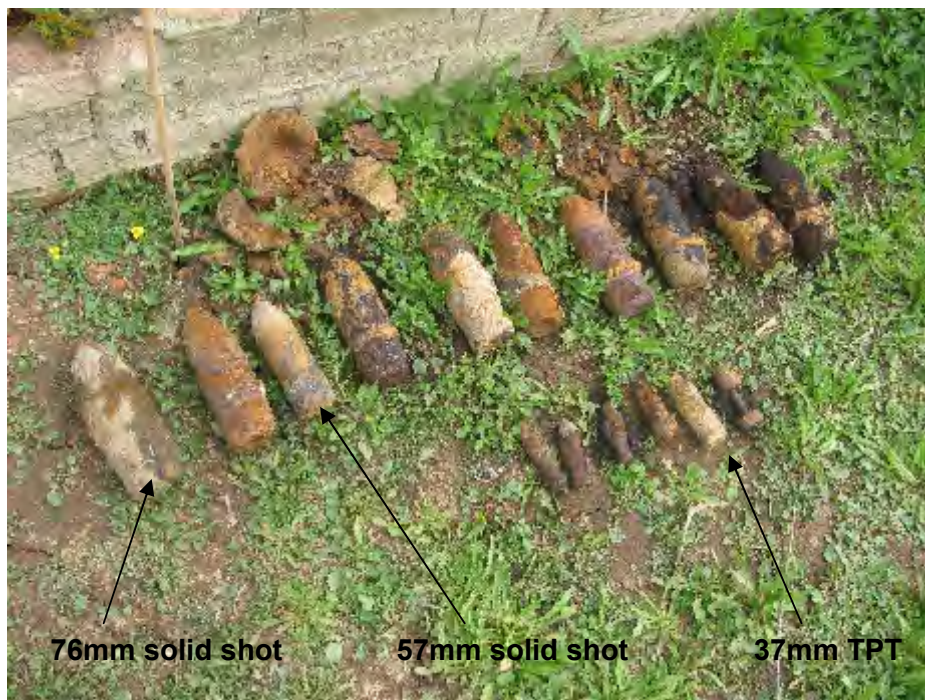
Cache from Areas 1 to 7

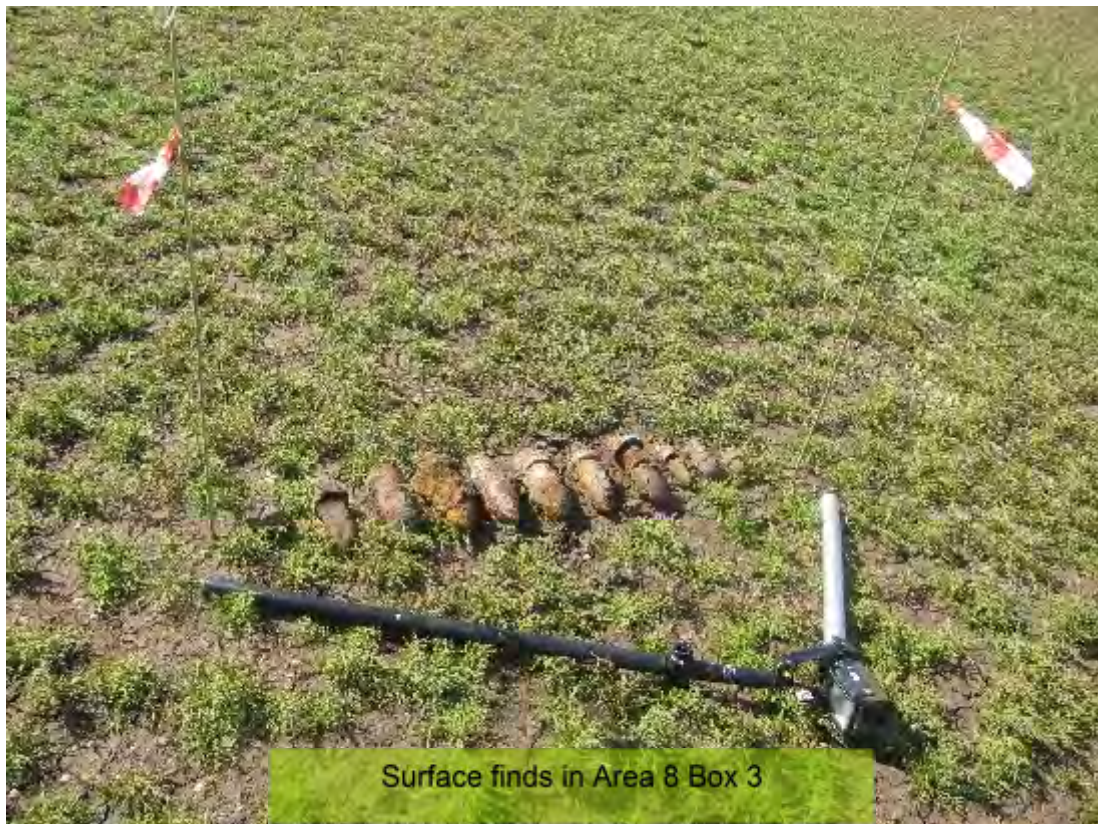
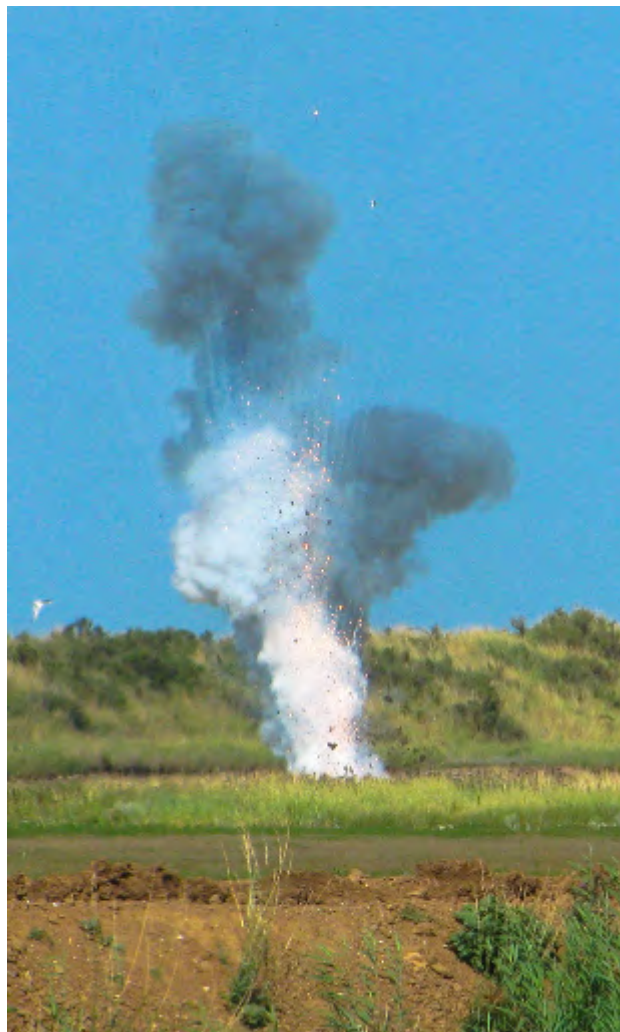
Rendered safe by explosive demolition in situ (by 5131 (BD) Squadron)
