TASK NO.	TASK/DESCRIPTION	NOTES
	H6 EXTERNAL LADDERS	
H6.03	<p data-bbox="405 387 687 421"><b>Upper Deck Ladders</b></p>

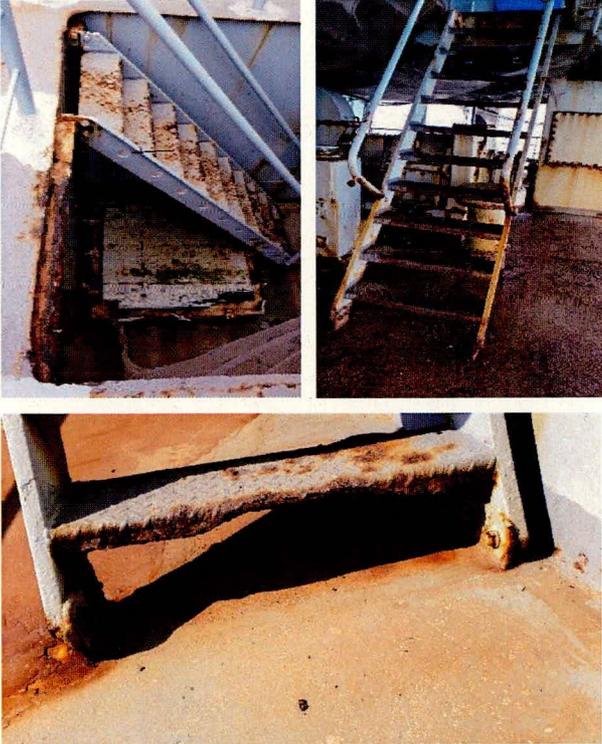
<p data-bbox="400 1196 1214 1308">All upper deck ladders paint coatings are breaking down with active corrosion evident on ladder treads. Ladders to be SURVEYED and treads RENEWED as required. Ladder handrails also require SURVEY, RENEW as required and REPRESENTATION on completion.</p> <p data-bbox="400 1339 1214 1397">ALLOW for 10 Ladder rungs and 6 handrail RENEWAL. ALLOW for 300m<sup>2</sup> REPRESENTATION.</p>	<p data-bbox="1249 387 1449 562">Hotwork Required – Appropriate precautions to be taken iaw General 8.4.</p> <p data-bbox="1249 591 1449 703">IAW Paint scheme -General 12 and Annex B refer.</p> <p data-bbox="1249 732 1449 790">Complete IAW Ref. 5.</p>

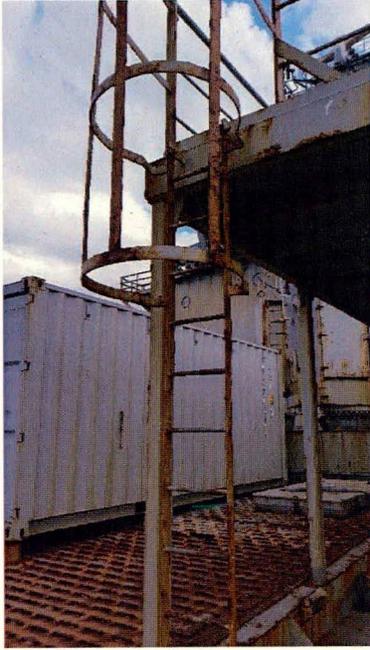
TASK NO.	TASK/DESCRIPTION H6 EXTERNAL LADDERS	NOTES
H6.04	<p><b>Crane Deck Ladder</b></p>

<p>The crane deck is out of bounds for training exercises therefore a lockable 'No Access' grill is to be manufactured and fitted to the ladder cage. Ladder and cage to be REPRESENTED following removal of broken down paint coatings.</p> <p>ALLOW for 3m<sup>2</sup> REPRESENTATION.</p>	<p>IAW Paint scheme -General 12 and Annex B refer.</p>

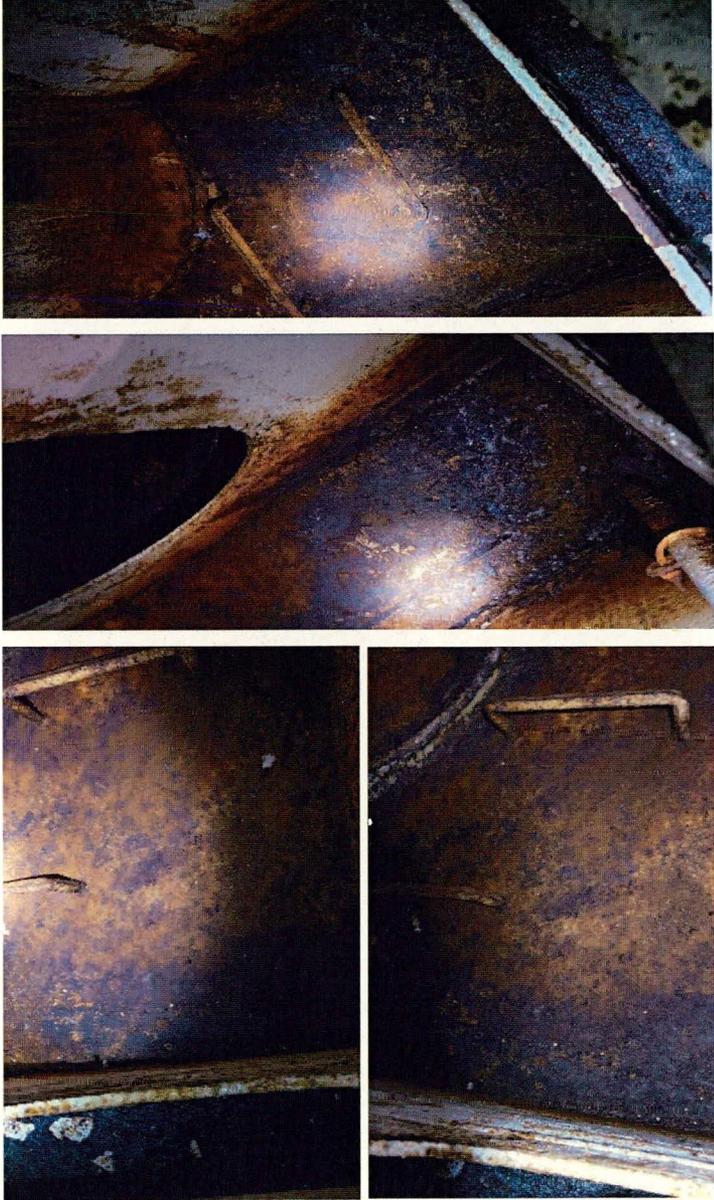
TASK NO.	TASK/DESCRIPTION	NOTES
H7.01	<p data-bbox="400 383 863 416"><b>Steering Gear Compartment Bilge</b></p>

<p data-bbox="400 1648 1233 1733">The paint coatings have broken down allowing active surface corrosion on both port and stbd sides bilge wells. Area requires scaling back and cleaning before REPRESENTATION.</p> <p data-bbox="400 1744 970 1776">ALLOW for 8m<sup>2</sup> REPRESENTATION. either side.</p>	<p data-bbox="1249 383 1445 499">IAW Paint scheme -General 12 and Annex B refer.</p> <p data-bbox="1249 528 1410 645">Contractor to remove and dispose of all arisings.</p> <p data-bbox="1249 674 1445 837">Adequate ventilation to be arranged before work commences IAW General 3.2.</p>
