# **OLD NATWEST BANK BUILDING RYDE MECHANICAL SURVEY REPORT**

**DATE 19.12.24**

**Old NatWest Building**  
**St Thomas Street,**  
**Ryde**

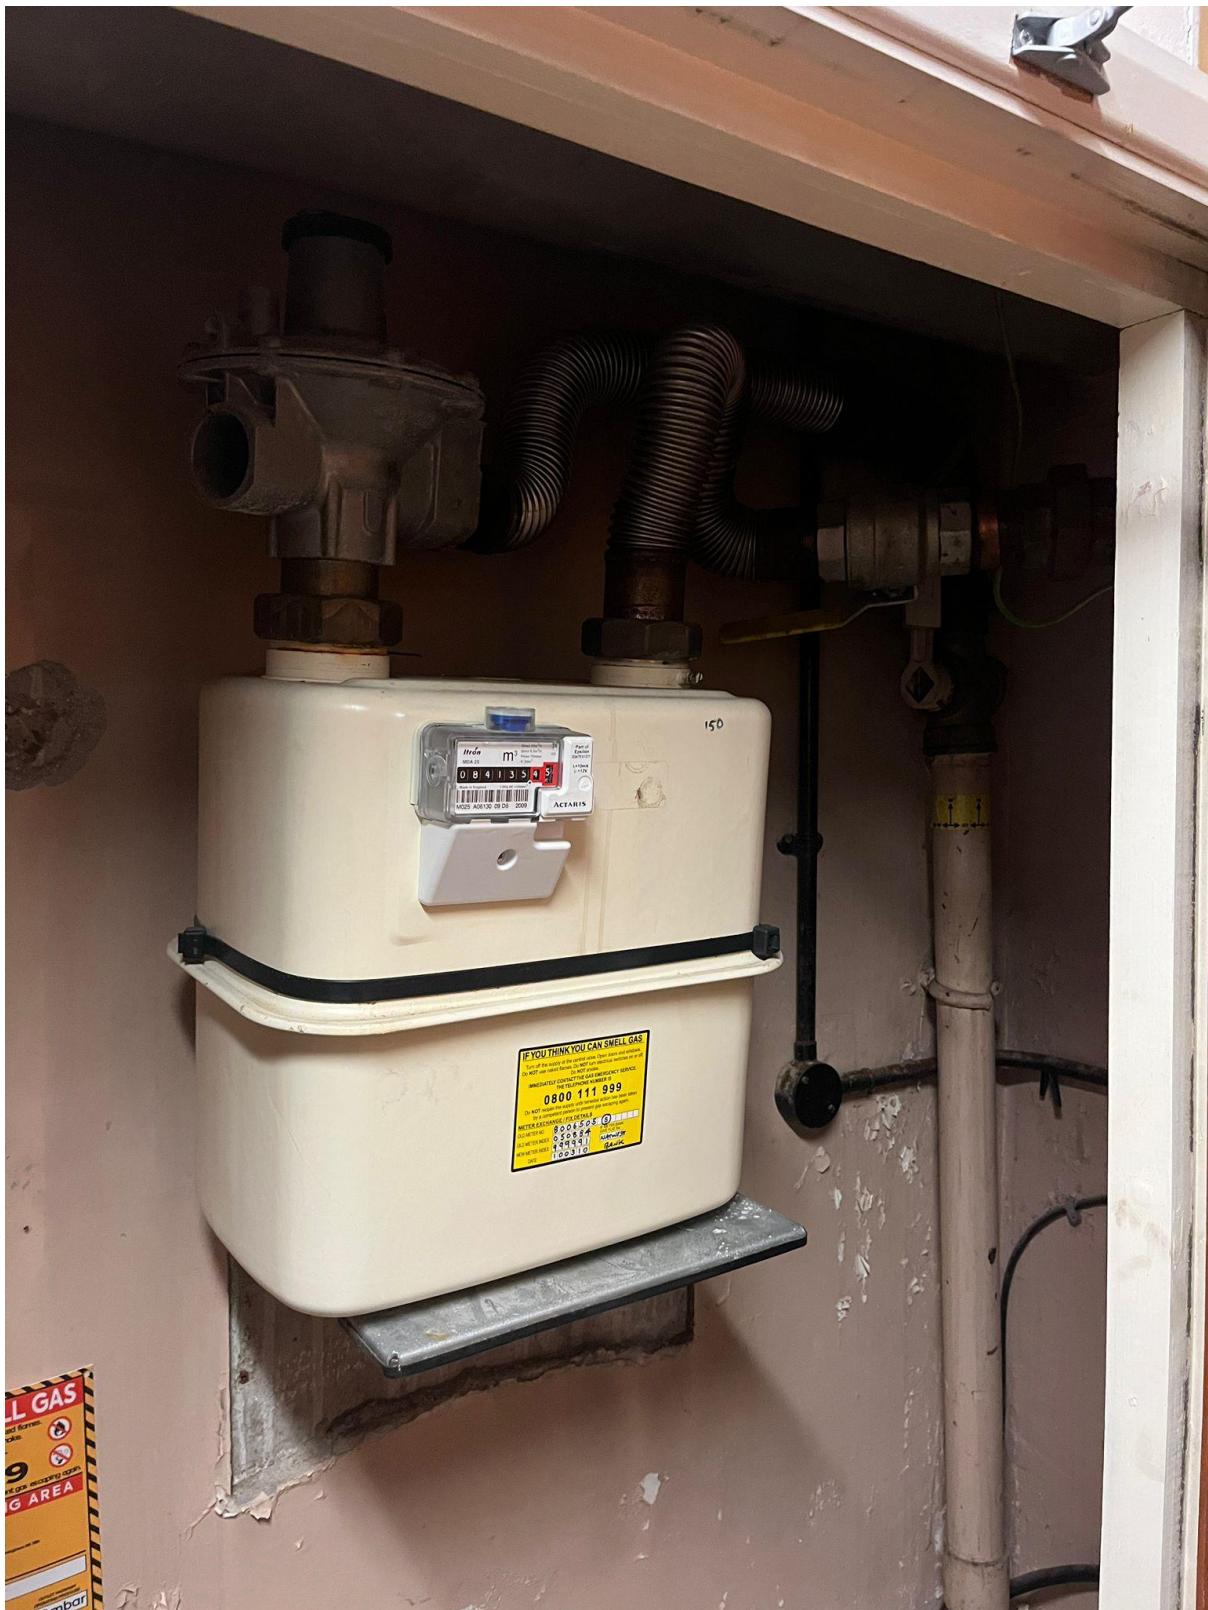
## Gas Meter

Appliance Type	Location	Make	Model	Serial No.	Manufacturer	Condition / Notes
Gas Meter	Basement electric room	Itron	MDA2S	M025A0613009D6 2009	—	Good

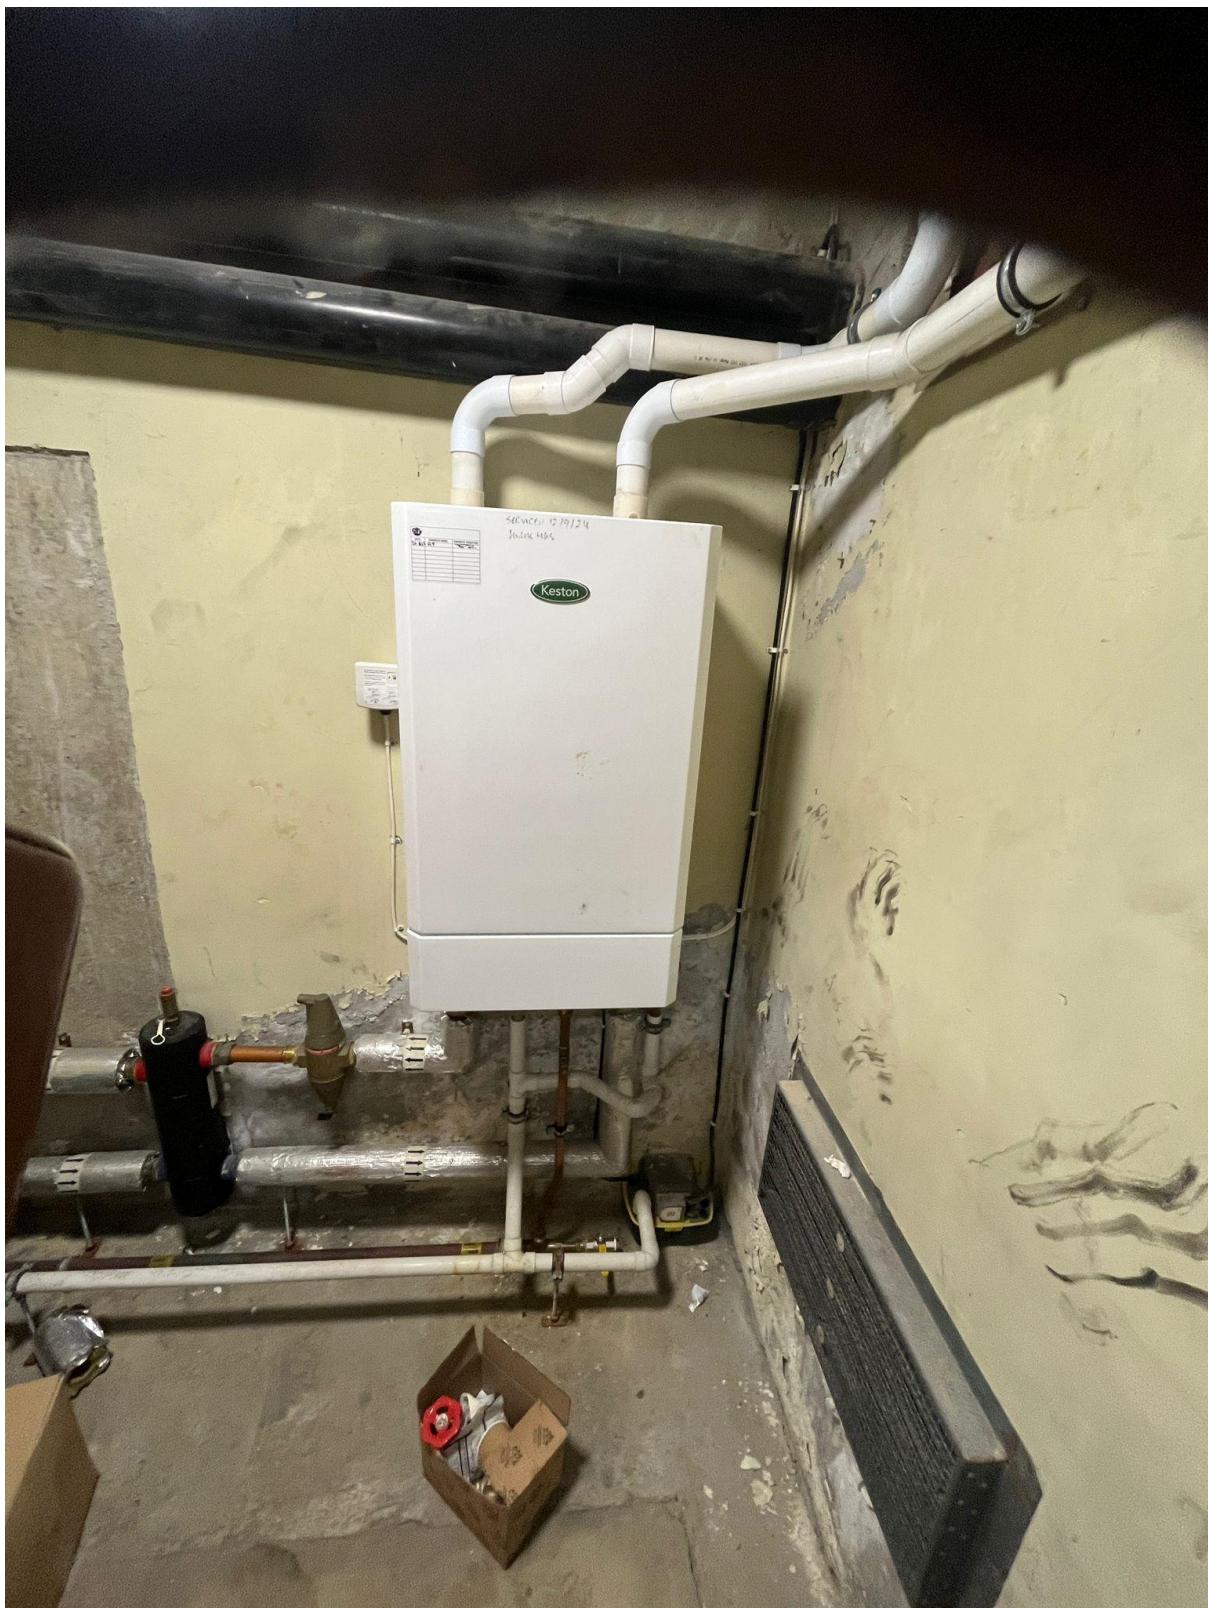
Wall Mounted Gas Boiler

Appliance Type	Location	Make	Model	Serial No.	Manufacturer	Condition / Notes
Boiler	Basement Plant Room	Keston	Keston Heat 55	ZU2086340000917	IDEAL	WORKING, AND OVERALL IN GOOD CONDITION.

The overall condition of the gas fired central heating system is in good condition and has a relatively new wall mounted boiler and flue system installed. The heating controls were also in good working order.

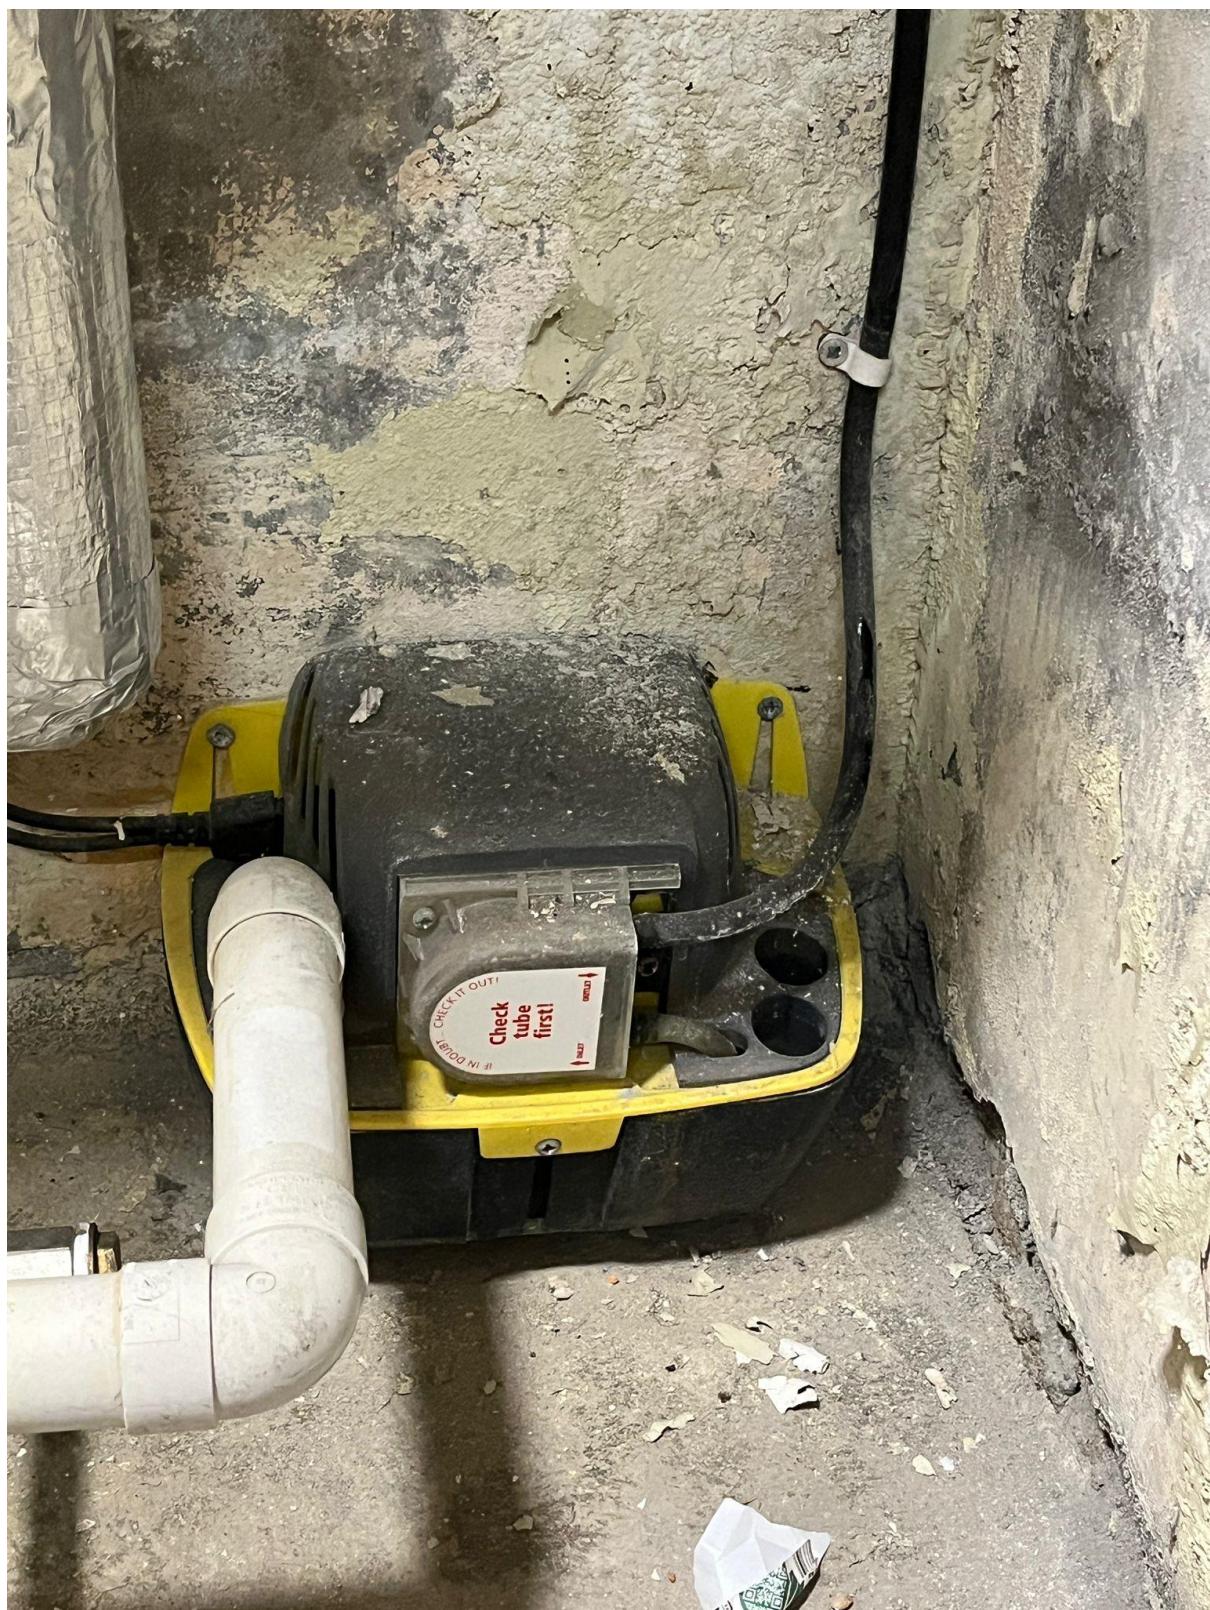
### Boiler Condensate Pump

Appliance Type	Location	Make	Model	Serial No.	Manufacturer	Condition / Notes
Condense Pump	Basement Plant Room	Aspen	FP2071/CHL28798122		Aspen	WORKING AND OVERALL IN GOOD CONDITION.

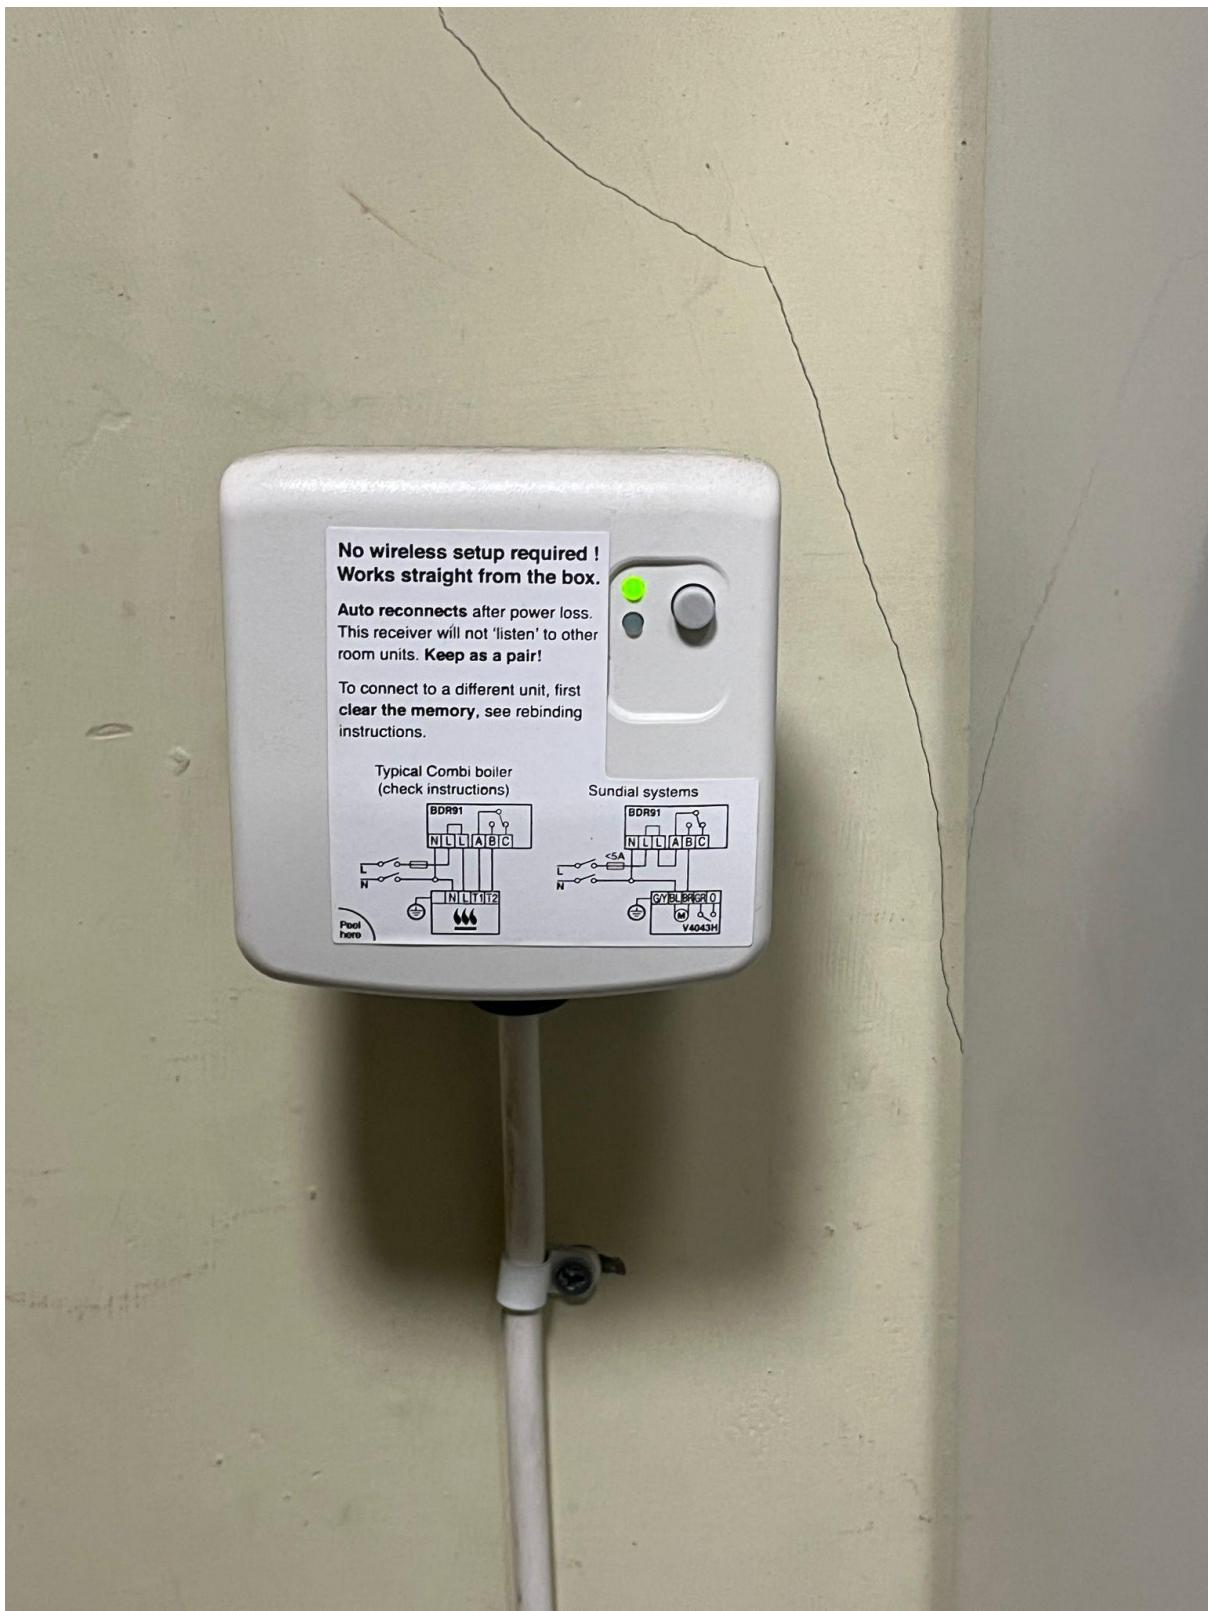
## Boiler Wireless Receiver

Appliance Type	Location	Make	Model	Serial No.	Manufacturer	Condition / Notes
Wireless roomstat	Basement Plant Room	Honeywell	CN927		Honeywell	WORKING AND OVERALL IN GOOD CONDITION

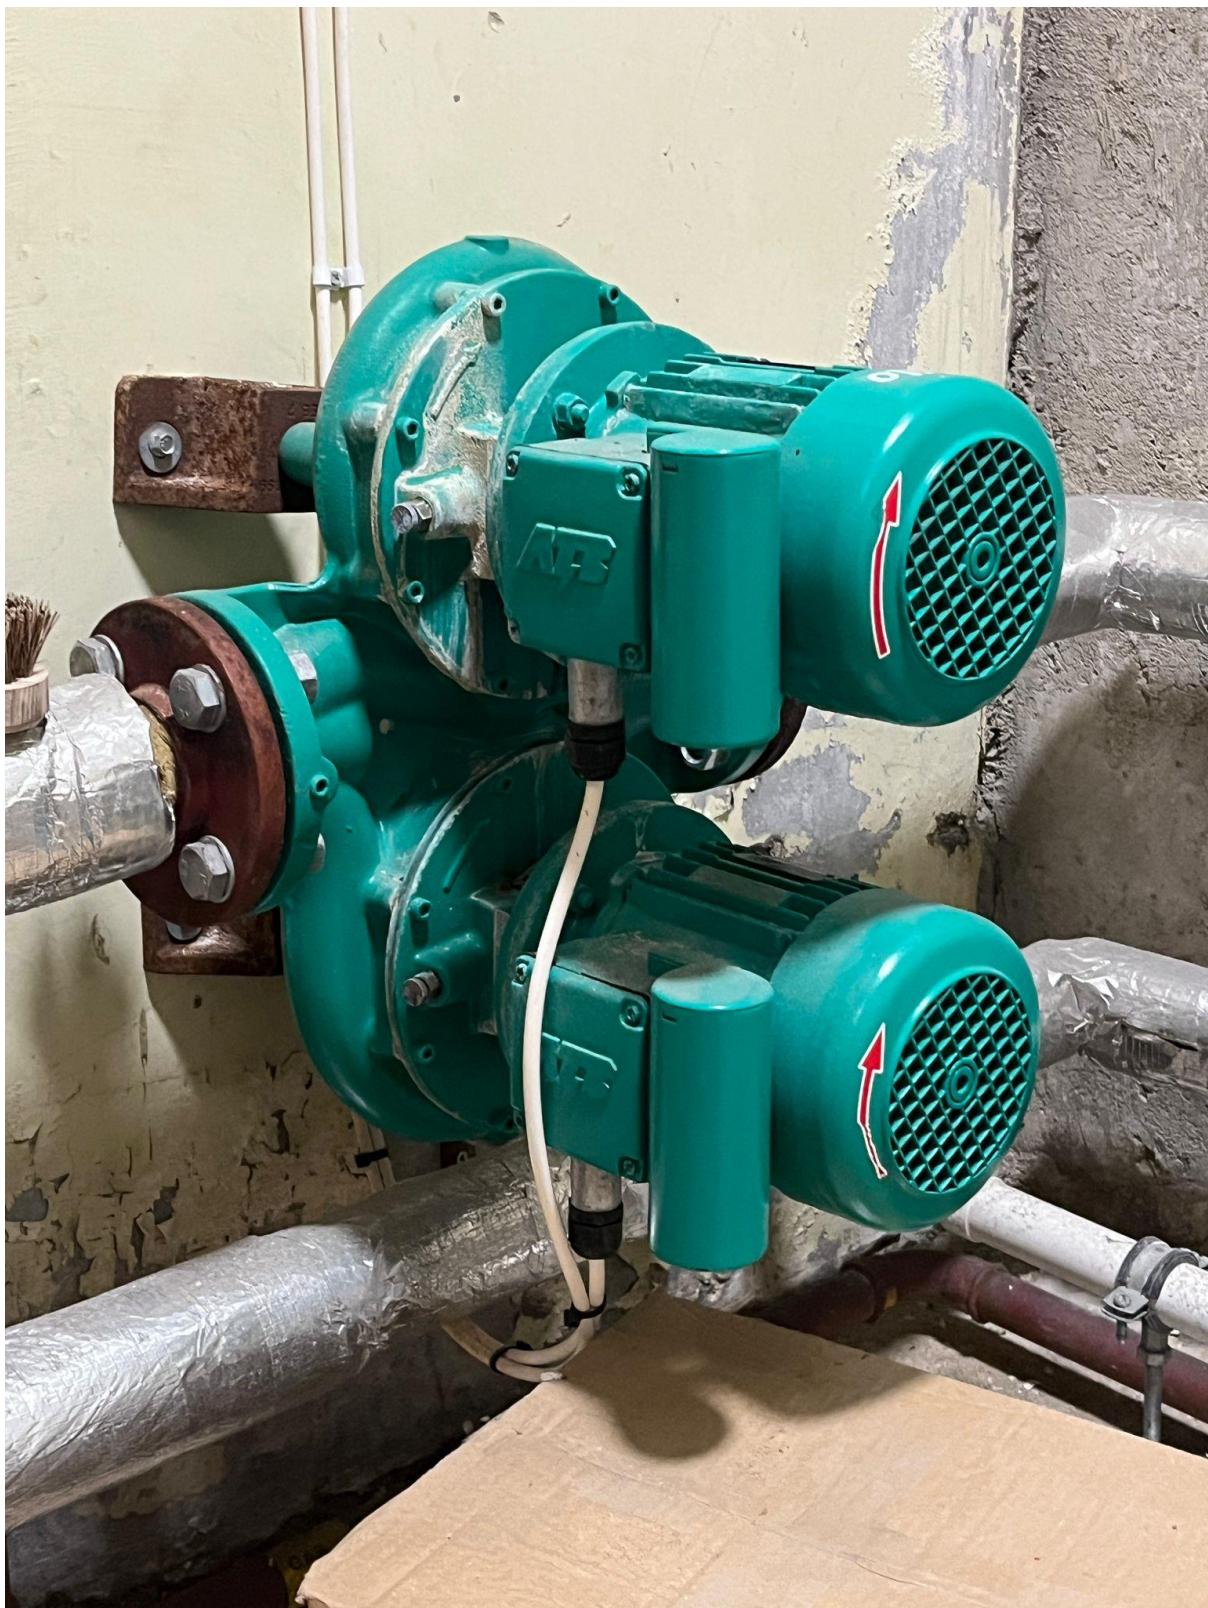
## Heating Primary Circulation Pumps

Appliance Type	Location	Make	Model	Serial No.	Manufacturer	Condition / Notes
Twin Head PUMP	Basement Plant Room	Wilo	DPL40/ 130-0.25/ 4-N-V4	21216641/0001	wilo	WORKING AND OVERALL IN GOOD CONDITION,

The heating is circulated around the building via twin head heating pumps located within the basement plantroom. These were tested and although, fairly old, were working ok.

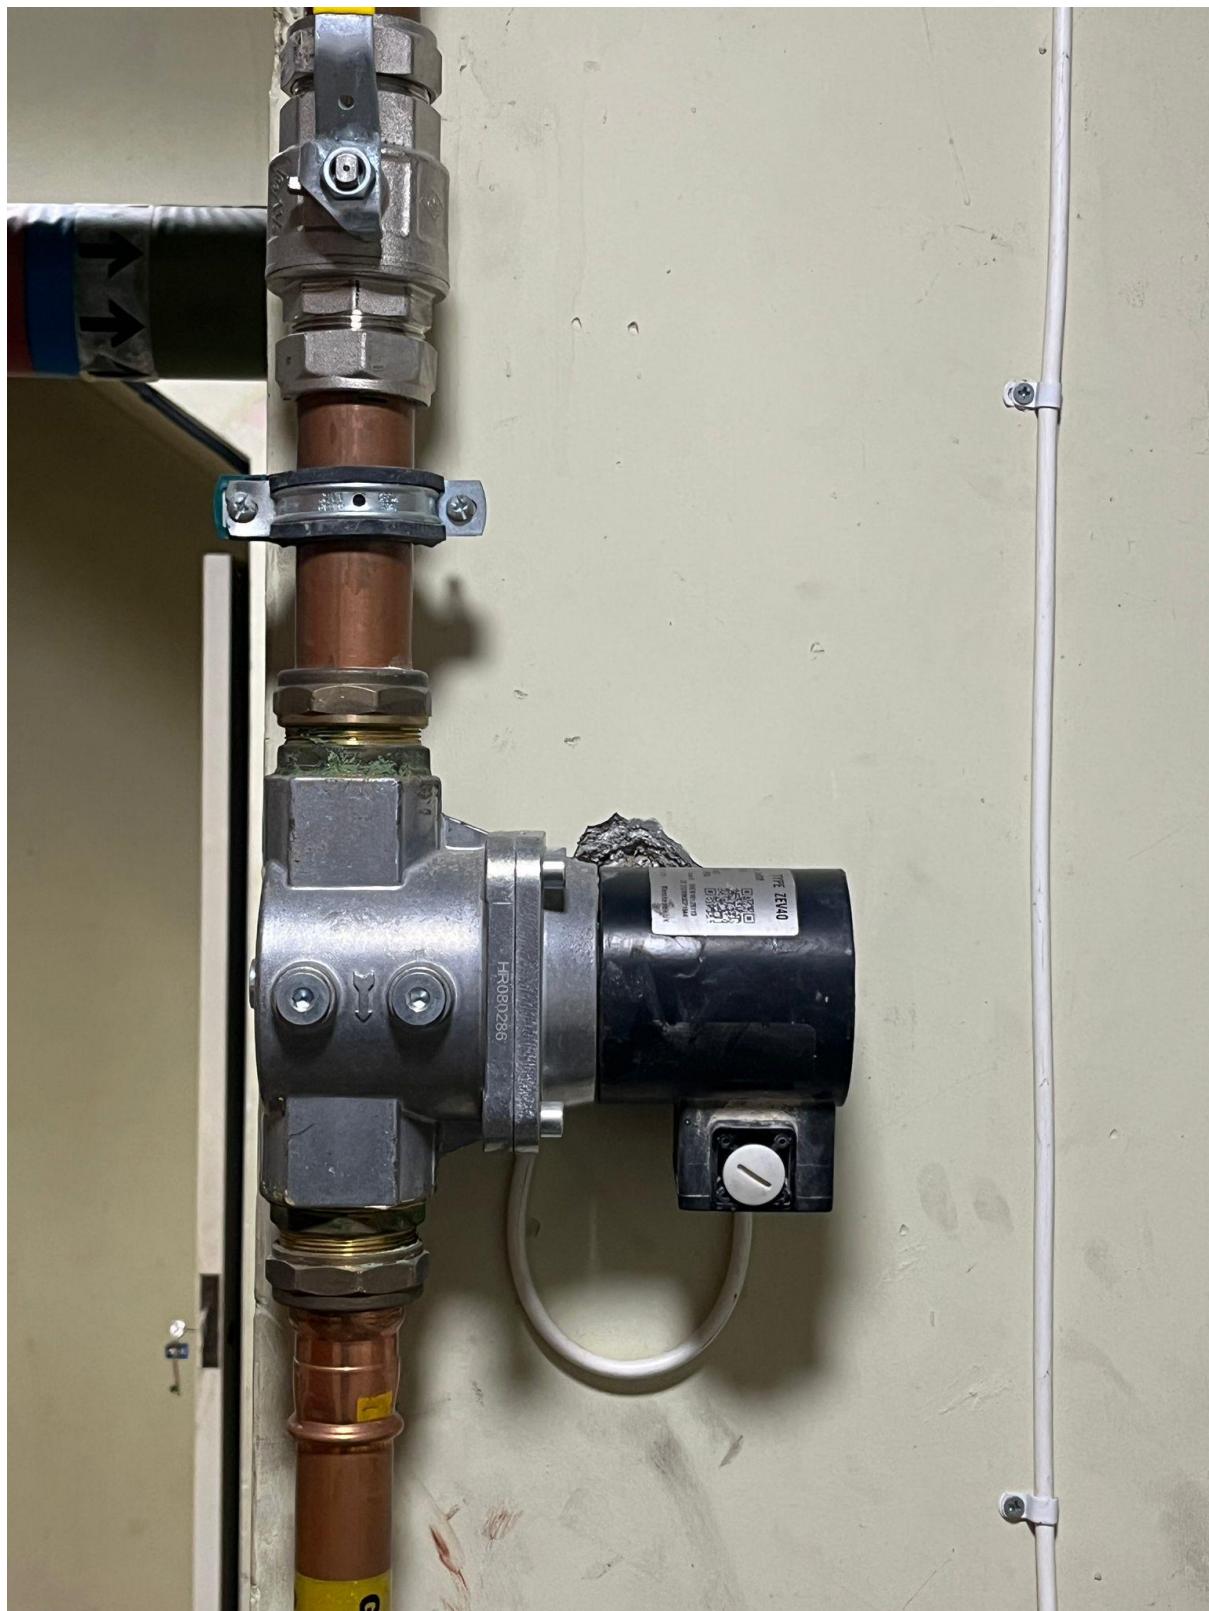
### Gas Solenoid Valve

Appliance Type	Location	Make	Model	Serial No.	Manufacturer	Condition / Notes
Gas Solenoid Value	Basement plant room	Bonico	ZEV40	ISO9001:2015	—	Good

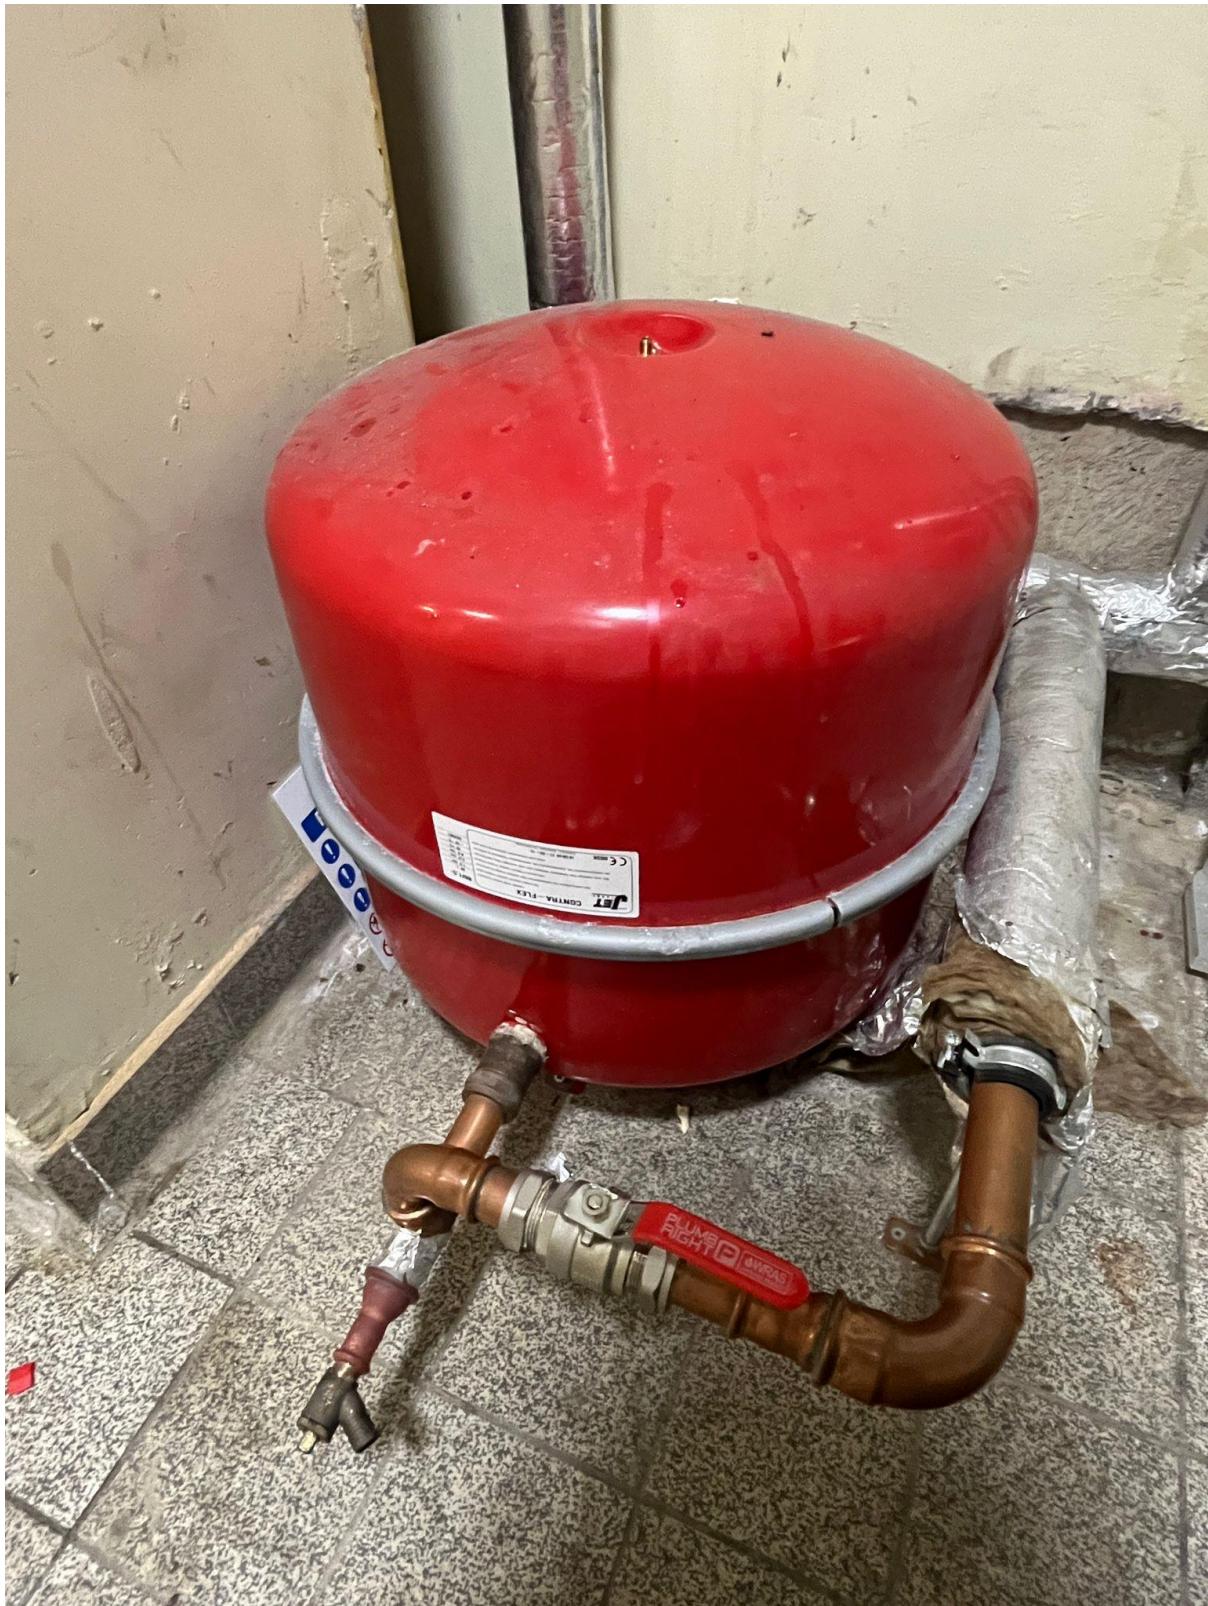
Heating Expansion Vessel

Appliance Type	Location	Make	Model	Serial No.	Manufacturer	Condition / Notes
Expansion vessel	Basement Plant Room	Jet	80L	-	-	Good

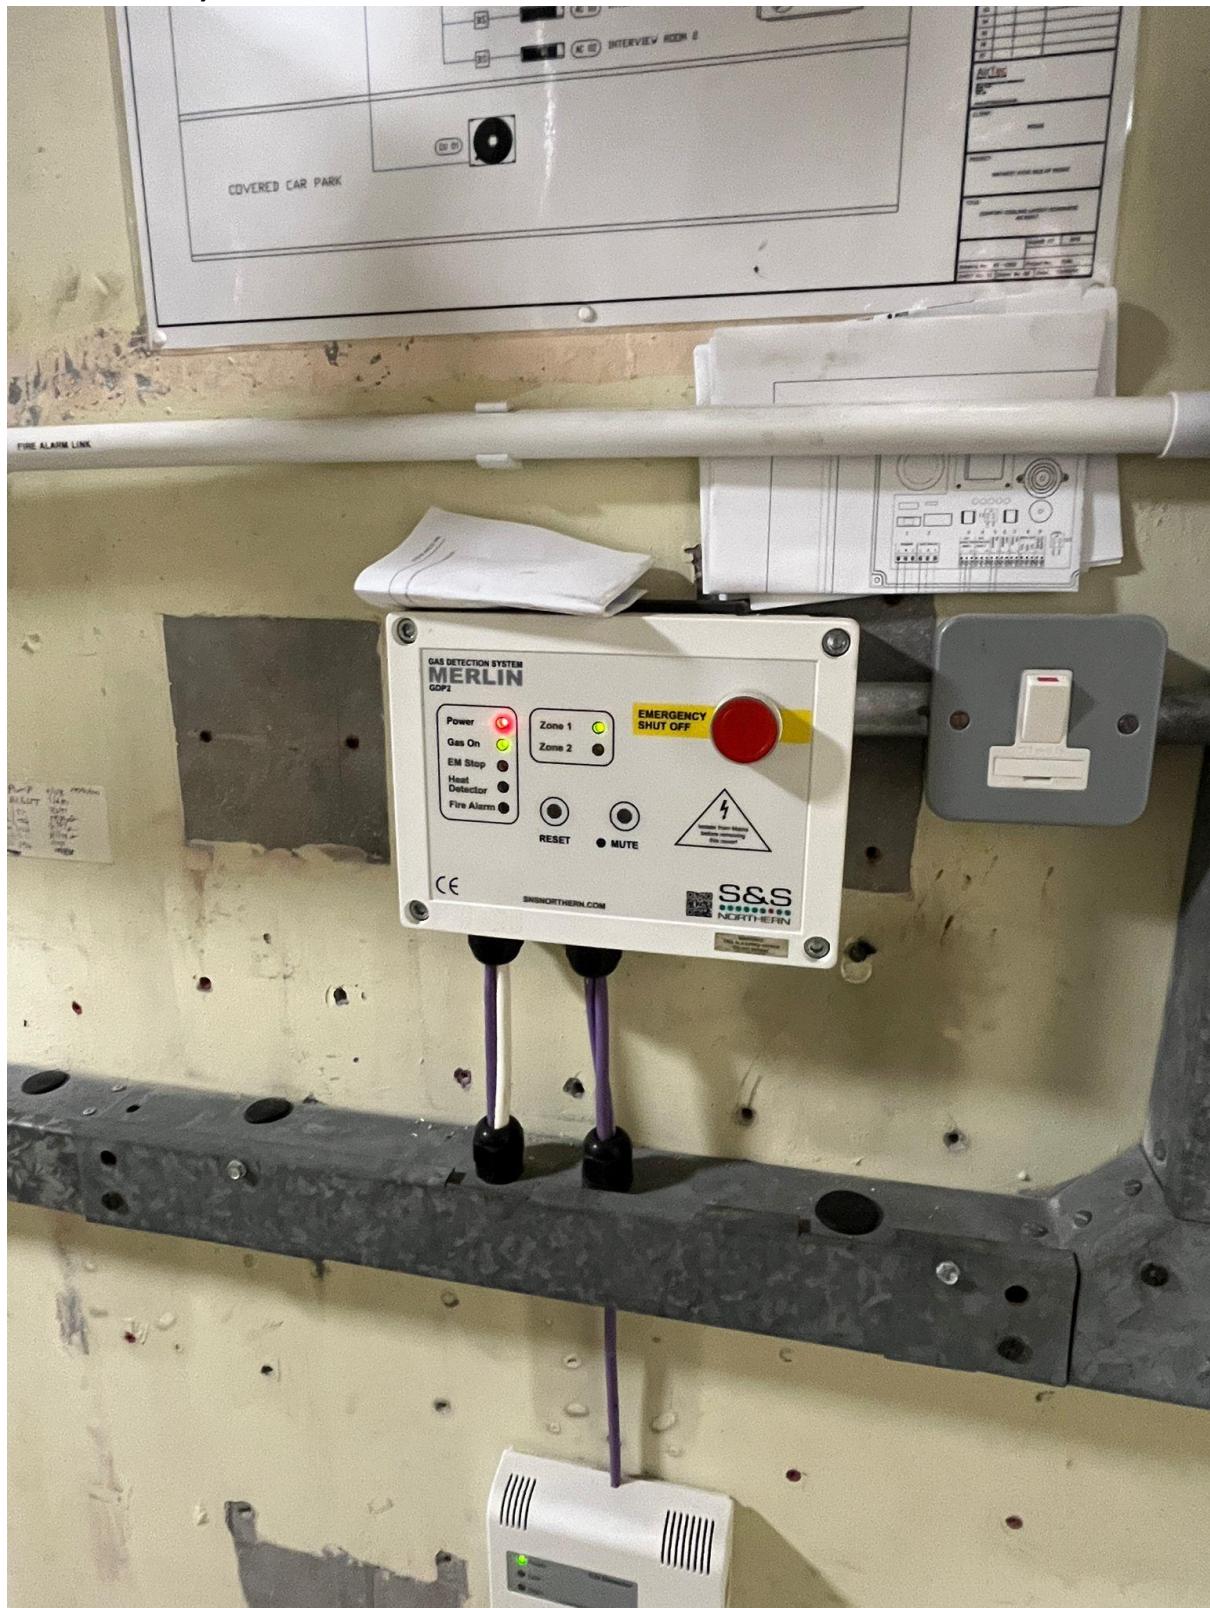
## Gas Detection System

Appliance Type	Location	Make	Model	Serial No.	Manufacturer	Condition / Notes
Gas detection system	Basement Plant Room	Merlin	GDP2	-	-	Working

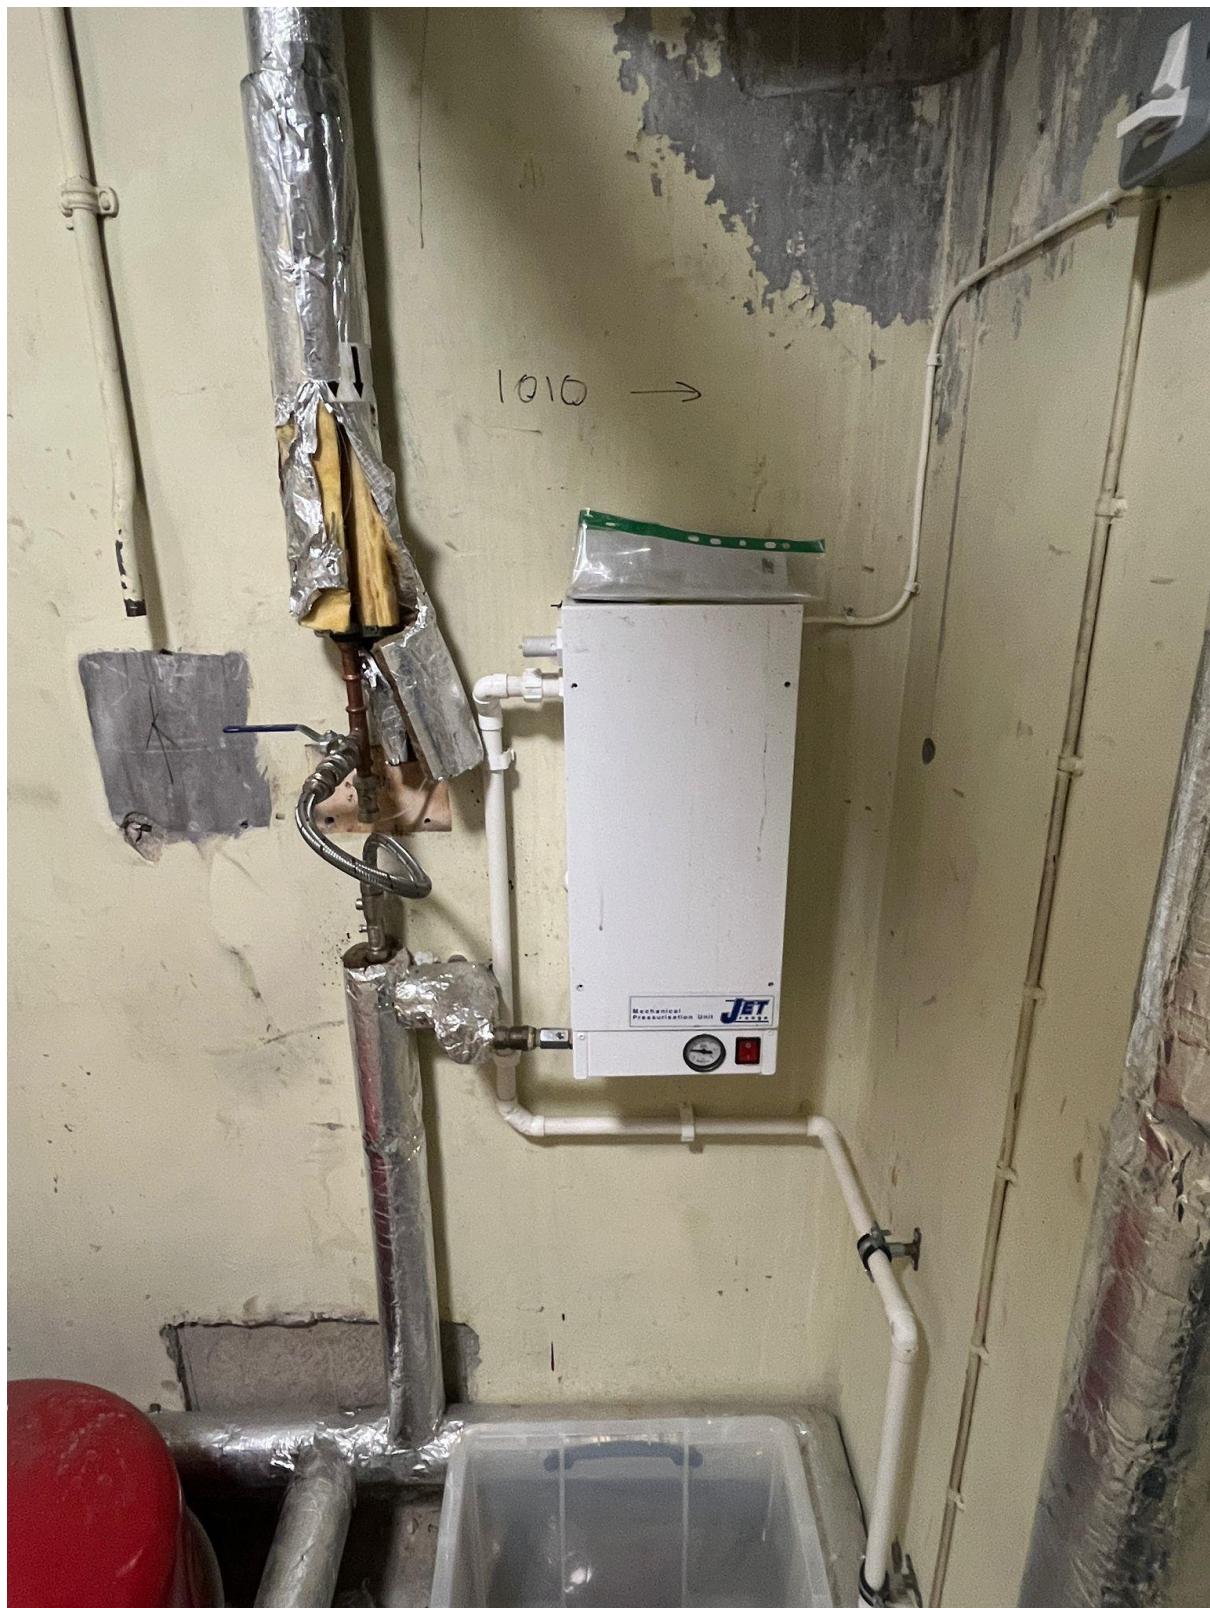
## Heating System Pressurisation Unit

Appliance Type	Location	Make	Model	Serial No.	Manufacturer	Condition / Notes
Auto top up	Basement Plant Room	Jet	mini 130 HL	505250	-	Not working

The 'Auto Top-up' or heating system pressurisation unit was not working.

Replace Heating system Pressurisation Unit.

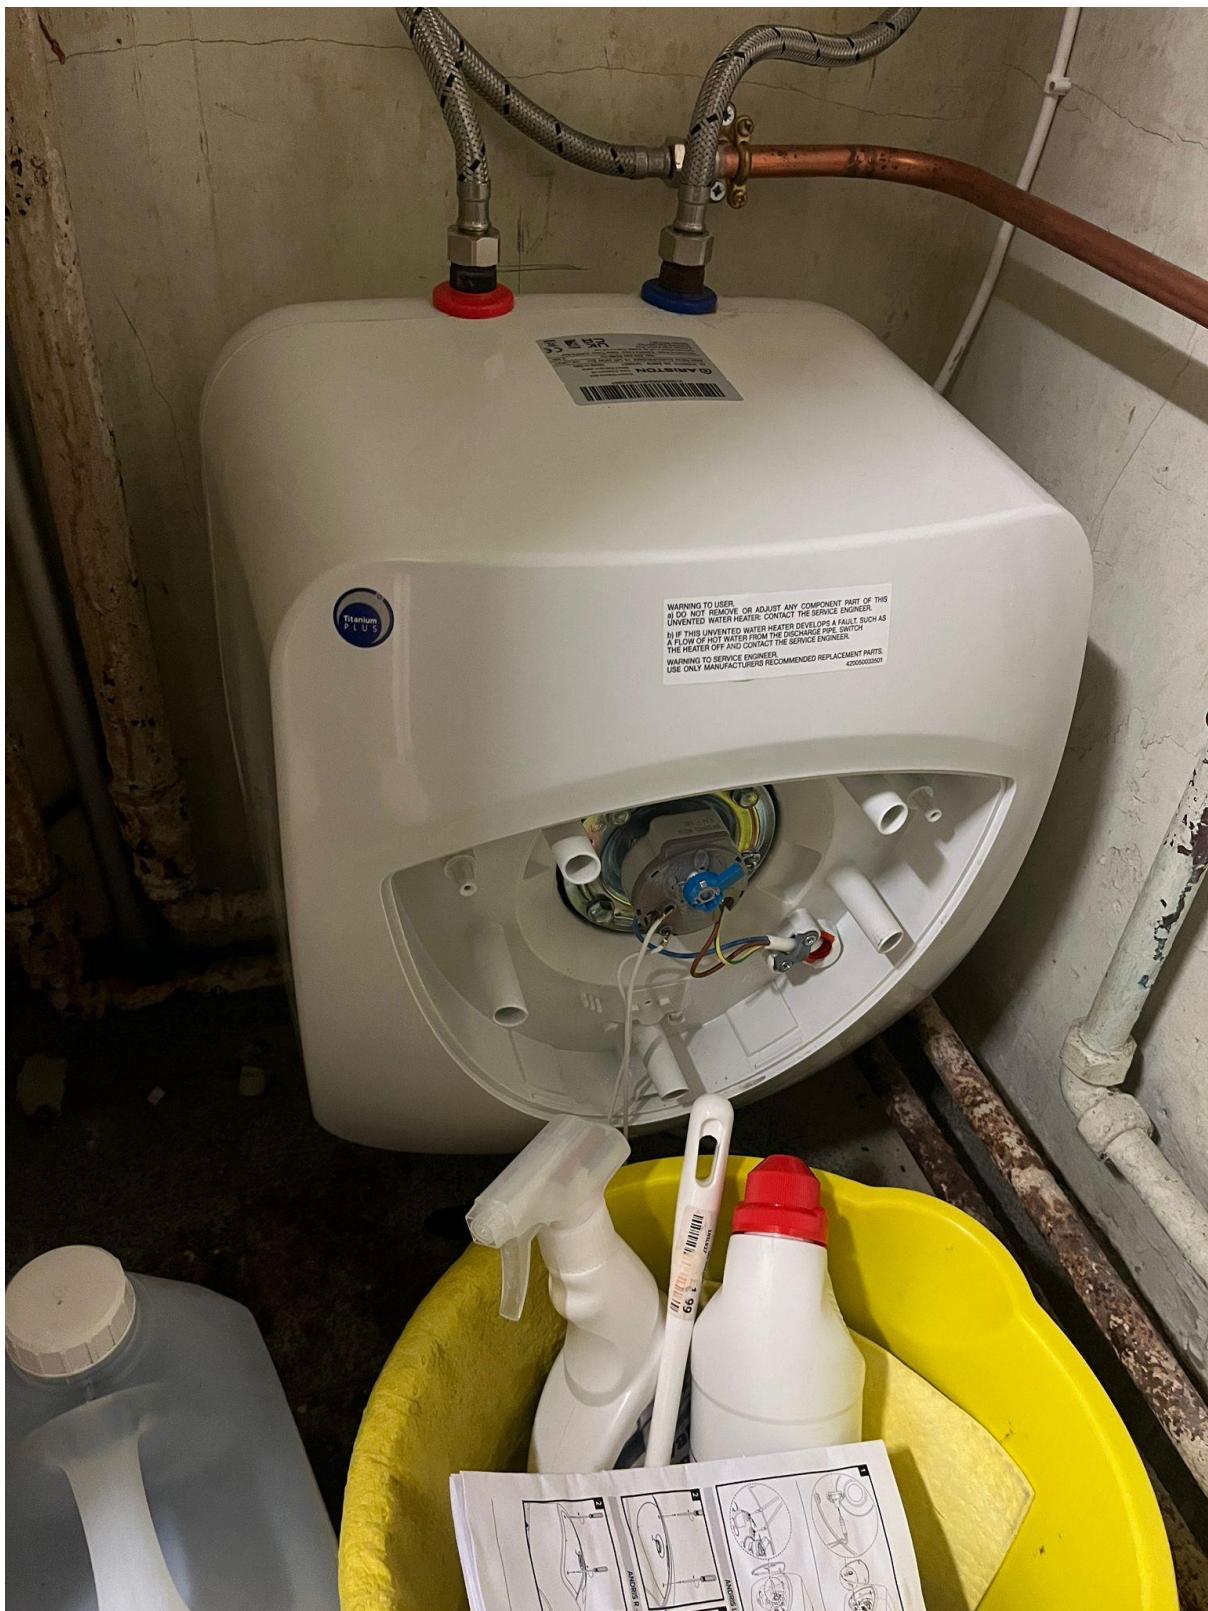
## Point of Use Hot Water Heater – First Floor Toilets

Appliance Type	Location	Make	Model	Serial No.	Manufacturer	Condition / Notes
water heater	1st floor toilets					Not working

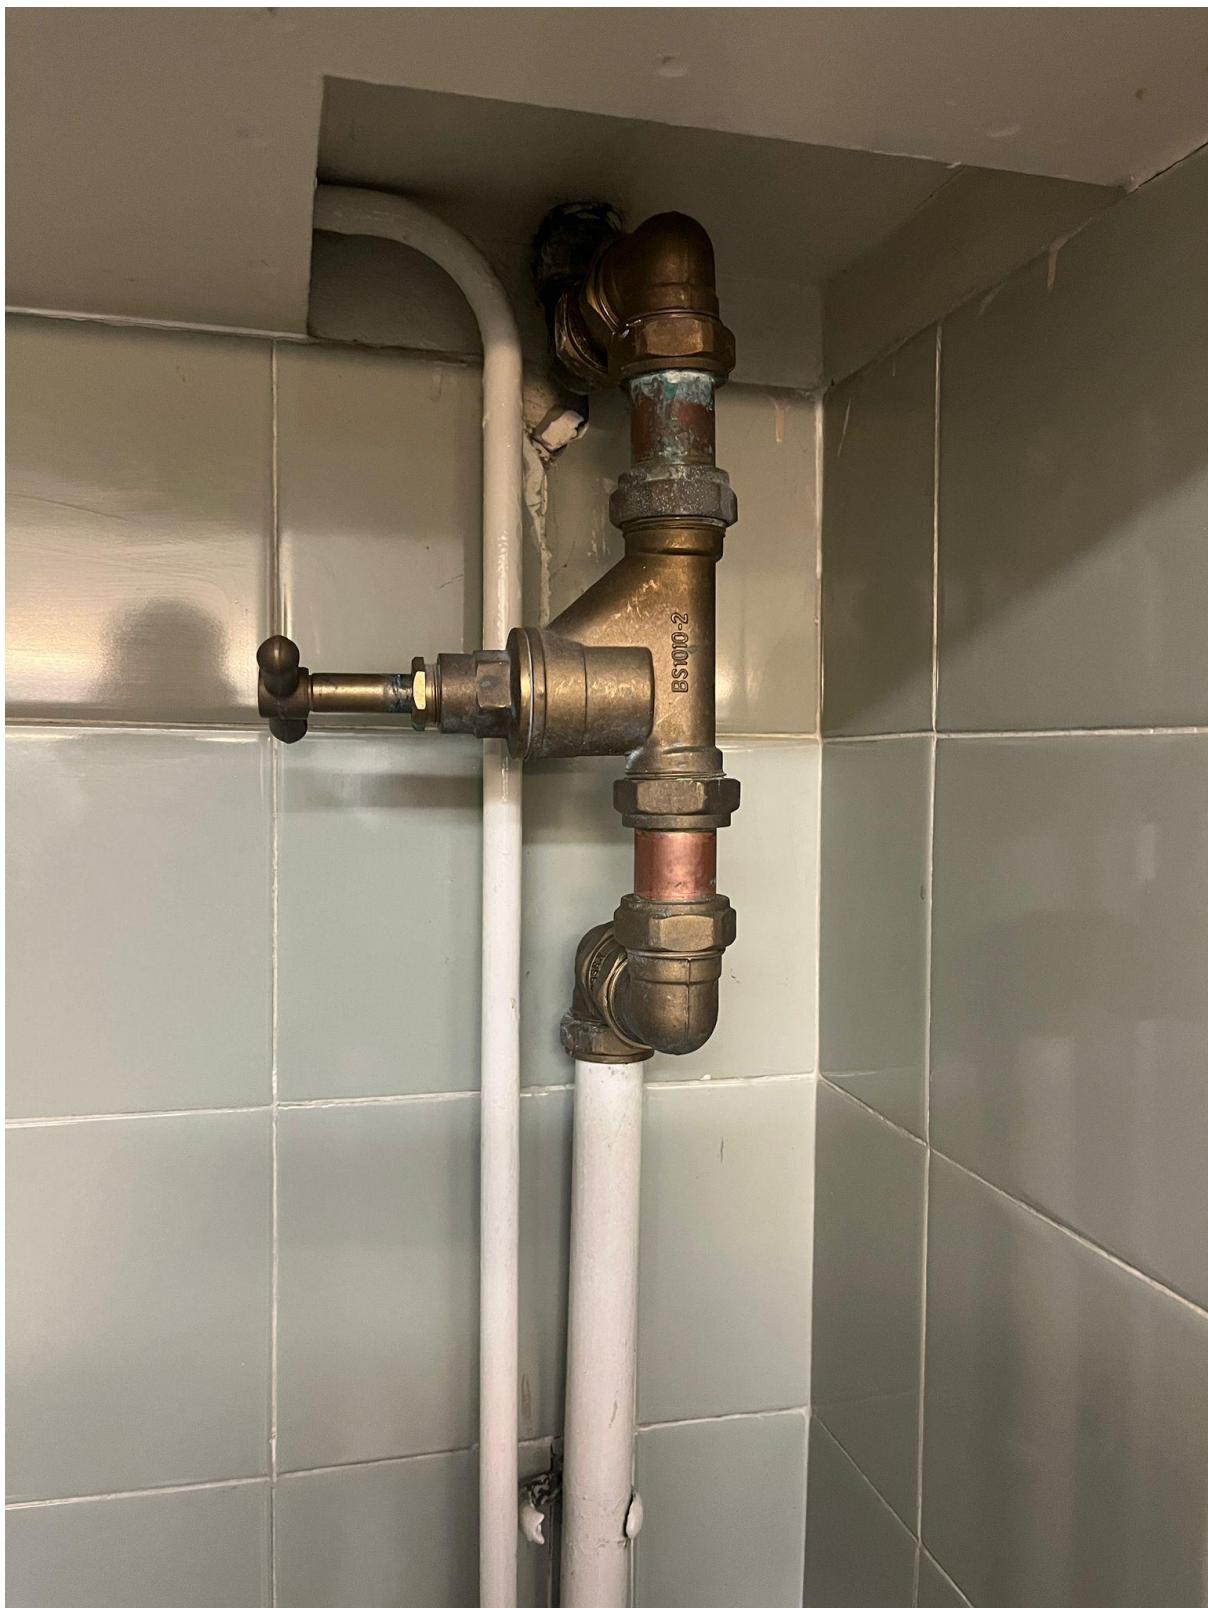
**Mains Water Stop Cock (28mm) in Basement Ladies Toilets**

Appliance Type	Location	Make	Model	Serial No.	Manufacturer	Condition / Notes
STOP COCK 28mm	Basement Ladies Toilets	-	-	-	-	Working.

The pipework system providing hot and cold water throughout the building was in good condition. The main stop cock to the building was found in the Basement Ladies Toilets and was working ok.
