# **OLD NATWEST BANK BUILDING RYDE MECHANICAL SURVEY REPORT**

**DATE 19.12.24**

**Old NatWest Building**  
**St Thomas Street,**  
**Ryde**

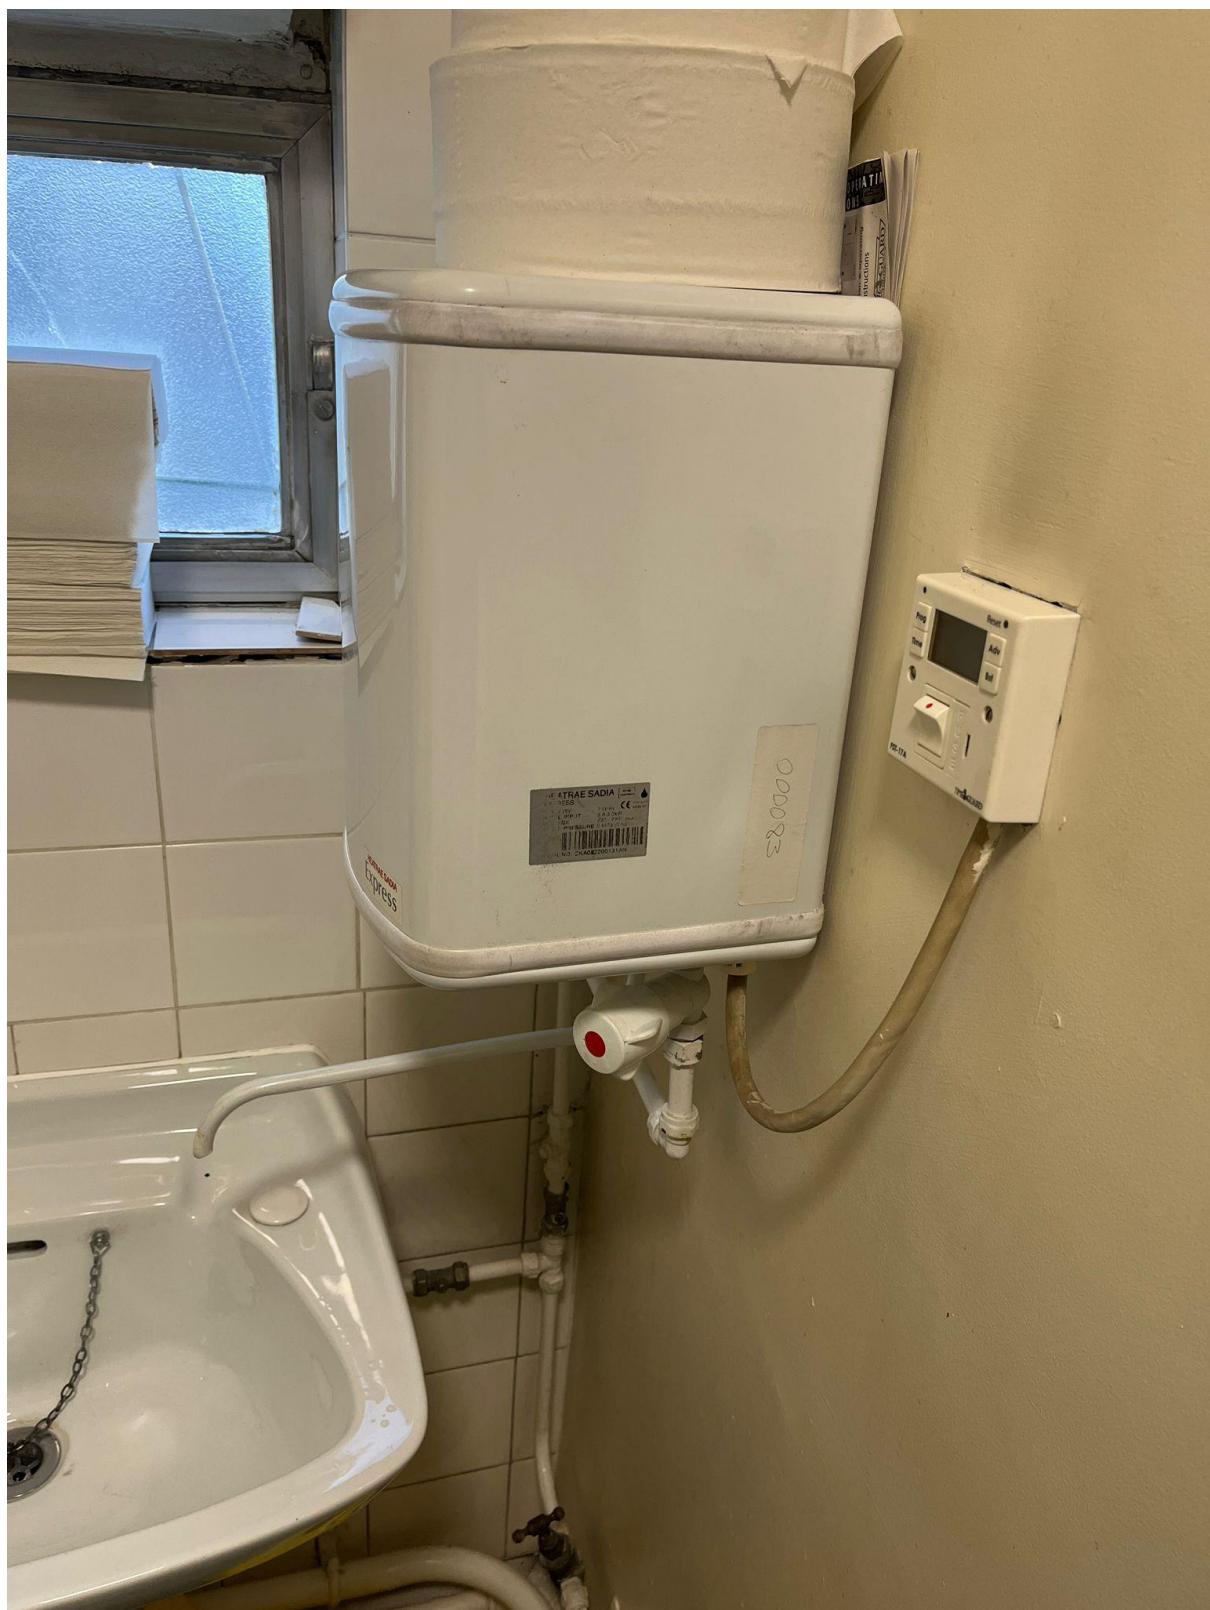
**Point of Use Hot Water Heater in Ground Floor W.C.**

Appliance Type	Location	Make	Model	Serial No.	Manufacturer	Condition / Notes
Water heater	Ground floor WC	Heatrae Sodiq	Express 7L	02A082200131AU		No Power

There were two point of use electric hot water heaters; one in the Basement cleaners cupboard and the other in the Ground Floor w.c. Both were not working.

Replace both hot water heaters. No repairs recommended.

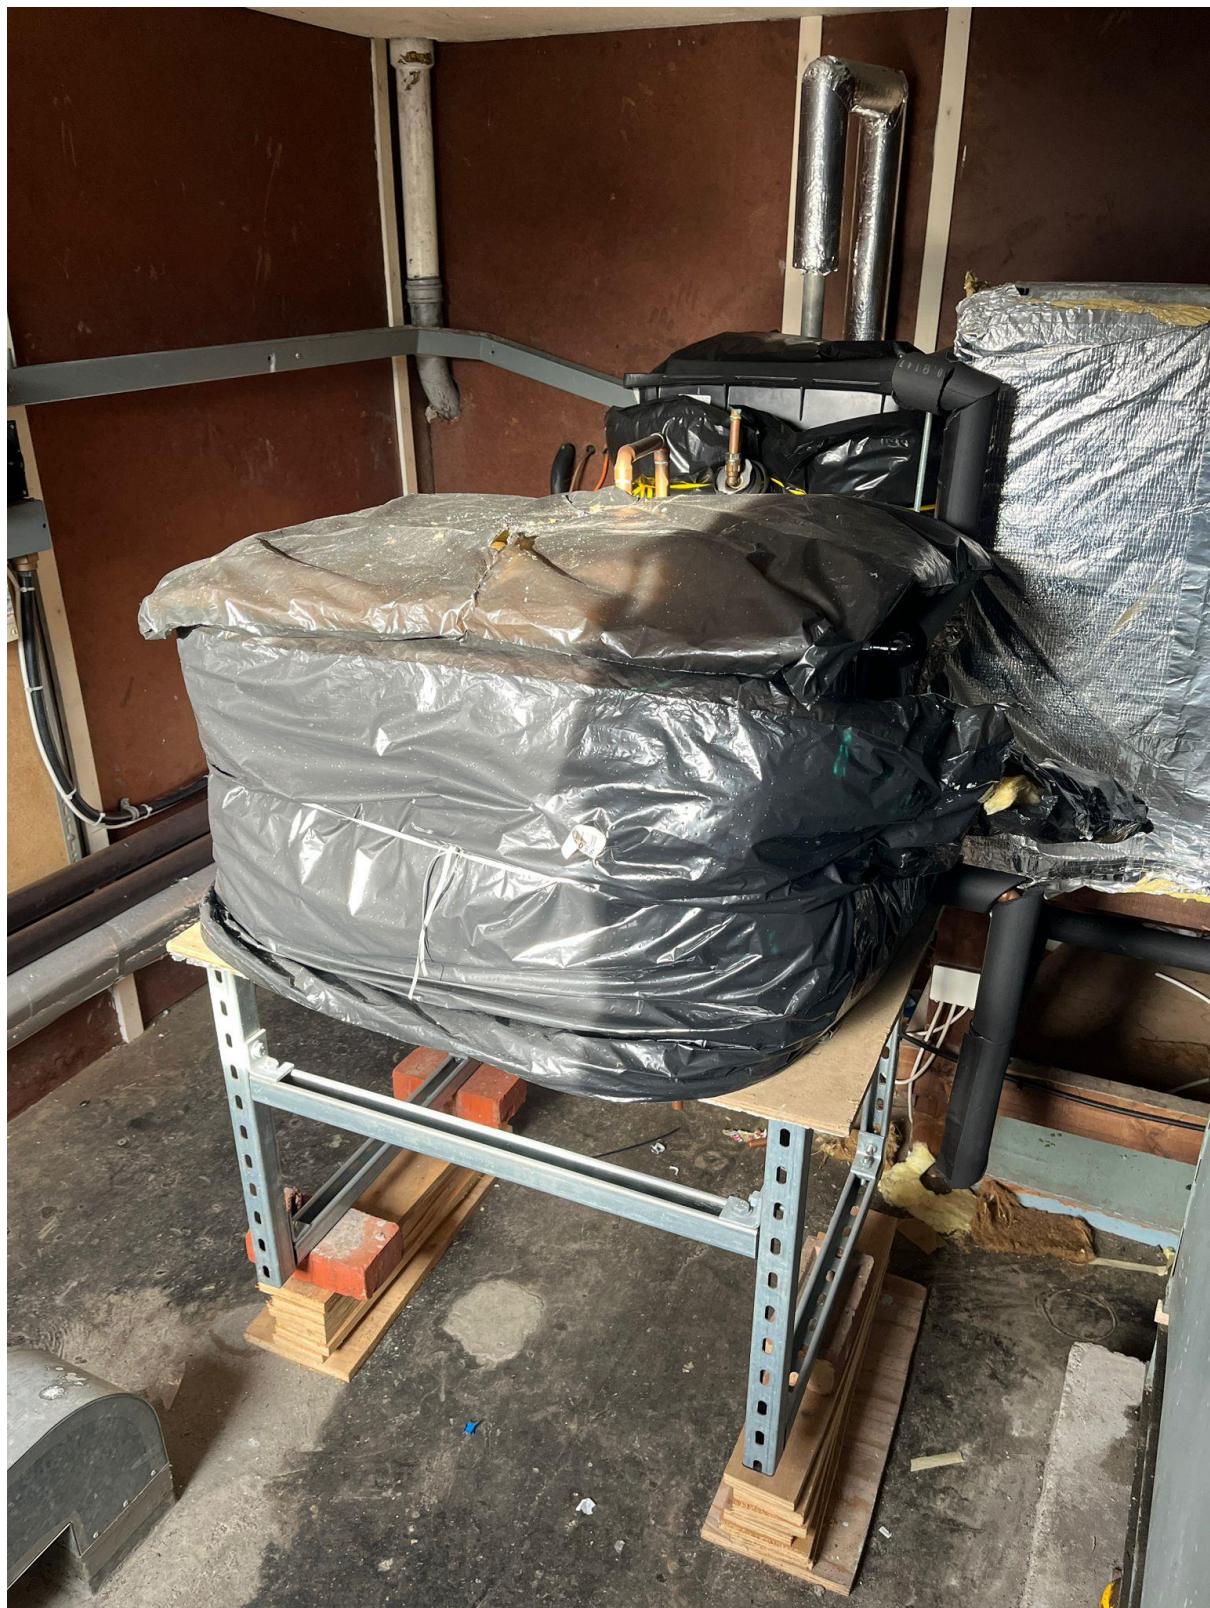
**Cold Water Storage Tank in First Floor Roof Space**

Appliance Type	Location	Make	Model	Serial No.	Manufacturer	Condition / Notes
water tank	1st floor loft space					Good

The cold water storage tank in the First Floor roof space was replaced with a newer plastic tank. This serves cold water taps to toilet wash hand basins and w.c. cisterns.

The old redundant galvanised tank alongside a redundant heating header tank still remain in their original positions.

The 'newer' plastic cold water storage tank supports should be replaced with a suitable support system, such as timber joists, instead of 'makeshift' wooden slats and a couple of bricks.

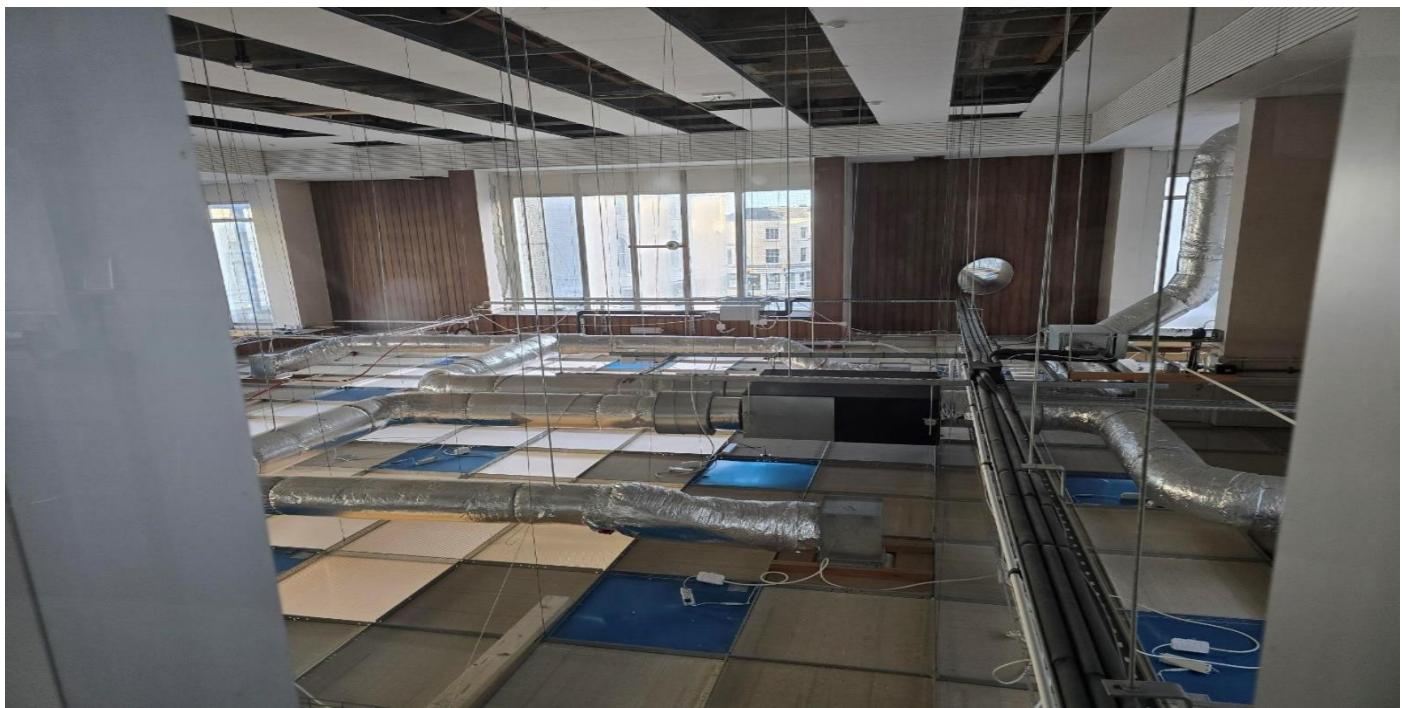
The system is a Daikin three pipe simultaneous heating and cooling system meaning each area can have independent heating and cooling all running off the same outdoor unit, the pipework, BS (branch selection) boxes, cable, drain and lagging looked to be in very good condition above the ceiling in the main area and looked to be installed to a high standard.

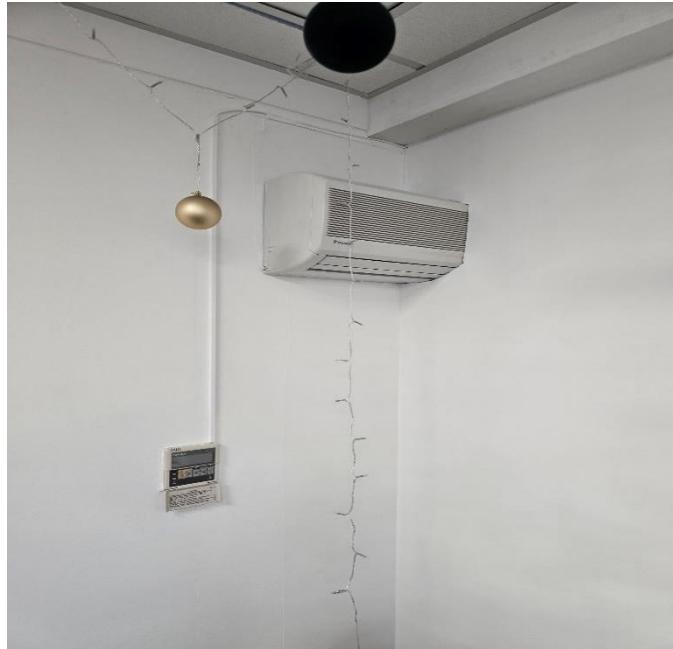
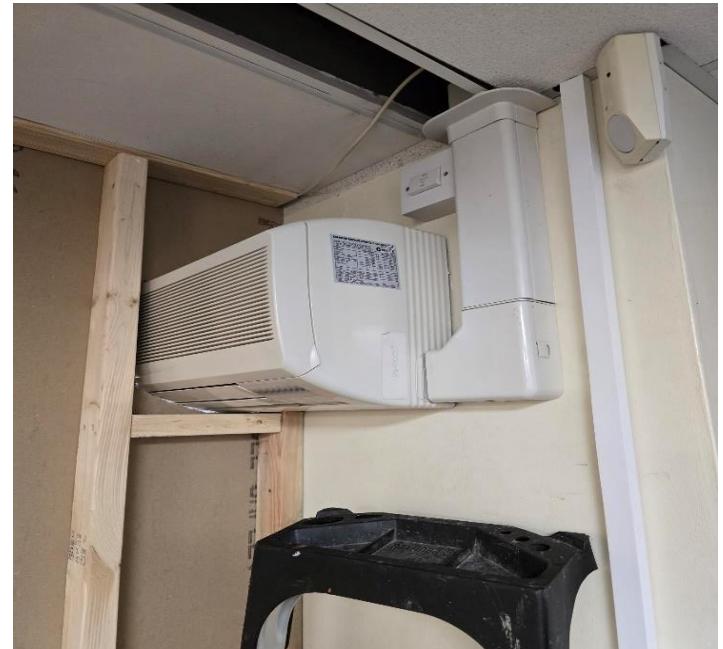
One of the indoor wall mounted units has had a wall built around it, so this unit would need to be removed from the main system or moved into the main area before this unit could be operational.

- Electrical connections reinstated to indoor A/C and Ventilation power supplies
- Test all A/C indoor units and condensate pumps.
- Move or remove A/C unit built into the wall.
- Repair or remove door curtain and add additional controller.
- Replace or remove central controller from the system.
- PCB boards fitted to outdoor unit and testing continued.
- New anti-vibration feet fitted to outdoor unit.
- Ventilation unit tested.

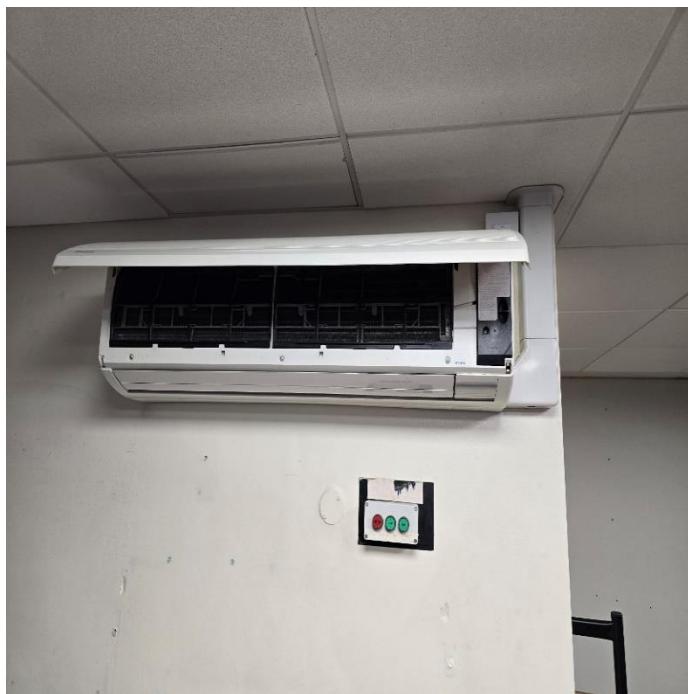
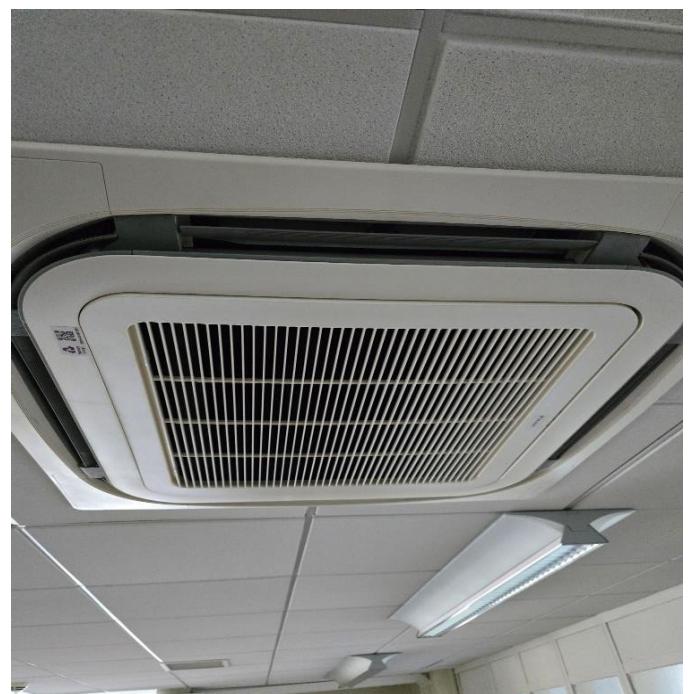
**Indoor units:** All the indoor units are old, and the estimated age/installation date was in early 2008, aside from this all the indoor units (apart from the one built into the wall) look to be **visually** in good condition, both internally and casings. The unit coils were clean and showed no signs of damage. We could not test any of the indoor units as none of them had a power supply.

There is the potential to re-use certain parts of the installation, such as pipework and ductwork. However, we would recommend replacing the indoor and outdoor AC units.

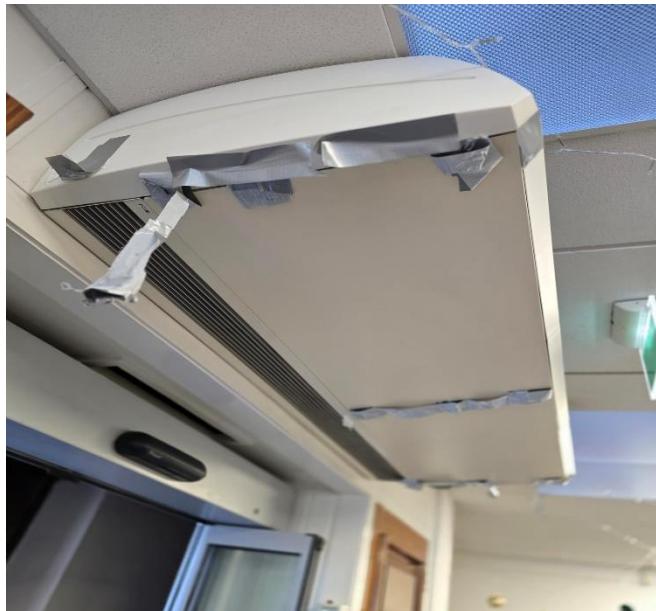
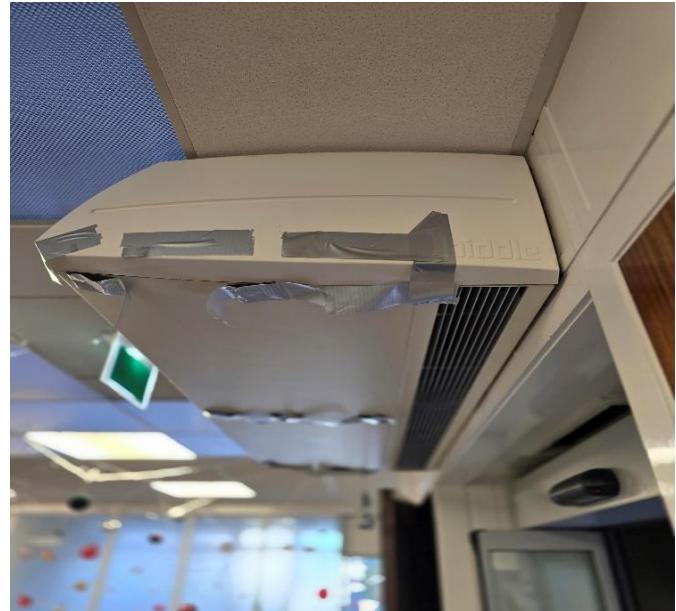
The door curtain had duct tape holding the outer case together so we did not inspect the inside of the unit, we also could not find a controller for this unit, so suspect that this is controlled via the centralised controller.

If this door curtain does not work when power is restored to the system and following our discussions with Daikin the new modern day equivalent DX door curtain would not be compatible with the existing Outdoor unit. Subsequently If the main door was going to be frequently used by the public and the door open to the outside environment, we would recommend fitting an electric air blower type door curtain in its place and remove the existing DX one from the centralised controller.

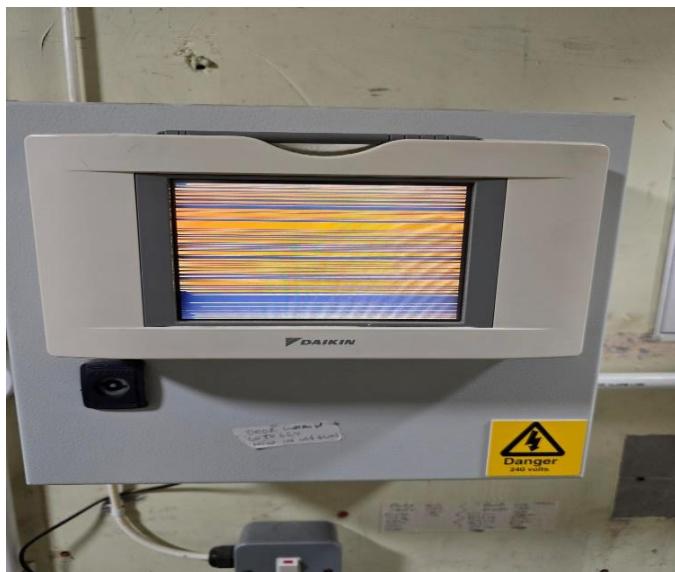
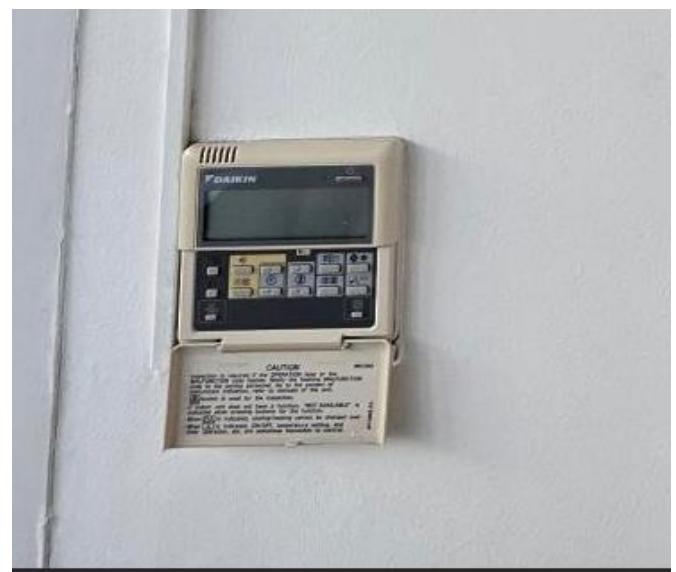
All the controllers on each indoor unit are very old but show no signs of visual damage, we could not test them due to the system not having power. We managed to power up the centralised controller in the basement, but the screen is damaged, the system could run in the future without this so we wouldn't need to replace it if the client does not want to adjust and control all the A/C at once as the indoor units could be controlled by their individual controllers instead.

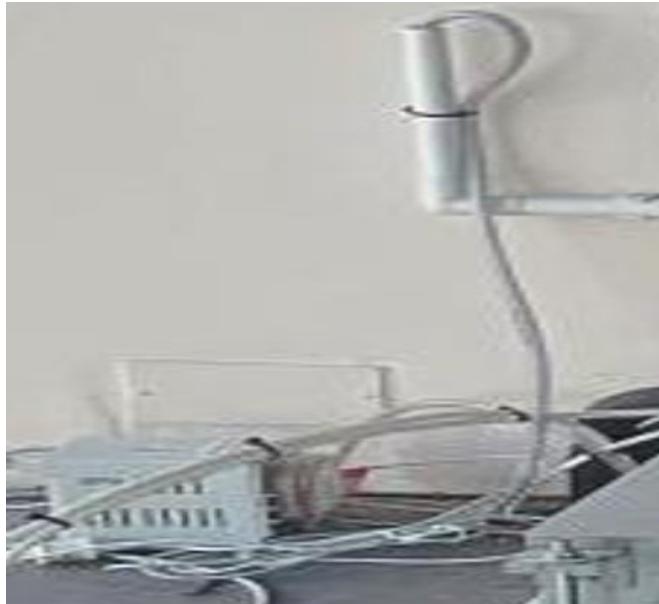
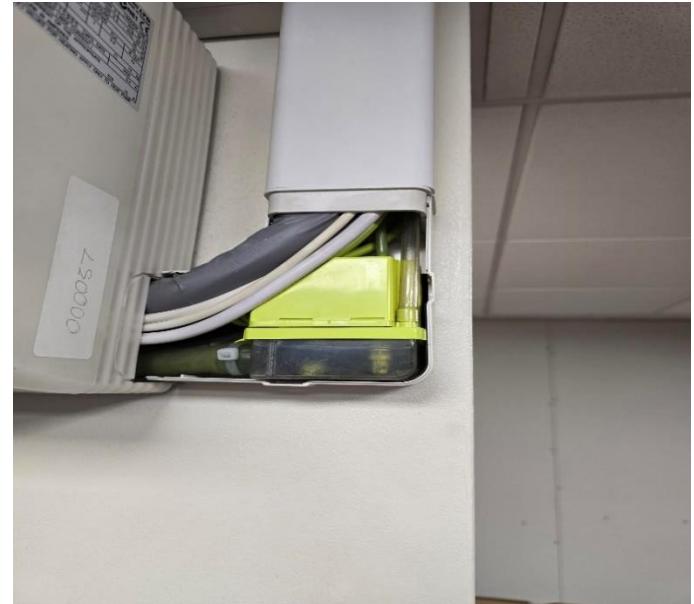
All indoor units have condensate pumps attached either through an old style ceiling peristaltic type or a newer corner tank pump, they looked visually to be in good condition, but we could not test these pumps as there was no power to the indoor units or pumps.

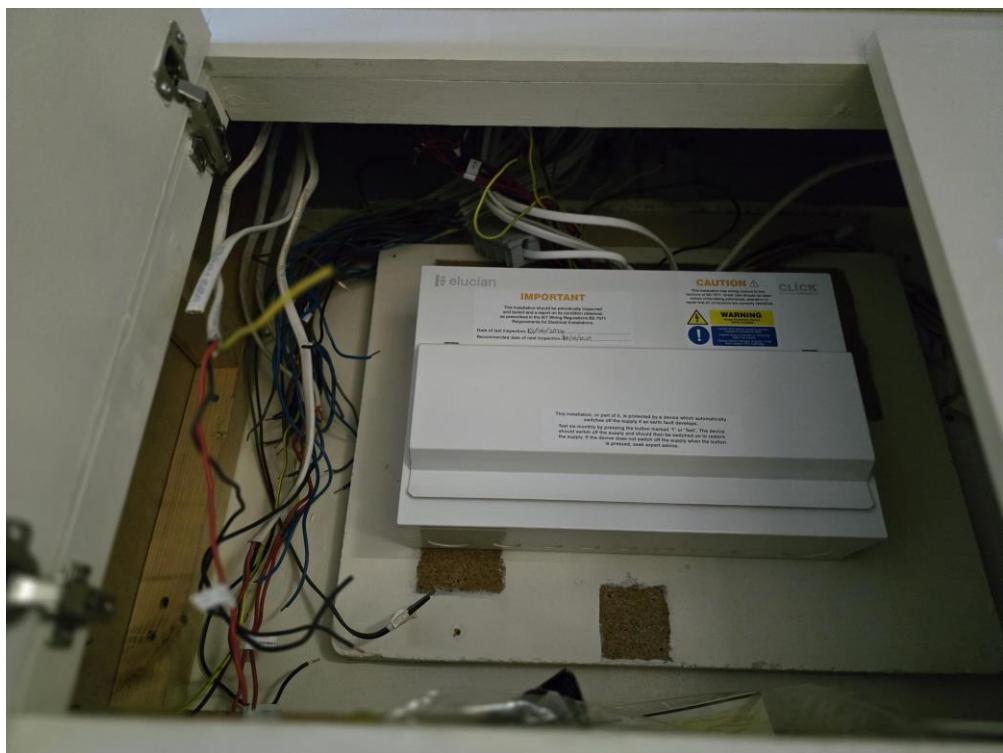
While on site we tried to identify the reason why we had no power to the internal A/C and Ventilation systems, the cables seemed to trace back to a Fuse board that the customer report that they had some damage and had an emergency repair and a new board fitted, but not all the fuse board was reconnected. We would need this reconnected to be able to run and test the internal units.

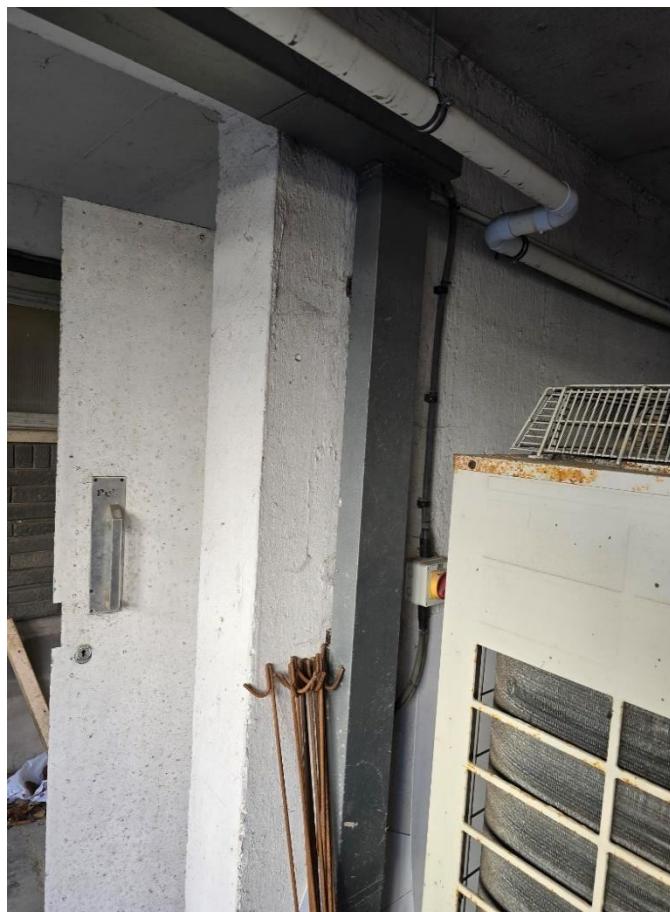
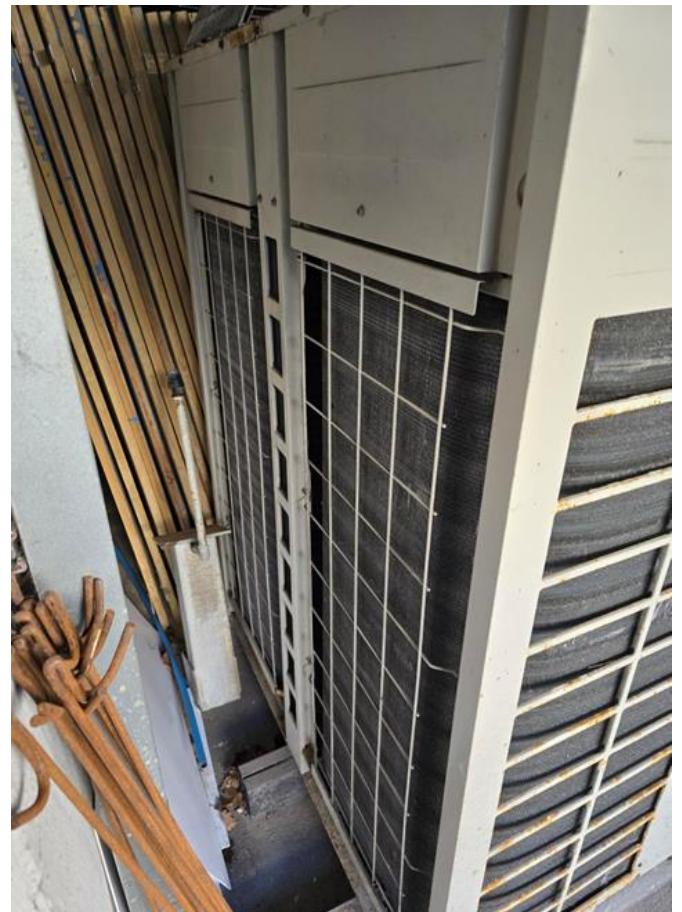
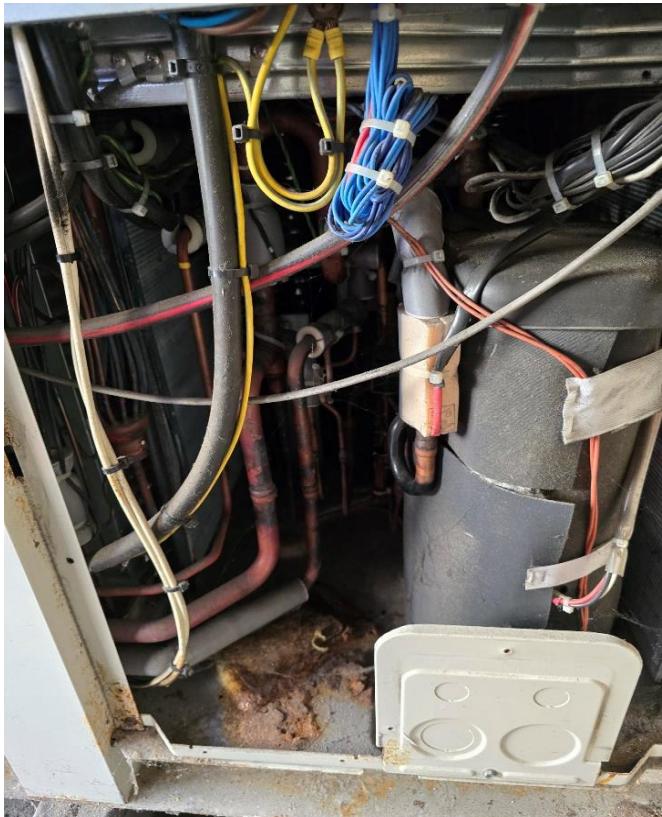
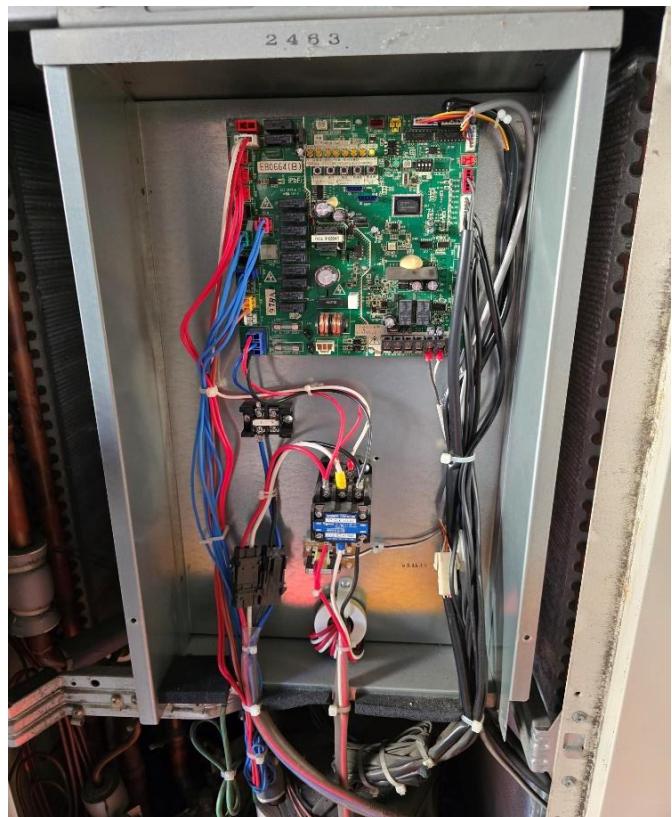
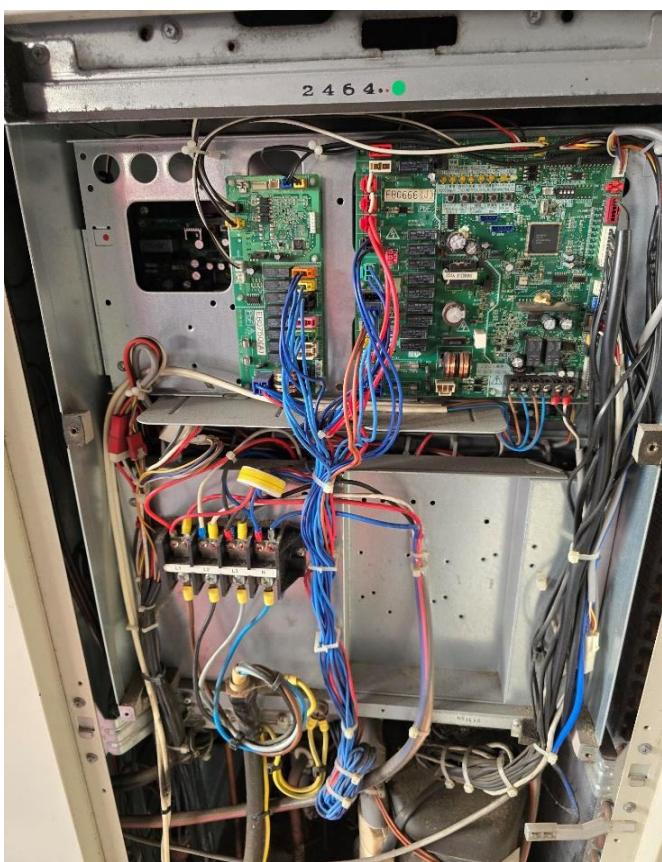
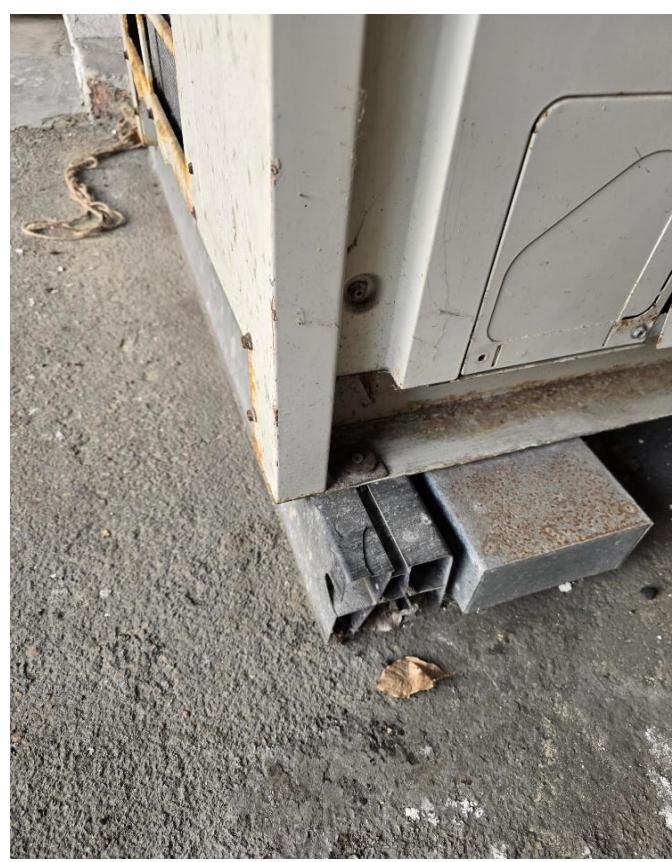
**Outdoor unit:** The outdoor unit is as old as the indoor units (2008) and like the indoor units the outer case, (apart from some small rust patches) and the general condition of the unit and coil looks to be in good condition for a unit of its age. The outside pipework is protected in metal containment trunking routed from the outdoor unit to inside of the building and is installed to a good standard. There are some materials stored too close to the coil restricting the airflow that would need to be removed when the system is up and running. The supporting feet are a basic Plyroc plastic type which are deteriorating, which would need to be replaced and upgraded to antivibration rubber support feet instead.

We inspected the inside of the unit for signs of damage and any sign of refrigerant leaks, visually and with an electronic detector, we could not identify any leaks, meaning there was no cause to break into the system and check the refrigerant levels. We tried to run and test the unit and on inspection of the electrical components and PCB we noticed the LED on one of the boards was not lit as they should be, so we traced the power and identified no power coming from the inverter PCB to the main PCB. We checked all other major components including the fan motors and compressors and they showed no signs of damage at this stage, but with the PCB damage and no internal power we could not test the system further or gain any fault code information.

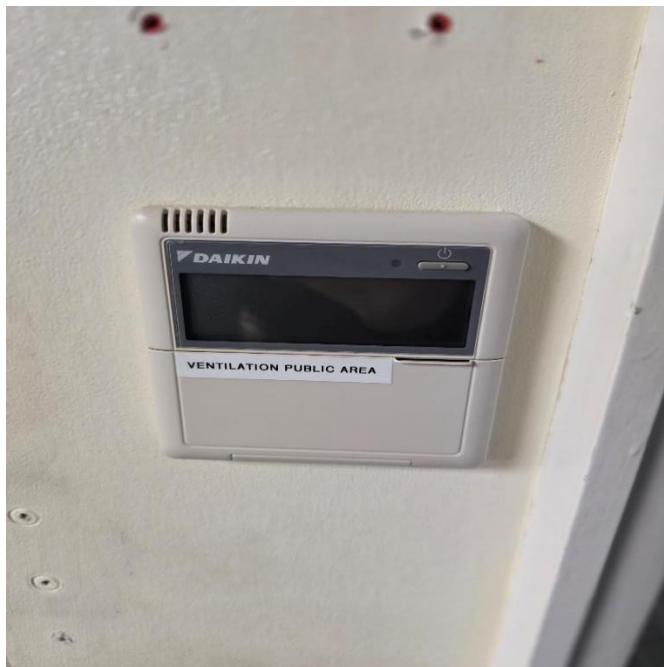
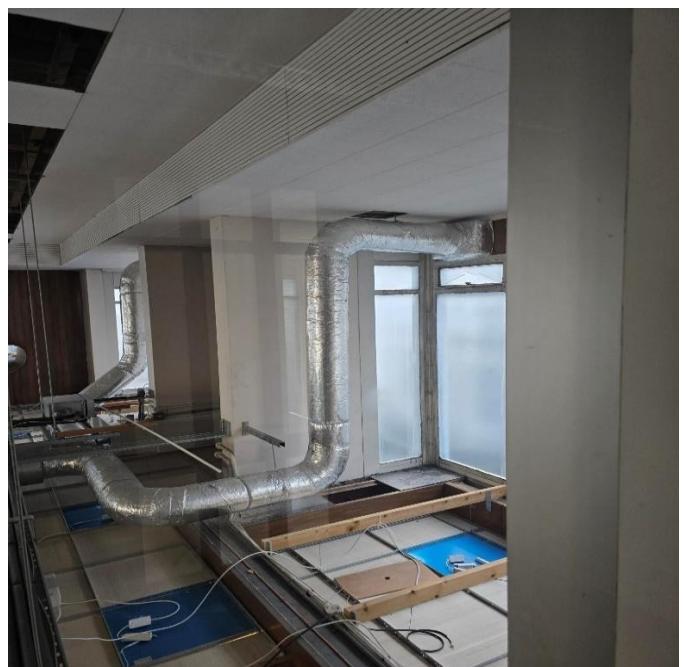
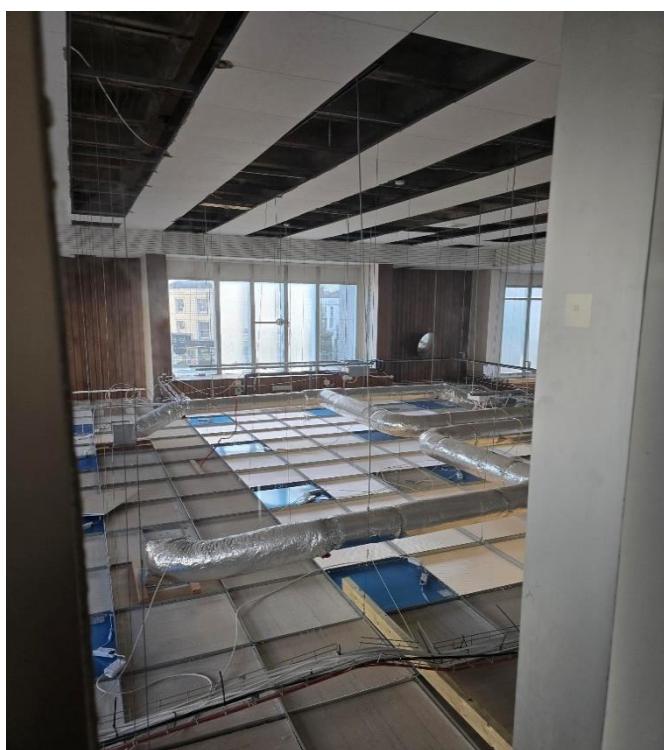
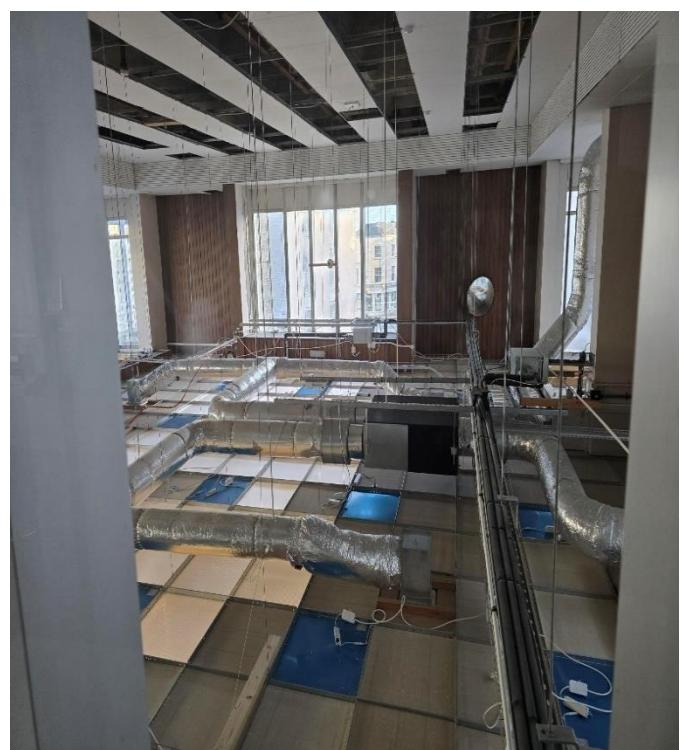
**Ventilation:** The ventilation system is a Daikin heat recovery system which brings in fresh air from outside and pretreats the unconditioned incoming air with the exhausted stale air but conditioned outgoing air, saving on running costs while replenishing the air in the main area of the old banking hall only. No other areas in the building are supplied by this unit and it is the only unit of its type on the property, and overall it is installed to a high standard and has its own controller but is also integrated into the A/C system central control. We could not test this system as there was no power to the unit and we suspect this is also fed from the damaged fuse board.
