Drains west of Greenlands Pond and Greenlands Mire Historic Environment Assessment

Project	Dorset Peatlands Project
Site NGR (centre both areas)	401386,83781
Site area (combined)	32.8 ha.
Client	The Dorset Peat Partnership
Client contact	Grace Herve, Andrew Norris
Document Author(s)	Matthew Williams MIfA
Document date	November 23

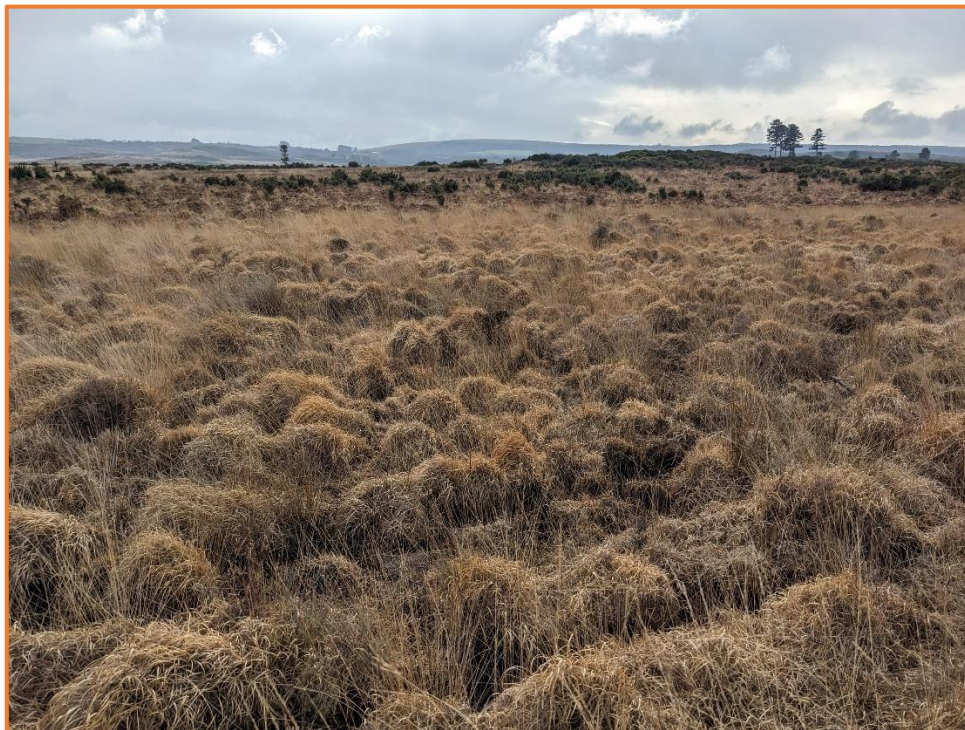
Figure 2 - Looking south west along northern restoration area of the Drains Site

The barrow is 1km from the north of the Site and was not visible from the restoration area. The visit confirmed that the Drains Site follows the lower ground and is very wet and tussocky; walking over the Site was extremely difficult and no archaeological features were noted. A short visit to the north of the Mire Site confirmed that the ground conditions were similar and again no additional features were noted.

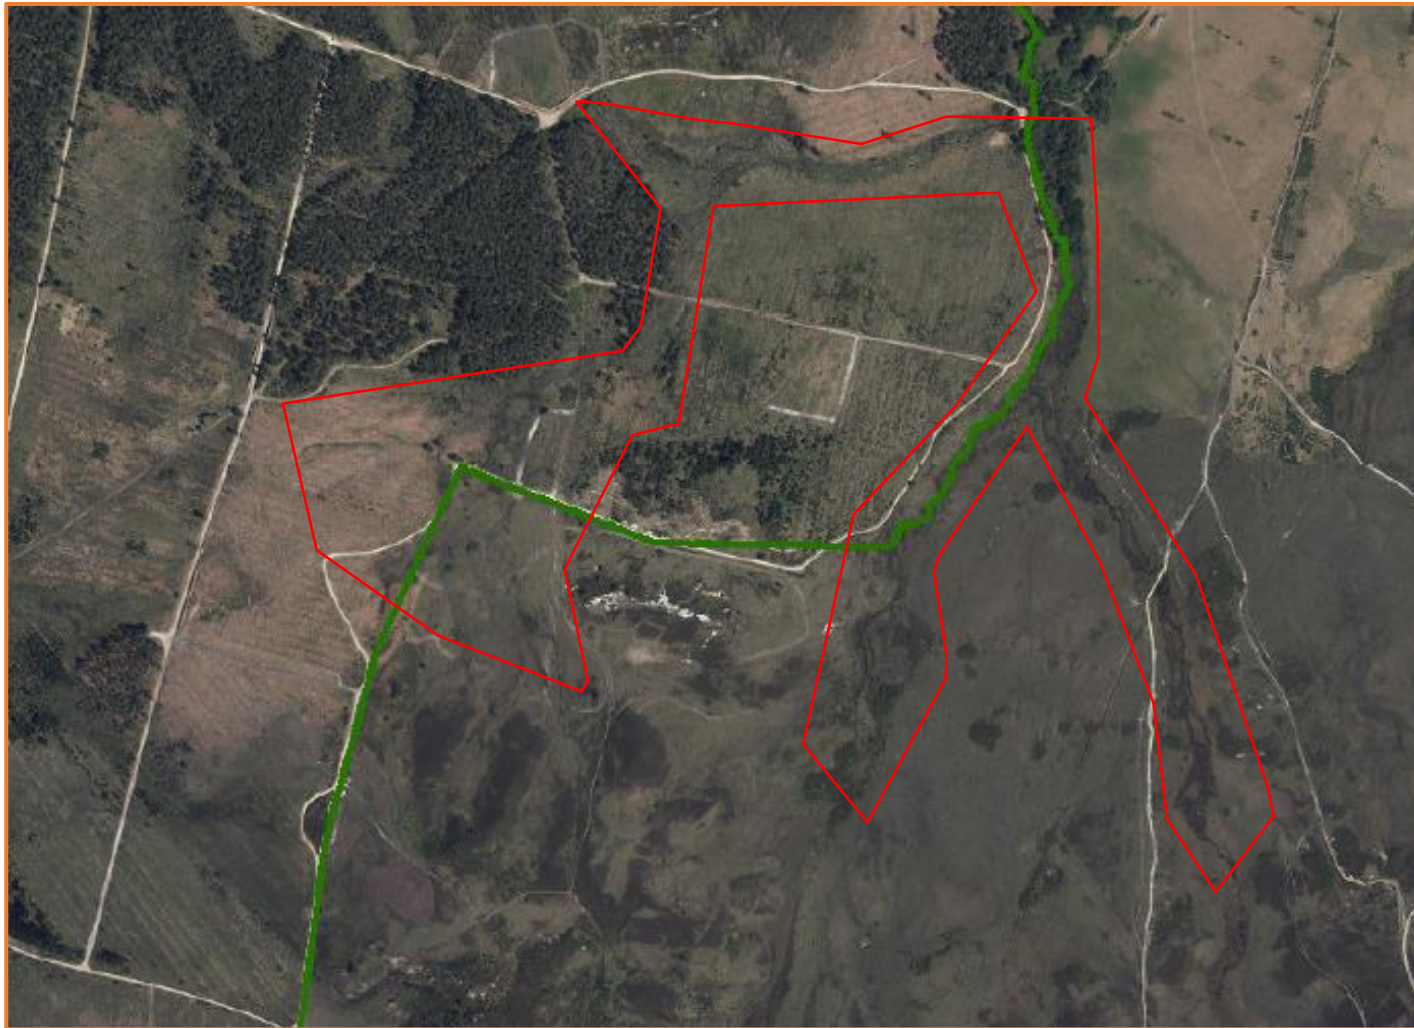
Figure 3 - High resolution AP of the general area of the Site in red. Image produced by the Dorset Wildlife Trust ©Getmapping and Bluesky International Ltd 2022

The high-resolution aerial photography shows numerous modern tracks crossing the Drains Site. The northern part of the Drains Site appears darker green where the wet conditions encourage vegetation but this is less apparent to the south. In the Mire Site the drainage channels are visible as sinuous watercourses which run the full length of the Site. No additional features were noted in either Site.

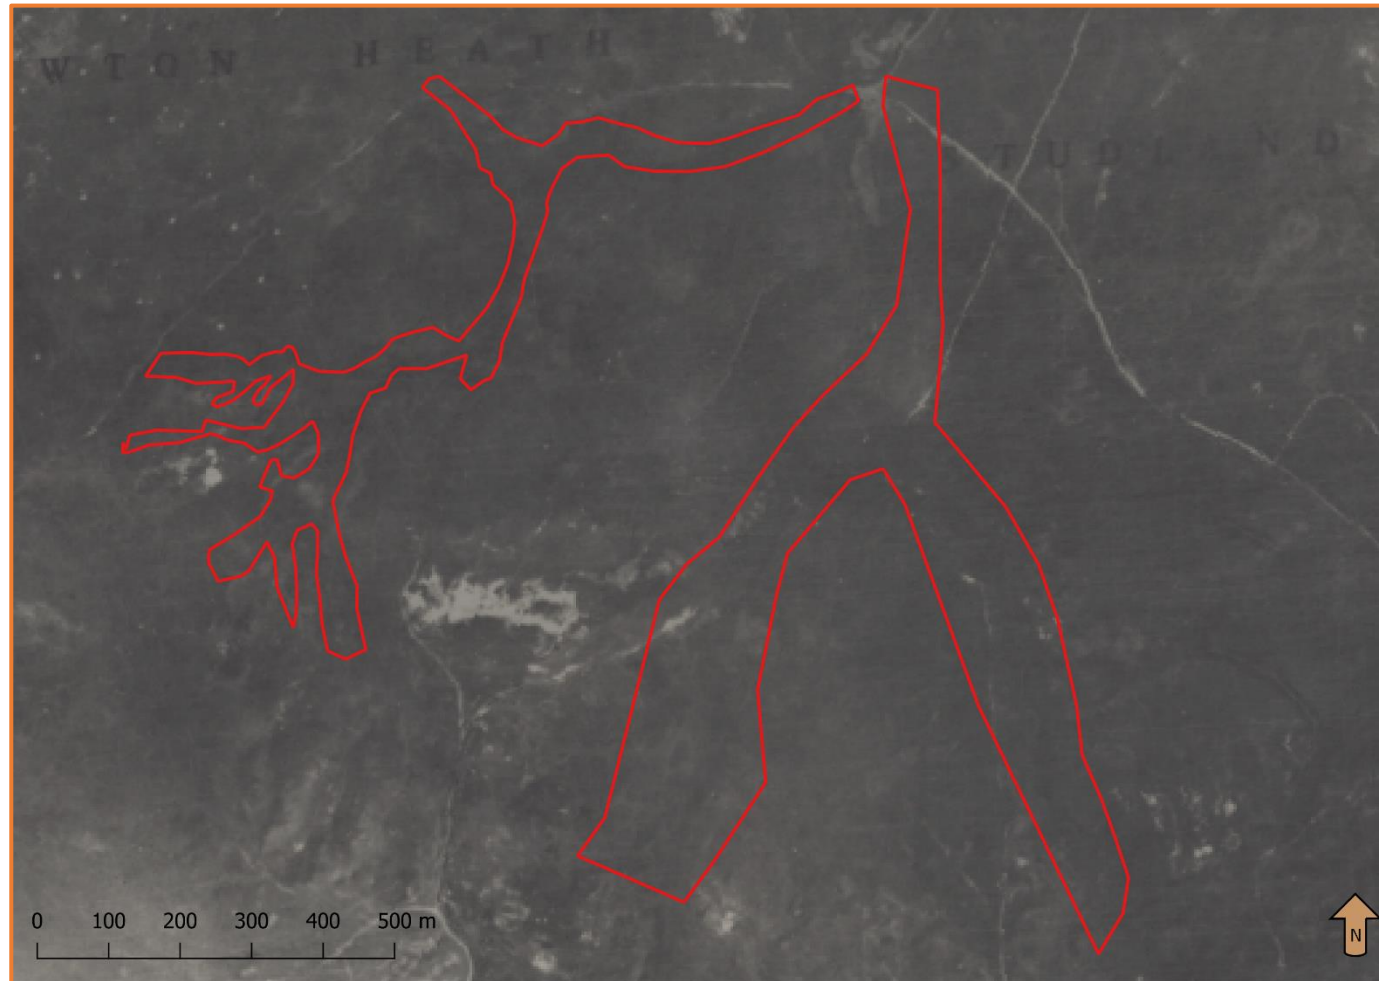
Figure 6 – 1947 aerial image. Reproduced with the permission of the National Library of Scotland

Several very faint tracks are just visible on the 1947 aerial photograph (Figure 6). These were recorded in the DHER as part of the Wild Purbeck project and no new features were noted.
