# Agglestone Mire, Knowle Valley

## Historic Environment Assessment

| Project | Dorset Peatlands Project |

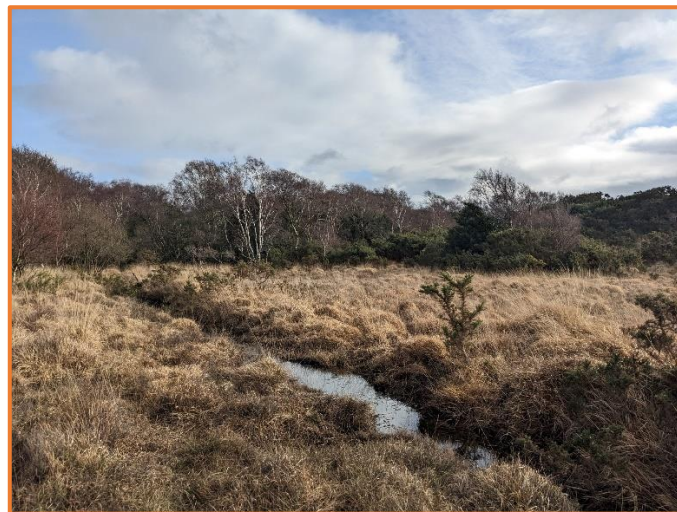
*Figure 3 - Looking south west along (4)*
