HORNIMAN MUSEUM
SUNKEN GARDENS

WEST RETAINING WALL REPAIR
DETAILS

230331-CON-XX-XX-DR-S-4000

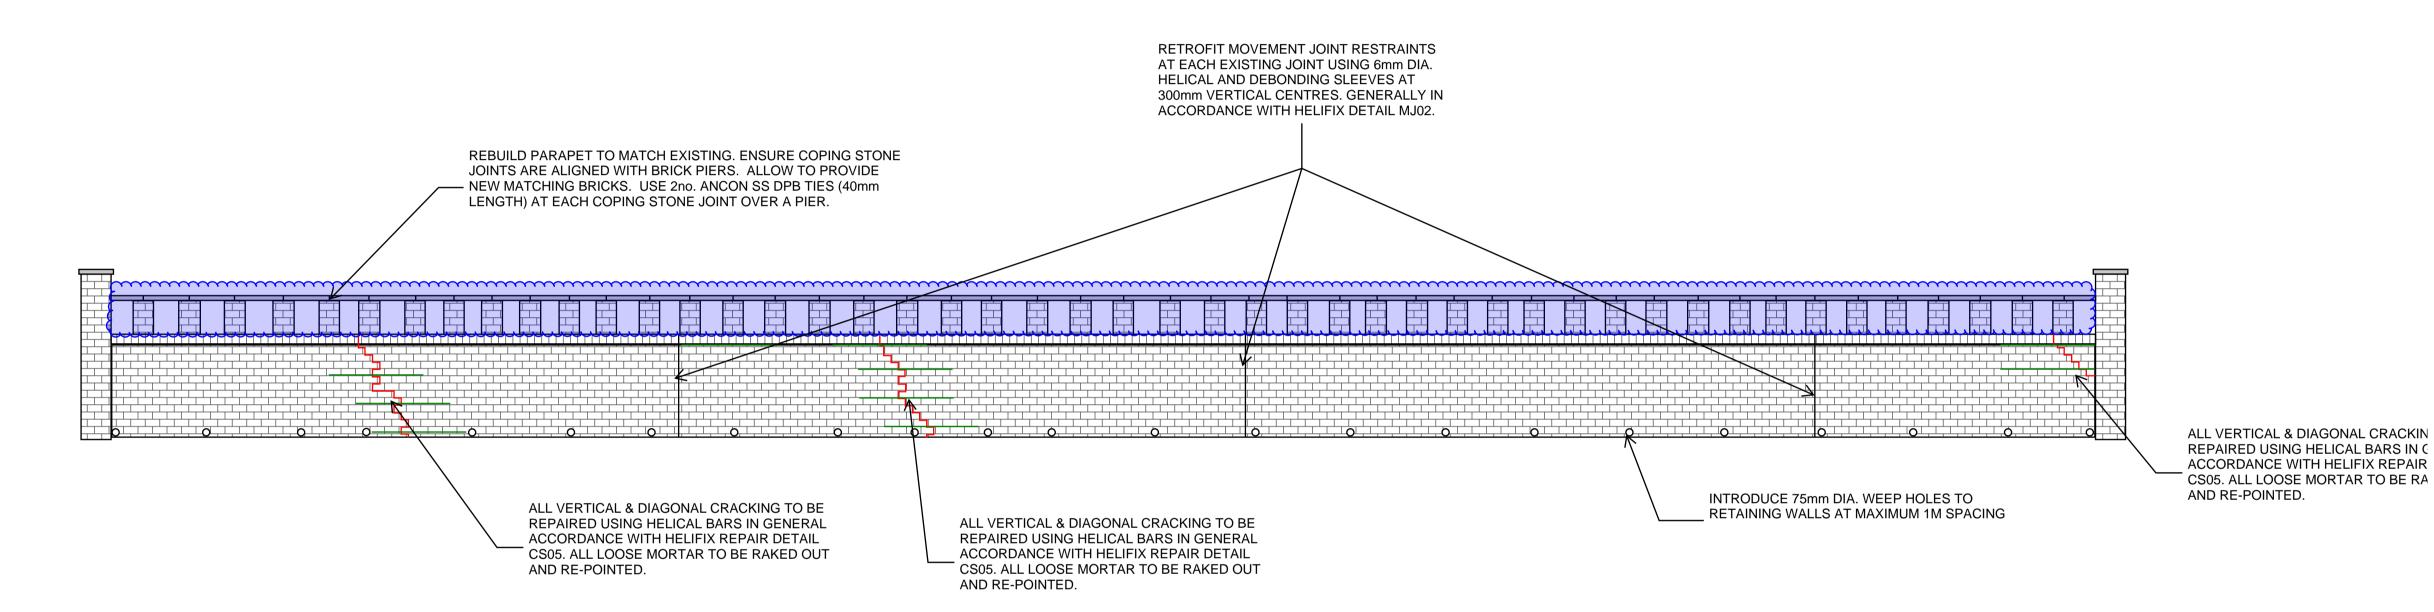
WEST RETAINING WALL FRONT ELEVATION

APPEARANCE OF EXISTING.

- 1. REPAIR VERTICAL/DIAGONAL CRACKS USING 1no 6mm DIA. HELICAL BAR IN ACCORDANCE WITH HELIFIX DETAIL CS05.
- 2. REBUILD FAILED PARAPET WALL. BRICKS MAY BE REUSED IF POSSIBLE BUT THE CONTRACTOR SHOULD ALLOW FOR FULL REPLACEMENT WITH NEW MATCHING BRICKS.
- 3. REUSE EXISTING COPINGS. INSTALL 2no. ANCON S/S DPB TIES WITH S/S SCREWS AT EACH COPING JOINT OVER A PIER. CAREFULLY DRILL EACH COPING TO ACCEPT DOWELS.
 - BED ON 1:1:6 CEMENT: HYDRATED LIME:SAND MORTAR.

ALLOW TO REPLACE ALL CRACKED/BROKEN COPING STONES FOUND WITH NEW TO MATCH STONE TYPE, DIMENSIONS &
- 5. INSTALL NEW 70mm DIA. WEEP HOLES AT APPROX 1m CENTRES AT WALL BASES. USE BLACK PLASTIC SLEEVING AND WRAP IN GEOTEXTILE MEMBRANE AT REAR FACE.
- 6. AT EACH EXISTING MOVEMENT JOINT INSTALL NEW 6mm DIA. HELICAL BAR RESTRAINTS WITH DEBONDING SLEEVE AT 300mm VERTICAL CENTRES. TO BE INSTALLED GENERALLY IN ACCORDANCE WITH HELIFIX DETAIL MJ02.
