976 / 104A

Trowbridge Museum Redevelopment
The Shires, Court Street, Trowbridge
Wiltshire, BA14 8AT
for Trowbridge Town Council

ROOF PLAN
EXISTING

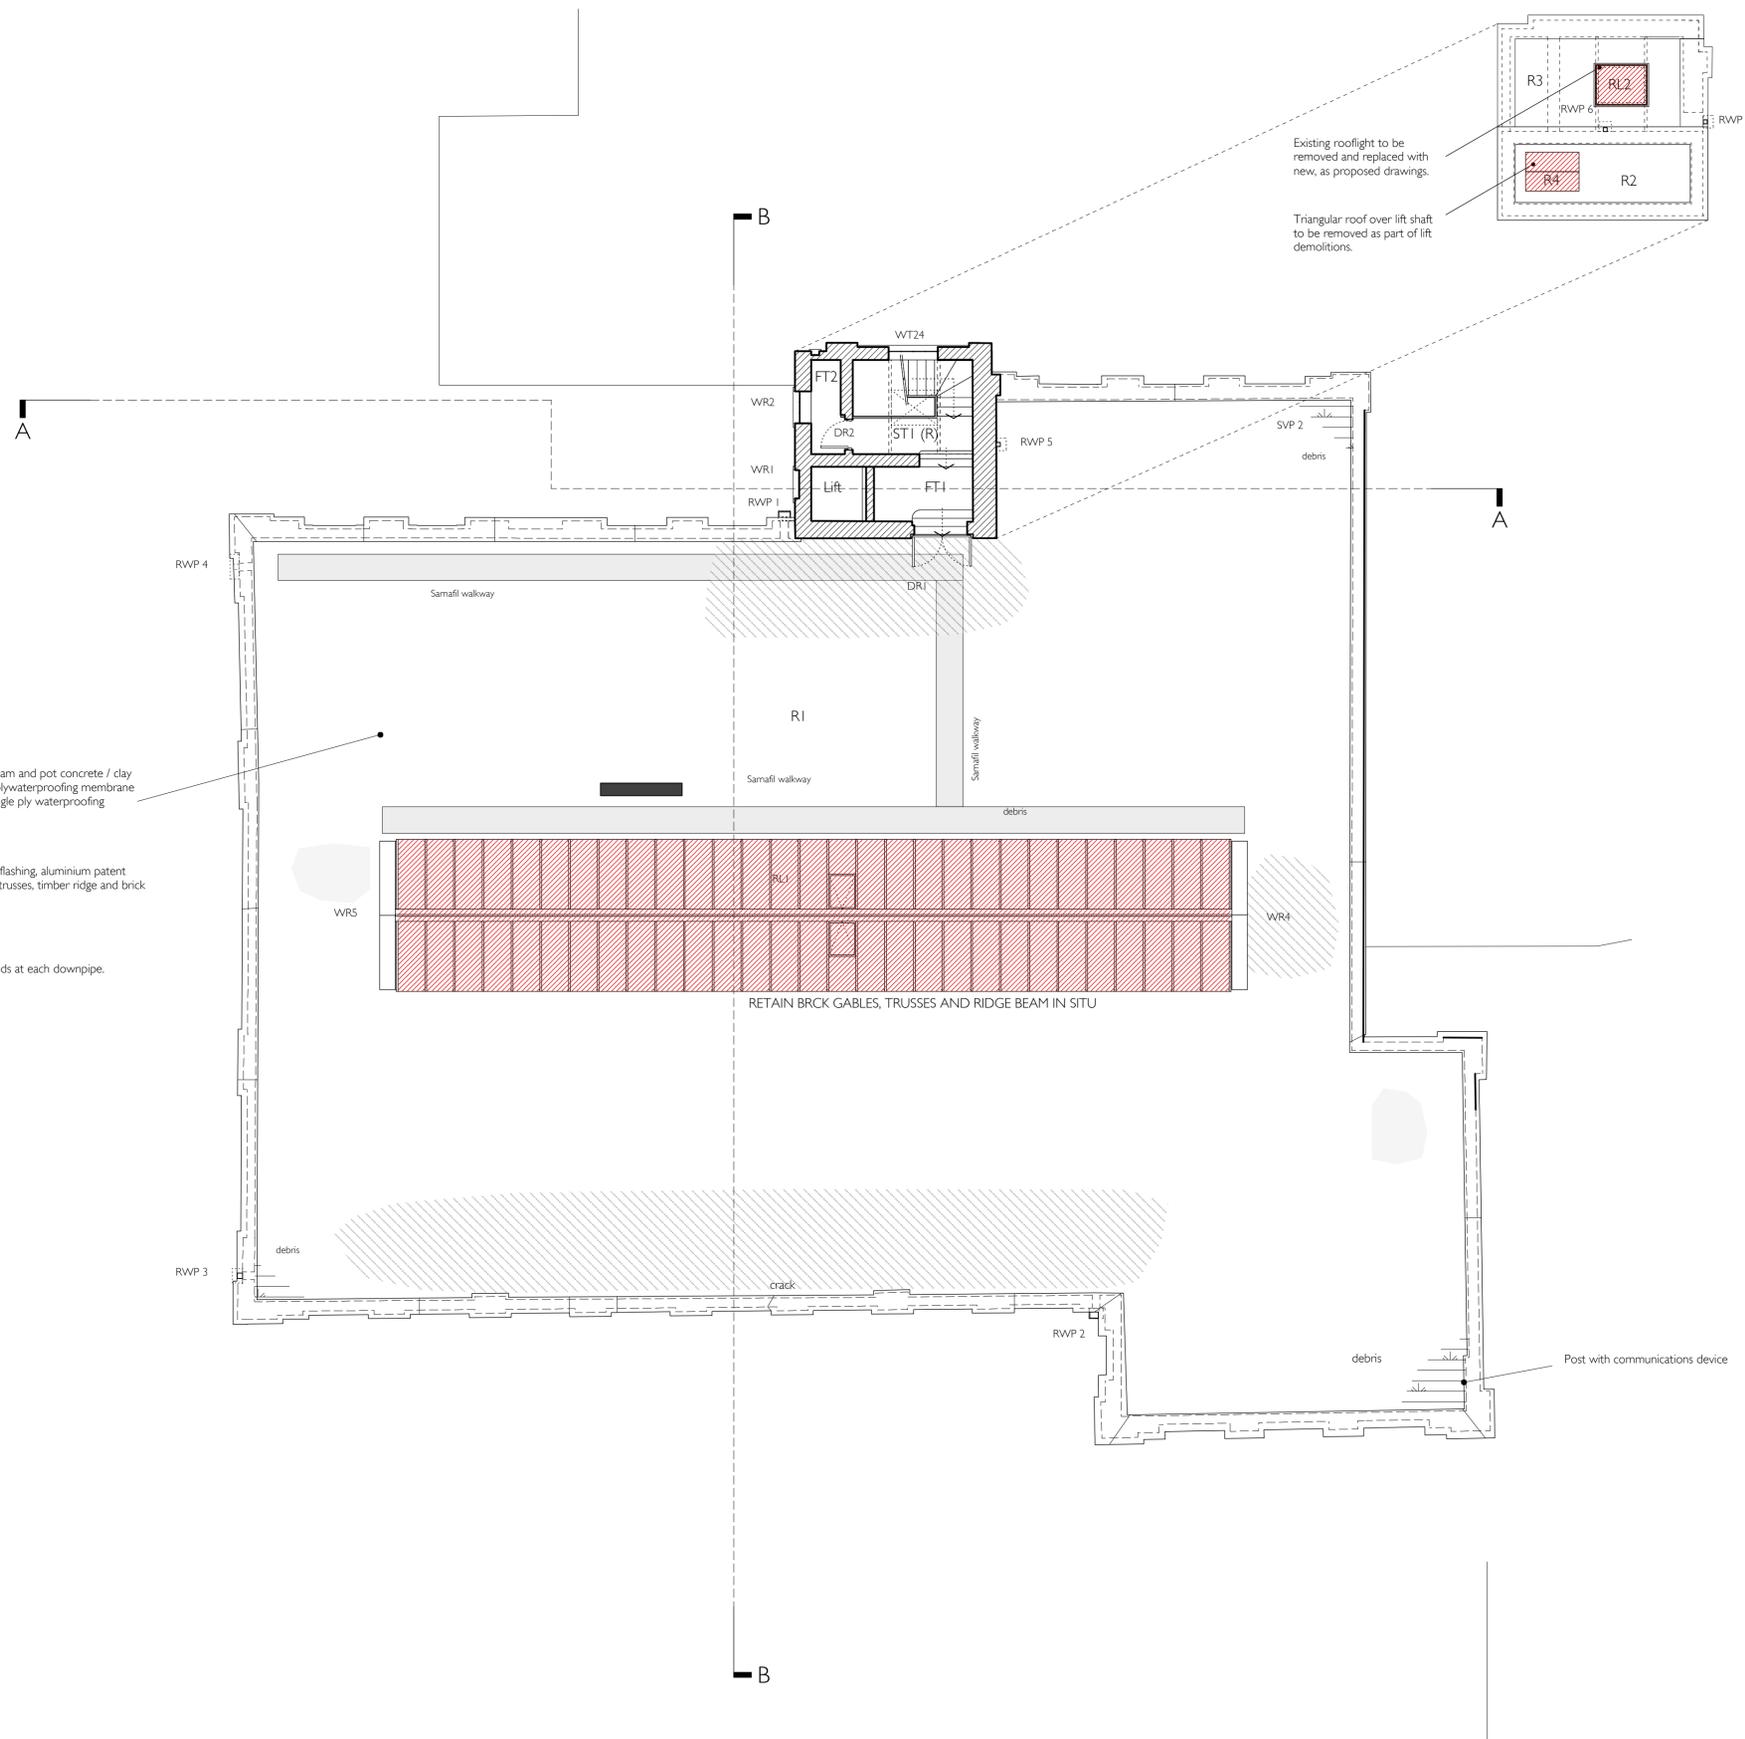
104•01 ROOF PLAN - EXISTING
1:100@ A1

- Roofs R2 & R4
Samafil covering circa: 1989.
- R2 parapet:
Brick parapets with aluminium coping
- R3 parapet:
Brick parapets with insitu cast concrete coping.
Sand cement rendered inner face in poor condition.
- R4 triangular roof above lift = aluminium?
- RL2 Steel framed rectangular rooflight with monopitch roof fixed to concrete upstand.
Georgian Wire armoured glazing - all in poor condition.
- RWP 5 & 6
110 x 110mm cast iron downpipes with hoppers and shoes discharging onto main roof.

R1 - Main roof.
Samafil Roof covering circa 1989.

Substrate: Existing warm roof comprising of a beam and pot concrete / clay deck, 20mm asphalt, PIR insulation and a single plywaterproofing membrane overlaid with a separation fleece and another single ply waterproofing membrane.

Areas of ponding / debris shown by shading.

Rooflight: Remove all rooflight to include: Ridge flashing, aluminium patent glazing sections, glass and flashings. Retain steel trusses, timber ridge and brick kerb / upstand in situ.

Lightning conductor:
Taped to parapets and rooflight with earthing rods at each downpipe.

Existing rooflight to be removed and replaced with new, as proposed drawings.

Triangular roof over lift shaft to be removed as part of lift demolitions.
