INVITATION TO TENDER RIVERBANK REPAIRS AT MILL AND MARSH MEADOWS, HENLEY-ON-THAMES, OXON

Summary or Recommendations based on River Bank Survey 2020

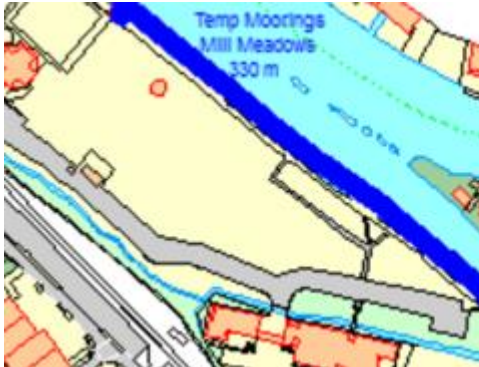
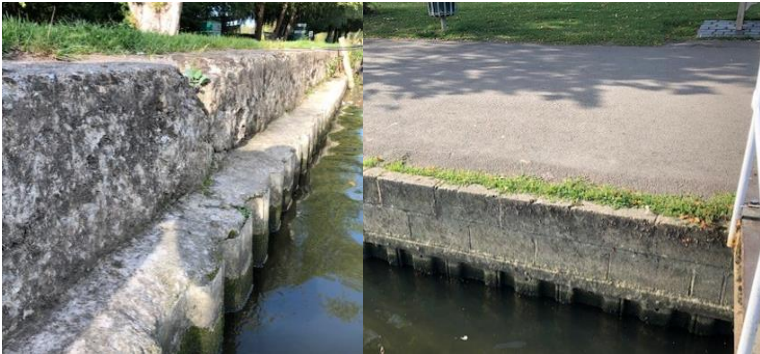
<p>Construction – an original stone wall which has had sheet piling, back filled with concrete, on a lower level and which in places has been built up with concrete blocks (see images below).</p> <p>Condition - The wall and kerbing has become been damaged over the years and the materials have become brittle and degraded with time and by vegetation growing up behind the stone wall and between the stone wall and the piling. The general condition of the wall is sound apart for an 8 m section below the River and Rowing Museum jetty.</p> <p>Issues - a) The original stone wall and the lower sheet piling forms a step out and creates a wider gap and which can add to difficulty embarking and disembarking).</p>

b) The top edge of the bank is damaged and does not provide an even surface to stand on when embarking and disembarking. The top edge is either the original stone wall or topped with concrete blocks and both have become degraded either due to parts breaking away for instance when heavy boats pull against the mooring rings, the material crumbling or general deterioration.

<p>A new river wall constructed in galvanised sheet piling would be the most suitable long-term solution providing a consistent, flat wall on which a new and uniform top edging could be placed. A hardwood timber capping (top) and/or waling (side) would make it more aesthetically pleasing from the towpath and the river, would provide a secure edge to stand on when embarking and disembarking and more forgiving than a hard stone, concrete or metal finish for boats to moor up against.</p>

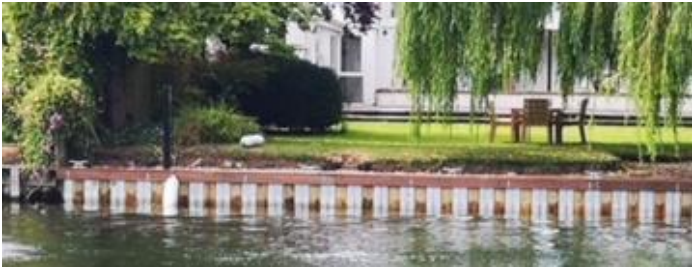
<p><i>Image shows hard wood capping</i></p>

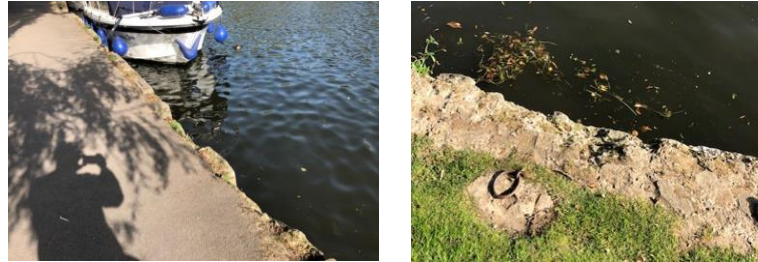
c) An 8 m section of the wall below the River and Rowing Museum jetty has slumped.

- ii) To repair the 8 m section of river wall under the River and Rowing Museum jetty which has slumped.
- iii) To install a ladder for exit from the river. Location to be close to the River and Rowing Museum landing stage but not conflicting with the moorings.

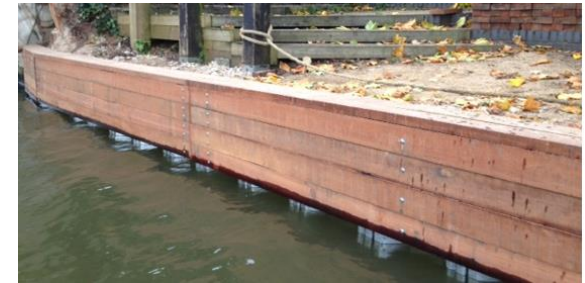
Image shows hard wood capping and waling

lii) install new, heavy duty mooring rings at 5 m intervals close to or on the new edge.

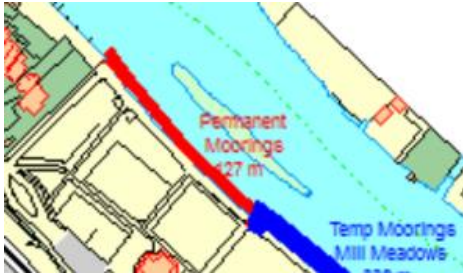
Construction – the permanent moorings are of the same basic construction as the temporary moorings with the original stone wall which has had sheet piling back filled with concrete on a lower level. In addition, there are mooring posts with metal rods attached which mooring ropes can slide up and down to allow boats to rise and fall with the water levels.

Condition – The wall is in a similar condition to the temporary moorings with an even top edge. The mooring posts are in sound condition and could be incorporated into any new design and cosmetically improved.

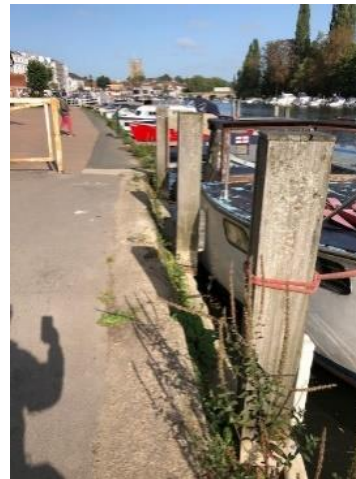
Issues: - f) The lower wall creates a step out (which can make embarking and disembarking more difficult (as a) above).

g) The top edge of the bank is uneven and does not provide an even surface when embarking and disembarking (as b) above).

iv) The suggested works would be as for the temporary moorings regarding the construction of a new wall with uniform capping and waling.

v) Retain and refurbish the mooring posts and new mooring rings as required.

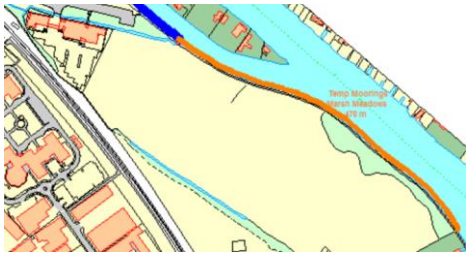
Construction - the majority of the river bank is steel sheet piling (456 m) installed over a number of years probably to replace the river wall when it started to fail. The bank is of variable height between 600 and 900 mm above normal river levels.

Condition - Most of the sheet piling has a steel angle iron running along the top and in others concrete sand bags have been placed on top of the sheet piling. Although some is likely to be at least 30 years old the steel piling is still in a reasonable condition. The piling is not the most attractive to view from the river however this area has a more rural feel and it is not a major eye-sore – future consideration could be given to recladding for aesthetic reasons.

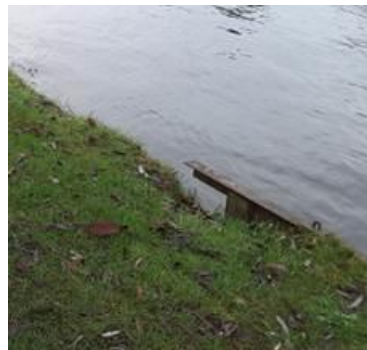
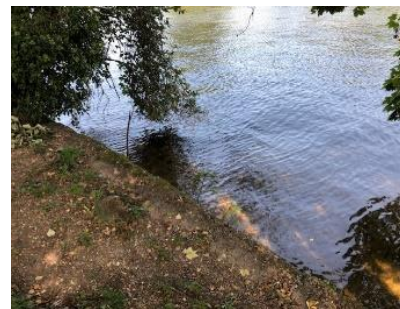
Issues: - g) As the river bank varies in height along this stretch and the sheet piling has been installed at different times with either an angle iron or sand bags on top this has led to works being required in 4 sections as follows: -

- a 10.8m section of river bank which is lower does not have the steel angle iron placed on the top of the sheet piling and the adjacent higher sections of bank on either end do – this means the angle irons are exposed and could cause a hazard.

- In addition, there are 3 more sections as above of 7.8m, 4.1m and 2.2 m – see images below.

iv) For (g) install sections of steel piling in front of the existing piling to the same level as the adjacent existing piling. The bank behind can then be filled, levelled and grassed.
