Detailed Unexploded Ordnance Risk Assessment

Site: **Junction of Station Road and Blyth Road**

Client: **Southwold Town Council**

Ref: **8893 RA**

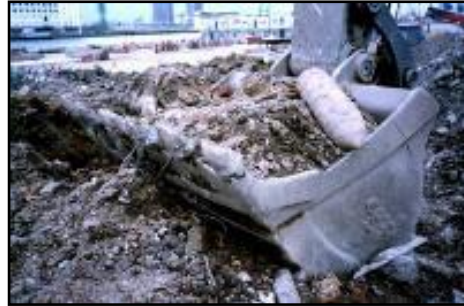
50kg bomb, London Docklands

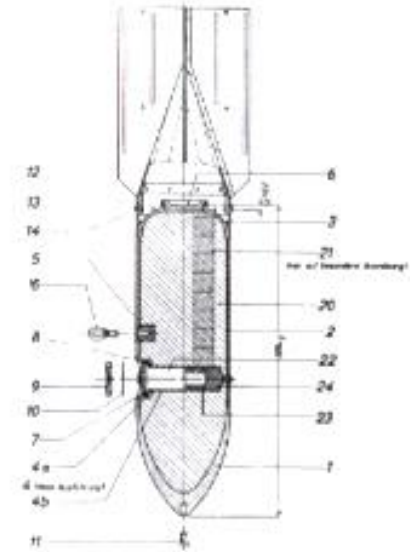
SC 50 JA (Guteklasse 1)

Use: Against lightly damageable materials, hangars, railway rolling stock, ammunition depots, light bridges and buildings up to three stories.

Remarks: The smallest and most common conventional German bomb. Nearly 70% of bombs dropped on the UK were 50kg.

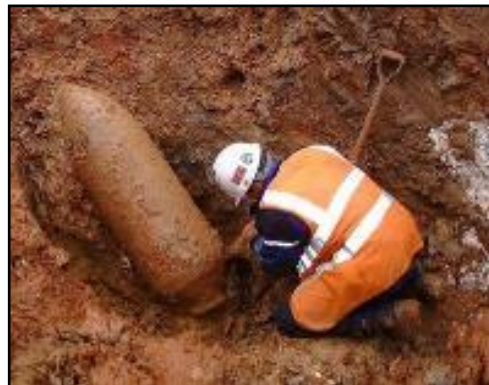
250kg bomb, Hawkinge

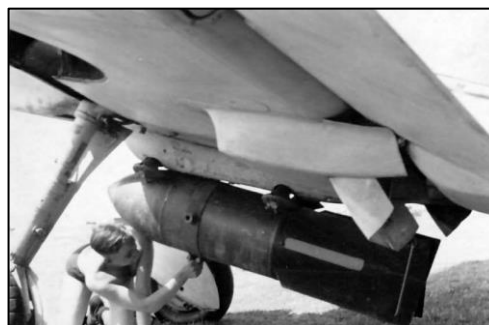
SC250 attached to undercarriage
of Messerschmitt Bf109

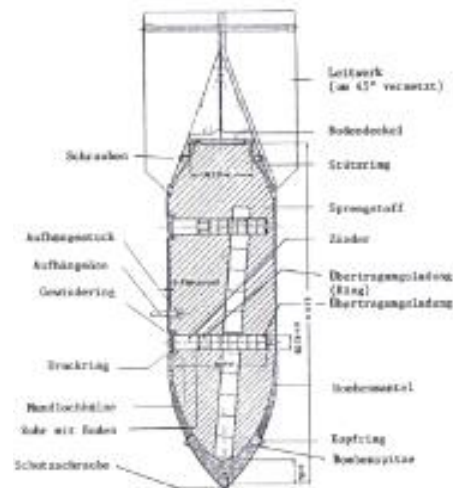
SC 250 JA (Guteklasse I)

Use: Against railway installations, embankments, flyovers, underpasses, large buildings and below-ground installations.

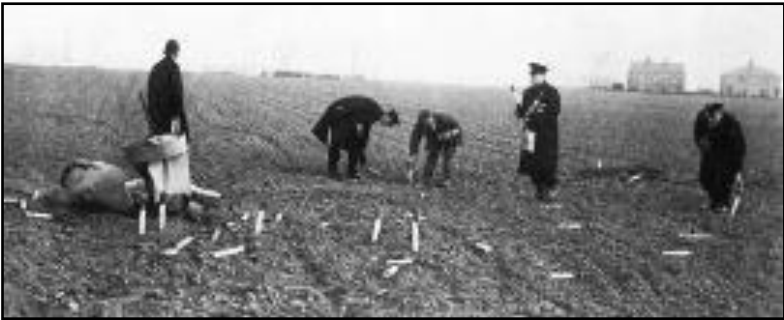
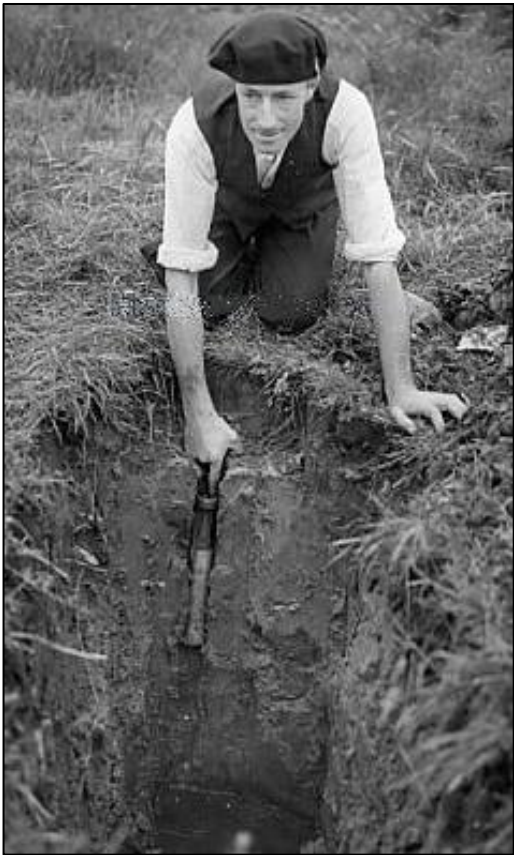
- 1. Ordinary scaffold pipe
- 2. 1kg incendiary bomb
- 3. Incendiary bomb recently found on site in UK

Bomb weight: 1.0 and 1.3kg (2.2 and 2.87lb)
Filling: 680gm (1.3lb) Thermite
Fuze type: Impact fuze
Bomb dimensions: 350 x 50mm (13.8 x 1.97in)
Body diameter: 50mm (1.97in)
Use: As incendiary – dropped in clusters against towns and industrial complexes
Remarks: Jettisoned from air-dropped containers. Magnesium alloy case. Sometimes fitted with high explosive charge

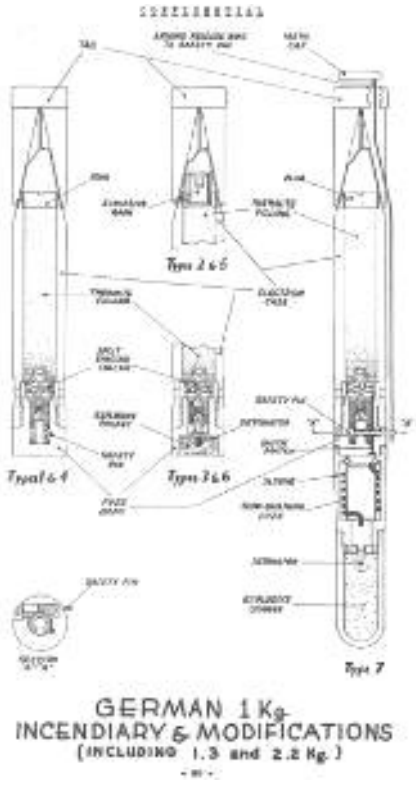
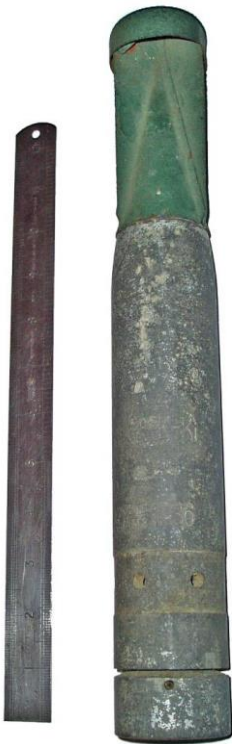
1kg German Incendiary Bomb next to a 30cm ruler

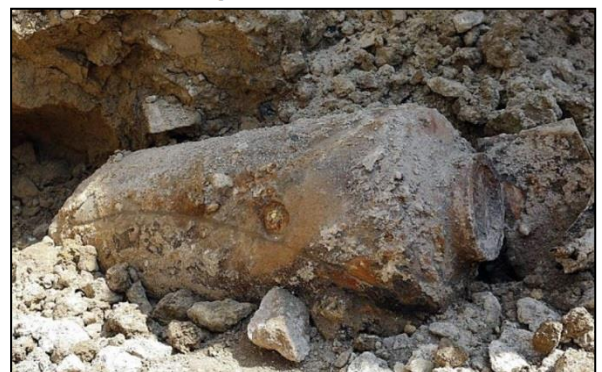
Path of UXB in soft ground

1. **Ricochet resulting from low level attack:** UXB stays perpendicular to ground and rests at surface.
2. **Buried UXB with J-Curve:** Bomb curves horizontally and rests perpendicular to surface.
3. **UXB returning to surface due to J-Curve:** Bomb points towards surface but may remain partially or completely below ground level.
4. **UXB deflected by buried objects:** Results in unpredictable path and unusual shaft.

Below: UXB can come to rest beneath undamaged buildings due to the J-Curve effect if it lands in nearby soft ground.

The location of the bomb is thus “offset” from the hole of entry. This “offset” from vertical is generally understood to be about one third of the penetration depth but can reach up to (and have been found at) 15m/50 ft from point of entry, dependent on ground conditions and the bomb's angle of impact. **Annex G** depicts the various paths of UXB through homogenous ground, showing how the J-curve effect can lead to a UXB coming to rest beneath undamaged buildings.

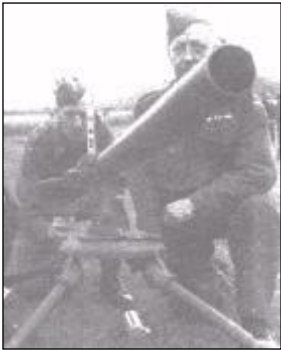
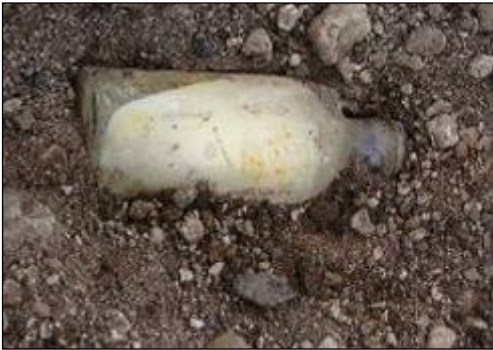
Self Igniting Phosphorous (SIP) Grenades

The grenade comprised a glass bottle with a total volume of approximately one pint. It was filled with White Phosphorus, benzene, a piece of rubber and water. Over time the rubber dissolved to create a sticky fluid which would self ignite when the bottle broke. Fired by hand or Northover Projector. Sometimes called the "A & W" (Albright & Wilson) grenade.

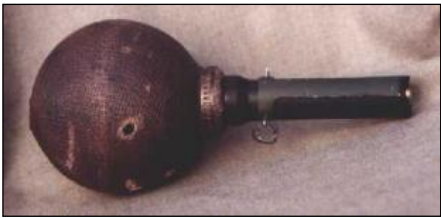
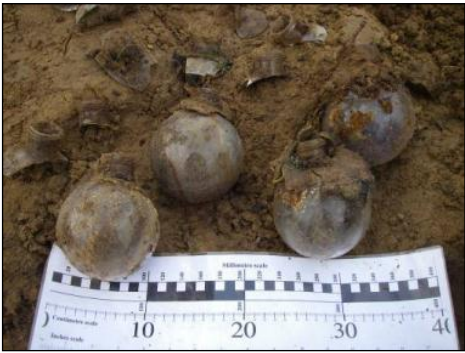
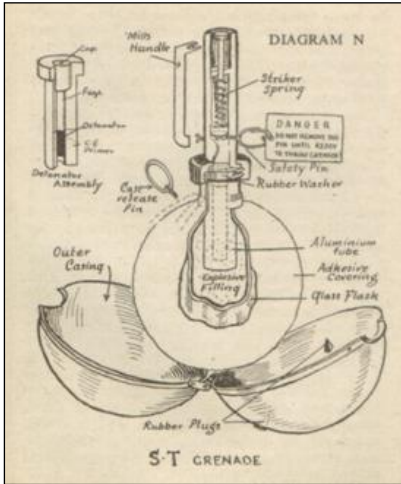
Flame Fougasse Bomb

A Flame Fougasse was a weapon in which the projectile was a flammable liquid, typically a mixture of petrol and oil. It was usually constructed from a 40-gallon drum dug into the roadside and camouflaged. Ammonal provided the propellant charge which, when triggered, caused the weapon to shoot a flame 3m (10ft) wide and 27m (30 yards) long. Initially a mixture of 40% petrol and 60% gas oil was used, this was later replaced by an adhesive gel of tar, lime and petrol known as 5B.

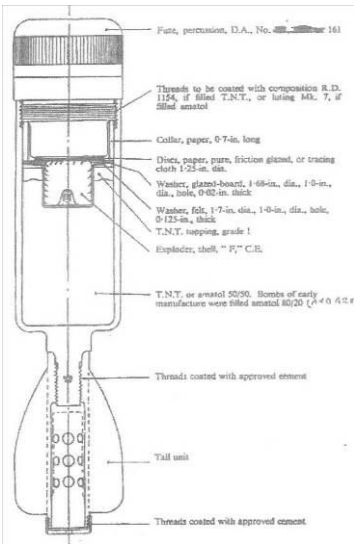
Typical 3 inch Smoke Mortar

- Type: Smoke
Dimensions: c490 x 76mm (19.3in x 3in)
Filling: Typically white phosphorous
Maximum Range: 2515m (2,750yds)
Remarks: On impact, the fuze functions and initiates the bursting charge. The bursting charge ruptures the mortar bomb body and disperses the white phosphorous filler. The white phosphorous produces smoke upon exposure to the air.

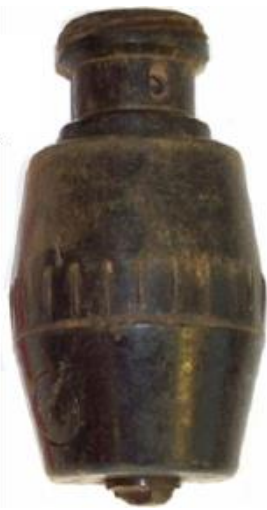
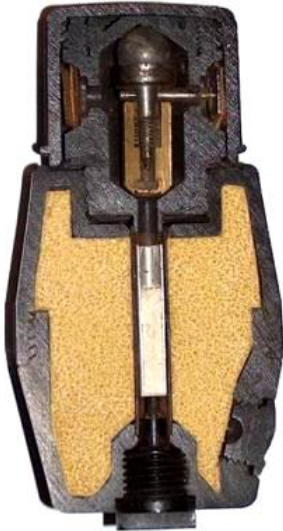
Typical Smoke Grenade

- Dimensions: Approx. 65 x 115mm (2.5 x 4.5in)
Type: Smoke
Date Introduced: Current MoD issue
Remarks: Smoke grenades are used as ground-to-ground or ground-to-air signalling devices, or landing zone marking devices, and screening devices for unit movement.

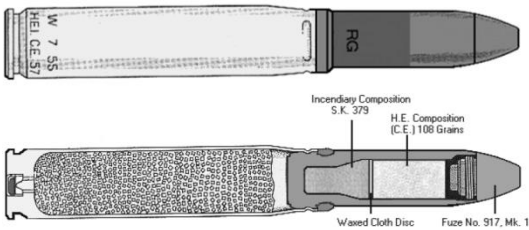
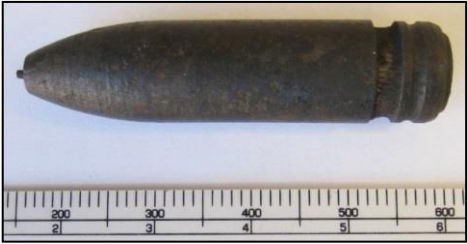
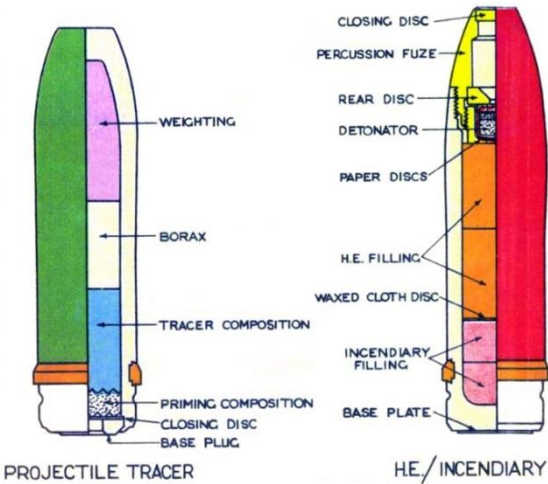
COLOUR IDENTIFICATION		
BRITISH		
NATURE OF SHELL	H.E. FILLING	COLOUR
H.E. TRACER	T.N.T.	Blue
H.E.	T.N.T.	Orange
PROJ. PRACTICE		Purple
PROJ. TRACER		Green
H.E. INCENDIARY	T.N.T.	Red
H.E. INCENDIARY TRACER	T.N.T.	Green

- Type: Rifle / machine gun round
- Markings: Regular round - none. Tracer round - red Primer
- Bullet Weight: 150 - 180 grams
- Dimensions: Total cartridge /projectile length - 78mm
- Filling: Regular round - none. Tracer round - small incendiary fill
- Threat: Explosive cordite within unspent cartridge
- Deployment: Royal Navy, RAF and British Army Light Anti-Aircraft guns, machine guns and rifles. Standard British and Commonwealth military cartridge from 1889 until the 1950s.
- Remarks: Cartridges are belted or supplied lose in cartons.

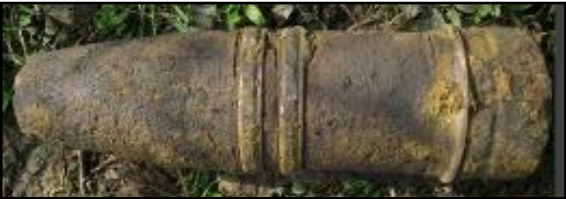
3.7 inch AA Projectile, Minus Fuze.

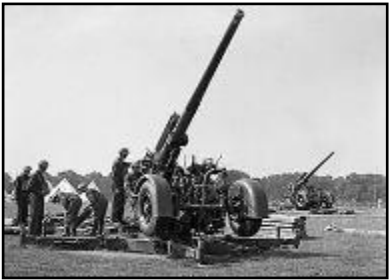
Hyde Park 1939 3.7 Inch QF gun on mobile mounting.

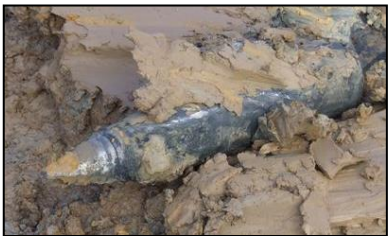
This AA shell was uncovered on a construction site in North London in February 2009.

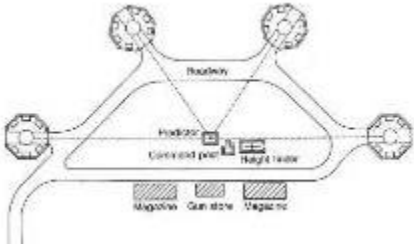
Layout plan for a typical HAA battery site.

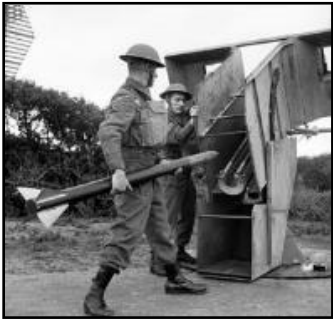
Home Guard soldiers load an anti-aircraft rocket at a 'Z' Battery.

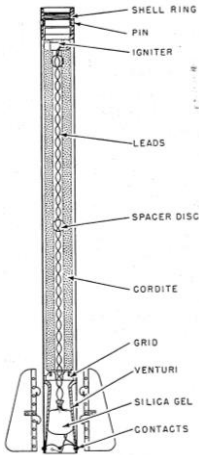
2" U.P AA Rocket.

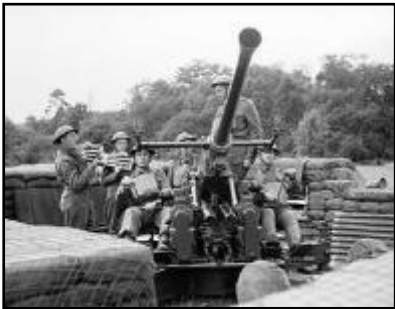
Unexploded 40mm Bofors projectile
