# PENZANCE DRY DOCK (2009) LTD

# PENZANCE DRY DOCK PENZANCE TR18 4BW

# PRELIMINARY INVESTIGATION REPORT

Contract: 24093

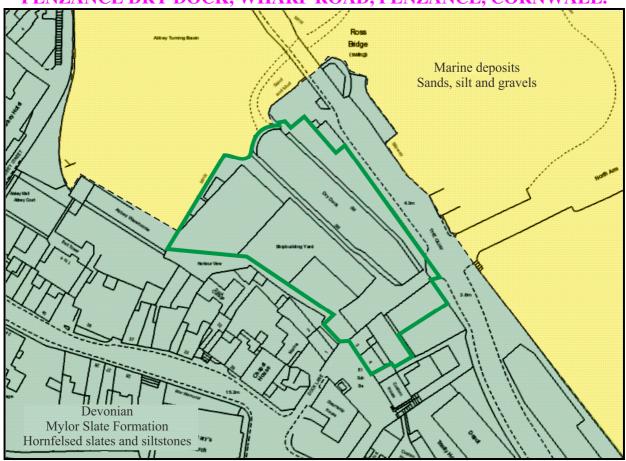
# MINING SEARCH PLAN PENZANCE DRY DOCK, WHARF ROAD, PENZANCE, CORNWALL.

THE MINING FEATURES SHOWN ON THIS PLAN ARE BASED ON READILY AVAILABLE INFORMATION AND CANNOT BE CONSIDERED AS EITHER BEING TOTALLY ACCURATE OR COMPLETE. BASED ON ORDNANCE SURVEY 1:2500 PLANS WITH PERMISSION OF THE CONTROLLER OF HIS MAJESTY'S STATIONARY OFFICE. COPYRIGHT LICENCE No: AC0000819539.
