SPECIFICATION FOR THE RENOVATION AND DRAINAGE OF AN EXISTING FOOTBALL PITCH AT SPITALFIELD, WELLAND, WR13 6NE.

14TH MARCH 2017

TGMS1048.2

APPENDIX 1 ABRIDGED FEASIBILITY STUDY

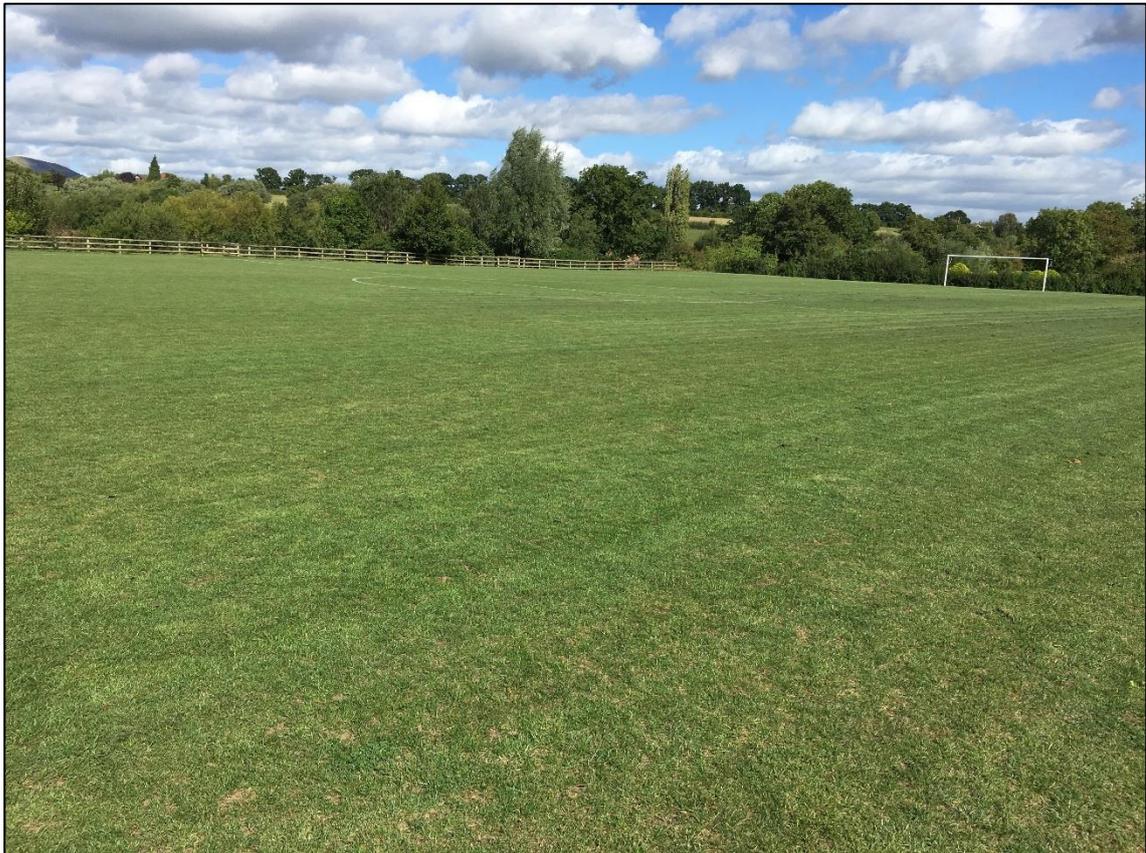
Figure 2 General View of site looking North West

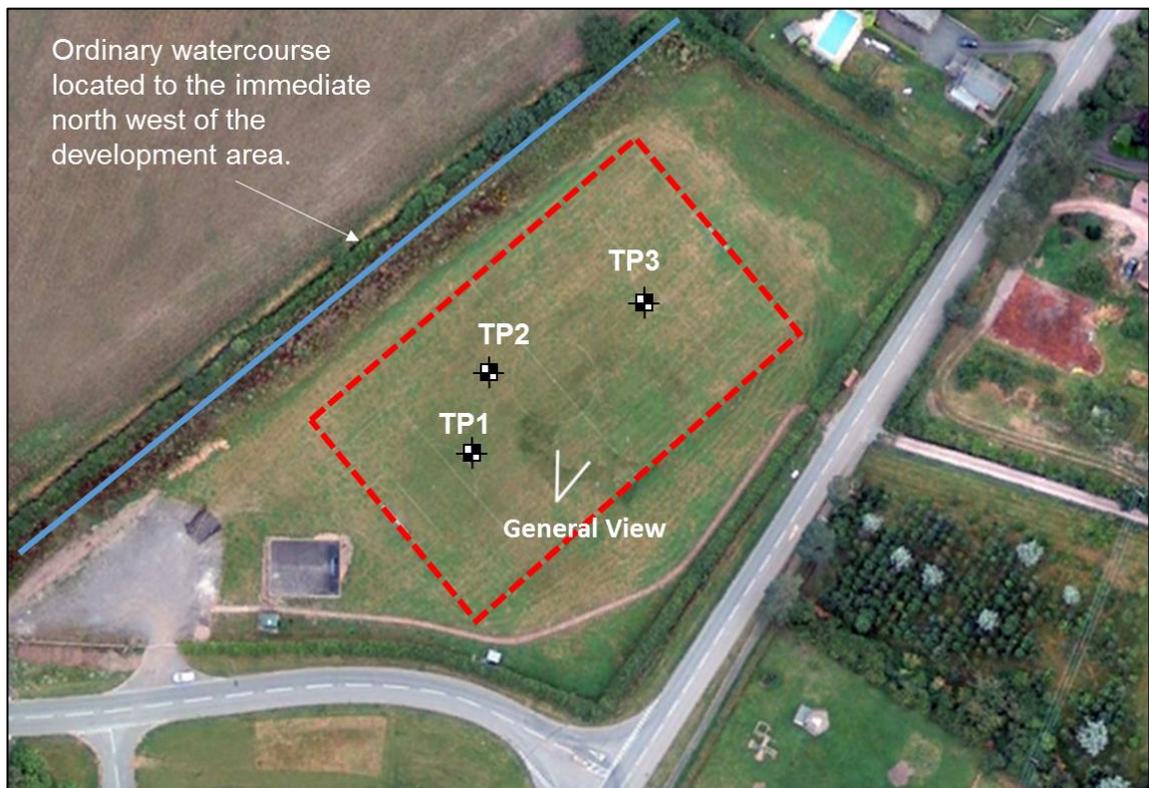
Figure 3 TP1 – TP3 mark the location of the trial pits. The general view refers to Figure 2. Location indicative only and not to scale.

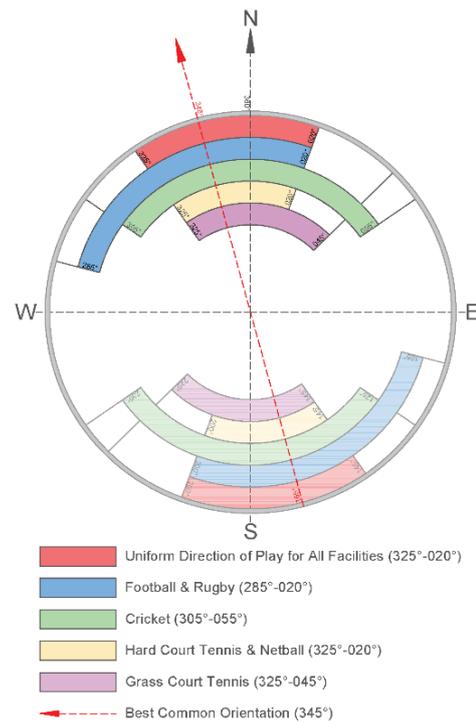
Figure 4 Optimum pitch orientations (Sport England).

Sport England has usefully provided some guidance on the maximum acceptable slopes for natural turf sports pitches. In summary, the maximum slope along the direction of play should not exceed 1.25%, whilst the maximum cross-fall should not exceed 2.00%. However, it is not desirable for both the longitudinal and cross-falls to be at these maximum values.

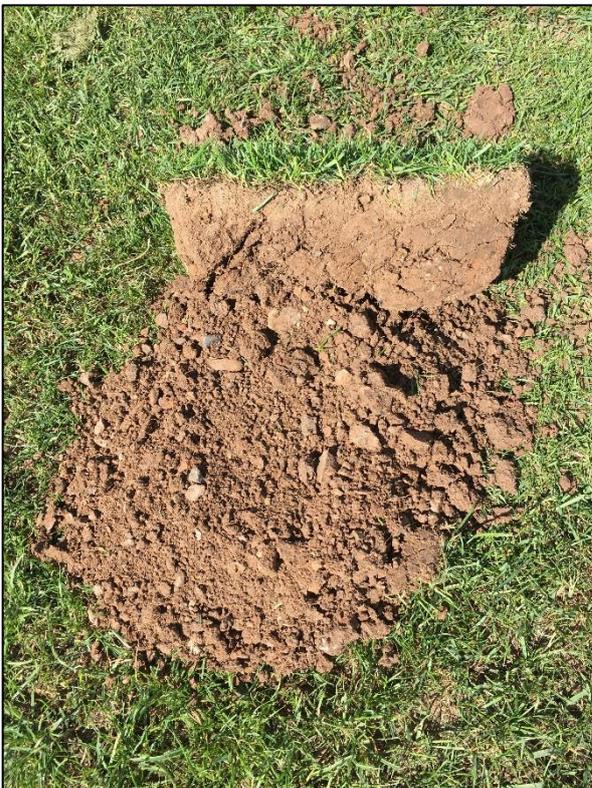
possible due to the hardness of the sub-base. This highly compacted pan will prevent the percolation of water through the subsoil and into the drainage layer, in effect creating a perched water table which will contribute to saturated surface conditions. There was evidence of de-compaction works and sand topdressing with a distinct layer of sand in the upper ~20 mm. Stones were present within the upper soil profile and predominantly comprised of sharp flints and cobbles (~30 mm in longest axis).

Rooting depth was typically ~100 mm and consistent with the time of year with grass heights maintained at ~30 mm. Thatch depth was ~10-15 mm, which is considered high and outside Sport England Performance Quality Standards. Grass cover was good (>90%) with sward composition consisting of perennial ryegrass (*Lolium Spp.*) and shallow rooting grasses such as Annual meadow grass (*Poa annua*). Weed content was moderate (~10-15%) and predominantly comprised of Greater plantain (*Plantago major*), Clover (*Trifolium repens*), Daisy (*Bellis perennis*) and Dandelion (*Taraxacum officinale*).

Figure 5 Overview of TP1 soil profile (CLAY LOAM overlying a heavily compacted CLAY)

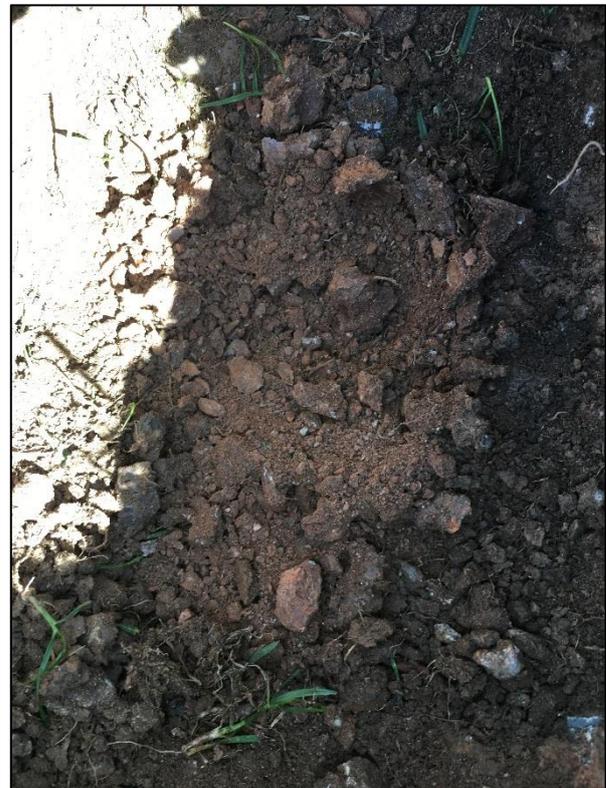
Figure 6 Overview of sharp flints and cobbles (~30 mm in longest axis)

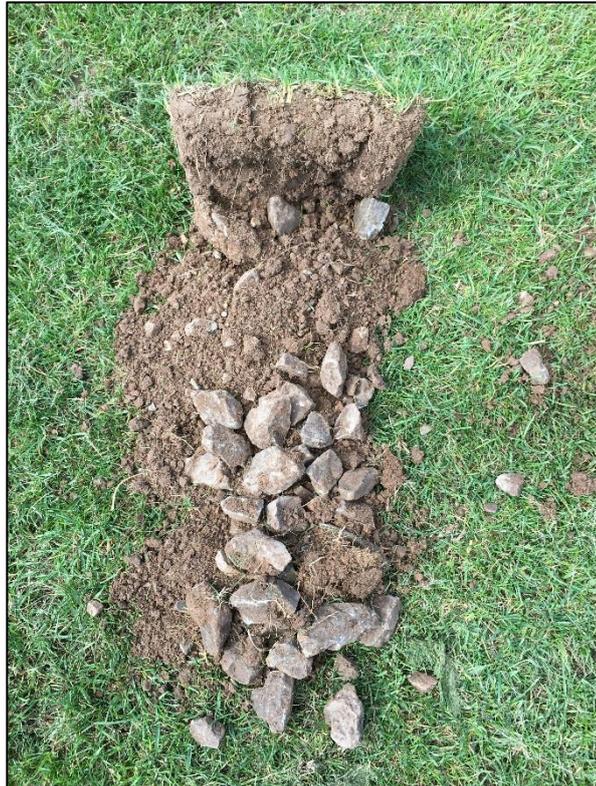
TP2 was excavated over an existing drain line to assess the immediate profile and efficacy of the drain. The TP was located in a central area of the existing pitch, in an area of medium elevation (~40 AOD).

The profile comprised ~200 mm depth of CLAY LOAM topsoil, overlying granite chippings (~80 mm in longest axis) interspersed with soil (figure 7). Further excavation to the pipe was not possible due to the chippings forming an impenetrable layer (for hand tools). It was evident that soil migration into the drainage layer had taken place, therefore reducing the efficacy of the drainage scheme. What was particularly pertinent was the absence of any aggregates i.e. rootzone or sand, which are commonplace materials found within constructed drainage trenches.

Figure 7 Overview of TP2 soil profile showing granite chippings

Additionally, trial pit 2 was purposely excavated to review an existing drainage channel. A large amount of silt/soil was present within the upper profile of the gravel drainage layer of TP2. To this end, based on site conditions, the current system would be considered insufficient. Based on site geology and the indigenous soil characteristics on site, a more intensive scheme with a secondary bypass system would be recommended.

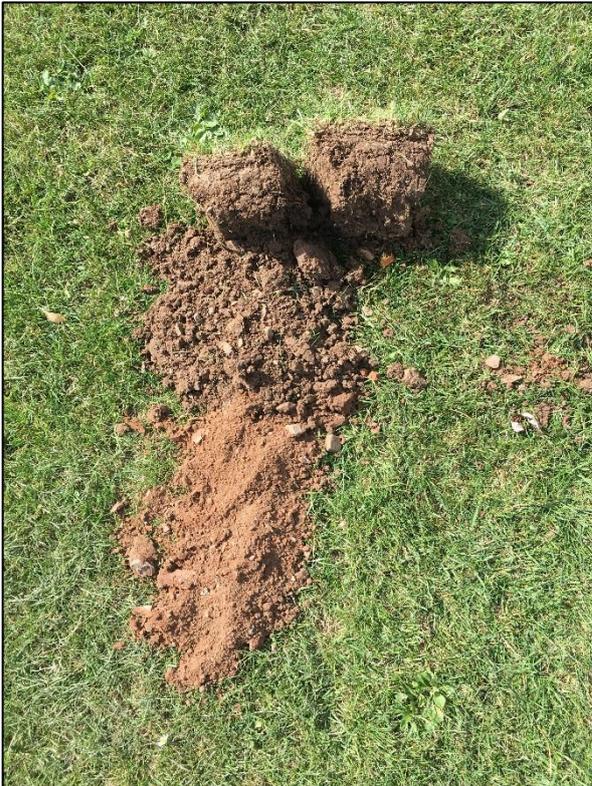
Agronomic condition was very similar to **TP1** and **TP2**. Rooting depth was typically ~110 mm and consistent with the time of year with grass heights maintained at ~30 mm. Thatch depth was ~10 mm, which is considered high and outside Sport England Performance Quality Standards. Grass cover was good (>90%) with sward composition consisting of perennial ryegrass (*Lolium Spp.*) and shallow rooting grasses such as Annual meadow grass (*Poa annua*). Weed content was moderate (~10-15%) and predominantly comprised of Greater plantain (*Plantago major*), Clover (*Trifolium repens*), Daisy (*Bellis perennis*) and Dandelion (*Taraxacum officinale*).

Figure 8 Overview of TP3 soil profile (CLAY LOAM overlying a heavily compacted CLAY)

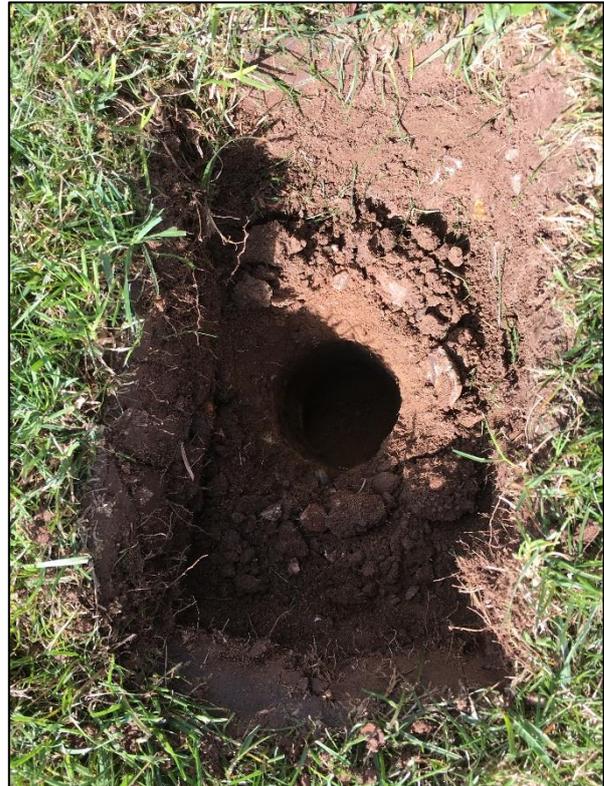
Figure 9 Overview of TP3 excavation

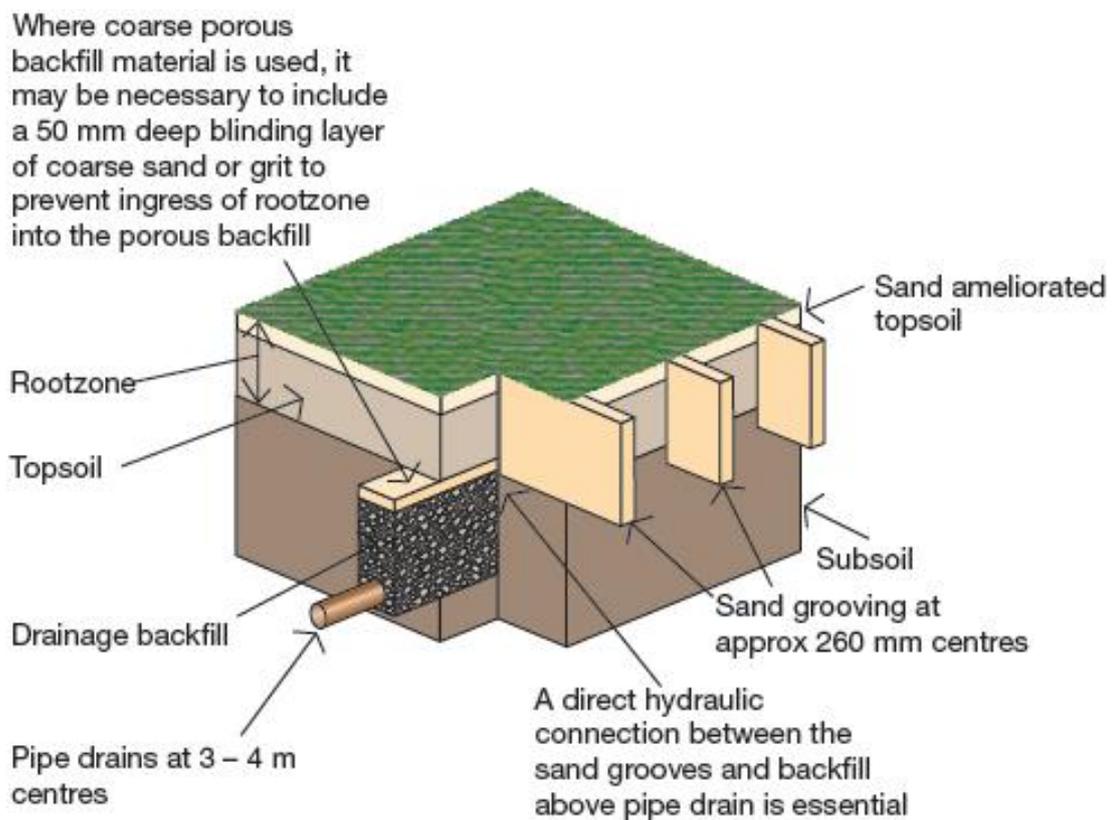
In order to correct this situation, consideration should be given to the installation of a surface bypass drainage system. These systems work by intercepting rain water at the surface before it has had an opportunity to soak in to the soil profile, and then removing this water to a system of piped drains. Typical systems would comprise sand grooves (Figure 10) linked into a system of lateral drains beneath the playing field.

Figure 10 Typical sand groove based drainage system (Ref: Sport England Design Guidance Note "Natural Turf for Sport", 2011)

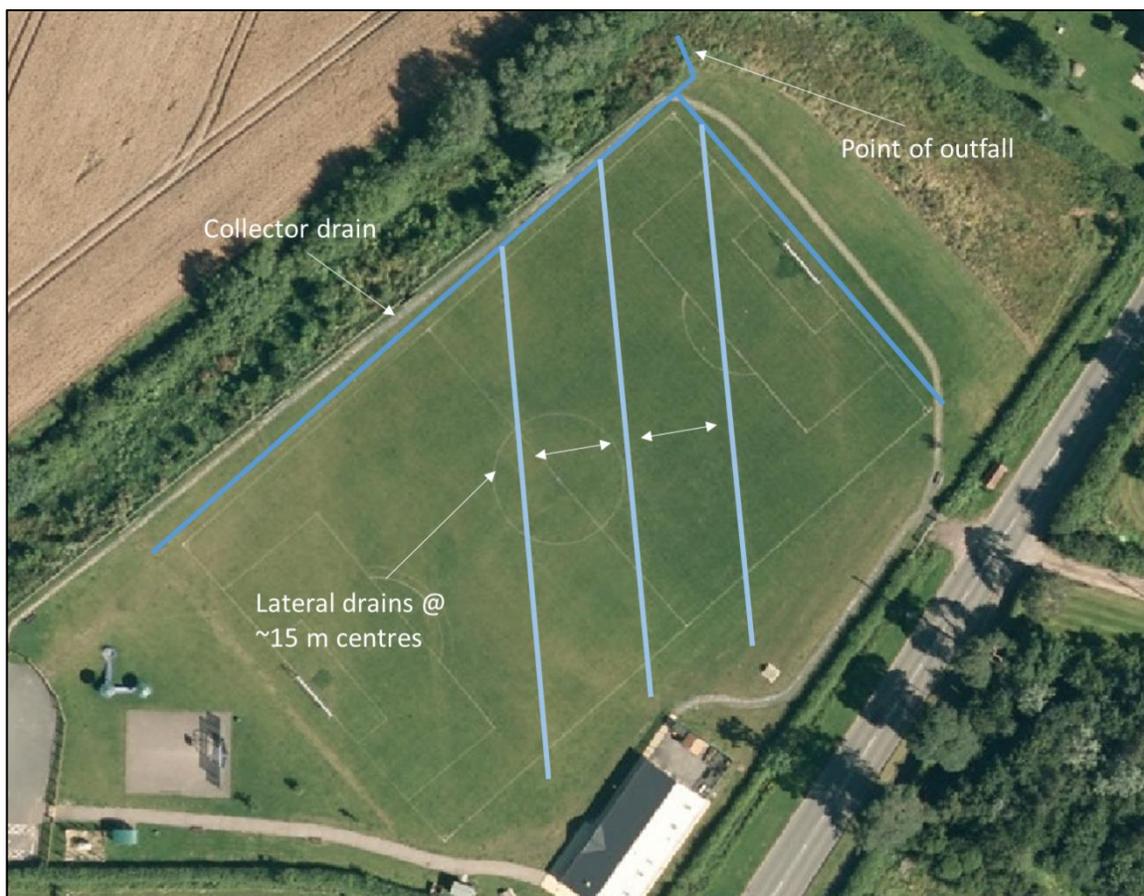
The lateral drains are at approximately 15 metre centres, which in today's standards, with a desire to increase usable hours per week on natural turf pitches, would be deemed inadequate to provide the requisite performance whilst maintaining sustainable turf surfaces. Sport England Design Guidance Notes for Natural Turf stipulate primary drainage at 3-4 metre centres and depending on soil type are frequently supplemented by secondary drainage schemes.

Figure 11 Overview of existing drainage scheme showing lateral drains, collector drains and point of outfall

8. Aerial imagery suggests a drainage scheme may be present with distinct drainage laterals running in a northerly direction to a collector drain, which outfalls into the small stream located along the northern perimeter of the site. The lateral drains are at approximately 15 m centres, which in today's standards would be deemed inadequate. Additionally, a large amount of silt/soil was present within the upper profile of the gravel drainage layer of TP2 (drainage line); this will further compromise the efficiency of any drainage scheme. Based on site conditions and the indigenous soil characteristics, a more intensive scheme with a secondary bypass system would be recommended.

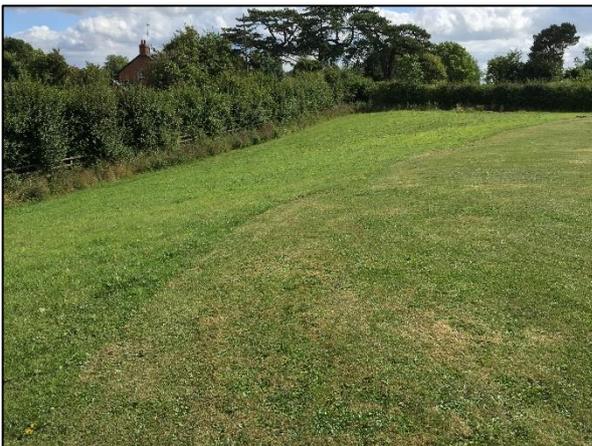
Figure 12 Overview of batter slope located to the north of the site beyond the existing football pitch

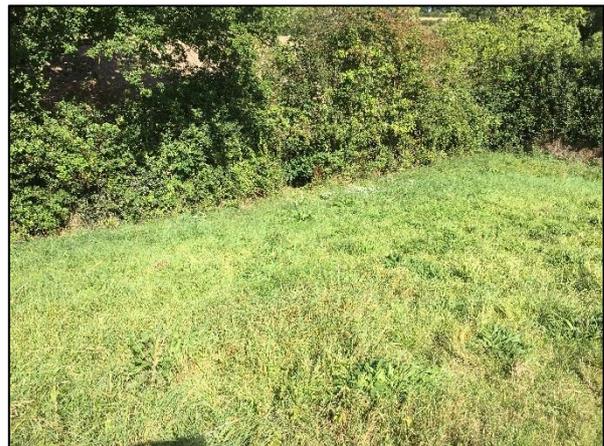
Figure 13 Overview of area where outfall pipe can be identified

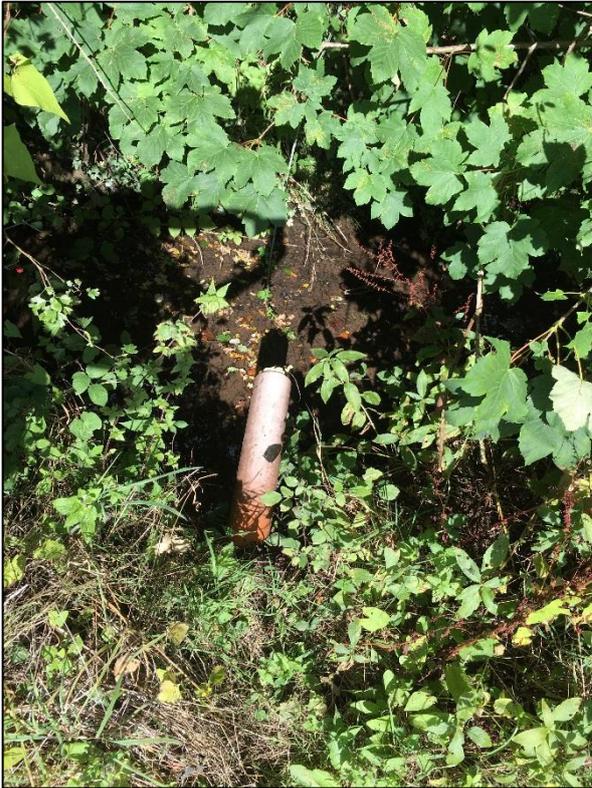
Figure 14 Overview of outfall pipe

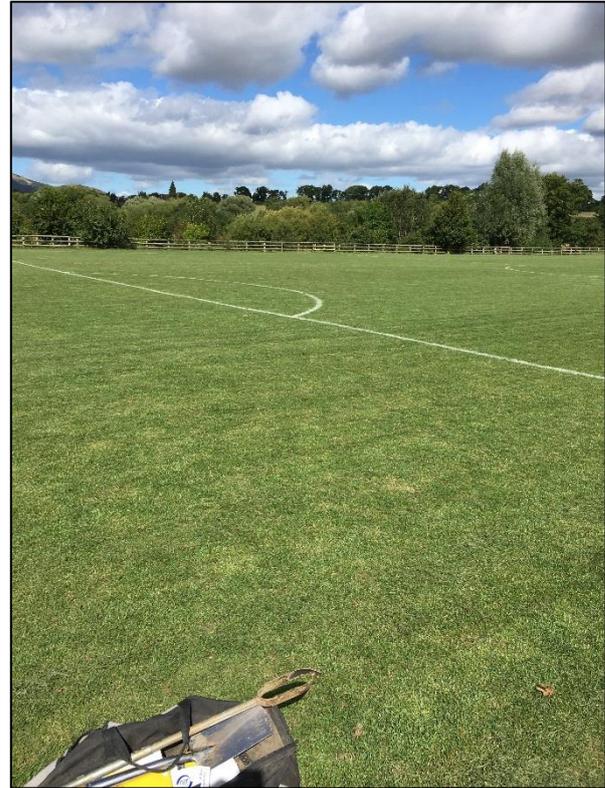
Figure 15 Overview of pitch looking north
