# Whitchurch Town Hall, Hampshire

Phase 1 & 2 Bat Surveys:

**Whitchurch Town Hall**

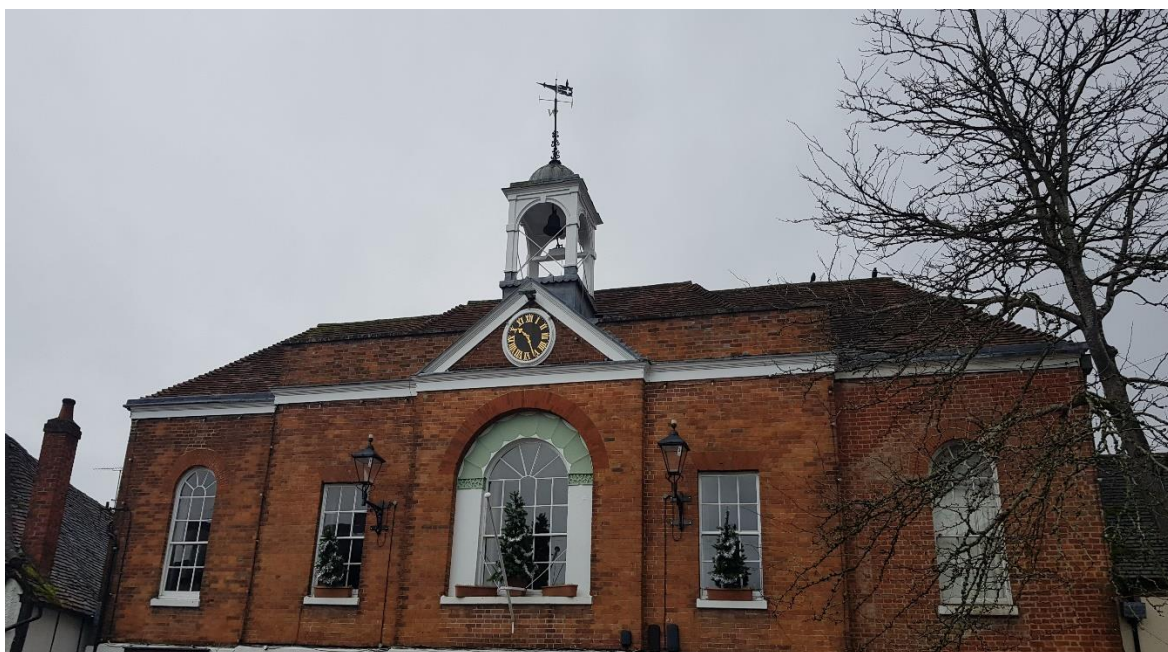
- 2.6 There is a large ornate clock and bell tower on the eastern elevation of the roof which is in good order and the lead work around it seems intact and tight

**Picture 1:** The eastern elevation showing clock and bell tower

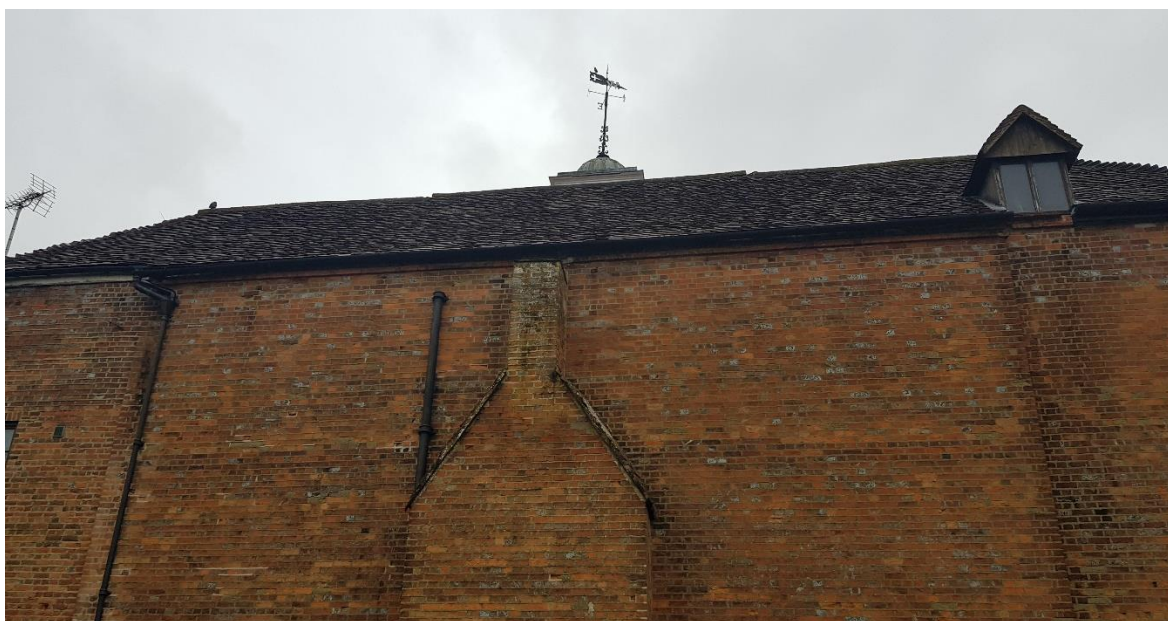
- 2.7 There is a small dormer type window on the western elevation, which has wooden cladding on the front and is clad in the same tiles on the roof, the pugging is all intact and there are no obvious holes or gaps that would allow ingress into the building.

**Picture 2:** Showing the western elevation, small dormer type window

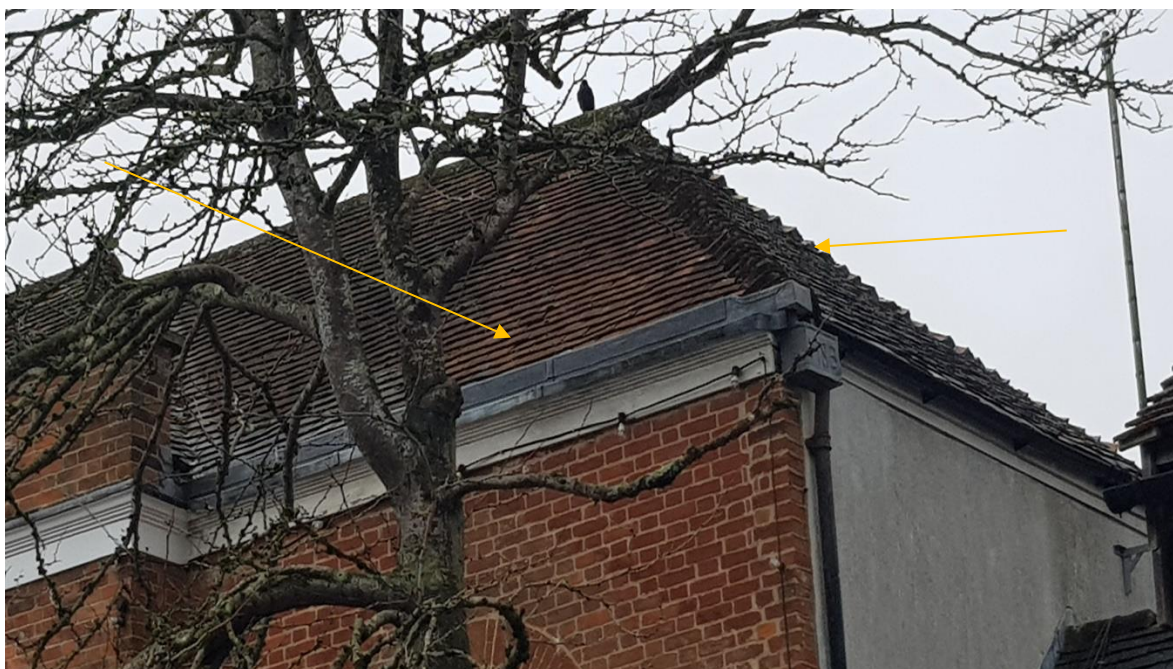
- 2.5 There are numerous gaps and lifted tiles on all elevations of the building that would allow ingress into the building, the hip tiles have numerous gaps and missing cement which could allow ingress into the building.

**Picture 3:** The a close-up of the northern elevation showing gaps under tiles (arrowed)

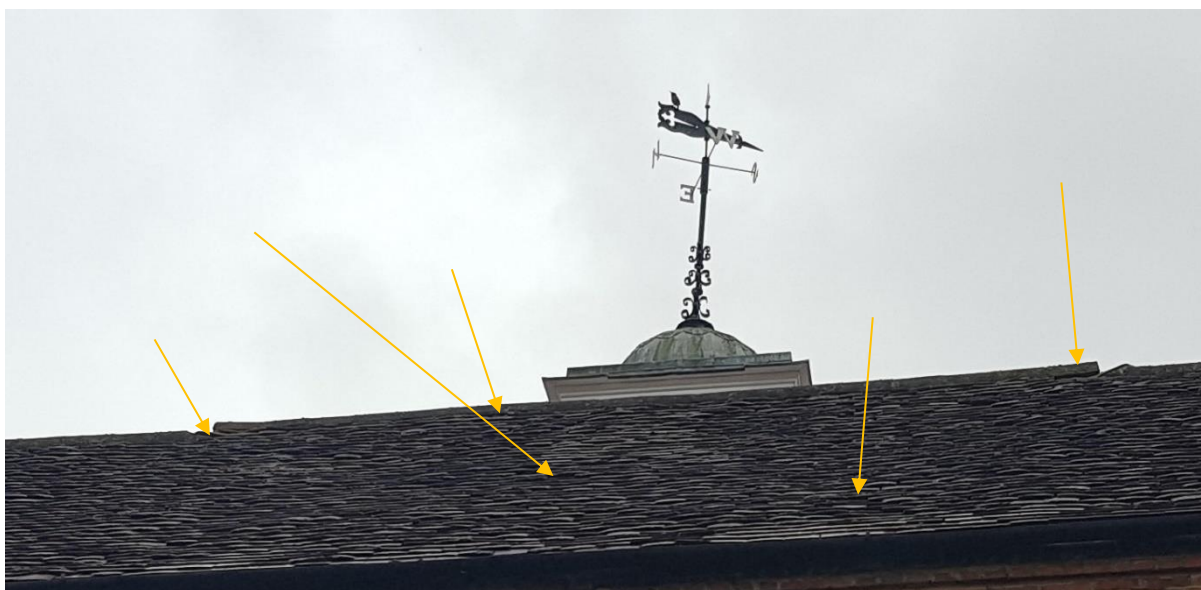
**Picture 5:** Showing a close-up of the western elevation some of the gasp arrows

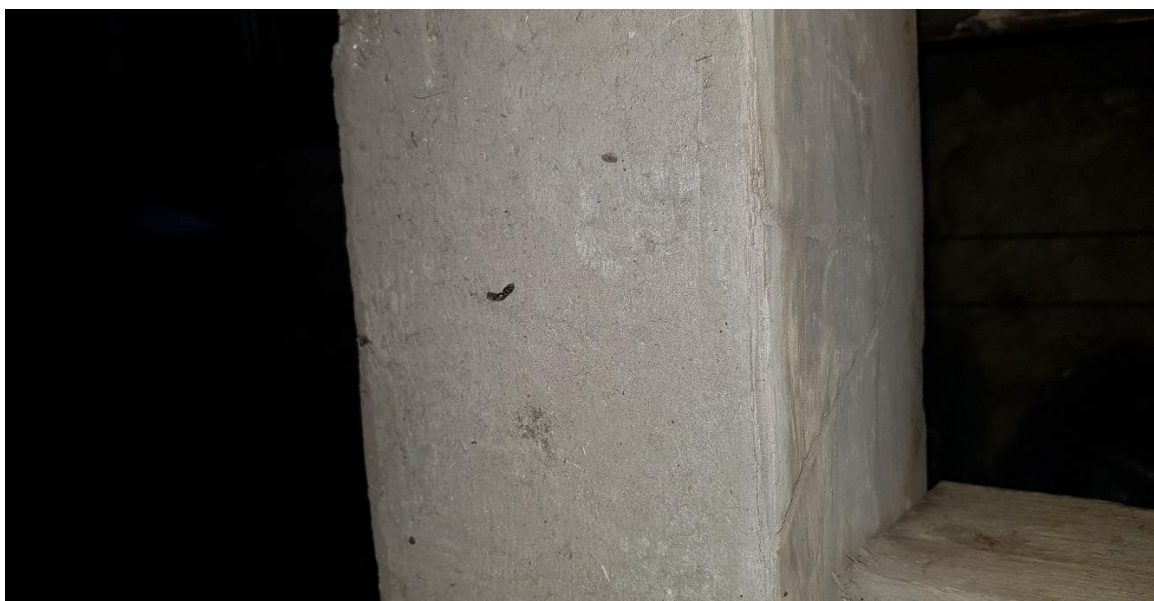
- 2.13 Bat droppings where seen on top of cross beam (nearest the enclosed area) and on the fibre glass insulation at the southern end of the roof, these look like small to medium size droppings from a although no bats where seen during the internal inspection. Droppings were collected and sent for DNA analysis, the analysis should that they were from Brown Long-eared bats.

**Picture 8:** Showing a bat dropping on a beam at the southern end of the building
