## **Harbury Future Energy & e-Wheels**

### **Ground Investigation**

**Harbury Electric Vehicle  
Charging Station Facility,  
Harbury Playing Fields,  
Constance Drive, Harbury  
Warwickshire CV33 9HZ**

**Report No: 21.04.022  
June 2021**

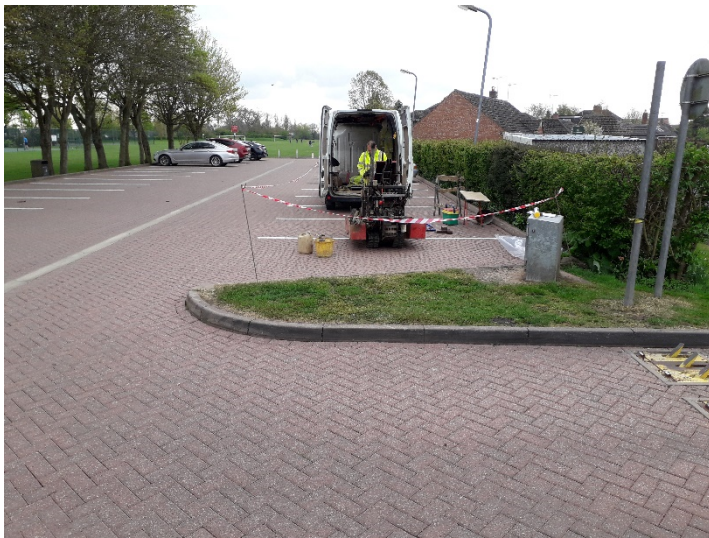
View southwards across car park. Rig on position of CT01

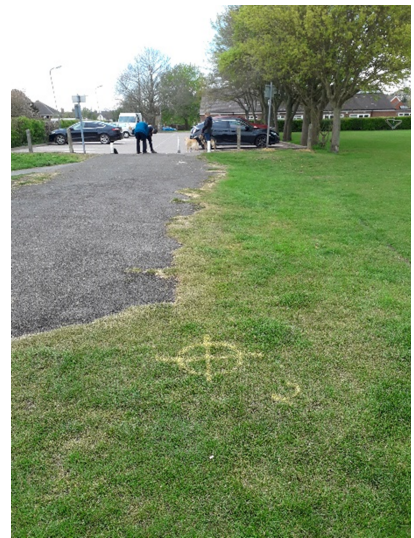
View northwards towards car park. CT02 painted out

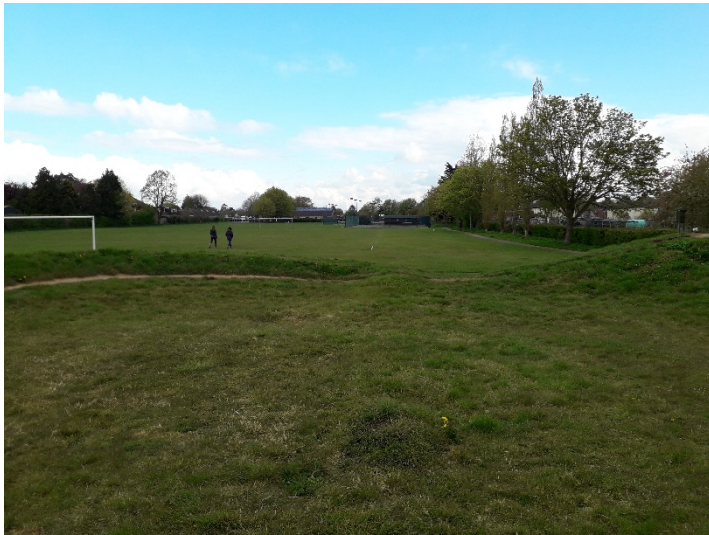
View northwards from CT03

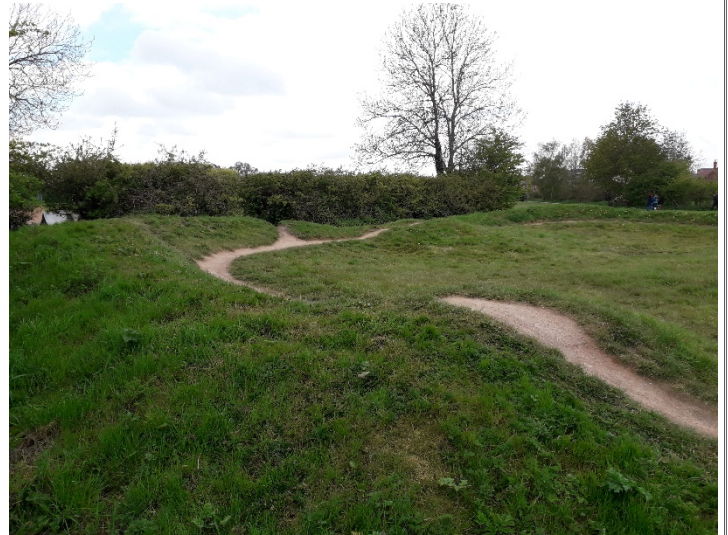
View southwards from close to CT03

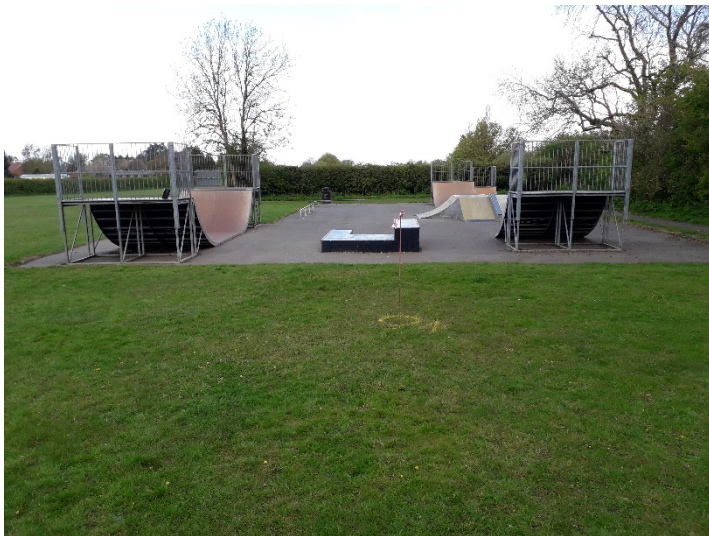
View northwards towards skate park. CT04 painted out

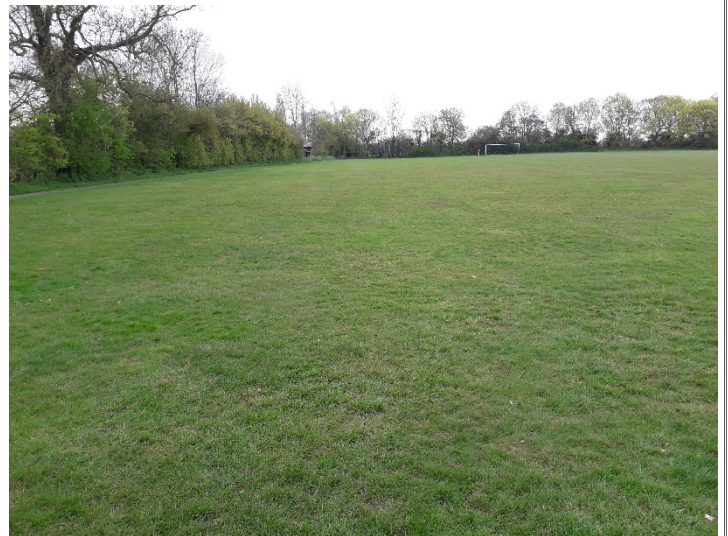
View southwards from CT04
