TASK NO.	TASK/DESCRIPTION	NOTES
H7.02	<p data-bbox="408 387 1062 421"><b>Engine Room and Generator Compartment Bilge</b></p>

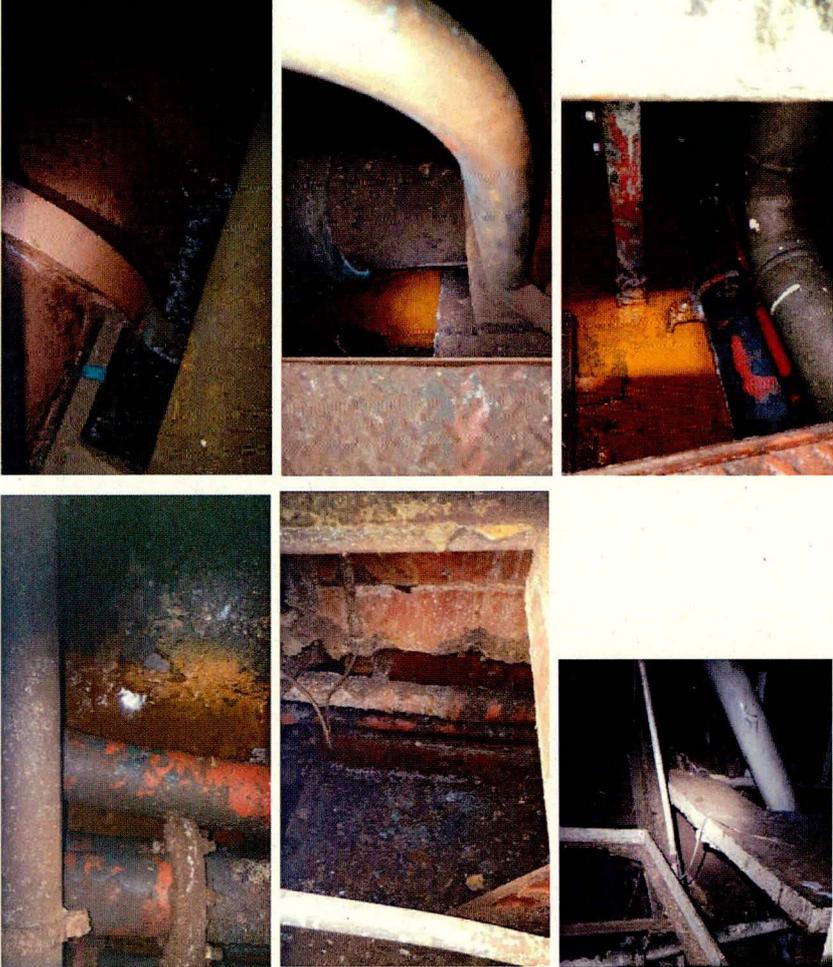
<p data-bbox="408 1424 1246 1592">Bilge wells contain standing water throughout. In some areas levels high enough to cover tank tops. Total breakdown of bilge coatings throughout resulting in active corrosion. Unable to check extent of corrosion below standing water. Bilges throughout to be pumped out, cleaned and dried to allow for scaling back, preparing and REPRESENTATION of affected areas.</p> <p data-bbox="408 1608 847 1637">ALLOW for 50m<sup>2</sup> REPRESENTATION.</p>	<p data-bbox="1246 394 1445 506">IAW Paint scheme -General 12 and Annex B refer.</p> <p data-bbox="1246 533 1406 645">Contractor to remove and dispose of all arisings.</p> <p data-bbox="1246 674 1445 842">Adequate ventilation to be arranged before work commences IAW General 3.2.</p>

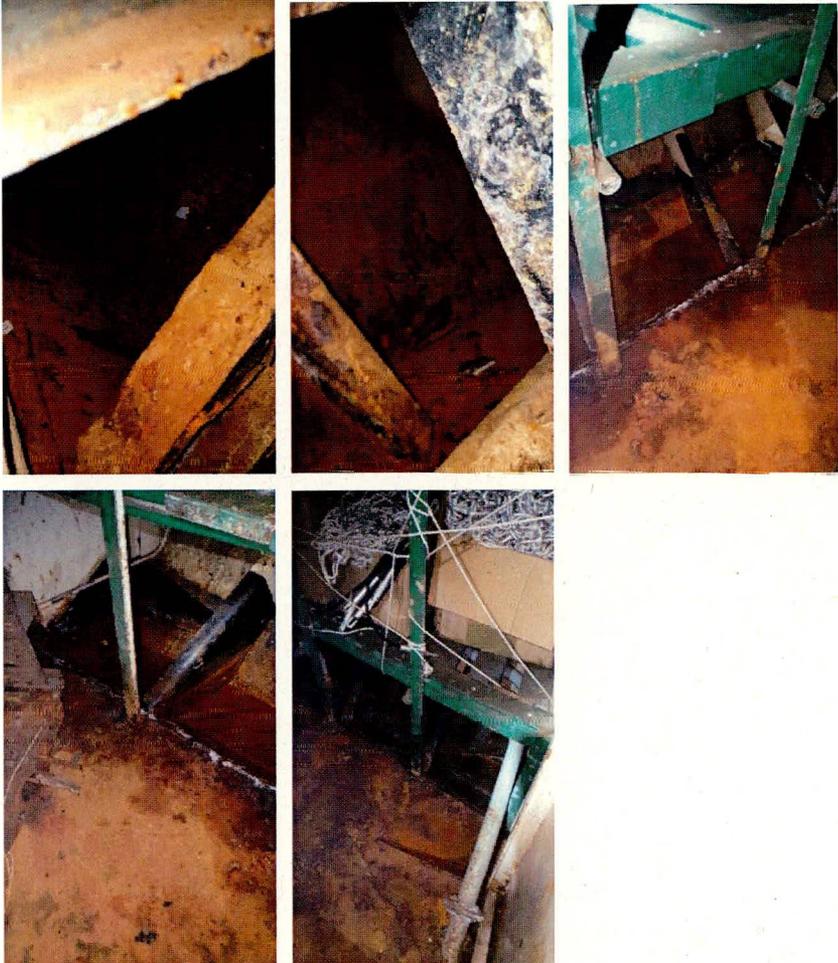
TASK NO.	TASK/DESCRIPTION	NOTES
H7.03	<p data-bbox="400 383 916 416"><b>Fwd Pump Room and No.1 Hold Bilge</b></p>

<p data-bbox="400 1415 1248 1554">Bilge wells contain standing water throughout. Total breakdown of bilge coatings throughout resulting in active corrosion. Unable to check extent of corrosion below standing water. Bilges throughout to be pumped out, cleaned and dried to allow for scaling back, preparing and <b>REPRESERVATION</b> of affected areas.</p> <p data-bbox="400 1570 847 1599">ALLOW for 30m<sup>2</sup> <b>REPRESERVATION</b>.</p>	<p data-bbox="1248 387 1449 499">IAW Paint scheme -General 12 and Annex B refer.</p> <p data-bbox="1248 528 1414 640">Contractor to remove and dispose of all arisings.</p> <p data-bbox="1248 672 1449 837">Adequate ventilation to be arranged before work commences IAW General 3.2.</p>
