A66 Northern Trans-Pennine Scheme 03a: Centre Parcs West-Penrith to Temple Sowerby

Site Information – Early Works

Keltbray

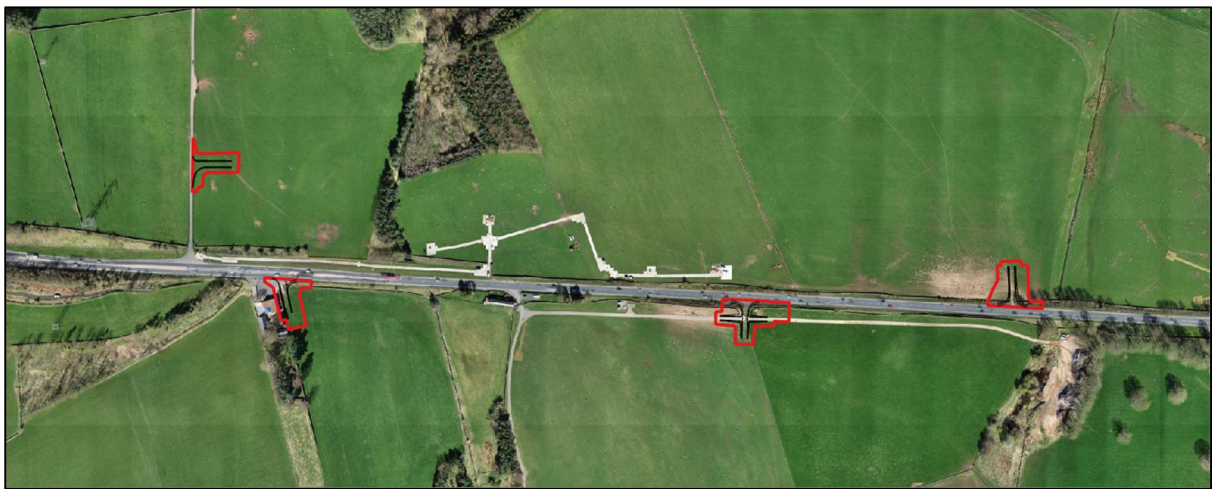
Figure 1: Site Overview of Temporary Accesses.

The 4 temporary accesses are located across the A66 between Penrith and Temple Sowerby, either directly off the A66 or an adjacent road as shown in Figure 1.

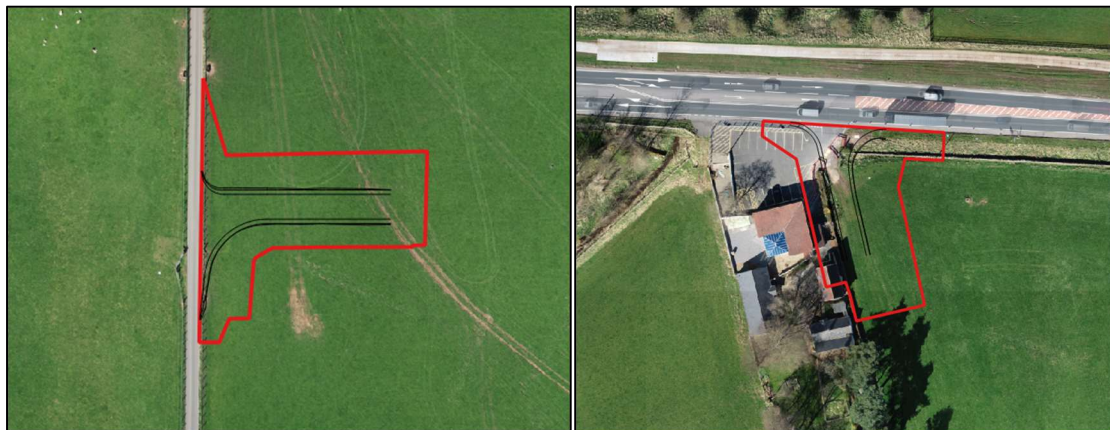
Figure 2: Temporary Access 1 (NW of site) and Temporary Access 2 (SW of site).

The red line boundary of each access is shown, as well as their proposed layouts in Figures 2 and 3. These boundaries encompass all the works to construct the access, as well as temporary fencing and topsoil storage. The welfare compound, material storage and waste management are located at the Llama Karma Café area, next to Temporary Access 2, shown in Figure 4, with legend for reference.

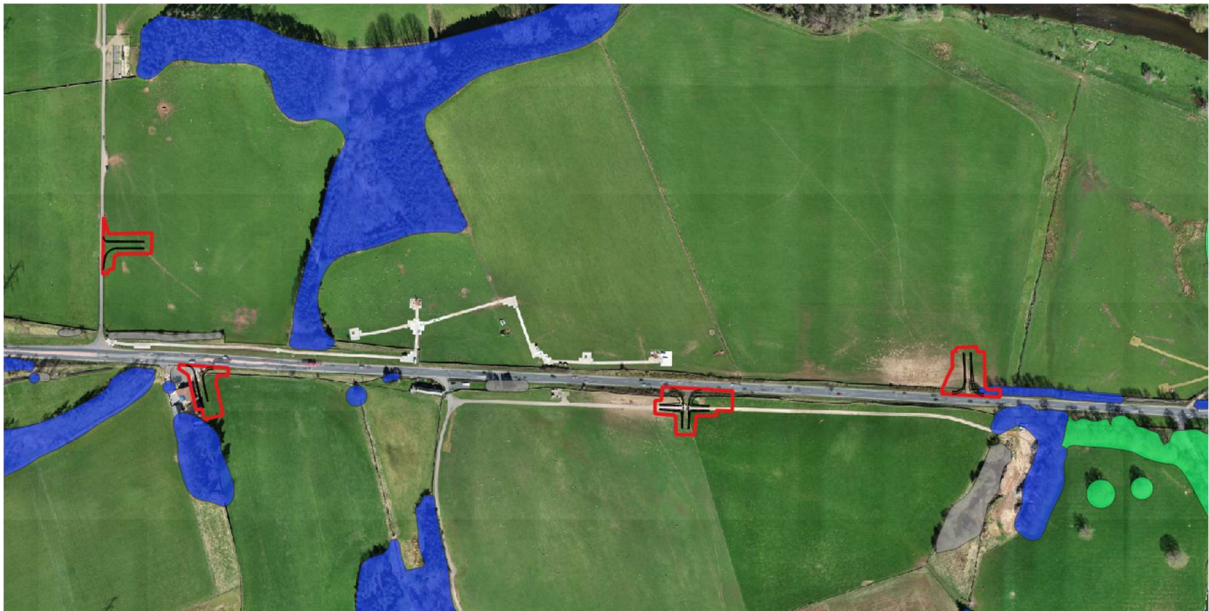
Figure 9: Arboricultural Survey Showing Protection Zones of Trees.

Drawing HE615323-KEL-EAC-03A_AL_SCHEM-DR-CH-000001 in the Appendix shows areas in which trees are and their protection zones. This arboricultural survey can be seen in Figure 9, with category A and B protection zones shown in green and blue respectively.

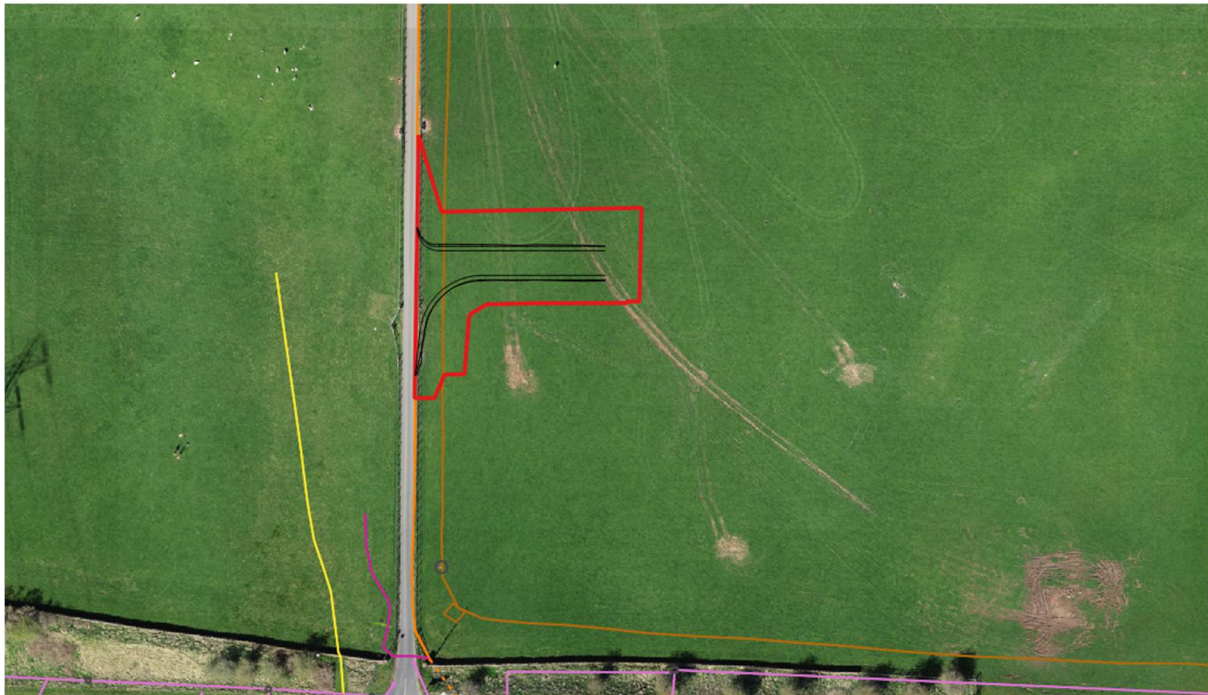
Figure 10: Buried Services Around TA 1.

Figure 10 shows the foul water service (orange solid line) which runs underneath Temporary Access 1, which then runs along the A66 carriageway towards the East.

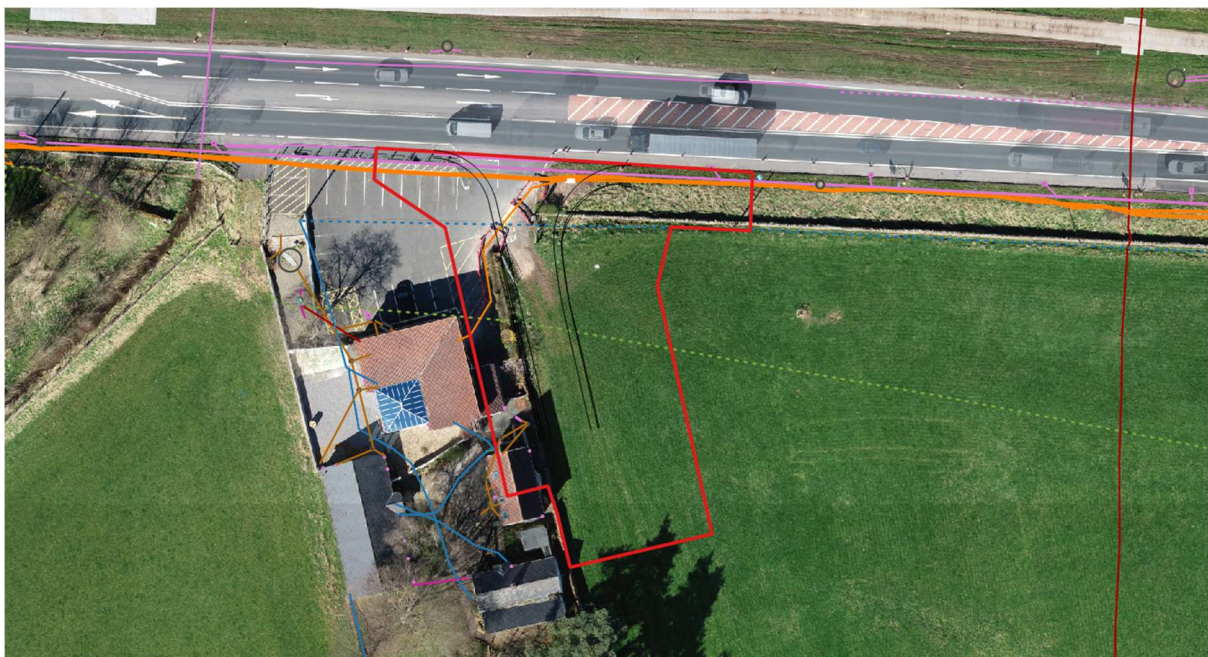
Figure 11: Buried Services Around TA 2.

Figure 11 shows the BT services (orange solid lines) running along the carriageway underneath Temporary Access 2, as well as the storm water records (dotted green line) potentially running underneath Temporary Access 2 also.
