trent  
rivers  
trust

## **Charnwood Forest Landscape Partnership Scheme Natural Flood Management Project Phase 1**

**Final Report**

**May 2021**

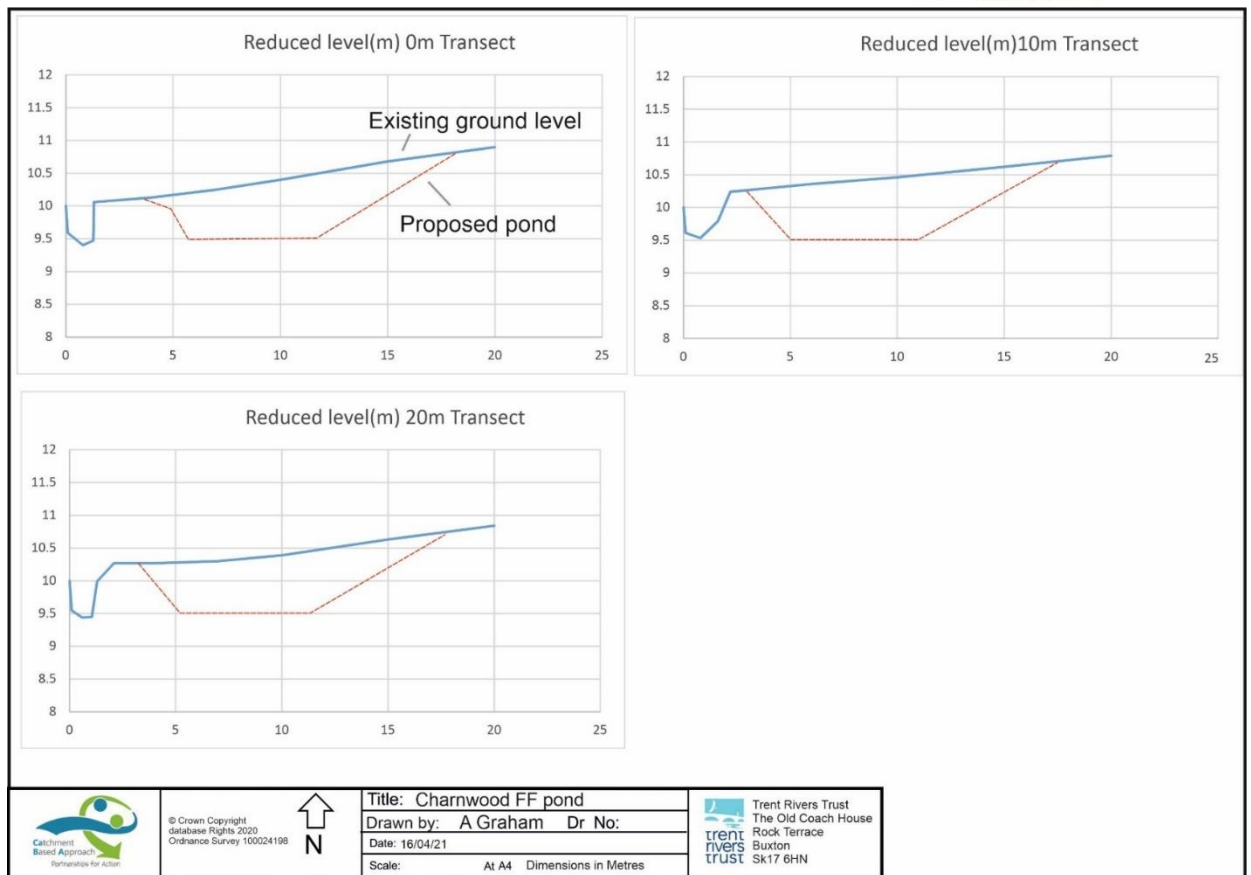
Figure A-12. Site N pond cross section design.

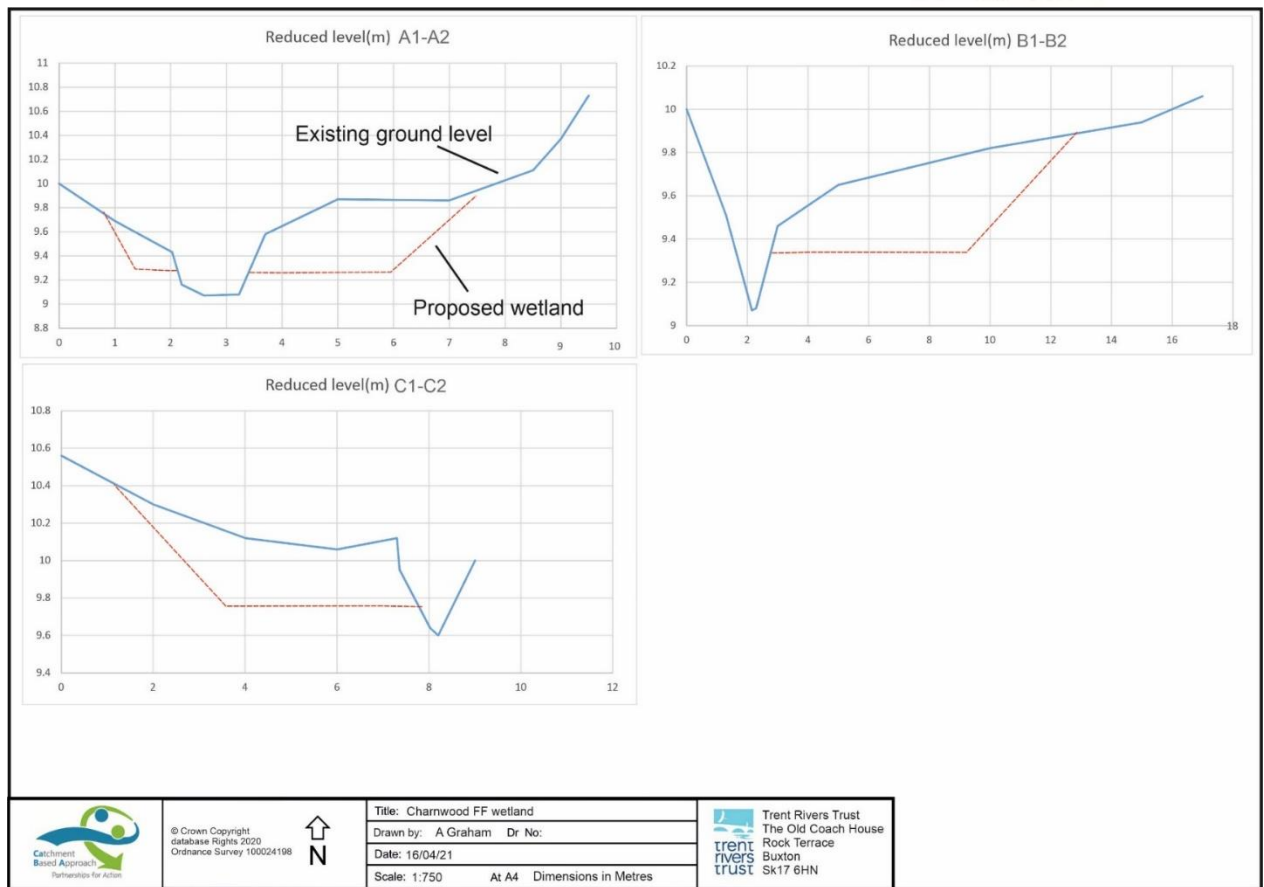
Figure A-14. Site O wetland cross section design.

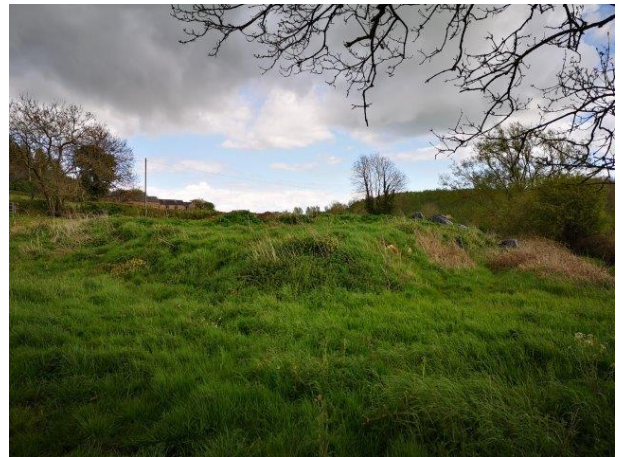
*Plate 16. Tipped debris near Site O (TN2)*

- 4.2.11 An area of tipped debris was noted at NFM initiative O (TN2). This was linked to agricultural activity but the contents of the tip were not known.

O  Wetland	The wetland location is within an area used as pasture, with a debris pile from farming activity. A hedge also borders the side of the brook.  The debris pile could be a source of pollutants depending on its contents.  Crayfish survey required to determine presence absence of white-clawed crayfish. If present then further licensing with Natural England may be required.	The debris pile should be investigated further to determine whether wetland creation in this area could cause leaching of pollutants.  Crayfish survey is advised for the brook to determine whether native white-clawed crayfish are present and would need consideration.	Works should consider Reasonable Avoidance Measures for common amphibians, biosecurity measures and pollution prevention guidelines.
