The Manor House

Church Street
Littlehampton
BN17 5EW

The investigation of The Manor House, Littlehampton.

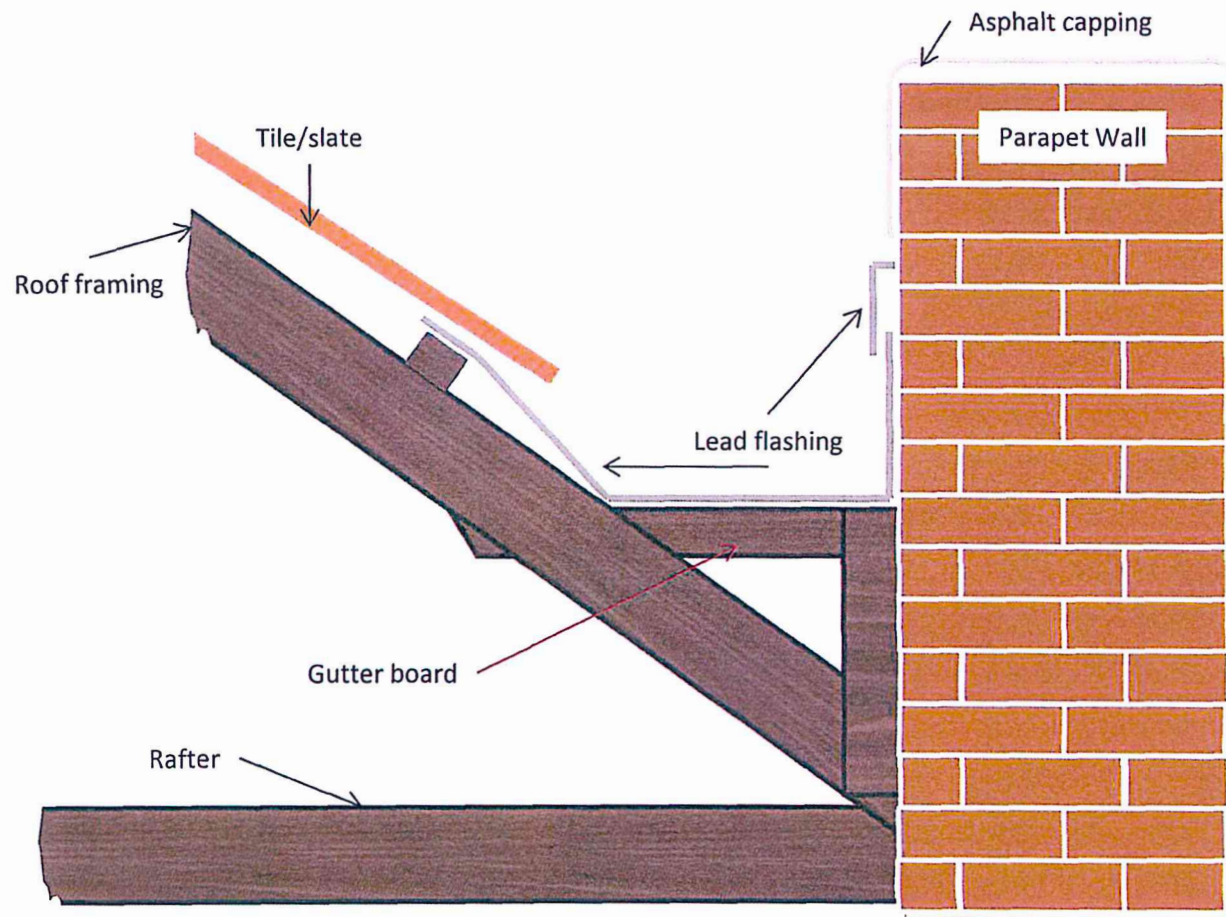
Example of basic box/parapet gutter structure

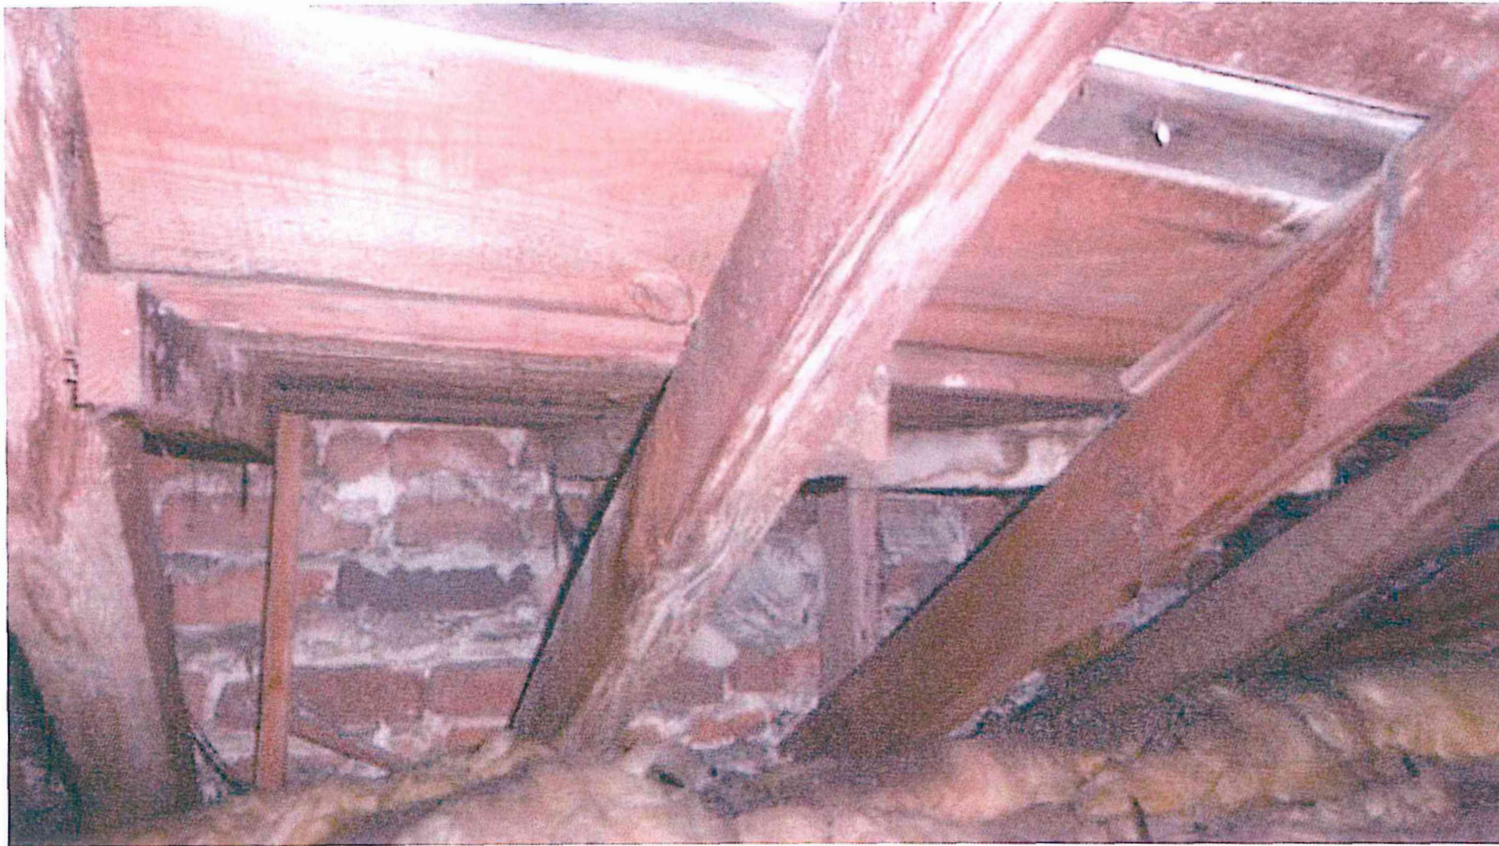
The Manor roof/parapet wall structure

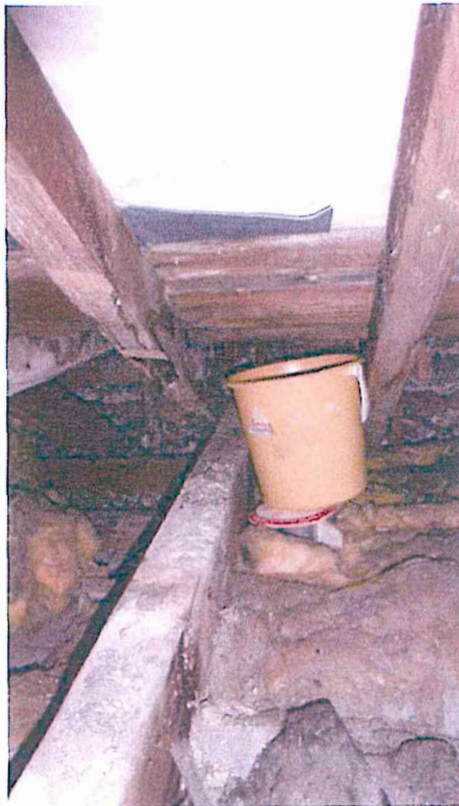
Initial findings

- Initial inspection of the area showed a yellow which was propped against a ceiling joist and was supported bucket by an empty reel that once held electrical wire.
- The bucket had evidence of a small amount of water inside.
- Roofing timbers although dry to the touch during inspection showed evidence of historic water staining.

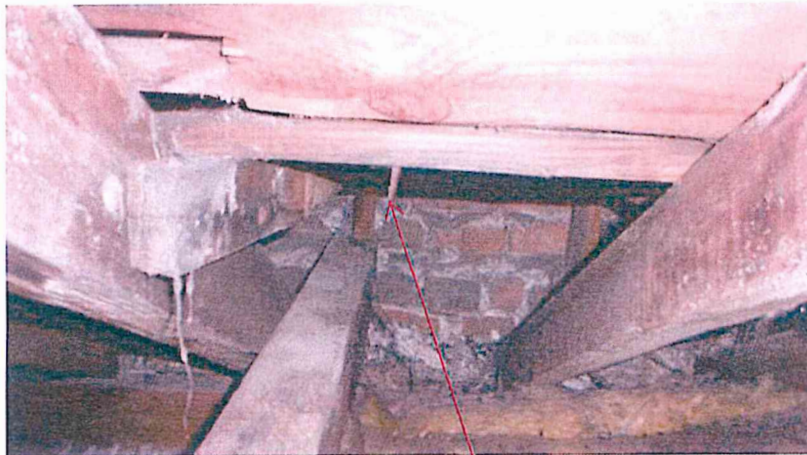
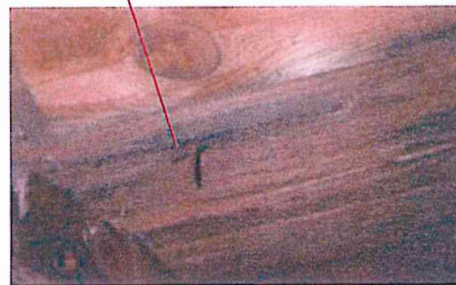
Observations

- The bucket was removed in order to enable a clearer inspection of the area.
- The gutter board was found to have a nail protruding from the underside directly above the bucket location.
- Where the nail has come through the gutter board there is a split.
- There is evidence of staining around the entry point of the nail.
