cornwall
environmental
consultants LTD

Bat and Barn Owl Assessment
10 Parade Street
Penzance
TR18 2JJ

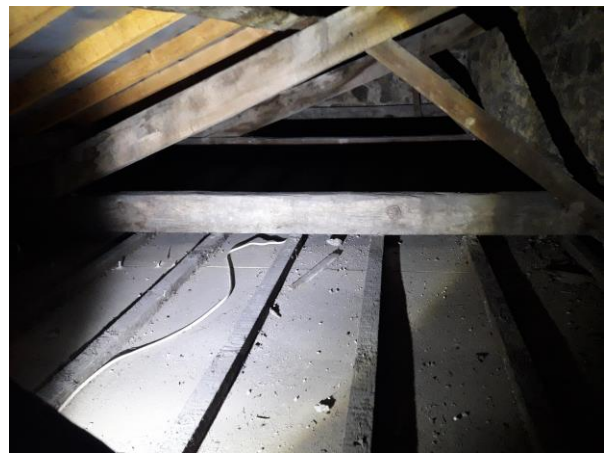
Figure 3. Interior of southern and western roof voids

The underside of the roof, the roof apex, and floor within each void were searched. This was followed by a search of the exterior of the property. The fascia and soffit boards are generally tightly fitted and offer very limited opportunities for use by roosting bats.

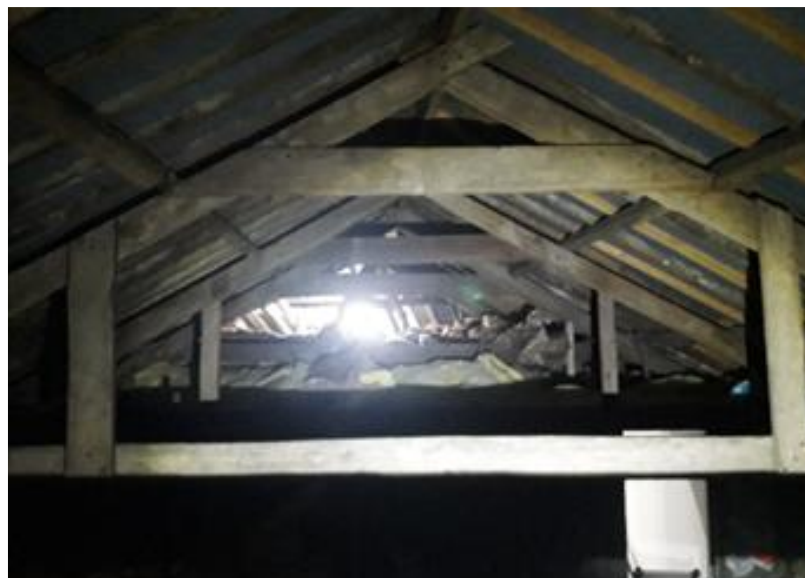
Figure 2. Interior of western roof void

The property is built from local stone and the roofs on all sections are covered with slates which are underlined with a plastic membrane. The building has three separate roof voids, and it was possible to access the voids by means of a telescopic ladder. The western elevation of roof has had conservation roof lights fitted making the interior of the void very light.

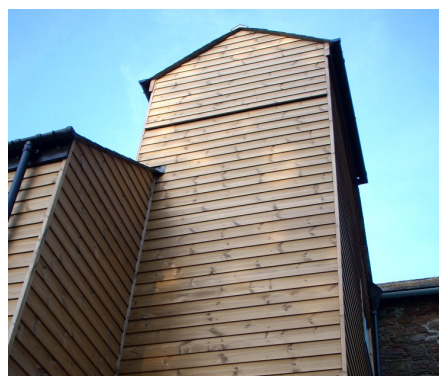
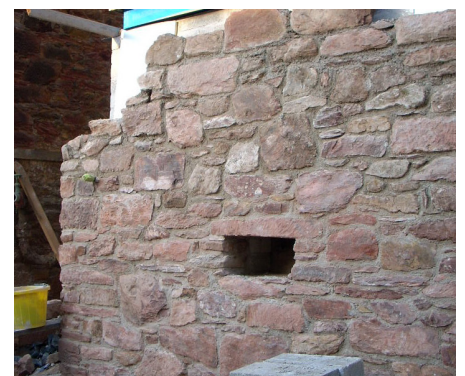
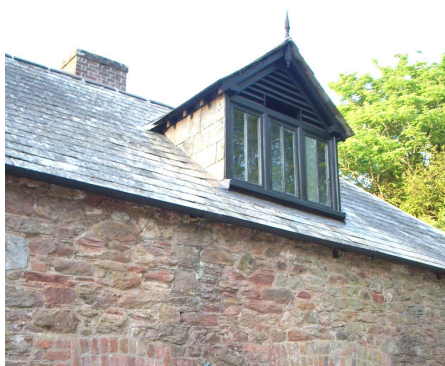
Ridge ventilators can be adapted as bat access points - it may be necessary to remove internal mesh

*Access for greater and lesser
horseshoes*
*Access for pipistrelle - see gap
in wood*
*Access for greater and lesser
horseshoes*
