Project Name
M4 Prince of Wales Bridge

Drawing Title
Core and Patch repair record

Drawing No SBIM-POW-TO824-DWG-0007	Rev P01
--	-------------------

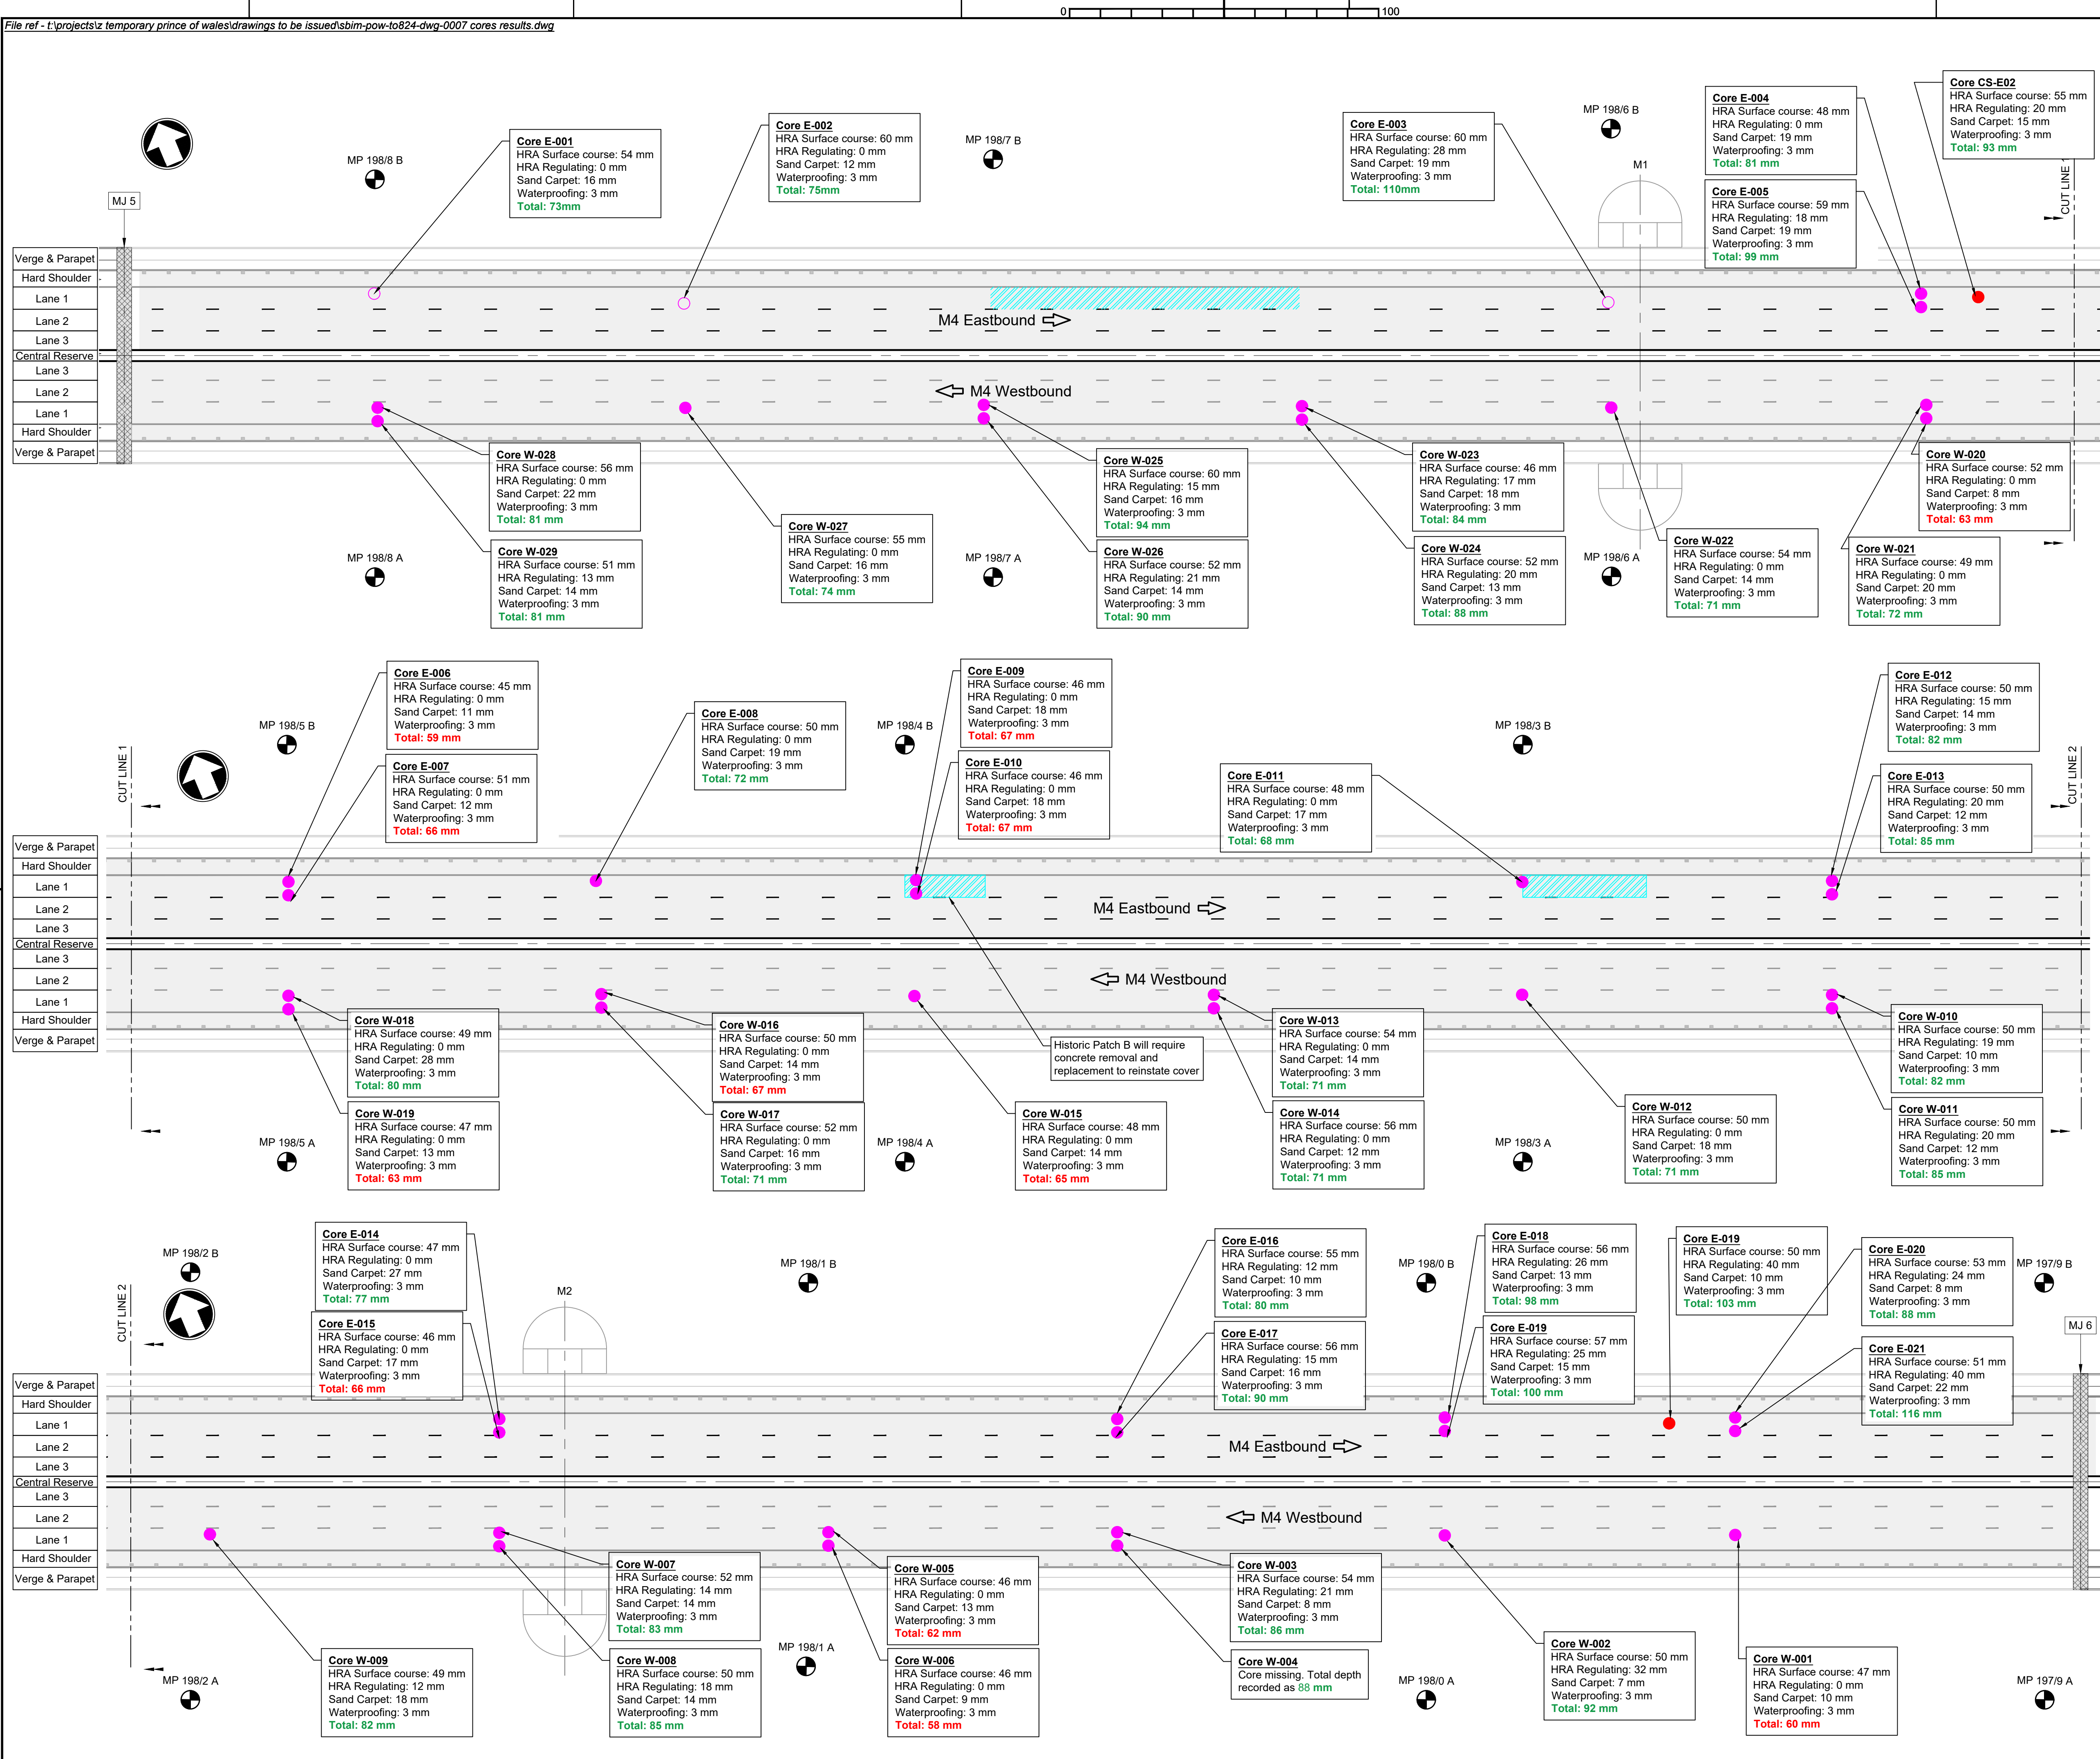
- KEY:
- M Main Tower
 - MJ Movement Joint
 - Historic patch repair carried out on the concrete deck in 2012. Refer to drawing SBIM-POW-TO824-DWG-0008 for further detail.
 - Core taken in May 2011
 - Core taken in March 2024
