6.0 Structural Proposals

Job No.: 2/10838
Rev. 00

2.0 Existing Structure

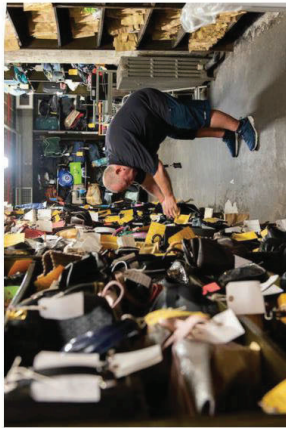
Figure 8 – Photo from within a TfL Lost Property Office showing the storage of lost property items (source: <https://londonist.com/london/transport/tfl-s-famous-lost-property-office-is-moving-to-south-hensington>)

3.8 The composition of the lost and found items is expected to vary significantly, from bags, jewellery, mobile phones, documents, etc. According to the TfL Lost Property Office transparency data (<https://content.tfl.gov.uk/lost-property-office-transparency-data-fy-2019-20-21.pdf>), approximately 115,000 items were found across the TfL network during 2020. As such, the density and weights of stored items do differ – see Figure 8. Due to the change in use from bus imposed loads to storage of lost and found property items, we would assume [to be confirmed by TfL] a reduced live load

allowance of 5.0kN/m² is adequate on the existing floor slabs. Therefore, there is a minimum additional 2.5kN/m² capacity within the existing structure to accommodate overall load changes.
