## HORNIMAN MUSEUM AND GARDENS

### DESK TOP STUDY, PROPOSED BUTTERFLY HOUSE

September 2016

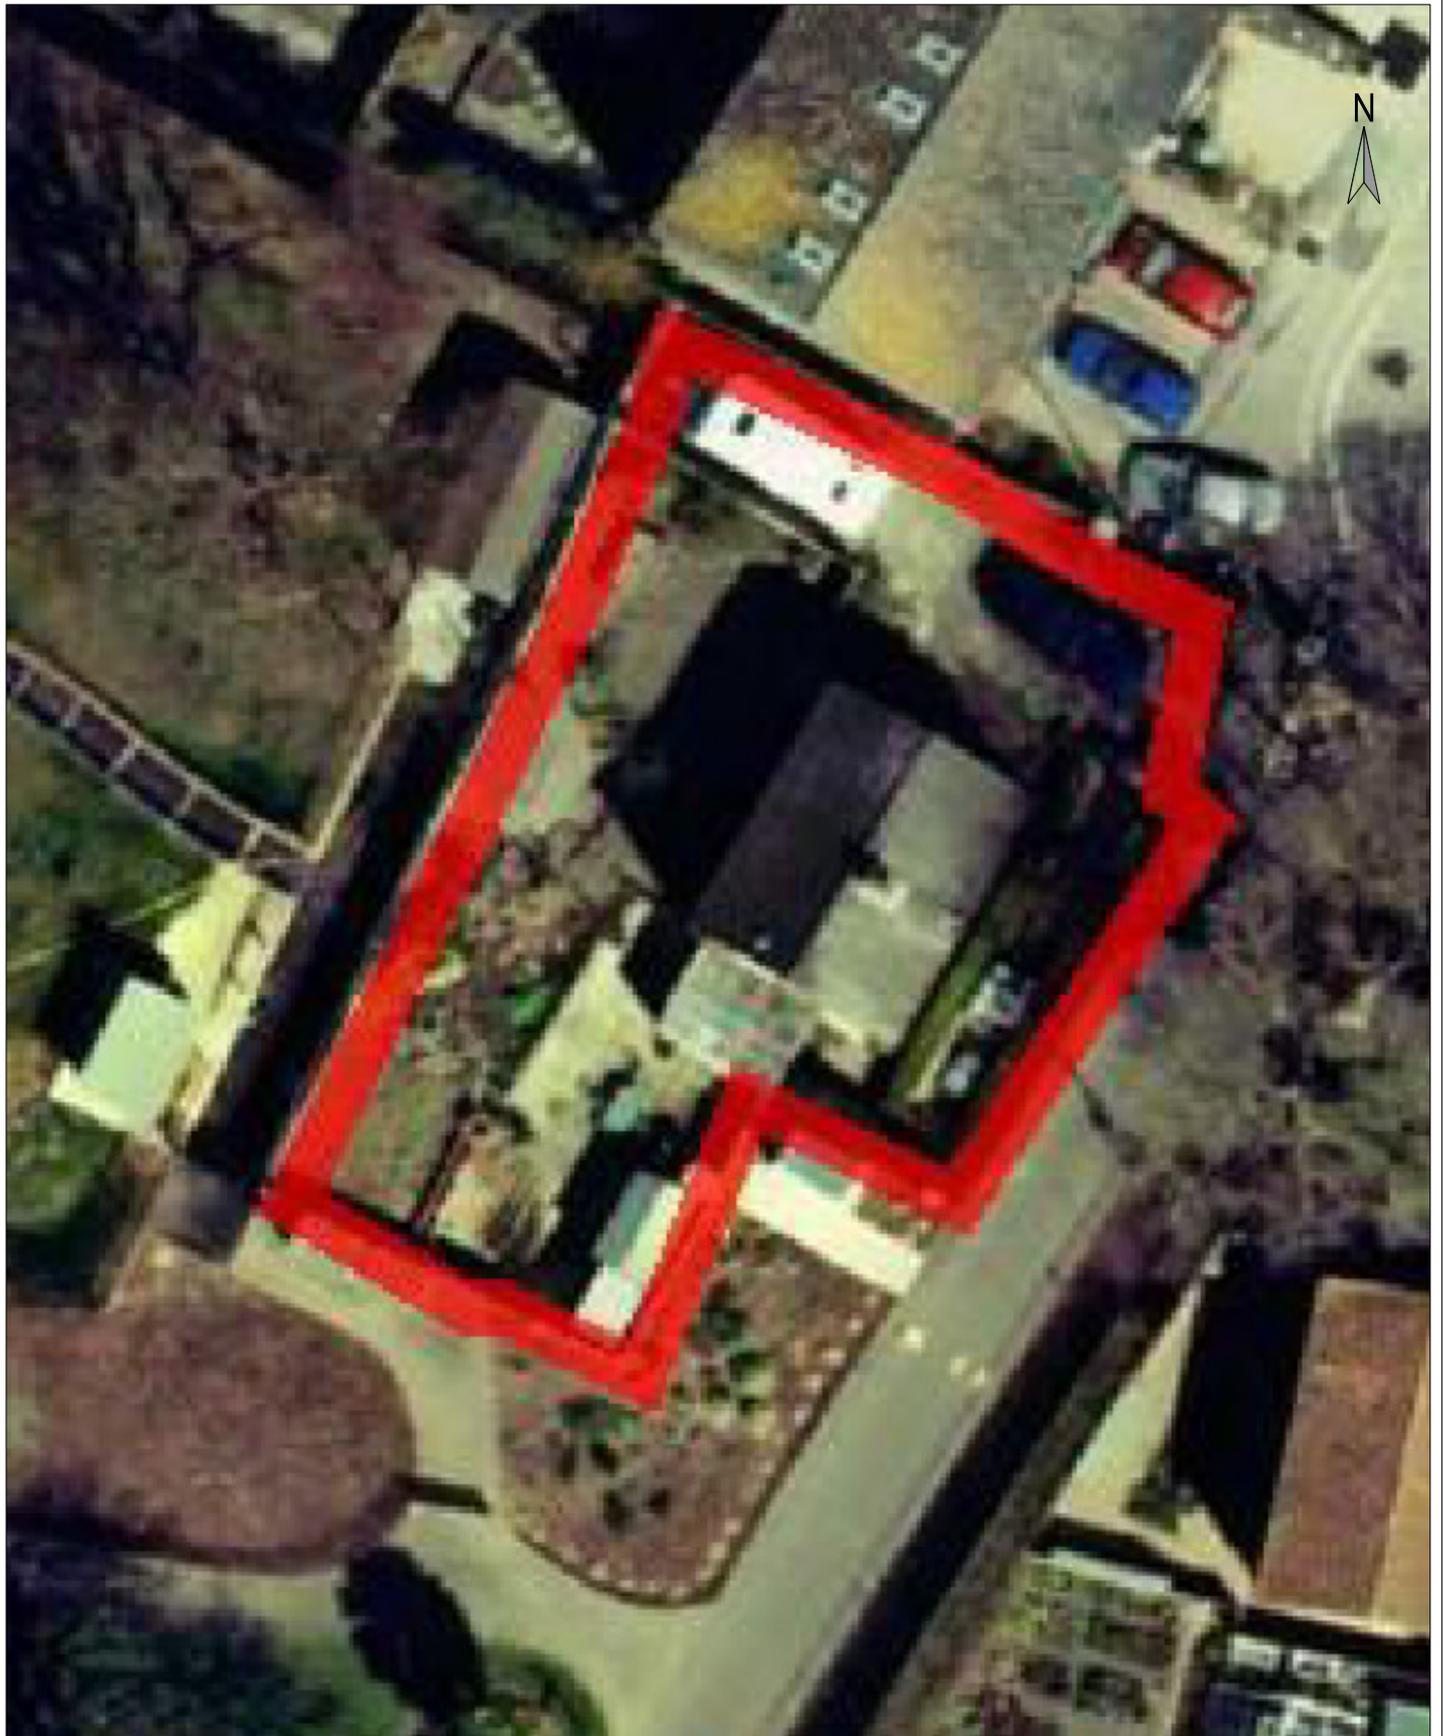
**FIGURE 2 – SITE LAYOUT PLAN**

DRAWING  
**5001510 - SITE LAYOUT PLAN**

The site chosen for the Butterfly House is irregular in plan shape and sits next to the Animal Walk and on the footprint of the Lodge (to be demolished) on Horniman Drive. The Lodge is currently not in use and used to be occupied by the Gardens Keeper. The area of the site surrounding the Lodge comprises mainly soft landscaping areas & gardens. It is understood from information provided by the client that the Lodge is likely to contain asbestos containing materials and that the demolition contractor is due to remove the asbestos containing materials during the demolition works.

The area to the west slopes down away from the site and is used for keeping animals as part of the Horniman Museum and Gardens Animal Walk. Horniman Drive is located adjacent to the east of the site with further parts of the Horniman Gardens beyond and to the south of the site. An electrical substation is also located adjacent to the southeast corner of the site. Residential properties outside of the Horniman Museum and Gardens Grounds are located adjacent to the north of the site.
