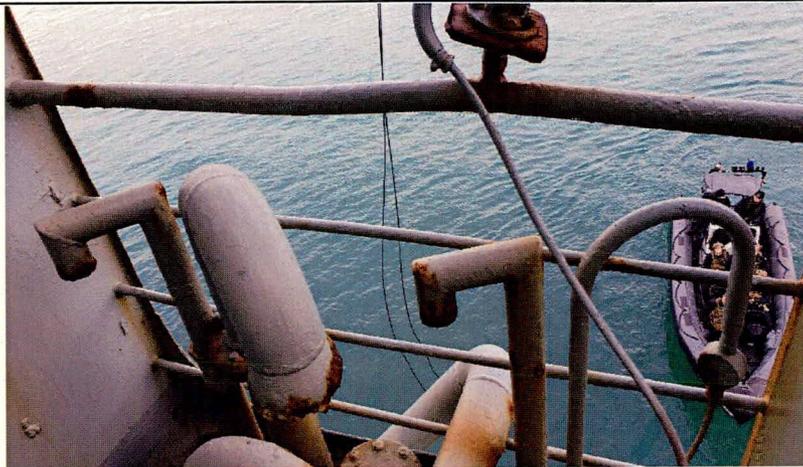
Guardrails have total paint covering breakdown in areas which has led to total thickness corrosion of tubular guardrails. Affected areas to be RENEWED including intermediate rails and end support fixings as shown. PRESERVE on completion.

ALLOW for 10m top rail and 6m intermediate rail RENEWAL. ALLOW for 6m² REPRESENTATION.

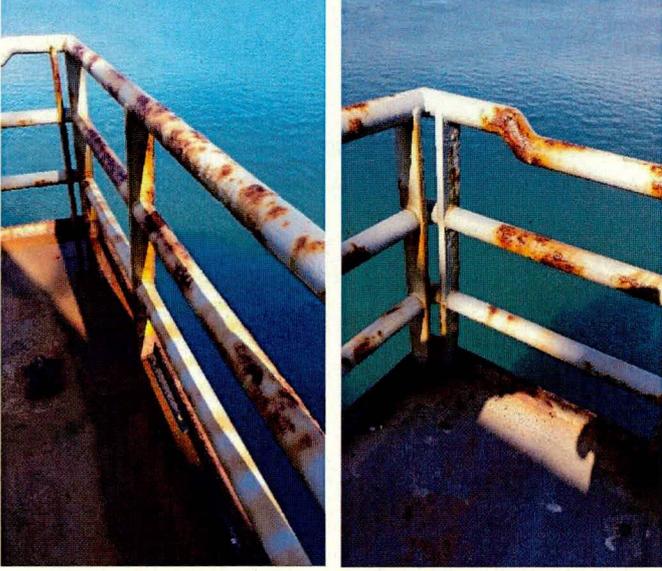
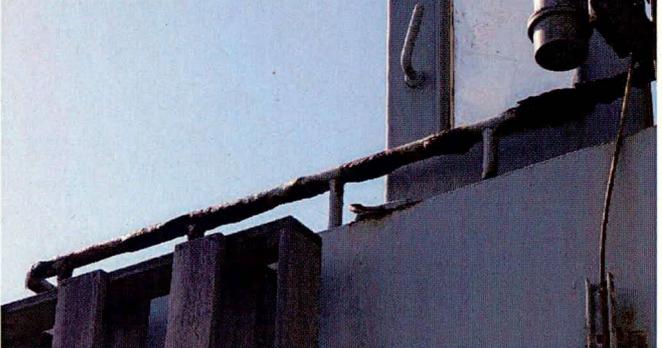
</div> <p data-bbox="408 1379 1219 1462">Stbd bridge wing guardrails show paint covering breakdown and active corrosion. REPRESENT all stbd guardrails. Port guardrail has severe full thickness active corrosion and requires RENEWAL.</p> <p data-bbox="408 1480 1219 1536">ALLOW for 8m guardrail RENEWAL. ALLOW for 20m² REPRESENTATION.</p>	<p data-bbox="1251 394 1449 566">Hotwork Required – Appropriate precautions to be taken IAW General 8.4.</p> <p data-bbox="1251 595 1449 707">IAW Paint scheme -General 12 and Annex B refer.</p> <p data-bbox="1251 736 1449 819">To be completed in conjunction with H2.15.</p> <p data-bbox="1251 848 1449 904">Complete IAW Ref. 5.</p>

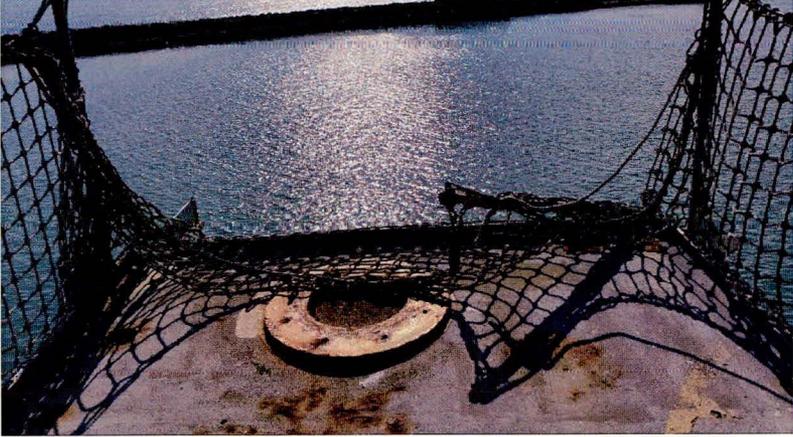
<p>Strikable guardrails port and stbd are damaged and not fit for purpose. RENEW with fixed stanchions and permanent guardrails as fitted elsewhere on board. PRESERVE guardrails and deck area on completion.</p> <p>ALLOW for 15m guardrail RENEWAL. ALLOW for 10m² REPRESENTATION.</p>	<p>Hotwork Required – Appropriate precautions to be taken iaw General 8.4.</p> <p>IAW Paint scheme -General 12 and Annex B refer.</p> <p>Complete IAW Ref. 5.</p>
