Henley Hockey Club
Clubroom

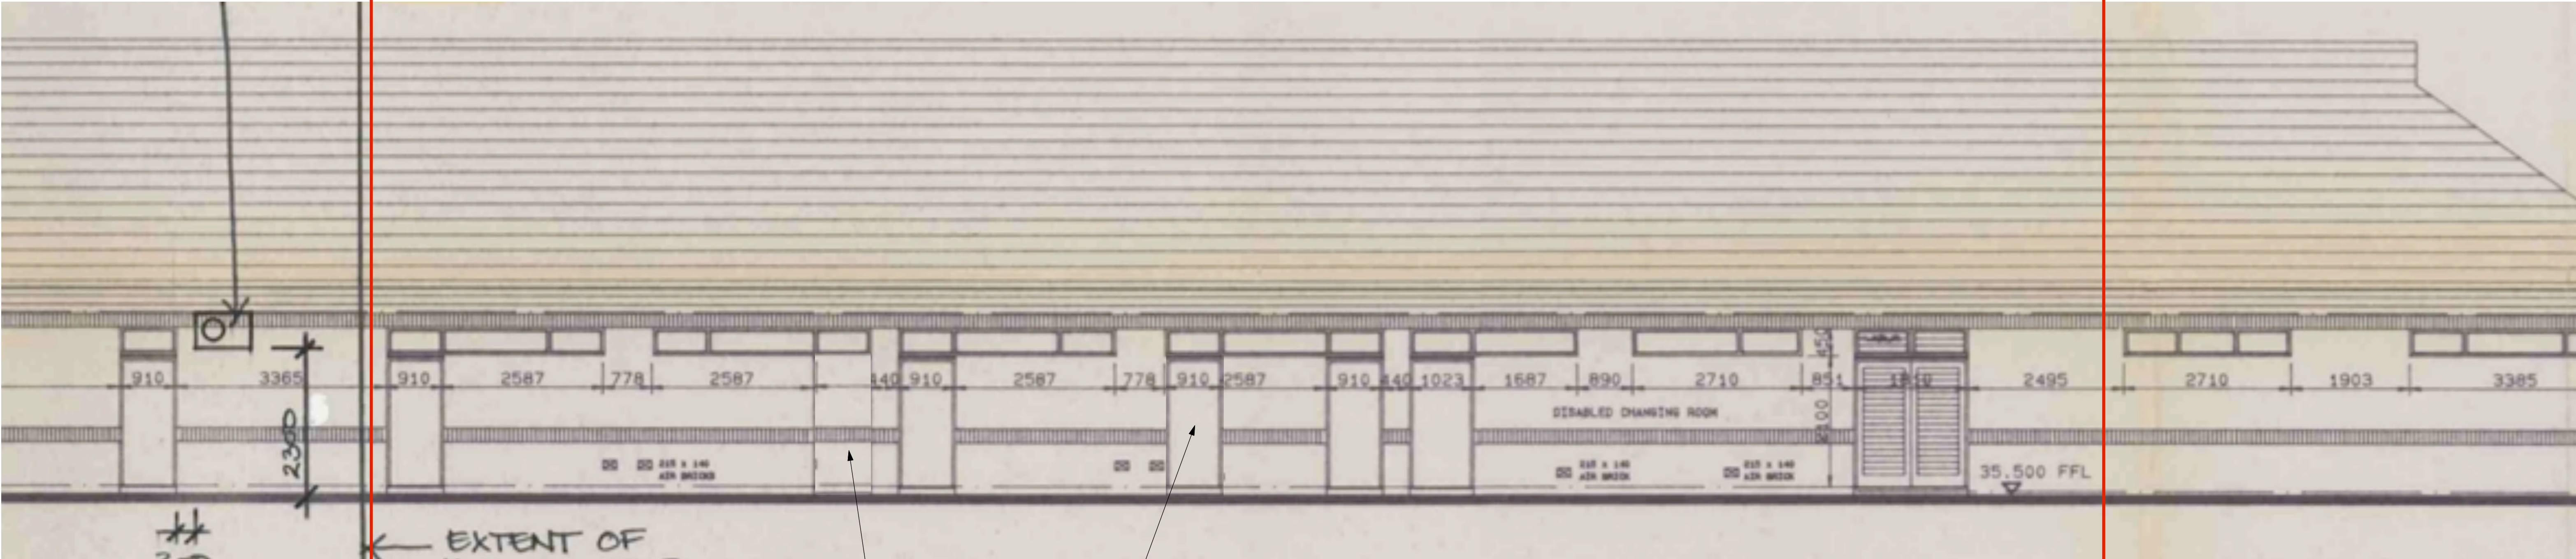
New door opening to be carefully cut into existing wall and facing
work made good. Window to remain intact through works. Door
leaf to be re-used from existing door which will be closed up in
these works.

This door opening closed up in facing brickwork and cavity block wall
Door set o be carefully removed and set aside for re-use

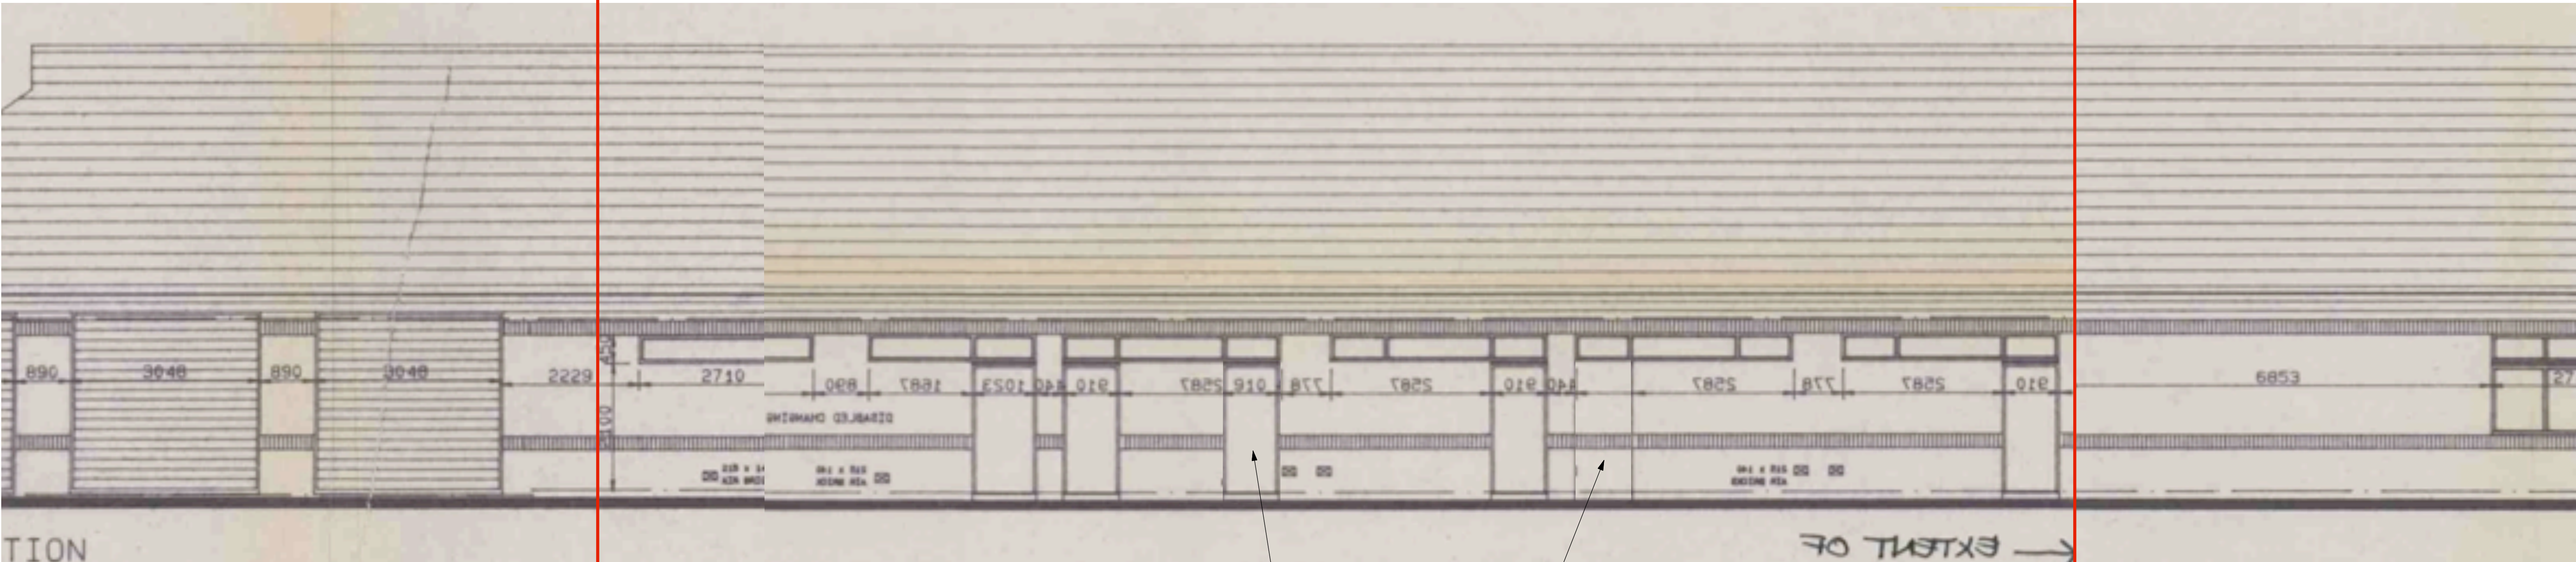
New door opening to be carefully cut into existing wall and facing
work made good. Window to remain intact through works. Door
leaf to be re-used from existing door which will be closed up in
these works.

This door opening closed up in facing brickwork and cavity block wall
Door set o be carefully removed and set aside for re-use
