Understanding the Forces and Energy in the Electrification System During a De-wirement

Summary report

Published: December 2016

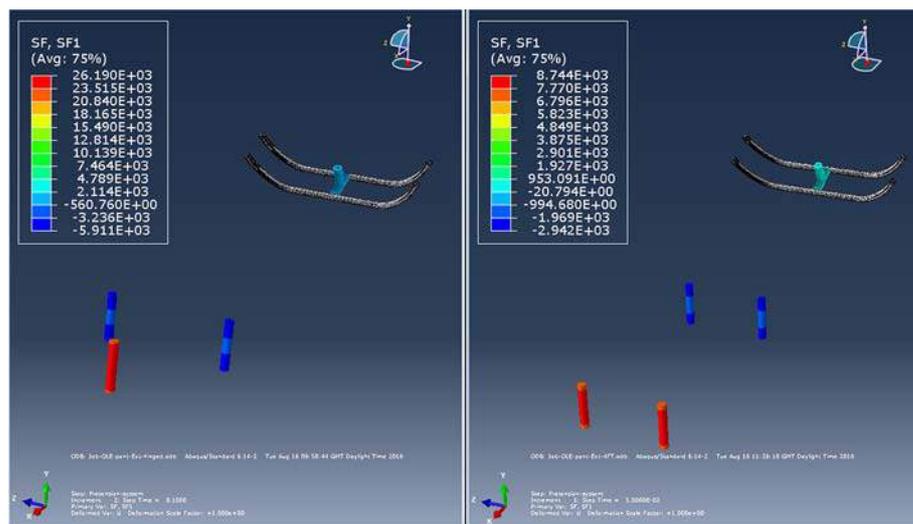
Figure 31 - Axial force distribution at the foot insulators for 3-foot (left) and 4-foot (right) of the pantograph.
