Barrington **Parish Council**

Scope of Works

Design and Feasibility Options Studies for
Community Facilities

BARRINGTON VILLAGE HALL & SPORTS PAVILION
INITIAL SURVEY REPORT

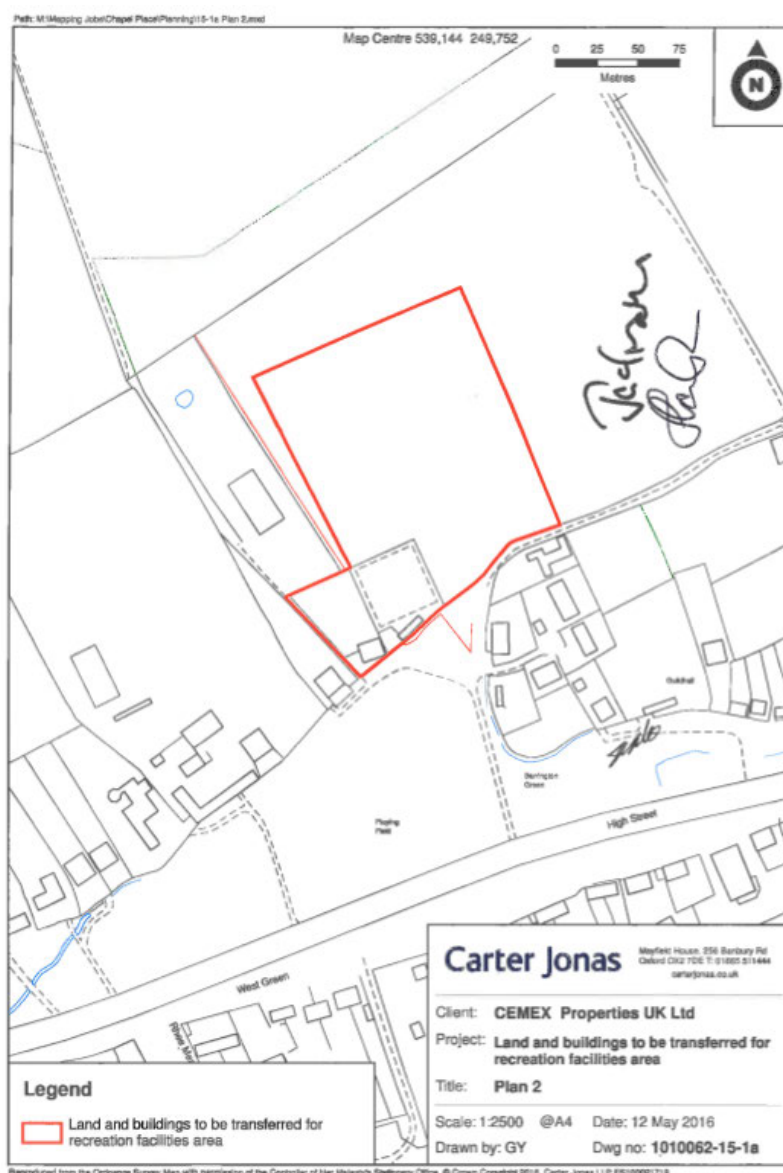
2.2.1 Sports Pavilion and Facilities Location Plan

The land occupied by the current Sports Pavilion and additional land behind the pavilion has been transferred into the ownership of the Parish Council (see Location Plan). This area includes the bowls club building and bowling green, and additional land for the creation of:
