# Pre-Occupancy Fire Risk Assessment

Date 13<sup>th</sup> September 2022

## Marjon Studio School

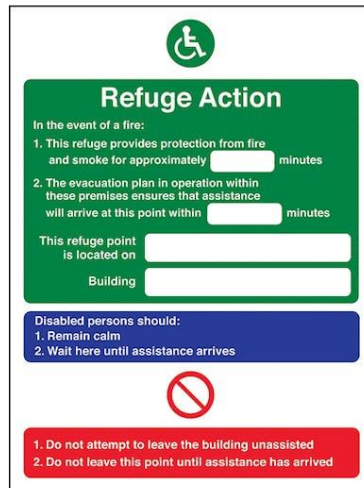
**Issue 4.** Sign as shown below should be mounted at both disabled refuges. It is vitally important that users understand what they need to do in the event of a fire emergency

The sign is a vertical rectangular template for a disabled refuge. At the top is a green circle with a white wheelchair icon. Below this is a green rectangular box with the title 'Refuge Action' in white. Inside the green box, the text reads: 'In the event of a fire:', followed by two numbered instructions: '1. This refuge provides protection from fire and smoke for approximately [ ] minutes' and '2. The evacuation plan in operation within these premises ensures that assistance will arrive at this point within [ ] minutes'. Below the green box is a white rectangular box with the text 'This refuge point is located on' followed by a line for 'Building'. Below this is a blue rectangular box with the text 'Disabled persons should:' followed by two numbered instructions: '1. Remain calm' and '2. Wait here until assistance arrives'. Below the blue box is a red circle with a white diagonal line through it. At the bottom is a red rectangular box with two numbered instructions: '1. Do not attempt to leave the building unassisted' and '2. Do not leave this point until assistance has arrived'.
