## C43 William Devonshire Monument

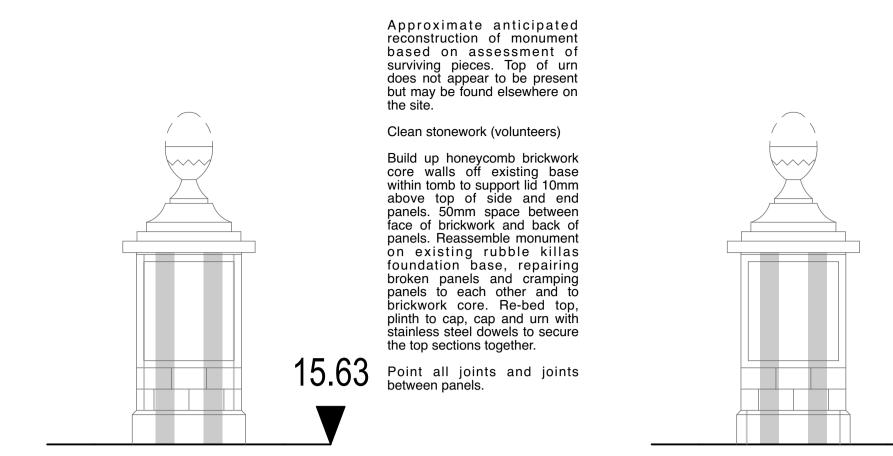
NORTH ELEVATION

Approximate anticipated reconstruction of monument based on assessment of surviving pieces. Top of urn does not appear to be present but may be found elsewhere on the site.

Clean stonework (volunteers)

Build up honeycomb brickwork core walls off existing base within tomb to support lid 10mm above top of side and end panels. 50mm space between face of brickwork and back of panels. Reassemble monument on existing rubble killas foundation base, repairing broken panels and cramping panels to each other and to brickwork core. Re-bed top, plinth to cap, cap and urn with stainless steel dowels to secure the top sections together.

15.63 Point all joints and joints between panels.

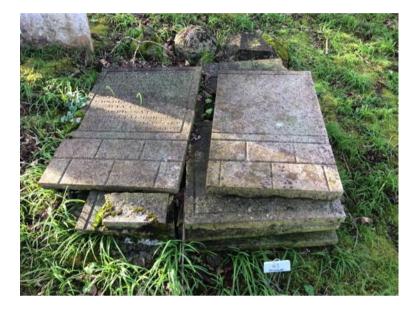
Panels of Monument 43 stacked on site in January 2020

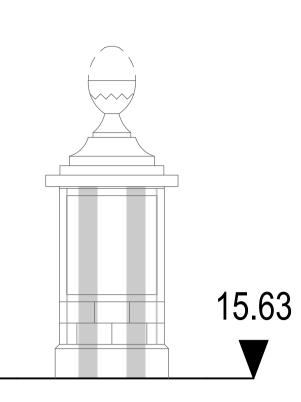
SOUTH ELEVATION

Approximate anticipated reconstruction of monument based on assessment of surviving pieces. Top of urn does not appear to be present but may be found elsewhere on the site.

Clean stonework (volunteers)

Build up honeycomb brickwork core walls off existing base within tomb to support lid 10mm above top of side and end panels. 50mm space between face of brickwork and back of panels. Reassemble monument on existing rubble killas foundation base, repairing broken panels and cramping panels to each other and to brickwork core. Re-bed top, plinth to cap, cap and urn with stainless steel dowels to secure the top sections together.

Point all joints and joints between panels.

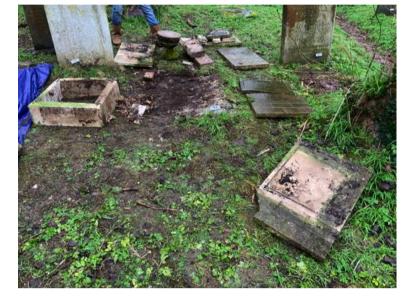
Panels of Monument 43 laid out on site in January 2021
