King Edward Mine Camborne, Cornwall Conservation Management Plan

Conservation Management Plan

Client	Cornwall Council Culture Team
Report Number	2012R086
Date	February 2013
Status	Submission draft for adoption
Report author	Colin Buck Dip. Arch. MifA

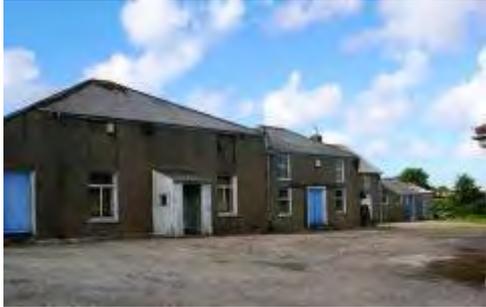
Construction materials: (walls, roof, floor, ceiling, windows, doors):	<i>External:</i> Corrugated asbestos roof sheeting replaced original slate in 1950s. Cementitious pebble dashed render over original granite quoins and stone masonry with earth rab/lime mortar. Only one original window appears to remain (Site 4), the remainder of later different 20 th century styles. Many original chimneys removed (including Counthouse, Smithy forge etc).
	<i>Internal:</i> Buildings have been unoccupied leading to damp, floors and walls. Counthouse Office has dry lining of plasterboard and painted woodchip wallpaper on some walls, covering damp lime plaster. Cement plastering in places. Many original plaster ceilings replaced. Floor joists in office collapsing. Smithy building has had major alterations (possibly 1960s). Miners Dry ceiling fully built over, walls faced with granolithic plaster (to create a wet room). Some original doors/floorboards and some dado rails.

Build date:	Mess Room (Site 1) c1870s. Counthouse Office (Site 2) c1864/5. Smithy (Site 3) 1865-1877. Miners' Dry (Site 4) 1865-1877. Carpenters' Shop (Site 5) 1865-1877. Store (Site 6) 1960s. Outhouse/chimney/store (Site 6) 1865-1877.
Modification date:	Complex re-roofed (some rafters replaced with steel) in mid

1950s. Windows replaced during 20 th century, possibly twice. Internal asbestos sheeting added to some walls and some re-plastering at a similar date. Office/Mess room relatively unaltered, but the Smithy buildings have been drastically altered at various times (possibly 1960s onwards). Miners' Dry walls re-plastered and ceiling rebuilt to infill balcony (1960s onwards). Carpenters' Shop internally unrecognisable when transformed into toilets (1960s).
Original function:	South Condurrow Mine: Counthouse, Smithy, Miners' Dry and Carpenters' Shop.
Current function:	Mess Room (Site 1): Unused. Count House Office (Site 2): Unused. Smithy (Site 3): Storage of some Trevithick Society items. Miners' Dry (Site 4): Wet room (unused). Carpenters' Shop (Site 5): Male toilets. Store (Site 6): Used.
Proposed function:	Mess Room (Site 1): Workspace. Count House Office (Site 2): Rented office space. Smithy (Site 3): Workspace. Miners' Dry (Site 4): Workspace. Carpenters' Shop (Site 5): Men's and Women's toilets with shower facilities. Store (Site 6): Unchanged as store.

Summary description:	Count House Complex is Listed Grade II* and now on EH Buildings at Risk Register (2012). The Count House was built first, closely followed by the remainder of the buildings in a single connected complex to serve the needs of South Condurrow Mine (1865-1896). From 1903 the buildings were used to serve the training needs and administration of Camborne School of Mines. Externally, it appears the original slate roof of all buildings in this complex was replaced in the 1950/60s, as well as re-rendering the external walls with cementitious pebble dash. It is likely many original windows were also replaced at this time. Internally, there were major alterations to the Smithy and Miners' Dry during the following decade – presumably to suit the training needs of the mining students. In the past, the Count House Office has suffered from damp, the walls being dry lined (twice), re-plastered and floor joists affected by damp rot. However, the Counthouse building is relatively unaltered compared to others in this complex.

<p>Completeness and condition:</p>	<p>This is a rare example of a 19th century Cornish mine complex housing the Count House Office, the Smithy, the Miners' Dry and Carpenters' Shop. Internally, the Office (Site 2) and Mess room (Site 1) are the most unaltered buildings, retaining degrees of original features.</p>
<p>Significance/conservation strategy:</p>	<p>The historic group value of this complex of buildings is highly significant (these are often separate buildings). However, individually, given the extent of the 1950s and later repairs and modifications externally and internally affecting site character, each building is therefore less significant. In any future building conservation/adaptive reuse project, replacement of the asbestos roof with slate, removal of the exterior pebble dash and repointing with an appropriate mortar, and repairing floor joists where appropriate would go a long way to restoring the original character of this complex. The issue of window replacement to an agreed design (reflecting a significant period of the site) will need to be debated with conservation professionals, but a conservation philosophy would relate to minimising impacts and reflecting/mimicking original details where they have been consistently applied, for example drain gutters and downpipe details for the Counthouse (c1860s). For new Counthouse replacement windows again I feel that any decision on window style should reflect basic conservation philosophy (a compromise between the spec that was included in the Listing detail and the original form). The agreed window style should be consistently used throughout the complex. However, it is likely that internal secondary glazing may be required for change of use and to meet current building regulations.</p>

<p>EH at Risk Register 2012:</p>	<p>Count House (Site 2), Blacksmiths Shop (Site 3), and Miners' Dry (Site 4).</p>
<p>Additional requirements for future projects/any other factors affecting reuse/repair etc:</p>	<p>Given the masking of the external walls by a later cementitious pebble dash, a structural assessment of the building after removal may be necessary, to assess if there are structural remediation works that may impact the building. Internal photographic survey should be undertaken before proposed works. Re-use of original internal features (doors, architraves, (unblock fireplace) etc), is recommended. It may be appropriate to rebuild the chimneys that have been removed if funding and consent is given. The use of lime wash as an exterior finish should be considered and maintenance implications discussed.</p>

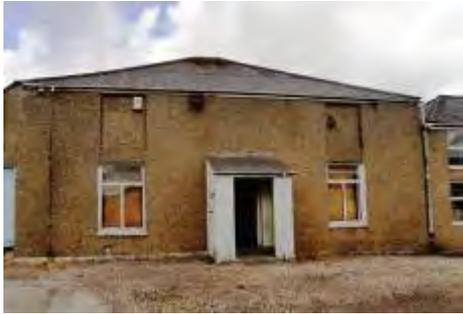
Construction materials: (walls, roof, floor, ceiling, windows, doors):	<p><i>External:</i> Corrugated asbestos sheeting replaced slate in 1950s. Cementitious pebble dashed render over original granite quoins and stone masonry with lime mortar. Windows are mostly 1970s replacements and other styles. Original chimneys removed. First floor windows blocked up.</p> <p><i>Internal:</i> This building has been unoccupied leading to damp floors and walls. Office has dry lining of plasterboard and painted woodchip wallpaper on some walls, covering damp lime plaster. Cement plastering in places. Many original plaster ceilings replaced with fibreboard. Floor joists in front office collapsing (dry rot). At rear some modifications to partitions, with original staircase to first floor (storage space) removed. Some original doors/floorboards/architrave and fireplace (removed/blocked up on east side).</p>

Build date:	Counthouse Office constructed c1864/5 as South Condurrow Mine Count House (shown in elevation on 1865 mine plan). The mine retained this complex until 1903 when it ceased operating. The lease was then sold by the Pendarves Estate to Camborne School of Mines.
Modification date:	In approximately the 1930s the interior of the building was dry lined with asbestos/cement sheets, no doubt the dado rails removed at the time. The building was re-roofed (some rafters replaced with steel) in the 1950s with corrugated asbestos sheets. Exterior pebble dash in cement render probably added at a similar time. Possibly at least three

<p>periods of window replacement (from the 1890s onwards). The earlier internal dry lining was removed in the 1990s and replaced with plasterboard and some new skirtings. The floor was re-laid with lino. Ceilings removed at some date and replaced with fibre board (probably 1960-70s). Staircase to first floor removed at an early date and modifications to timber partitions at rear of building, both at unknown dates.</p>
Original function:	<p>Count House Office for South Condurrow Mine (1864-1903), then Camborne School of Mines admin office up to 1974.</p>
Current function:	<p>Unused.</p>
Proposed function:	<p>To be converted by adaptive reuse for rented office space.</p>
Significant features/contents:	<p>South Condurrow Mine Count House which retains its original plan and design. Some original lime wall plaster, original floorboards, doors and architraves. Original fireplace in south west office. South east fireplace not visible but opening probably blocked up. Some original timber partitions at rear of building are still extant (painted white).</p>

Completeness and condition:	<p>This is a rare example of a relatively unaltered (in plan) 19th century Count House Office, retaining a few original fittings and features.</p>
Significance/conservation strategy:	<p>The historic group value of this building within this complex is highly significant. However, individually, given the extent of the 1960s repairs/modifications externally and internally affecting site character, each building is less significant. Replacement of the asbestos roof with slate, removal of the exterior pebble dash and repointing with an appropriate mortar, and repairing floor joists where appropriate would go a long way to restoring the original character of this building. The issue of window replacement will need to be debated with conservation professionals (refer to Record Sheet R1).</p>
EH at Risk Register 2012:	<p>Count House (Site 2)</p>

Additional requirements for proposed work/any other factors affecting reuse/repair etc:	Given the masking of the external walls by a later cementitious pebble dash, a structural assessment of the building after removal may be necessary, to assess if there are structural remediation works that may impact the building. Internal photographic survey before proposed works. Re-use of original internal features (doors, architraves, (unblock fireplace) etc), is recommended. It may be appropriate to rebuild the chimneys that have been removed if funding and consent is given. The use of lime wash as an exterior finish should be considered and maintenance implications discussed.
--	--

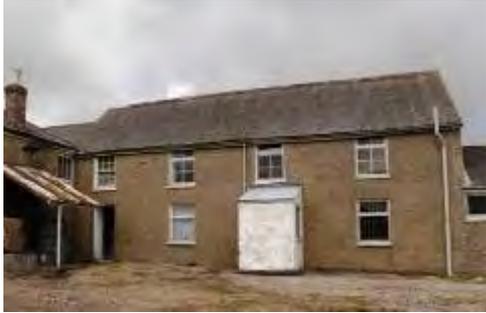
Construction materials: (walls, roof, floor, ceiling, windows, doors):	<p><i>External:</i> Corrugated asbestos sheeting replaced slate in 1950/60s. Cementitious pebble dashed render over original granite quoins and stone masonry with lime mortar. Only one original window appears to remain, the remaining windows of different styles.</p> <p><i>Internal:</i> An 1899 photograph (Fig 16) shows the internal layout of the Miners' Dry at that time. The walls were lime washed, with a part open ceiling and ground floor boiler. The building now has a full ceiling and first floor with open roof joists. At ground floor the building has been re-plastered with a granolithic finish to provide a 'wet room' with showers, possibly in the 1960s/70s.</p>
Build date:	Original Miners' Dry (Site 4) c1865-1877.

Modification date:	The 1899 Miners' Dry archive photograph shows a central boiler, baths and basins with hooks and wooden slatted seats. Light was provided on the south side by windows on two floors, through the open ceiling with stairway access to a balcony with access to lockers etc. The boiler was removed at an unknown date and the ceiling extended over the entire floor plan to create two rooms above the former boiler/wash room, accessed via a new staircase at the west end of the building. The previously open ceiling joists were boxed in and windows replaced with the present form. At ground floor, it was re-plastered with a granolithic finish and showers installed. All of these works date to the late 1960s/early 1970s. A central doorway opening was blocked.
Original function:	South Condurrow Mine/King Edward Mine Miners' Dry.
Current function:	Unused former CSM 'Wet room' with showers.
Proposed function:	Rented workspace/arts/crafts etc.

<p>the existing roof with slate, removal of the exterior pebble dash and repointing with lime mortar would go a long way to restoring the original external character of this complex. The issue of window replacement will need to be debated with conservation professionals (refer to Record Sheet R1). Internally, removal of the later granolithic plastered walls is not necessarily recommended – adaptive re-use of its existing form may be possible (after the washing facilities are removed), and have less impact.</p>
<p>EH at Risk Register 2012:</p>	<p>Miners’ Dry (Site 4)</p>
<p>Additional requirements for proposed work/any other factors affecting reuse/repair etc:</p>	<p>Given the masking of the external walls by a later cementitious pebble dash, a structural assessment of the building after removal may be necessary, to assess if there are structural remediation works that may impact the building (including removal of wall pipes etc). The insertion of a first floor in the Miners’ Dry has substantially reduced natural light levels in that space, and any decision on insertion of one or more windows in the north side of the Miners’ Dry to increase natural light levels should reflect the conservation philosophy and be informed by a natural light assessment. Internal photographic survey should be undertaken before proposed works. The use of lime wash as an exterior finish should be considered and maintenance implications discussed. Internal photographic survey before proposed works should be undertaken. An impact assessment of any proposed ground floor works should be undertaken in order to preserve original pipe work (above/below ground) relating to its original function.</p>

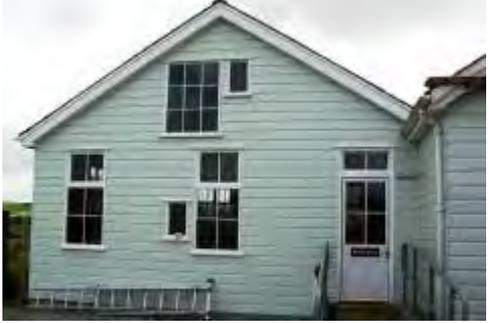
Completeness and condition:	Although it is only three years old, many people would be hard put to recognise this fact, it exactly mirrors the character and design of adjacent timber frame buildings, a conservation philosophy followed by KEM.
Significance/conservation strategy:	The northern extension used as a store dates from 1902, and is highly significant because of historic group value with the Mill complex. The remainder of the building was rebuilt in 2010, but only the original foundations are significant. The rebuild has not compromised or impacted adjacent original buildings, rather complimented them.
EH at Risk Register 2012:	Not applicable
Long term requirements, any other factors affecting reuse/repair	Presumably putting the steam engine back to operational use will not impact upon existing planning/building control regulations. The steam compressor is partly rebuilt.
