**Subject:** Corby Cube Noise Investigation  
**Client:** North Northamptonshire Council  
**Address:** Corby Cube, George Street, Corby, Northamptonshire, NN17 1QG  
**Date:** 28/01/2025  
**Our ref:** 41900 L1

## 1 INTRODUCTION AND BACKGROUND

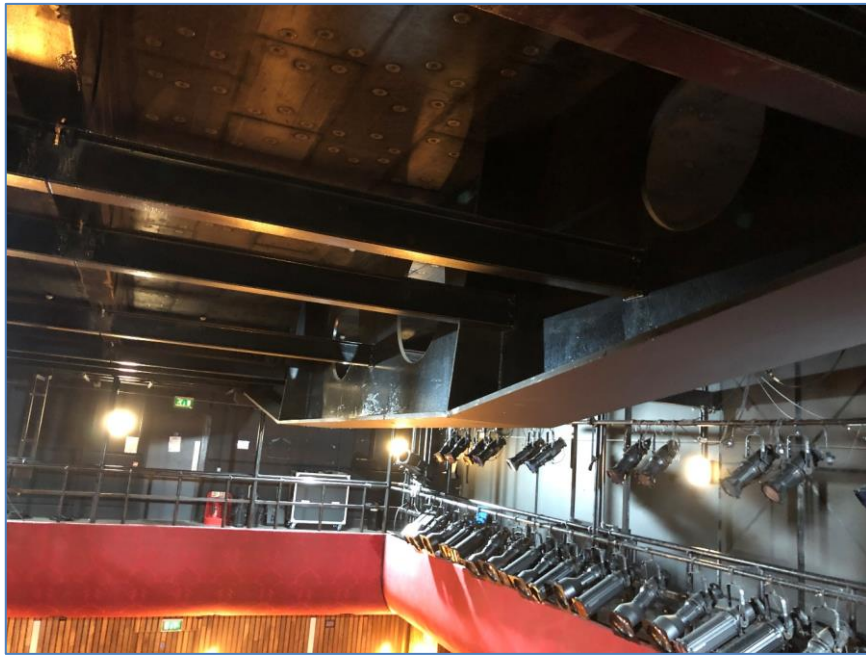
- 3.4 In the absence of detail drawings, it is assumed based on site observations that the separating floor between Theatre and Council Chamber comprises >200 mm concrete slab with undetermined soffit treatment below and raised access floor above.

**Figure D1 – L01 Theatre soffit supported by steels**

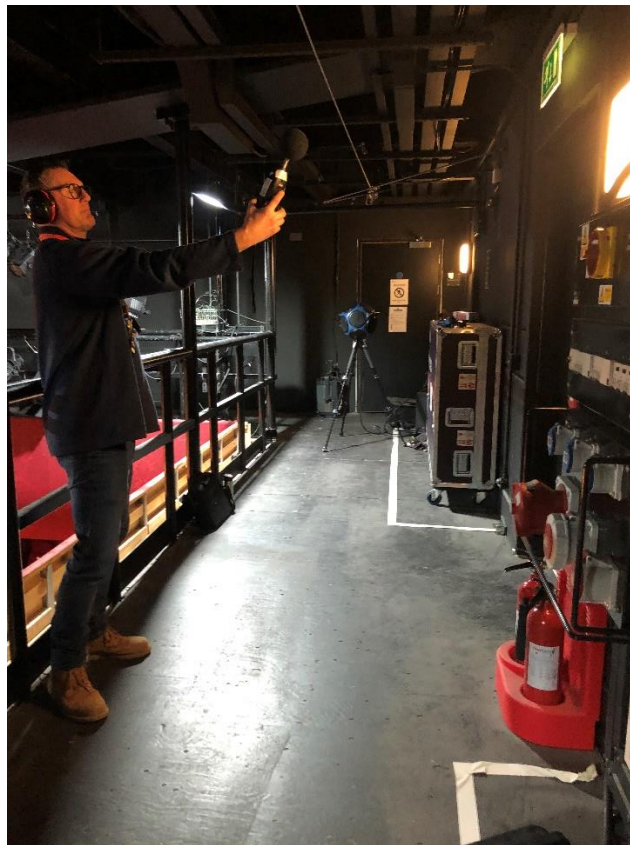
**Figure D2 –Sound Insulation Testing on L01 Theatre technical gallery**

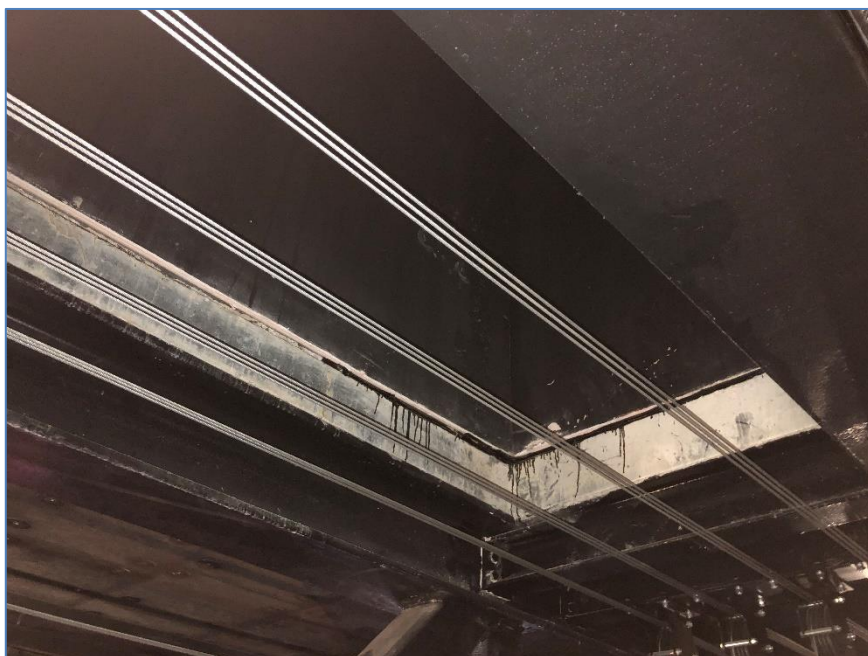
- 3.27 It is expected that noise levels in the smoke extract void above the theatre stage could be > 30 dB higher than the riser. This is expected to be the principal transmission route between Theatre and Council Chamber based on listening observations and the assumed lightweight shaftwall construction.

**Figure D4 –Smoke extract void opening as viewed from L01 Theatre gantries above the stage**

- 4.10 This could be achieved through installation of acoustic rated smoke extract louvres to cap the underside of the smoke extract void. These louvres would typically remain closed to reduce noise levels in the smoke extract void, but would be automated to open in the event of a fire or smoke in the Theatre.
