At
Southfields Court
Off Inham Road
Chilwell

ASBESTOS SURVEY REPORT 2949

Name and Address of Client 650	Property Name ,Address & Ref No 4981
Broxtowe Borough Council Chief Executive Department Town Hall, Foster Avenue, Beeston Nottingham NG9 1AB	Southfields Court Off Inham Road Chilwell Notts
Type of Survey	Related Documents
Type 2 full survey	BS report 8236
Nature of Clients Request	Air report -
Carry Out Type 2 Surveys (communal To Residences)	Plan report 32482v1, 32483v1.
Name of surveyor(s)	Photo file 17533-17537, 20952-20956
SD Smith/I Haney	Register 4089
Survey Limitations	Priority One -
Communal areas	Misc documents
	Survey Date 14.6.2005 Report Date 30.6.2005

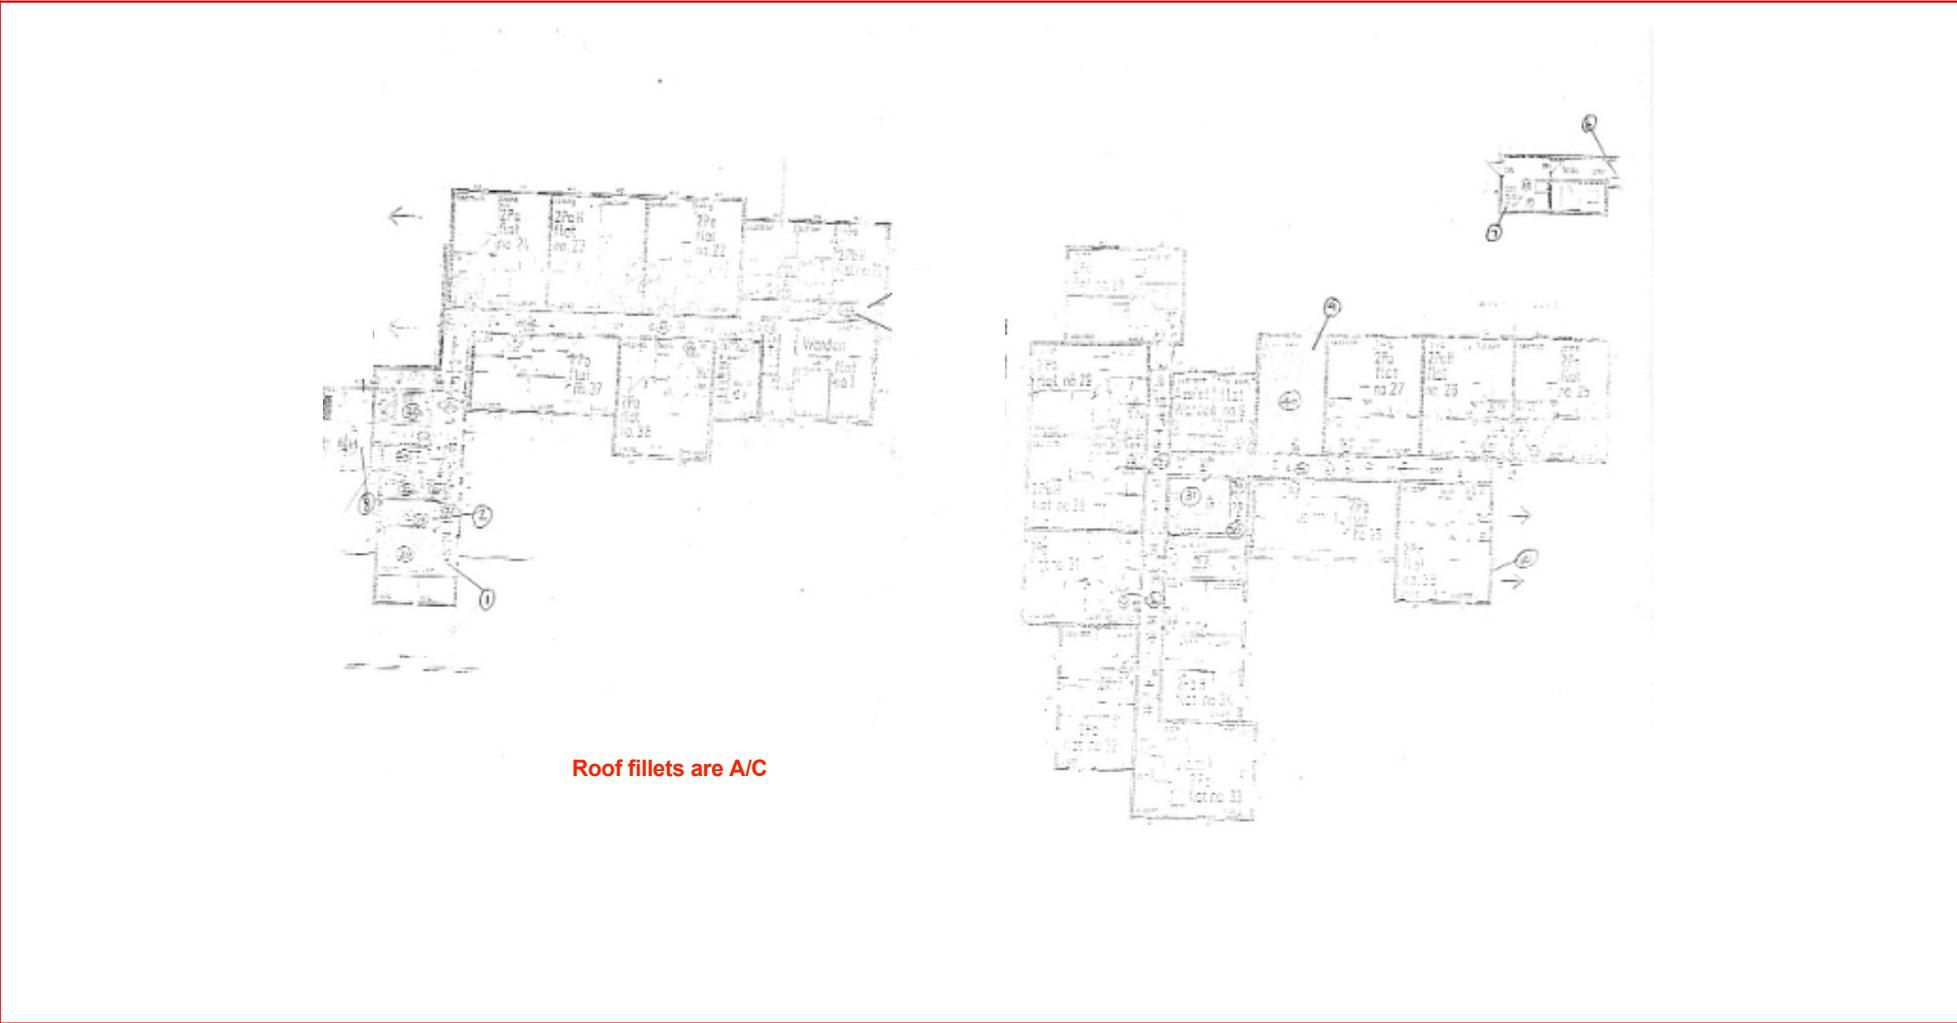
Site Plans Showing Acm's

This is a traditional brick building used as a residential home. It has plastic rain goods and timber soffits and fascias. The tiled pitched roof has *asbestos cement fillets to edges*. Flue pipes are plastic. The bin stores are of similar construction. Bulk heads inside are supalux (non asbestos).

Roof fillets are A/C

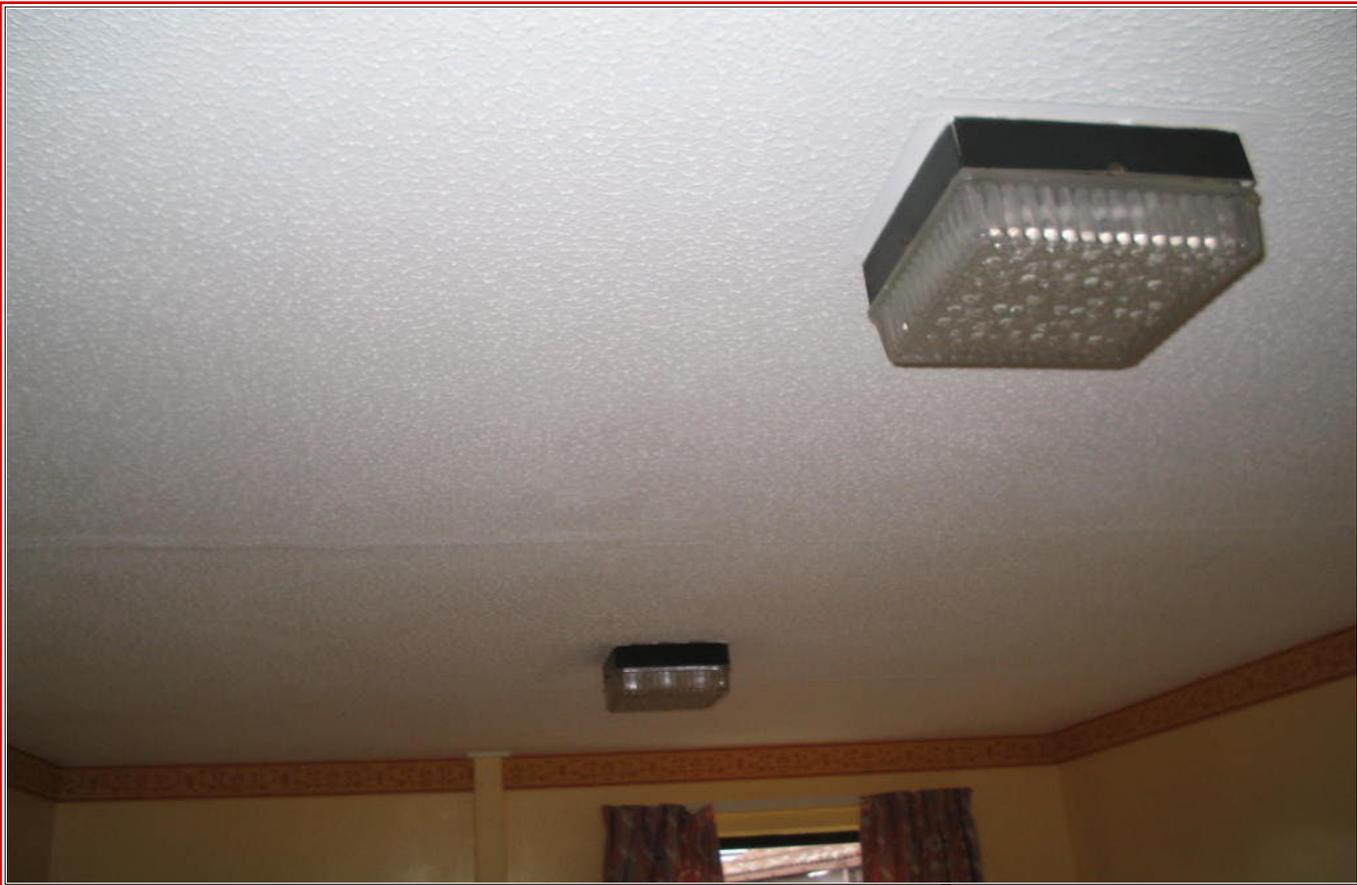
Textured Coating To Ceiling

Test No.	1273	score
* Component	7	
Condition		
Acm Type		
Asbestos type	Non Asbestos	0
Material Risk Assessment Score		0
Accessibility		Priority:
Extent (m2)		
* 7= non asbestos (see registers)

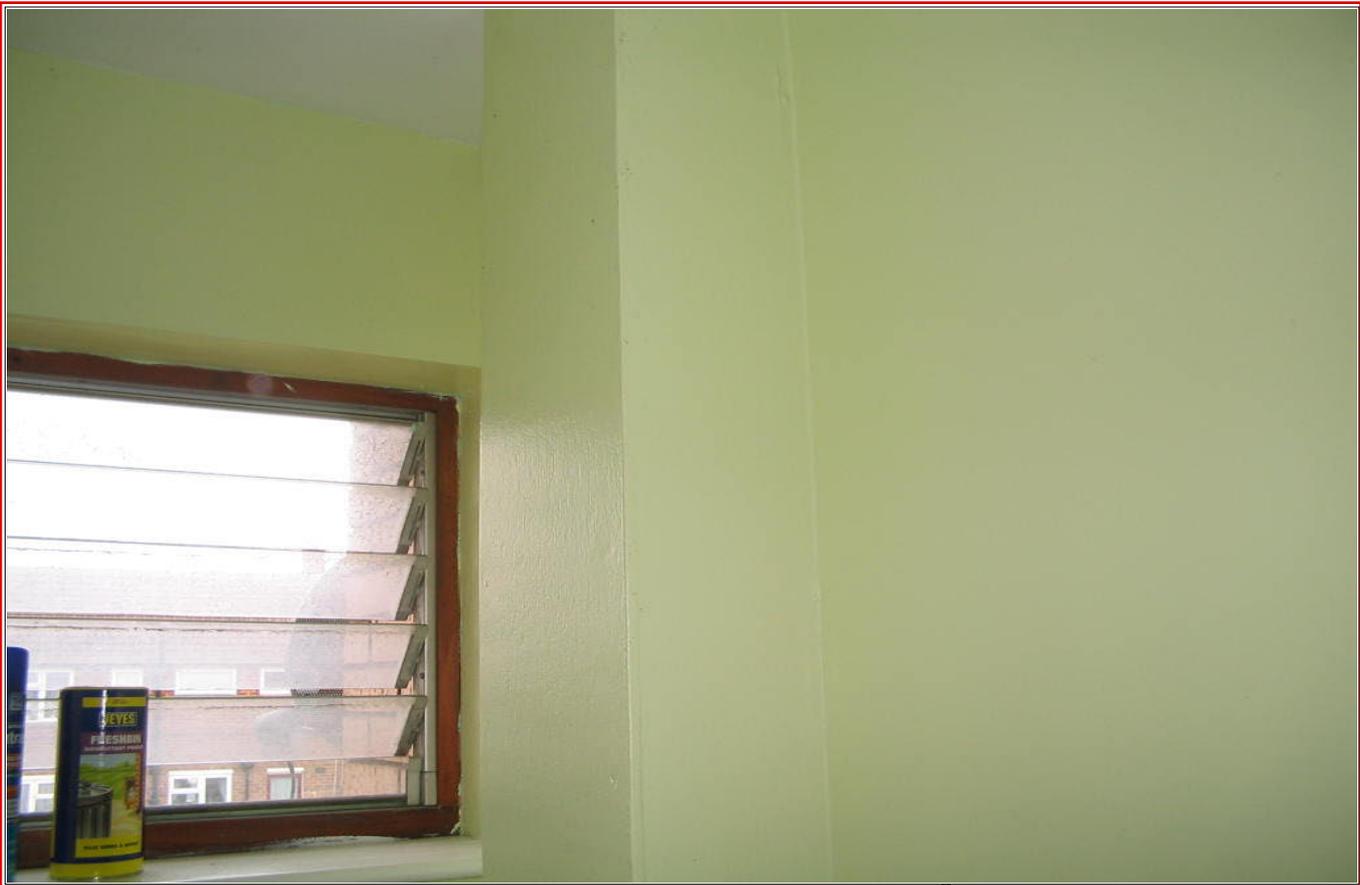
Boxing In Refuse Store

Test No.	1275	score
* Component	7	
Condition		
Acm Type		
Asbestos type	Non Asbestos	0
Material Risk Assessment Score		0
Accessibility		Priority:
Extent (m2)		
* 7= non asbestos (see registers)

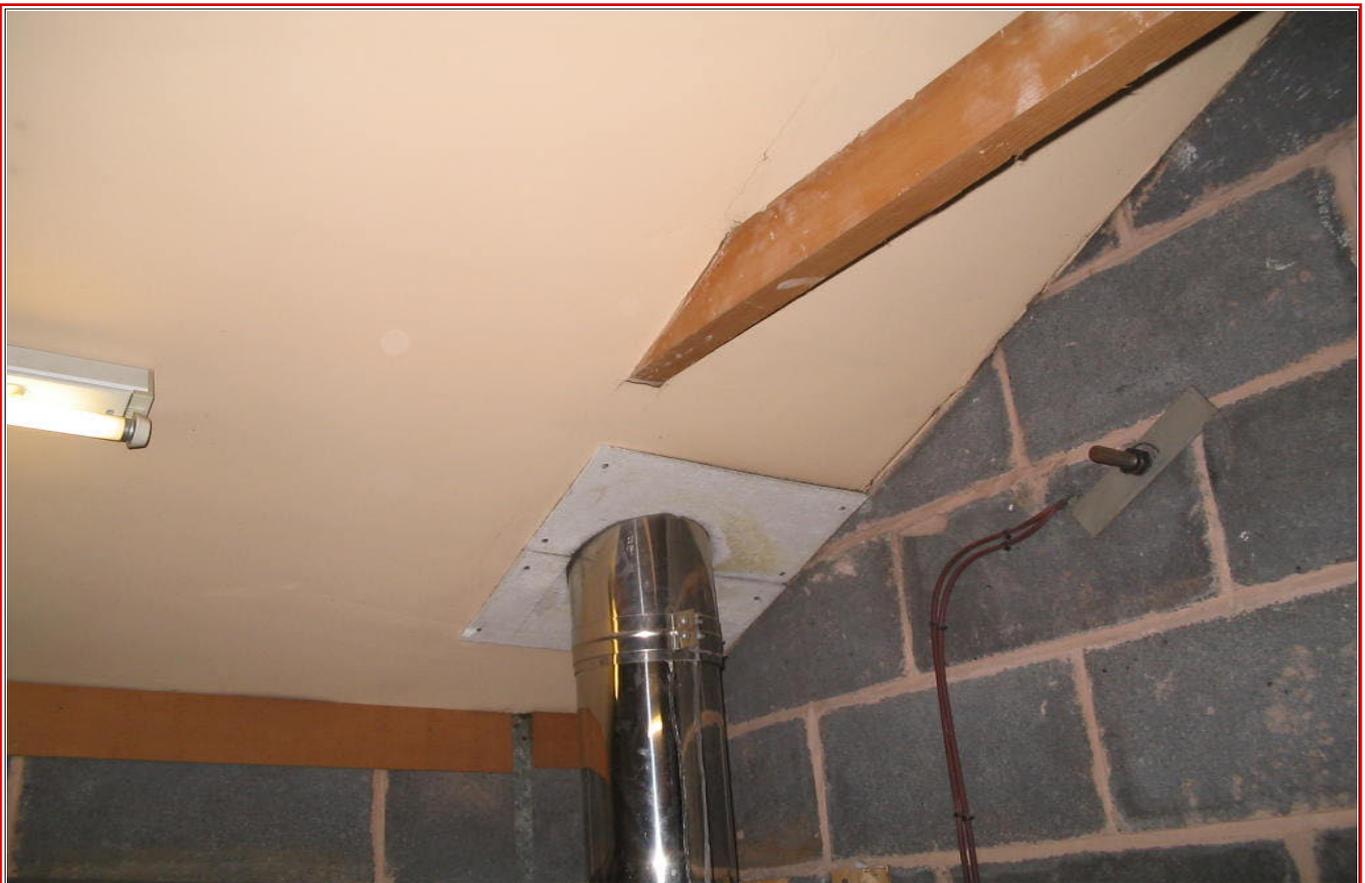
Panel Above Metal Flue In Tank Room

Test No.	1279	score
* Component	7	
Condition		
Acm Type		
Asbestos type	Non Asbestos	0
Material Risk Assessment Score		0
Accessibility		Priority:
Extent (m2)		
* 7= non asbestos (see registers)

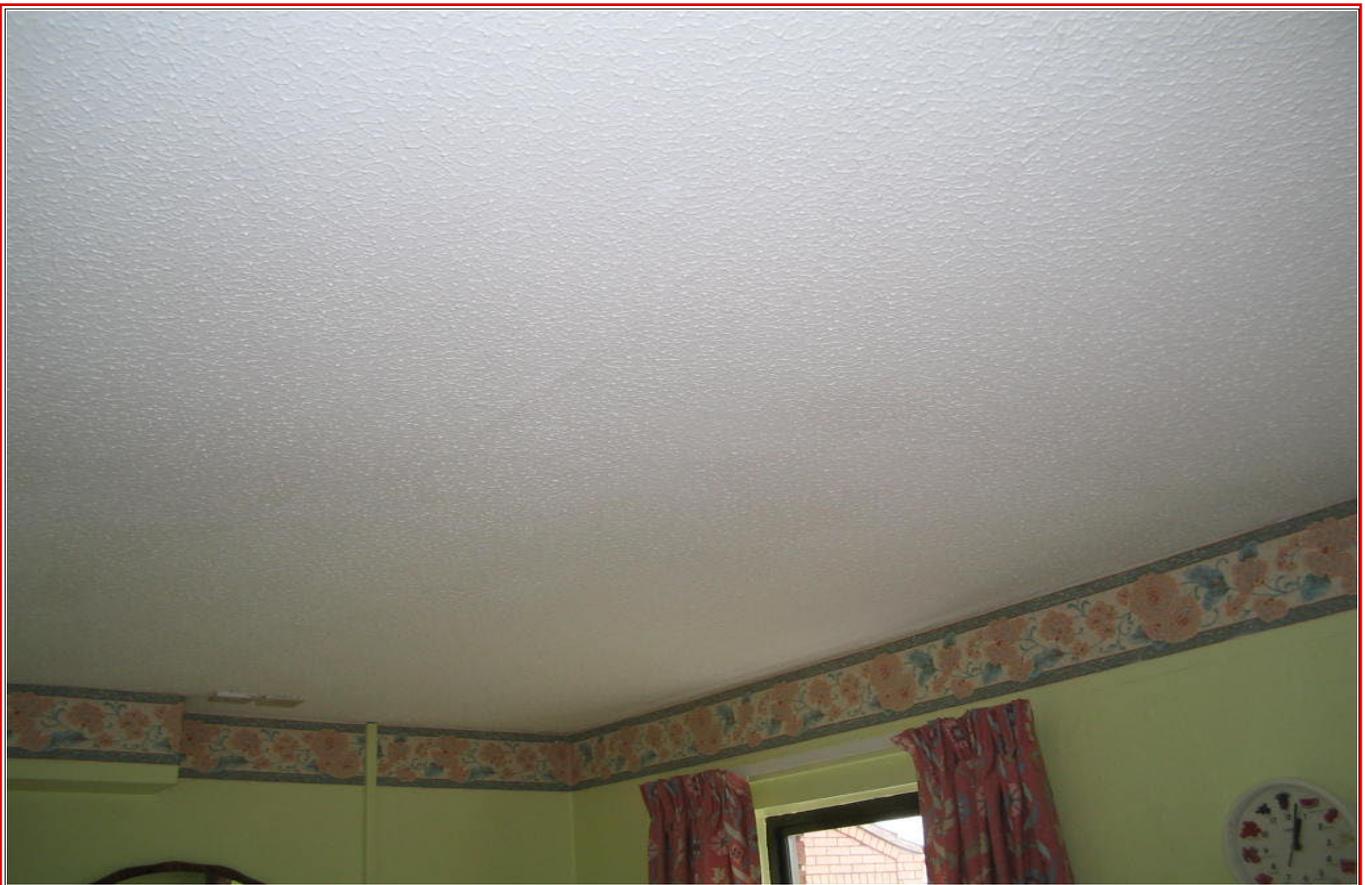
Textured Coating To Ceiling

Test No.	1281	score
* Component	7	
Condition		
Acm Type		
Asbestos type	Non Asbestos	0
Material Risk Assessment Score		0
Accessibility		Priority:
Extent (m2)		
* 7= non asbestos (see registers)

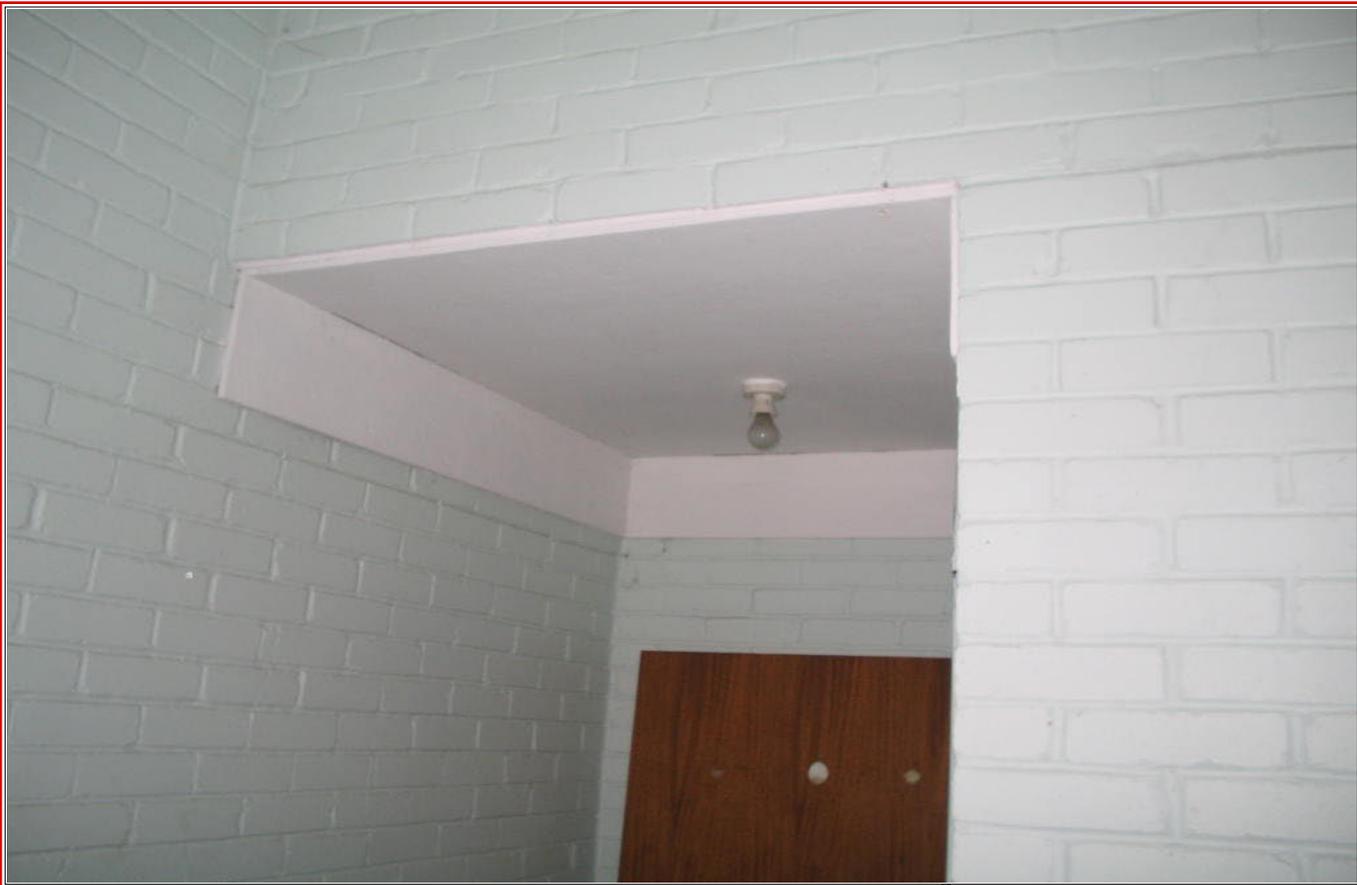
Bulkhead

Test No.	1283	score
* Component	7	
Condition		
Acm Type		
Asbestos type	Non Asbestos	0
Material Risk Assessment Score		0
Accessibility		Priority:
Extent (m2)		
* 7= non asbestos (see registers)

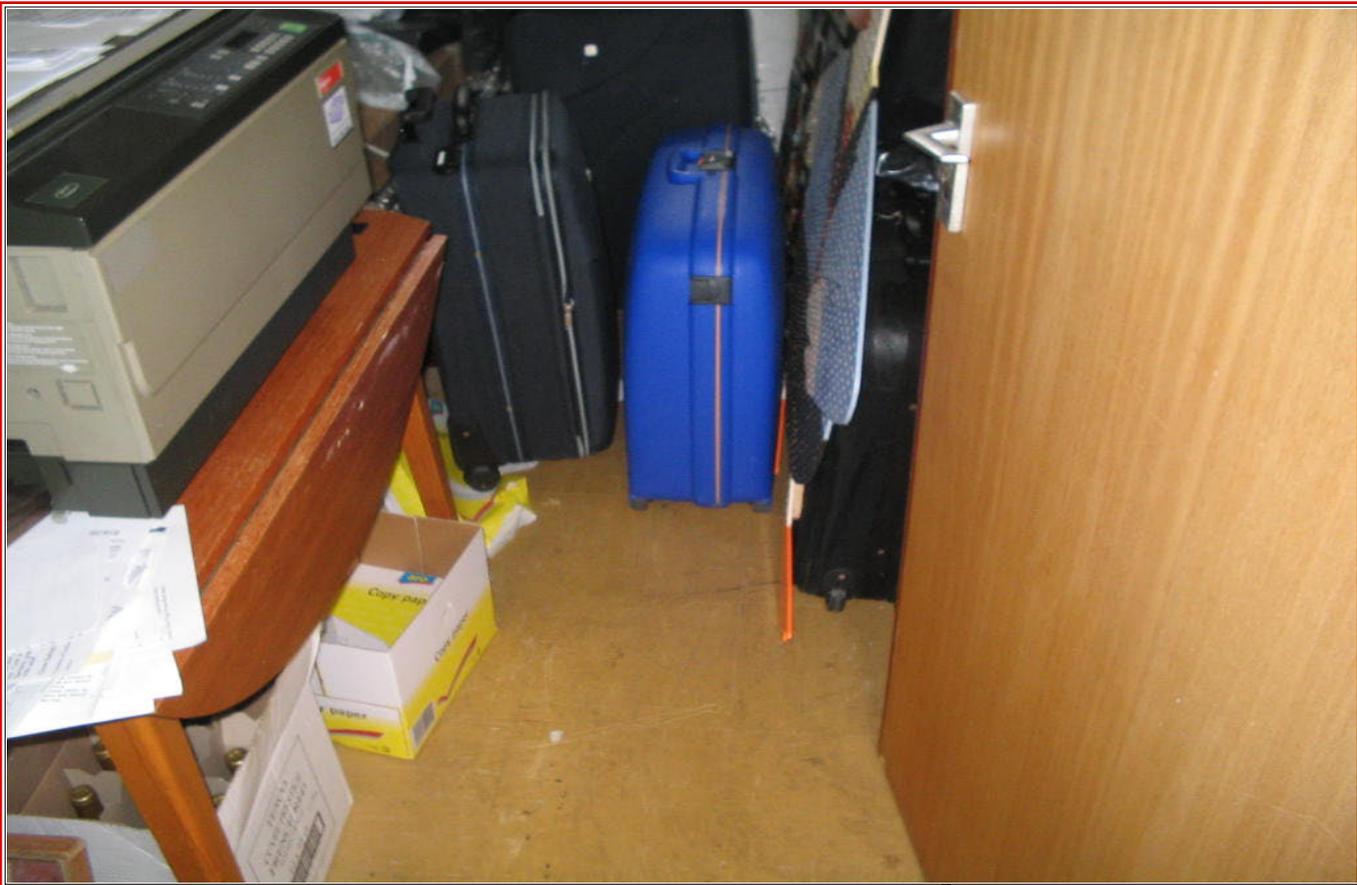
Floor Tiles To Store

Test No.	1274	score
* Component	7	
Condition		
Acm Type		
Asbestos type	Non Asbestos	0
Material Risk Assessment Score		0
Accessibility		Priority:
Extent (m2)		
* 7= non asbestos (see registers)

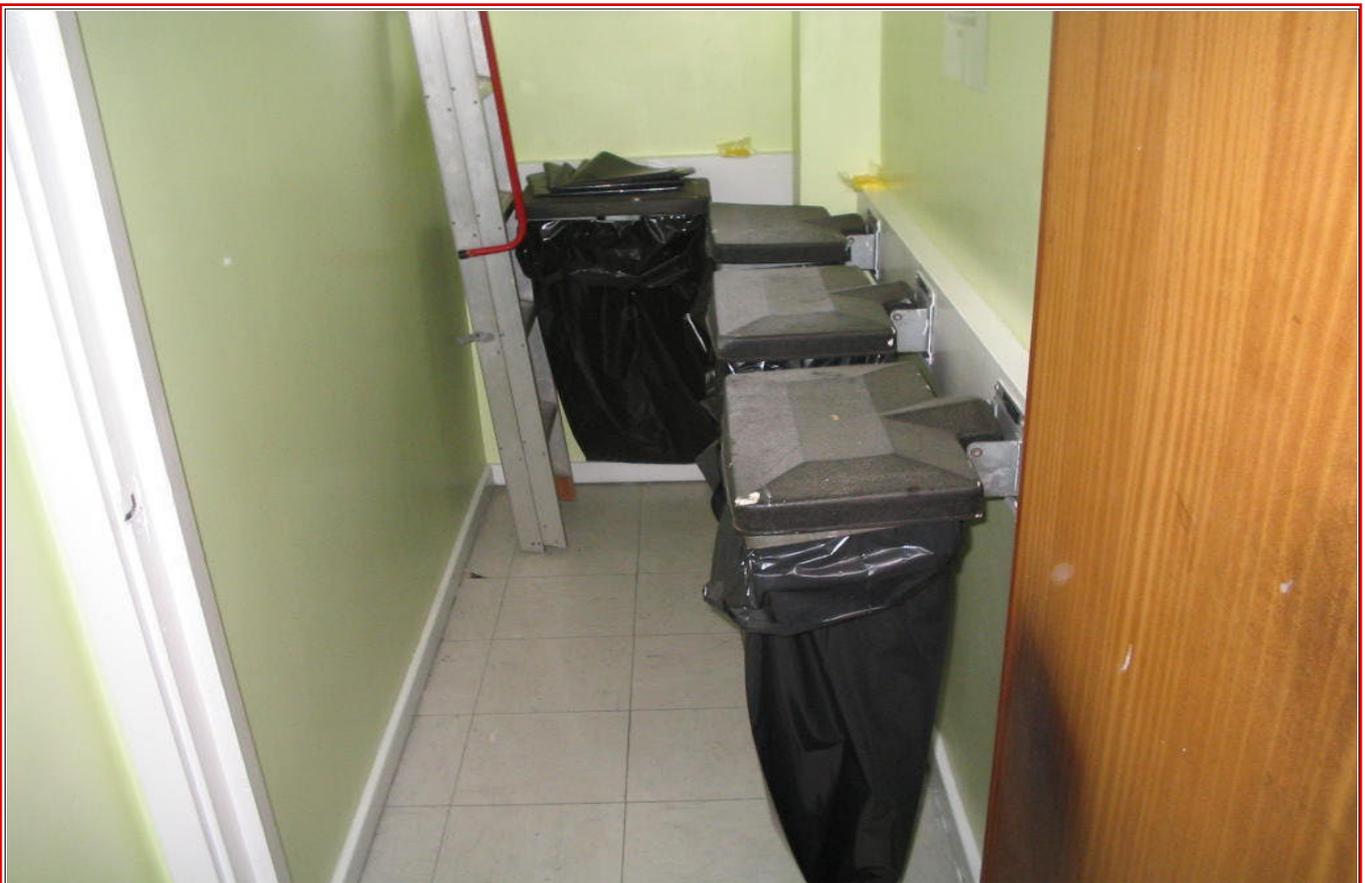
Floor Tiles To Refuse Store

Test No.	1276	score
* Component	7	
Condition		
Acm Type		
Asbestos type	Non Asbestos	0
Material Risk Assessment Score		0
Accessibility		Priority:
Extent (m2)		
* 7= non asbestos (see registers)

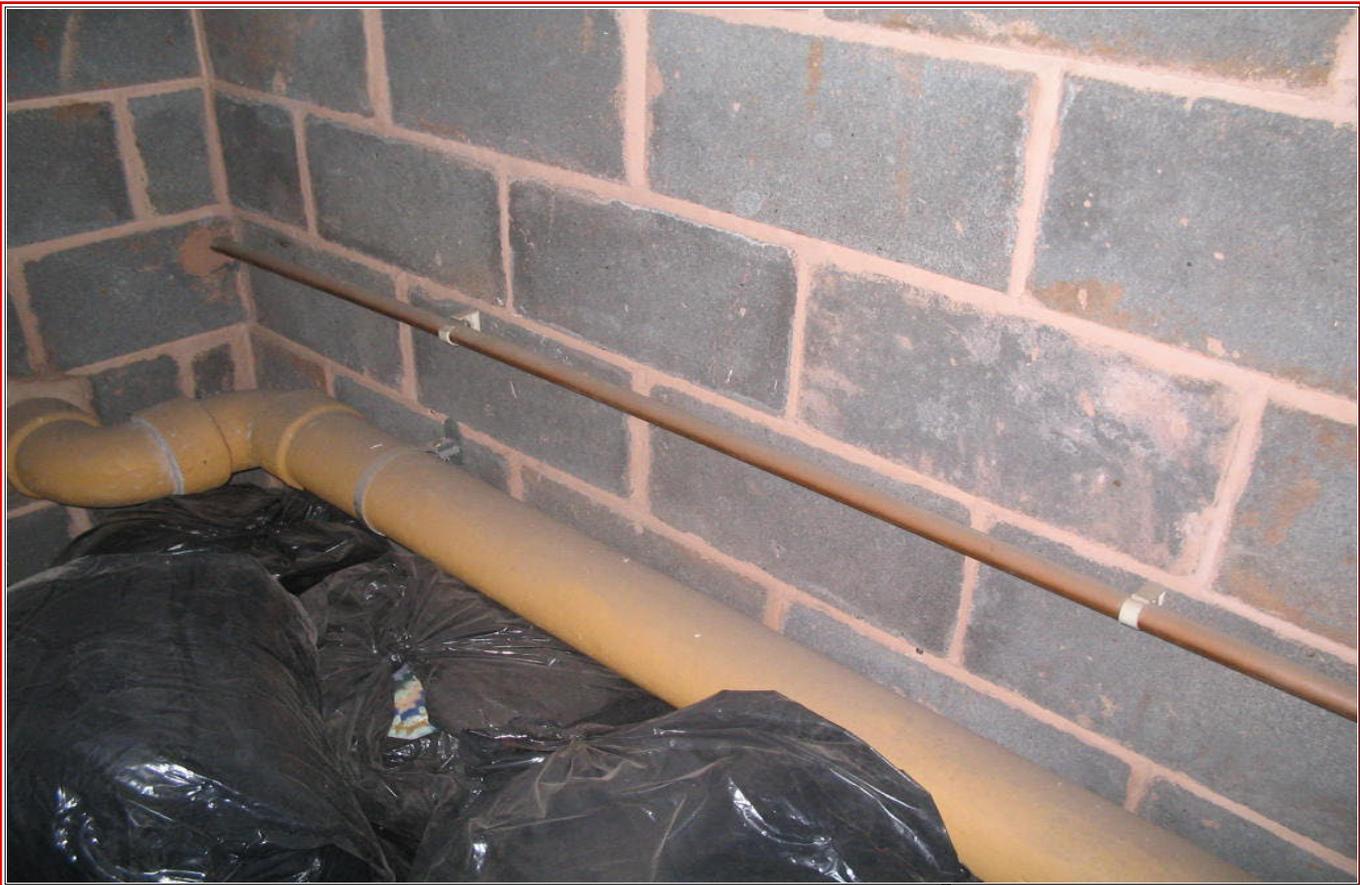
Flue Pipe In Tank Room

Test No.	1278	score
* Component	7	
Condition		
Acm Type		
Asbestos type	Non Asbestos	0
Material Risk Assessment Score		0
Accessibility		Priority:
Extent (m2)		
* 7= non asbestos (see registers)

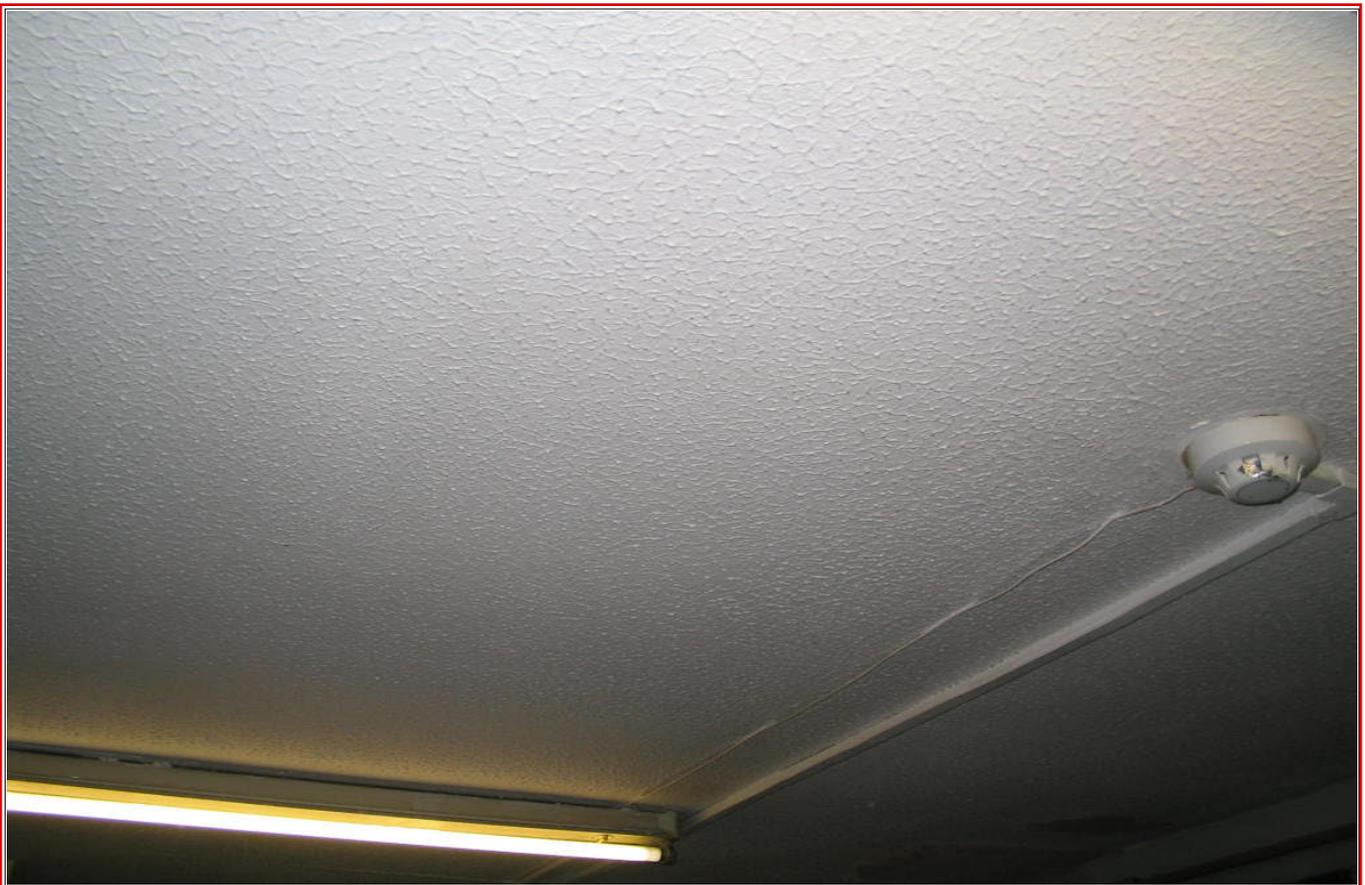
Textured Coating To Ceiling

Test No.	1280	score
* Component	7	
Condition		
Acm Type		
Asbestos type	Non Asbestos	0
Material Risk Assessment Score		0
Accessibility		Priority:
Extent (m2)		
* 7= non asbestos (see registers)

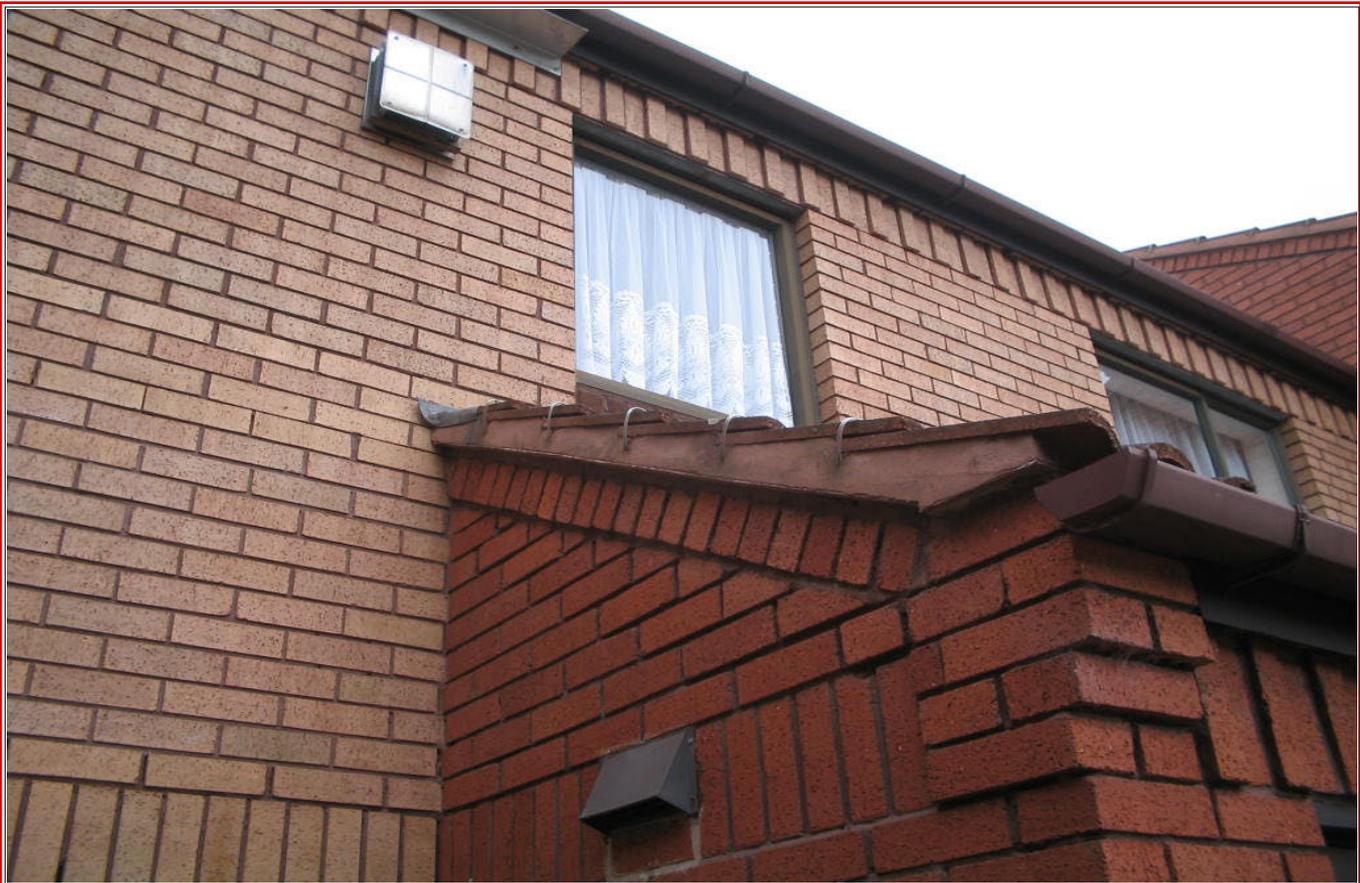
Roof Fillets

Test No.	1282	score
* Component	A/ C	1
Condition		1
Acm Type		1
Asbestos type	Chrysotile	1
Material Risk Assessment Score		4
Accessibility	1	Priority: 3
Extent (m2)	180	
* 7= non asbestos (see registers)
