SPECIFICATION DOCUMENT

**Penton Hook Lock House
147 Thames Side
Staines-upon-Thames
TW18 2JA**

Phase 2 - Refurbishment / Fit Out

23 January 2025

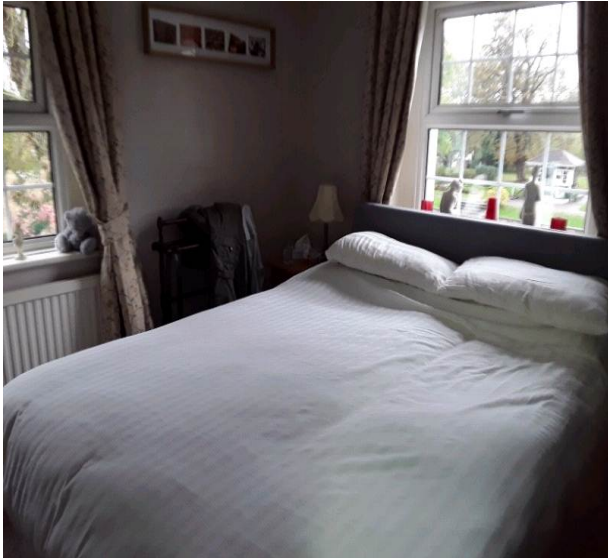
Item	Level	Building Name / Location / Room Number	Survey Type	Sample Reference	Quantity			
3	First Floor	Bedroom 1	Refurbishment	Visual Inspection	-

Material Description / Location		Material Risk			
			No suspect materials observed within surveyed area		Product Type	Extent of Damage	Surface Treatment	Asbestos Type
			Additional Information		-	-	-	-
			UPVC windows. Non asbestos timber doors.		Score - Material Risk			
					-		-	
			Recommendations		Accessibility			
			-		-			
					Review Period			
-								
Inspection Level		Analysis Result		Product Type		Licensed / Non-Licensed		
-		-		-		-

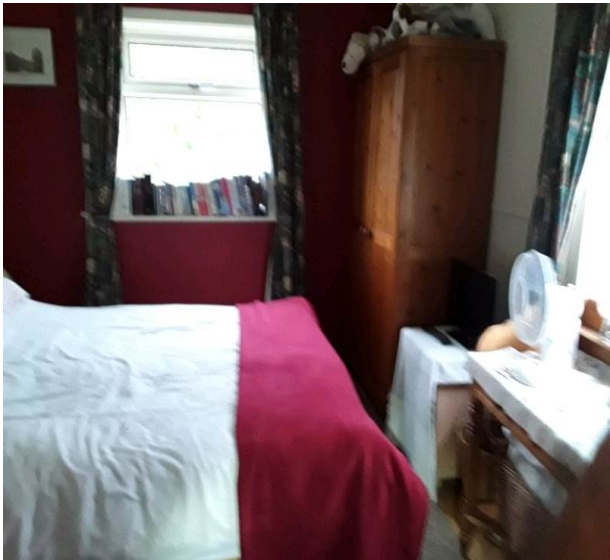
Item	Level	Building Name / Location / Room Number	Survey Type	Sample Reference	Quantity			
4	First Floor	Bedroom 2	Refurbishment	Visual Inspection	-

Material Description / Location		Material Risk			
			No suspect materials observed within surveyed area		Product Type	Extent of Damage	Surface Treatment	Asbestos Type
			Additional Information		-	-	-	-
			UPVC windows. Non asbestos timber doors.		Score - Material Risk			
					-		-	
			Recommendations		Accessibility			
			-		-			
Review Period								
-								
Inspection Level		Analysis Result		Product Type		Licensed / Non-Licensed		
-		-		-		-

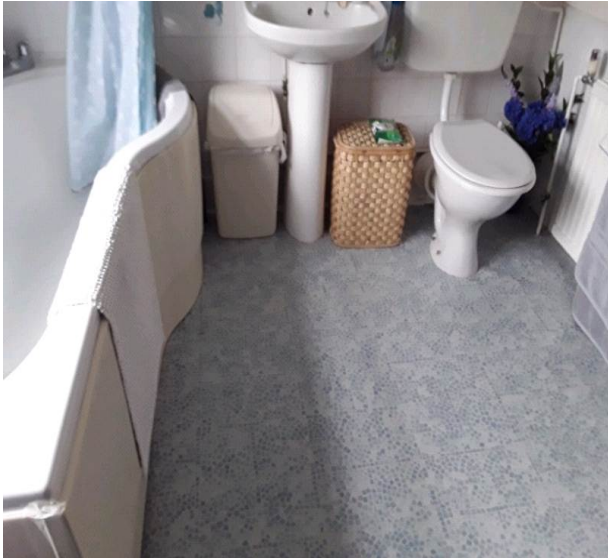
Item	Level	Building Name / Location / Room Number	Survey Type	Sample Reference	Quantity			
7	First Floor	Bathroom	Refurbishment	Visual Inspection	-

Material Description / Location		Material Risk			
			No suspect materials observed within surveyed area		Product Type	Extent of Damage	Surface Treatment	Asbestos Type
			Additional Information		-	-	-	-
			UPVC windows. Plastic bath panel. Ceramic toilet cistern. Non asbestos vinyl flooring. Limited inspection below fixed glue fixed vinyl flooring without causing irreparable damage, apply caution.		Score - Material Risk			
					-		-	
			Recommendations		Accessibility			
-		-						
		Review Period						
		-						
Inspection Level		Analysis Result		Product Type		Licensed / Non-Licensed		
-		-		-		-

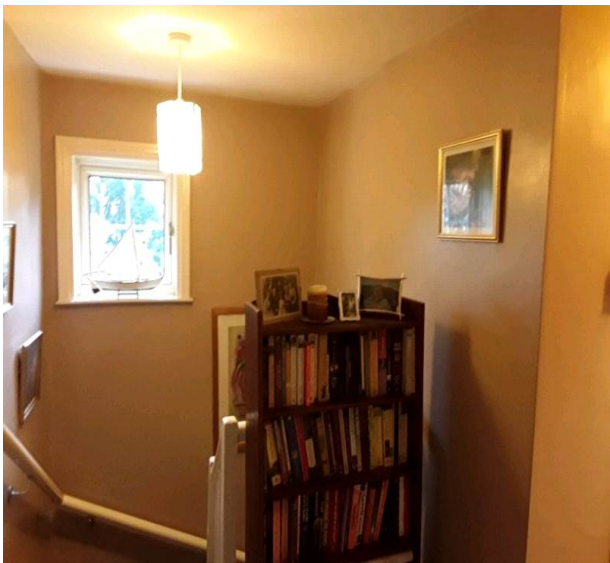
Item	Level	Building Name / Location / Room Number	Survey Type	Sample Reference	Quantity			
8	First Floor	Stairs/ Landing and Cupboard	Refurbishment	Visual Inspection	-

Material Description / Location		Material Risk			
			No suspect materials observed within surveyed area		Product Type	Extent of Damage	Surface Treatment	Asbestos Type
			Additional Information		-	-	-	-
			UPVC windows. Non asbestos timber doors. Timber trap hatch.		Score - Material Risk			
					-		-	
			Recommendations		Accessibility			
-		-						
		Review Period						
		-						
Inspection Level		Analysis Result		Product Type		Licensed / Non-Licensed		
-		-		-		-

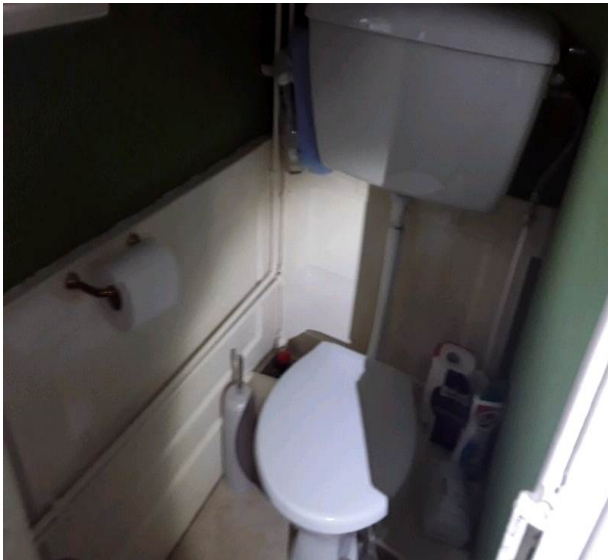
Item	Level	Building Name / Location / Room Number	Survey Type	Sample Reference	Quantity			
10	Ground Floor	Toilet	Refurbishment	Visual Inspection	-

Material Description / Location		Material Risk			
			No suspect materials observed within surveyed area		Product Type	Extent of Damage	Surface Treatment	Asbestos Type
			Additional Information		-	-	-	-
			UPVC windows. Ceramic toilet cistern. Non asbestos vinyl flooring. Limited inspection below fixed glue fixed vinyl flooring without causing irreparable damage, apply caution.		Score - Material Risk			
					-		-	
			Recommendations		Accessibility			
			-		-			
Review Period								
-								
Inspection Level		Analysis Result		Product Type		Licensed / Non-Licensed		
-		-		-		-

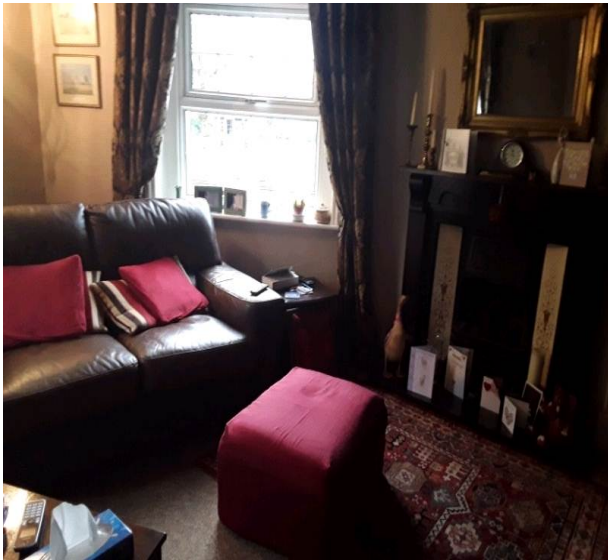
Item	Level	Building Name / Location / Room Number	Survey Type	Sample Reference	Quantity			
12	Ground Floor	Lounge	Refurbishment	Visual Inspection	-

Material Description / Location		Material Risk			
			No suspect materials observed within surveyed area		Product Type	Extent of Damage	Surface Treatment	Asbestos Type
			Additional Information		-	-	-	-
			UPVC windows. Non asbestos timber doors. No access within fireplace, apply caution.		Score - Material Risk			
					-		-	
			Recommendations		Accessibility			
			-		-			
Review Period								
-								
Inspection Level		Analysis Result		Product Type		Licensed / Non-Licensed		
-		-		-		-

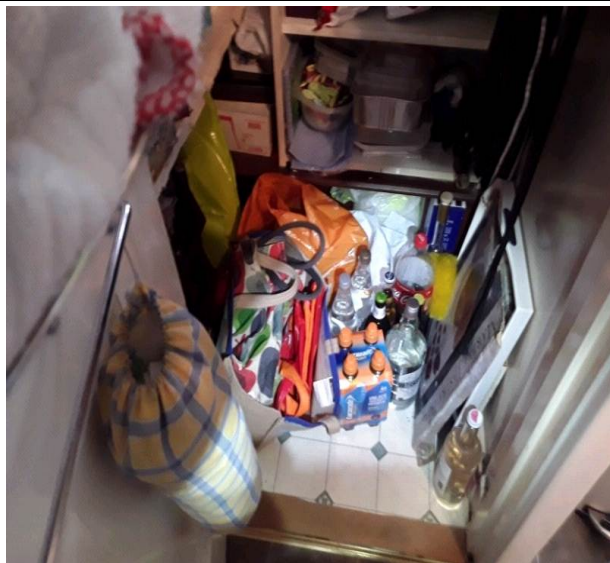
Item	Level	Building Name / Location / Room Number	Survey Type	Sample Reference	Quantity				
14	Ground Floor	Kitchen Store	Refurbishment	Visual Inspection	-

Material Description / Location		Material Risk				
			No suspect materials observed within surveyed area		Product Type	Extent of Damage	Surface Treatment	Asbestos Type	
					-	-	-	-	
			Additional Information		-	-	-	-	
			UPVC windows. Non asbestos timber doors. Non asbestos vinyl flooring.		Score - Material Risk				
					-		-		
			Recommendations		Accessibility				
			-		-				
Review Period									
-									
Inspection Level		Analysis Result		Product Type		Licensed / Non-Licensed			
-		-		-		-

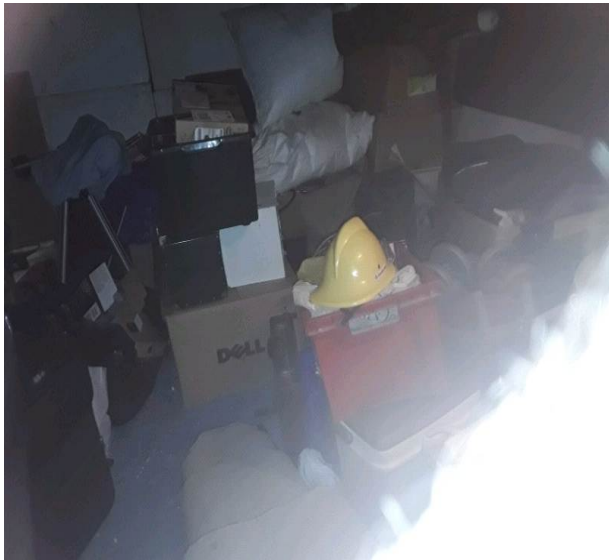
Item	Level	Building Name / Location / Room Number	Survey Type	Sample Reference	Quantity			
15	Basement	Main Cellar	Refurbishment	Visual Inspection	-

Material Description / Location		Material Risk			
			No suspect materials observed within surveyed area		Product Type	Extent of Damage	Surface Treatment	Asbestos Type
			Additional Information		-	-	-	-
			Non asbestos timber doors. Non asbestos fuseboard. Limited inspection due to stored Items, apply caution.		Score - Material Risk			
					-		-	
			Recommendations		Accessibility			
			-		-			
Review Period								
-								
Inspection Level		Analysis Result		Product Type		Licensed / Non-Licensed		
-		-		-		-

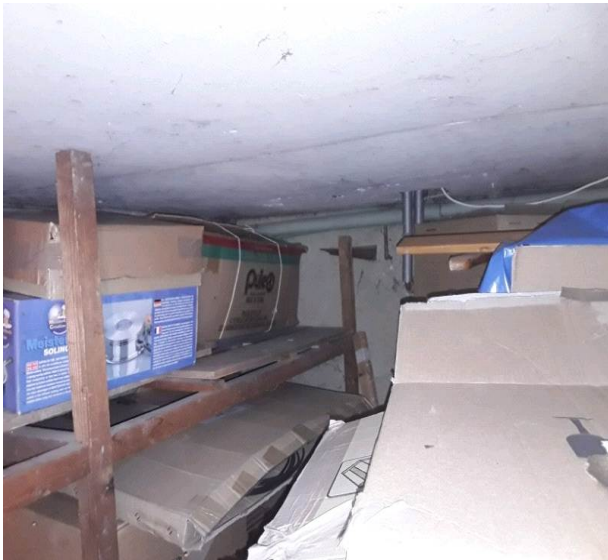
Item	Level	Building Name / Location / Room Number	Survey Type	Sample Reference	Quantity			
16	Basement	Cellar	Refurbishment	AH000065	24m²

Material Description / Location		Material Risk			
			Asbestos insulating board high level panels to ceiling		Product Type	Extent of Damage	Surface Treatment	Asbestos Type
			Additional Information		2	1	2	2
			High level unencapsulated ceiling panels. Non asbestos Vaillant boiler. Limited inspection due to stored items, apply caution.		Score - Material Risk			
					7		Medium	
			Recommendations		Accessibility			
Remove under asbestos controlled conditions if affected by works or encapsulate and manage in accordance with current asbestos legislation		High						
		Review Period						
		Annual						
Inspection Level		Analysis Result	Product Type		Licensed / Non-Licensed			
Identified		Chrysotile + Amosite	Asbestos Insulating Board		Licensable

3.5.2	The contractor is to note that the asbestos containing materials that were found in the basement ceiling (included within the Asbestos Report in Appendix D) have already been safely removed. Details of this removal can be found within Appendix D.
