**Sawtry Colts FC Clubhouse, Green Field Sports Field, Sawtry,
Huntingdon, PE28 5XP**
Interpretative Ground Investigation Report

Report on behalf of:
Dragon Structural Ltd.

May 2022

R22013/R001

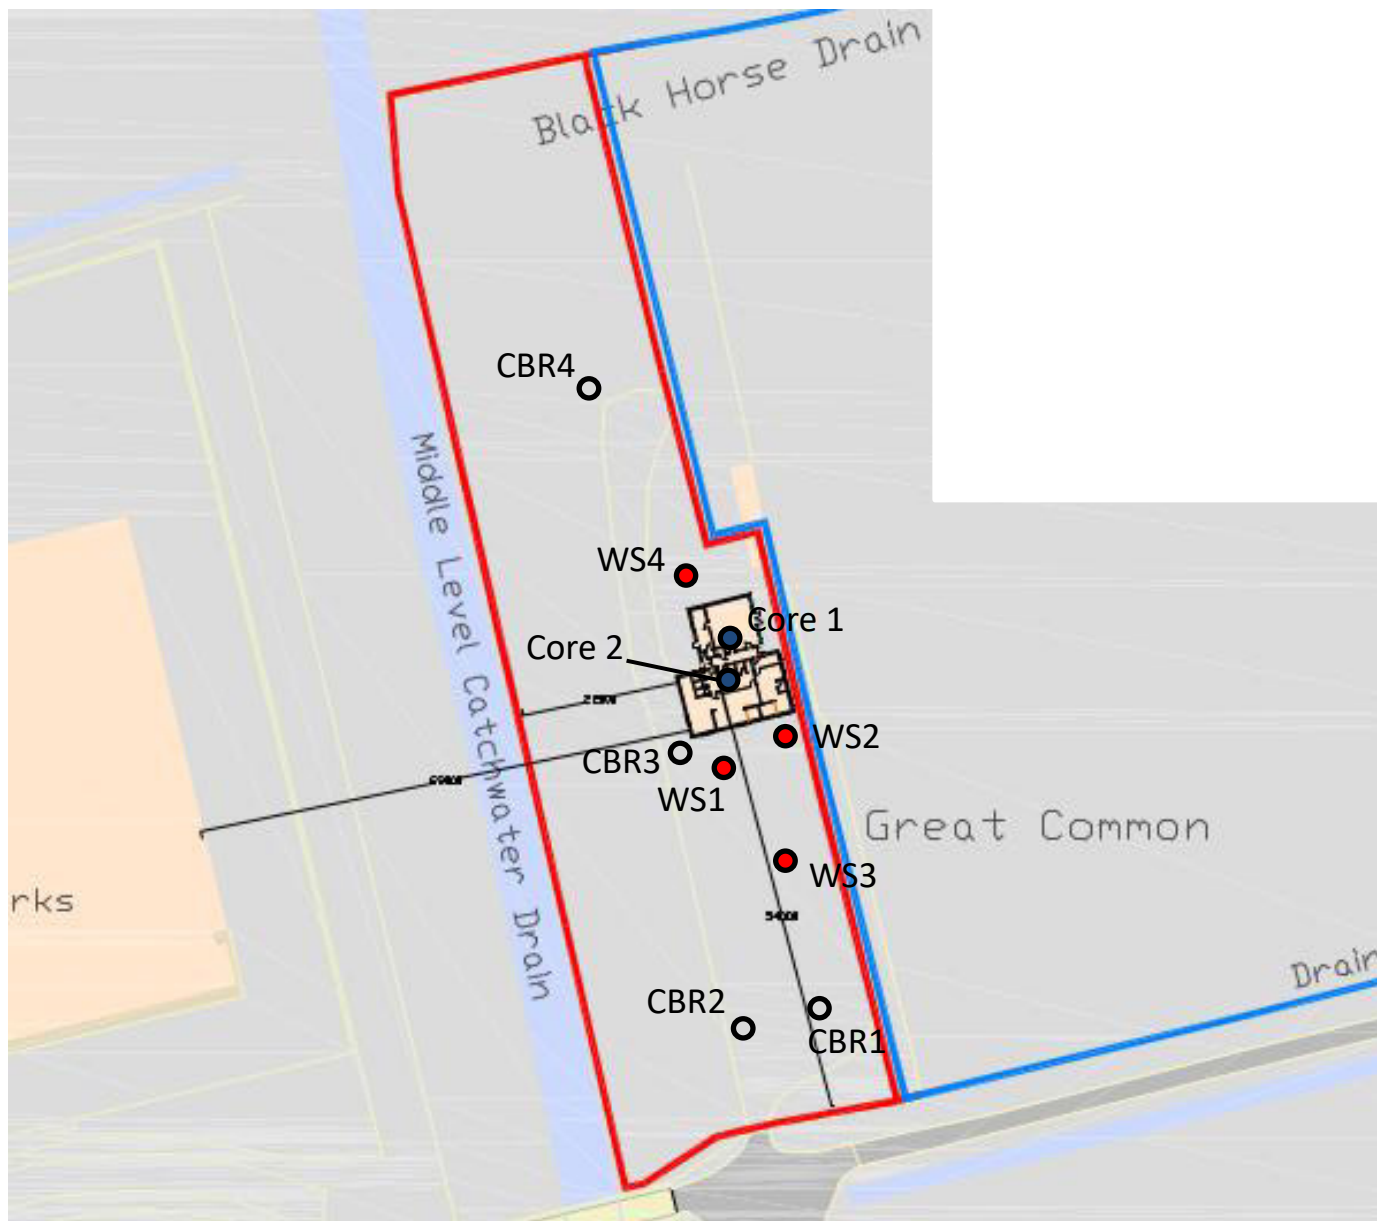
Exploratory Hole Loc. Plan
Sawtry, Huntingdon

The approximate positions of the excavations were surveyed using a tape measure, with distances measured from landmarks present on site. The locations are shown in the Site Investigation Plan (Drawing R22013-DWG2) provided in Appendix A. The works undertaken are summarised in Table 2.2. The exploratory hole logs, including details of the ground conditions encountered, water strikes, any visual or olfactory evidence of contamination, and in-situ testing are presented in Appendix C.

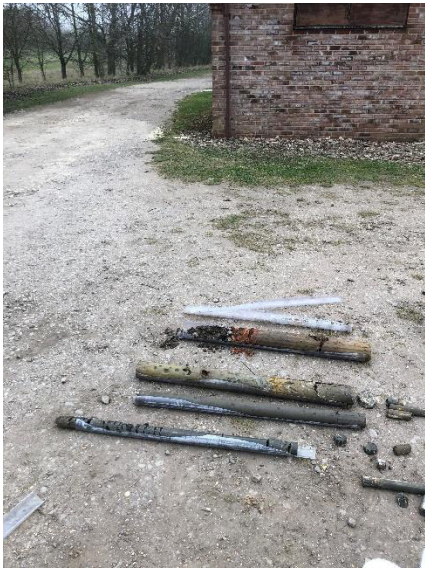
Exploratory Holes	Depth (m bgl)	In-situ testing	Observations
WS1	4.0m bgl	SPTs undertaken at 1m intervals throughout the excavation. Low SPTs at 1m and 2m bgl, Moderate SPT at 3m and Moderate to High SPT at 4m bgl. No SPT refusals (N>50) noted.	No groundwater encountered. Made Ground containing occasional clinker and slag was encountered between 0.0m and 0.3m bgl. Excavation was backfilled with arisings.
WS2	4.0m bgl	SPTs undertaken at 1m intervals throughout the excavation. Low SPTs at 1m and 2m bgl, Moderate SPT at 3m. High SPT at 4m bgl. No SPT refusals (N>50) noted.	No groundwater encountered. Made Ground containing occasional clinker was encountered between 0.0m and 0.4m bgl. Excavation was backfilled with arisings.
WS3	4.0m bgl	SPTs undertaken at 1m intervals throughout the excavation. Low SPTs at 1m and 2m bgl, Moderate SPT at 3m. High SPT at 4m bgl. No SPT refusals (N>50) noted.	No groundwater encountered. Made Ground containing occasional clinker was encountered between 0.0m and 0.35m bgl. Excavation was backfilled with arisings.

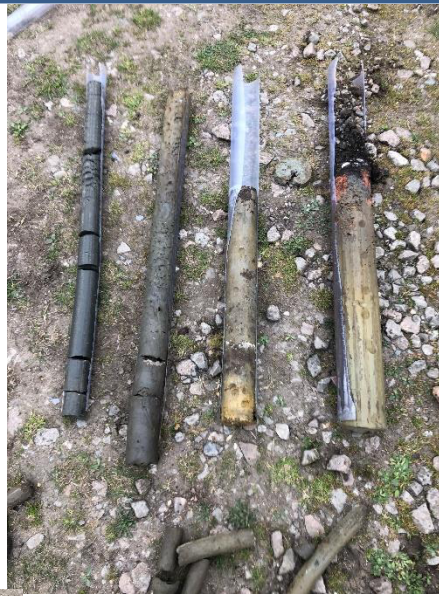
WS3

Whilst this sequence (with localised slight variations in colour, consistency, and gravel characteristics) was present across the investigation areas, notable anomalies were recorded in WS2, which contained a zone of very soft material between 2.0m and 2.3m bgl, and in WS3, where a layer of stiff clay was noted toward the top of the unit.

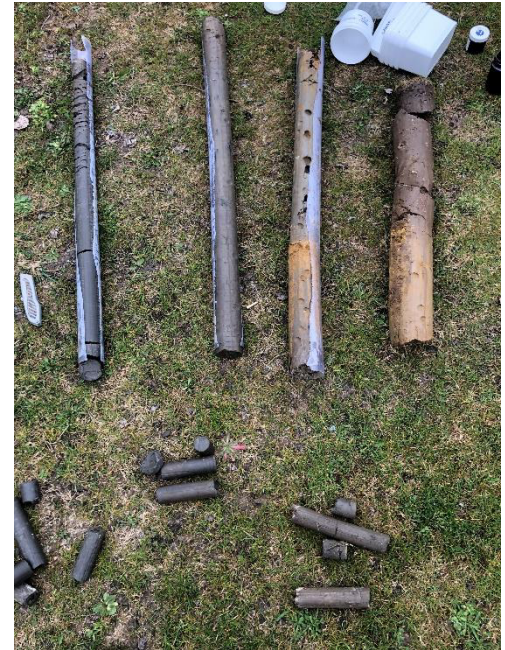
WS4	4.0m bgl	SPTs undertaken at 1m intervals throughout the excavation. Low SPTs at 1m and 2m bgl, Moderate SPT at 3m. High SPT at 4m bgl. No SPT refusals (N>50) noted.	No groundwater encountered. No visual or olfactory evidence of contamination. Excavation was backfilled with arisings.
HP1	1.31m bgl	None	Groundwater encountered at 0.8m bgl. Trial Pit was stable. No visual or olfactory evidence of contamination. Excavation was backfilled with arisings.
HP2	1.2m bgl	None	Groundwater encountered at 0.8m bgl. Trial Pit was stable. Plastic debris encountered, however no significant visual or olfactory evidence of contamination was noted. Excavation was backfilled with arisings.
Core 1	0.152m bgl	TRL DCP testing undertaken through base	Reinstated using excavated core and cement.
Core 2	0.182m bgl	TRL DCP testing undertaken through base	Reinstated using excavated core and cement.
CBR1	ca. 0.9m	TRL DCP testing undertaken	None

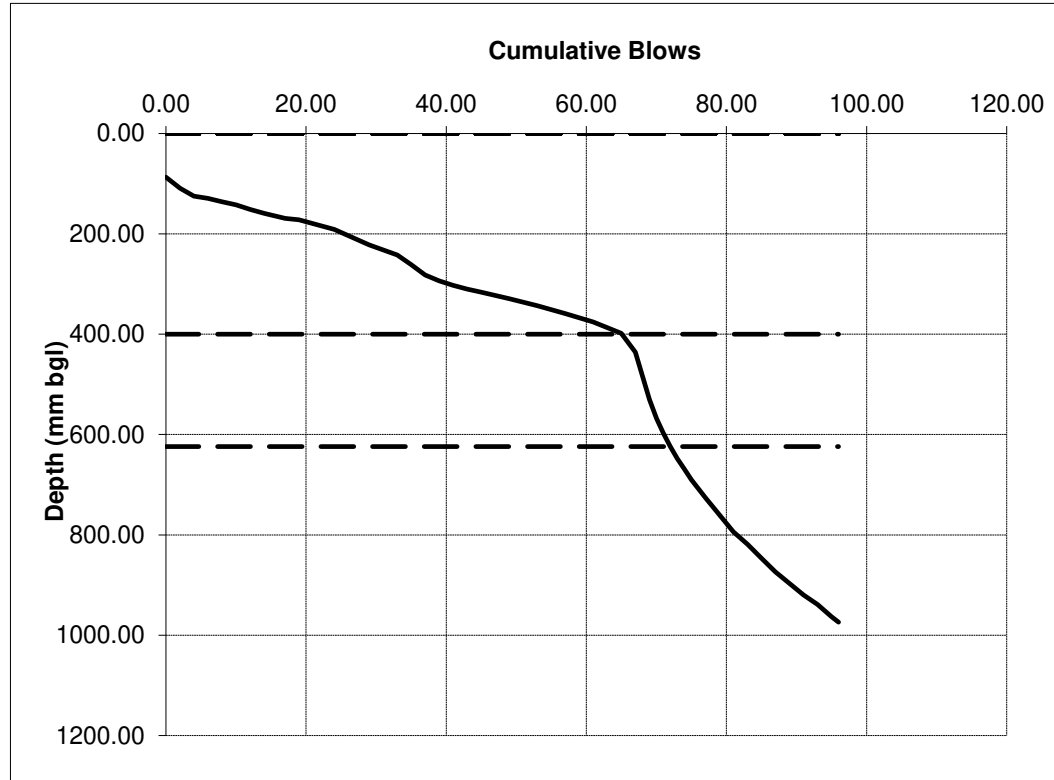
CBR Interpretation based on the TRL Equation: $\text{Log}_{10}(\text{CBR}) = 2.480 - [1.057 \times \text{Log}_{10}(\text{DCP Strength})]$

Dynamic Cone Penetrometer

Based on the near surface ground conditions encountered, and the findings of in-situ TRL DCP Probing (See Section 2.7.2) it is recommended for preliminary design purposes a CBR value of 5% is adopted where formation level is within the existing compacted Made Ground, and 4% where formation level is within the natural Oxford Clay Formation Deposits (rounded down from 4.4%- worst case CBR from TRL probing).

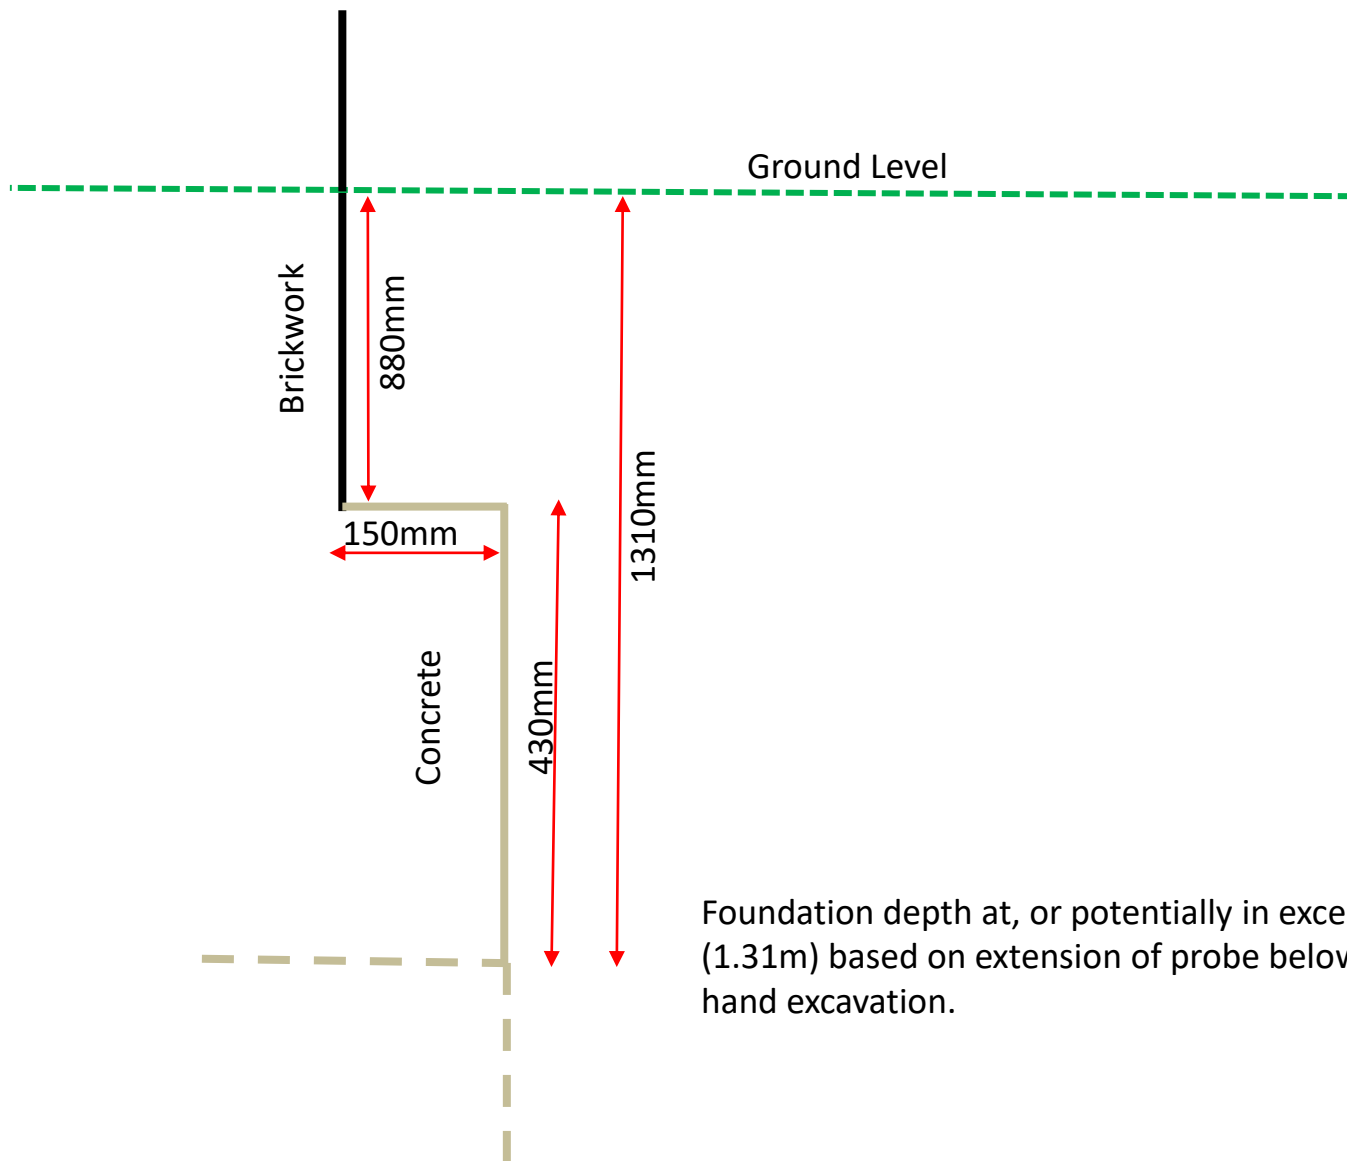
The external brick wall in this location extended approximately 880mm below the adjacent ground level, terminating on a footing of concrete construction. The concrete foundation extended horizontally for a distance of 1580mm, and was proven to a depth of approximately 1310mm bgl. which was the maximum depth reached using a metal probe. The foundation base could not be determined through hand excavation, and subsequent probing through the base of the excavation, however based on the behaviour of the inserted probe it is considered possible that the foundations terminated at this depth. Due to foundation depth, the founding stratum could not be confirmed.

Foundation depth at, or potentially in excess of 1310mm (1.31m) based on extension of probe below the base of hand excavation.

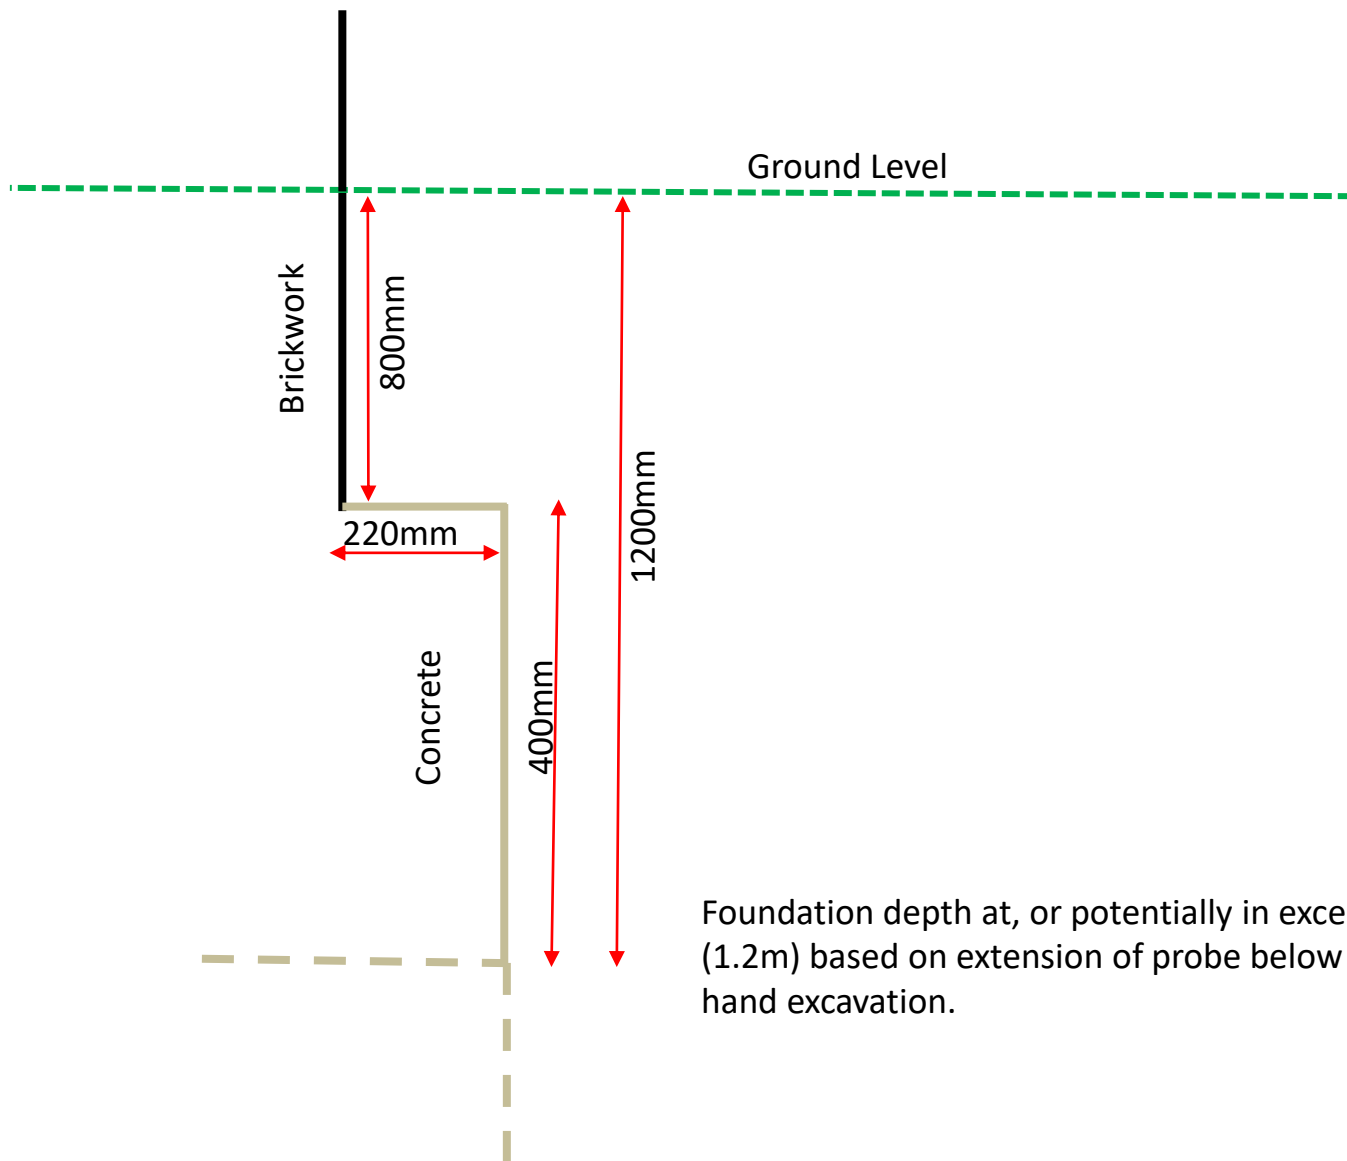
The external brick wall extended 800mm below ambient ground level, terminating at this depth on a concrete footing. The concrete foundation extended horizontally for a distance of 220mm, and was proven to a depth of approximately 1200mm bgl. The foundation base exceeded the maximum depth achievable through hand excavation, and was tentatively identified using a metal probe extended through the pit base. Due to the requirement for probing, the founding stratum could not be definitively confirmed.

Foundation depth at, or potentially in excess of 1200mm (1.2m) based on extension of probe below the base of hand excavation.

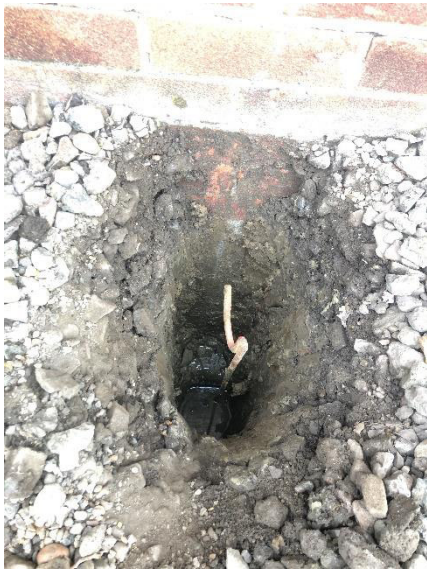
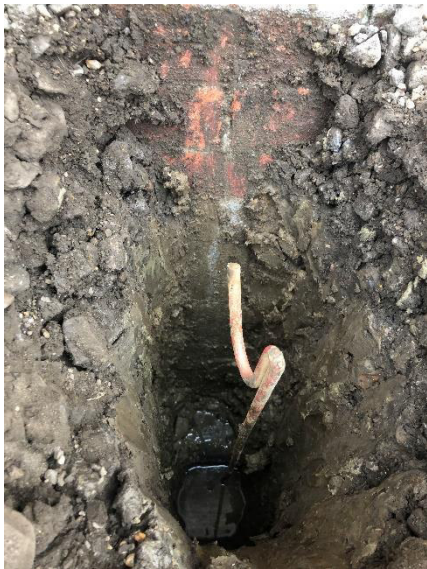
The strike encountered in HP1 is therefore not considered to be representative of a wider groundwater regime, and is considered likely to be a result of localised perching and/or a damming effect associated with the presence of adjacent foundation structures.

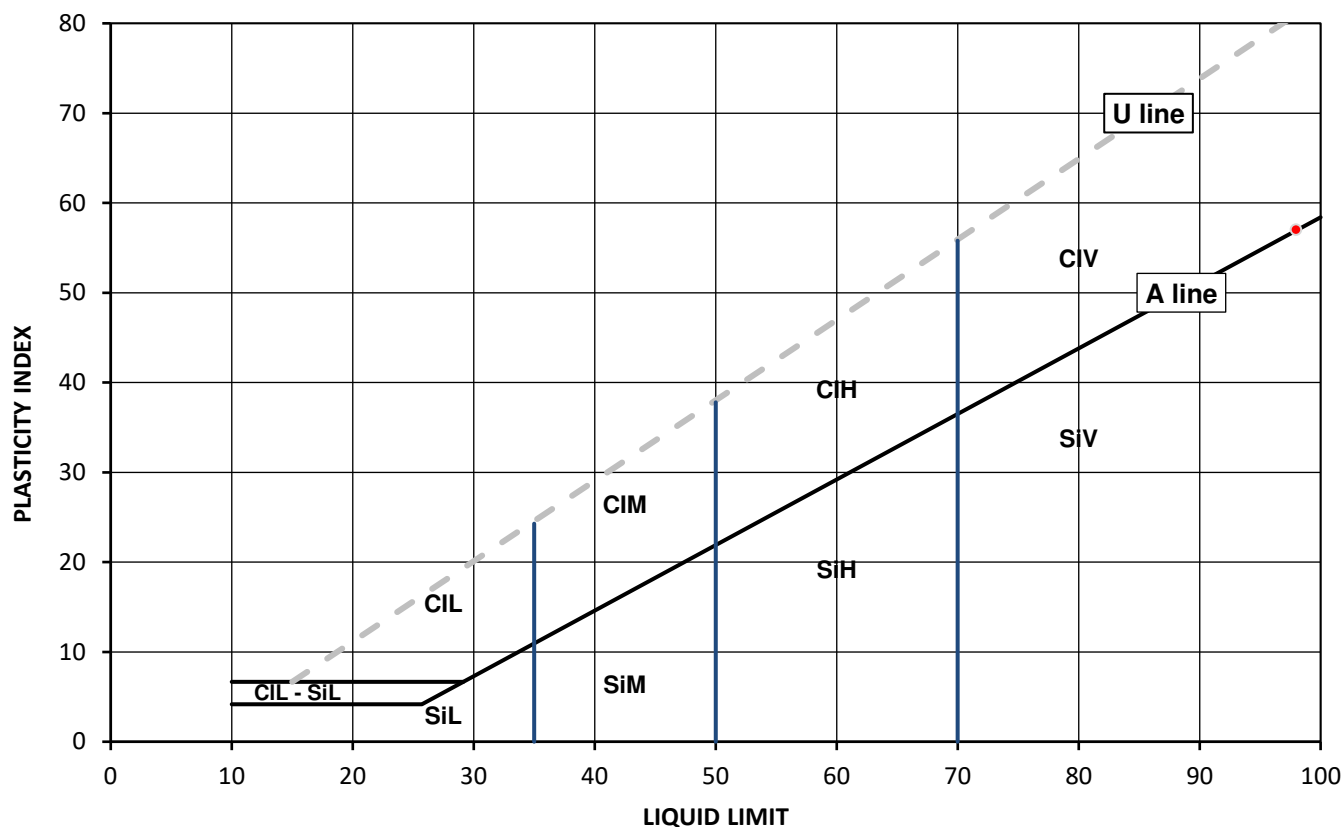
As Received Water Content [W] %	Liquid Limit [WL] %	Plastic Limit [Wp] %	Plasticity Index [Ip] %	% Passing 425µm BS Test Sieve
44	98	41	57	100

As clay soils of high volume change potential are present at the site, it is recommended that suspended floor slabs should be adopted, in accordance with NHBC Standards.

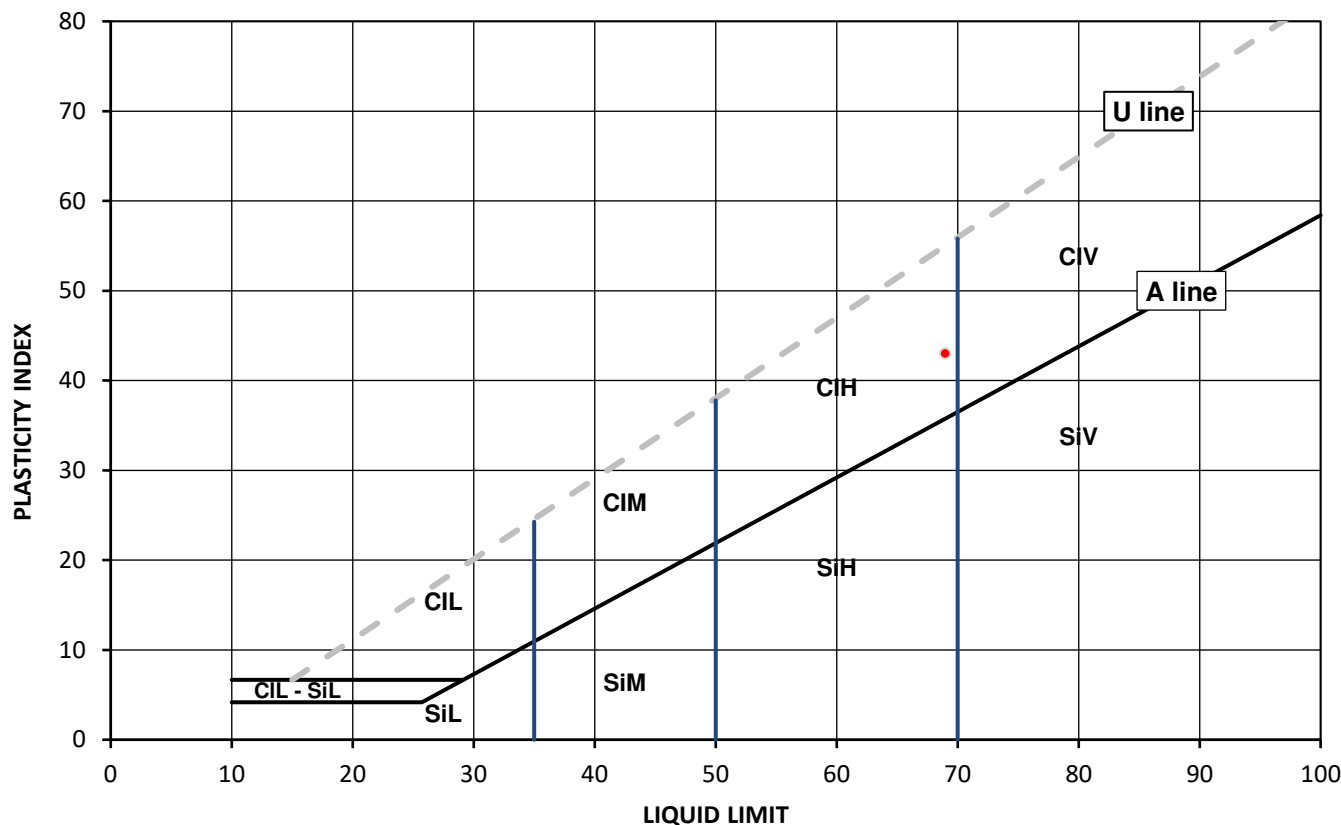
As Received Water Content [W] %	Liquid Limit [WL] %	Plastic Limit [Wp] %	Plasticity Index [Ip] %	% Passing 425µm BS Test Sieve
28	69	26	43	100

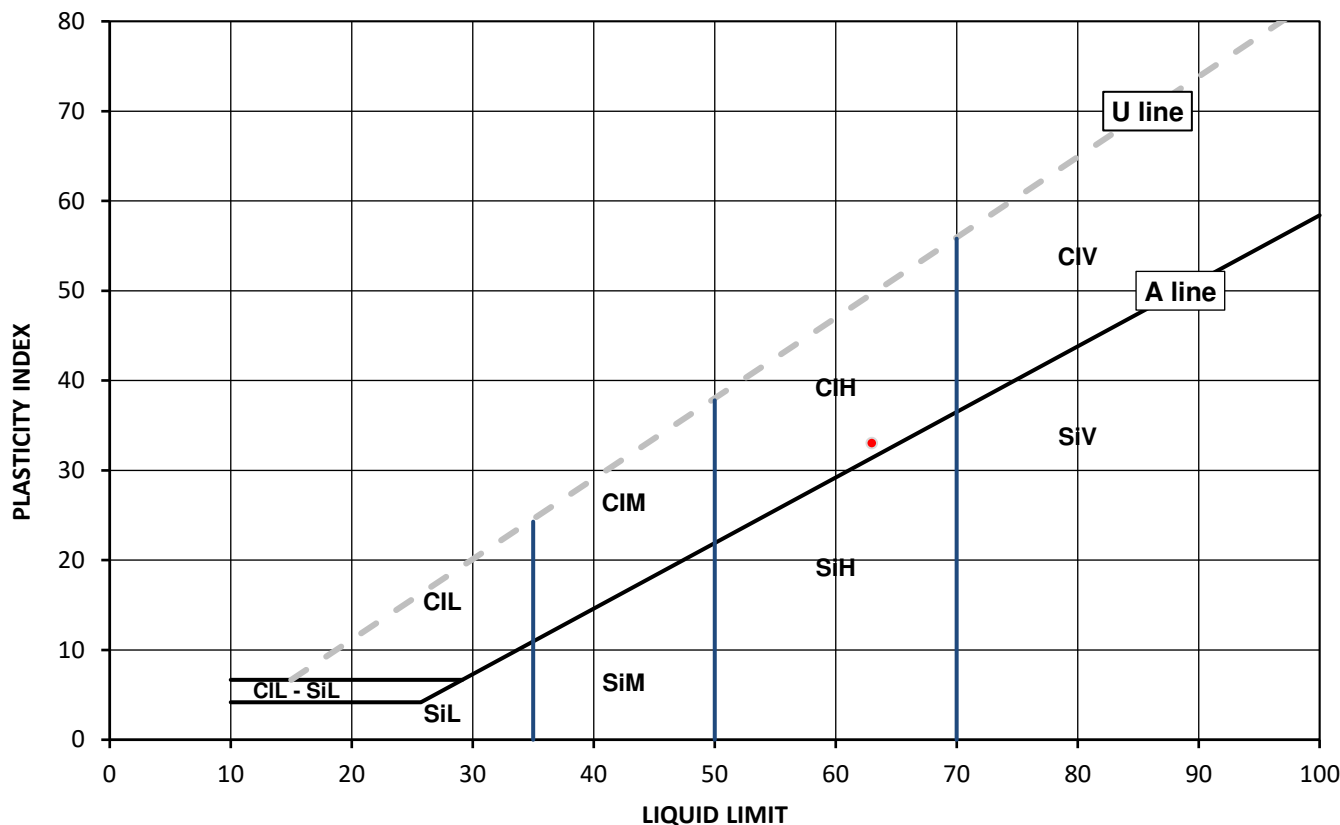
As Received Water Content [W] %	Liquid Limit [WL] %	Plastic Limit [Wp] %	Plasticity Index [Ip] %	% Passing 425µm BS Test Sieve
25	63	30	33	100

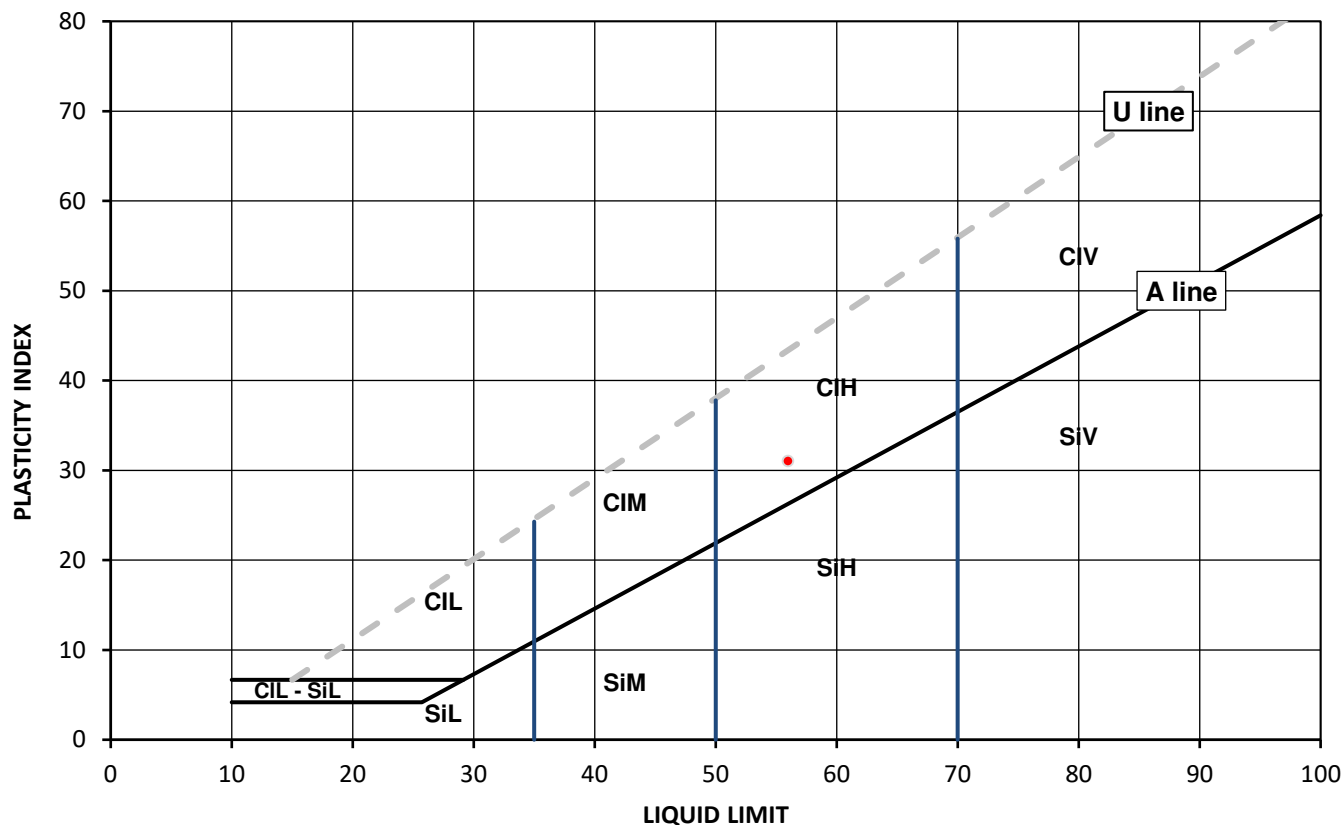
As Received Water Content [W] %	Liquid Limit [WL] %	Plastic Limit [Wp] %	Plasticity Index [Ip] %	% Passing 425µm BS Test Sieve
38	56	25	31	100

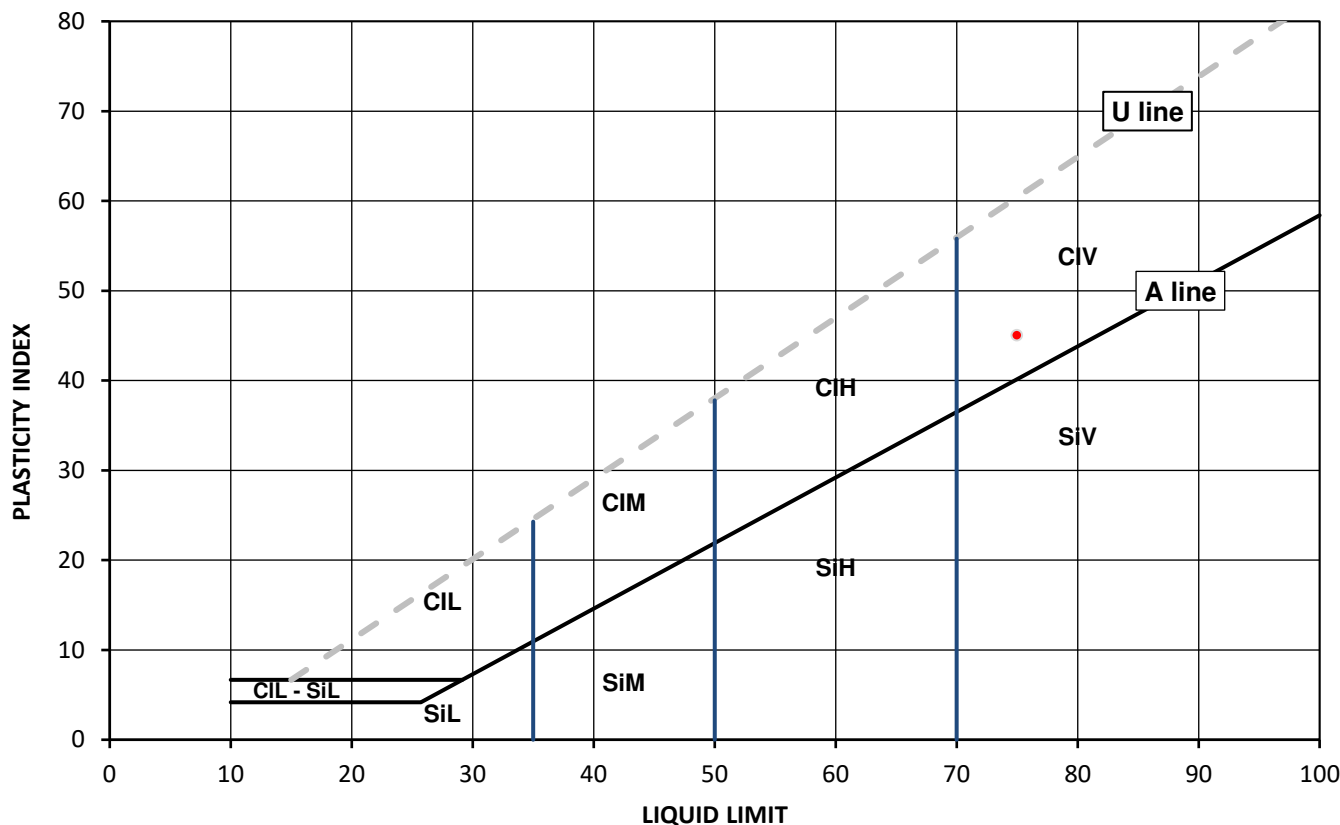
As Received Water Content [W] %	Liquid Limit [WL] %	Plastic Limit [Wp] %	Plasticity Index [Ip] %	% Passing 425µm BS Test Sieve
33	75	30	45	100

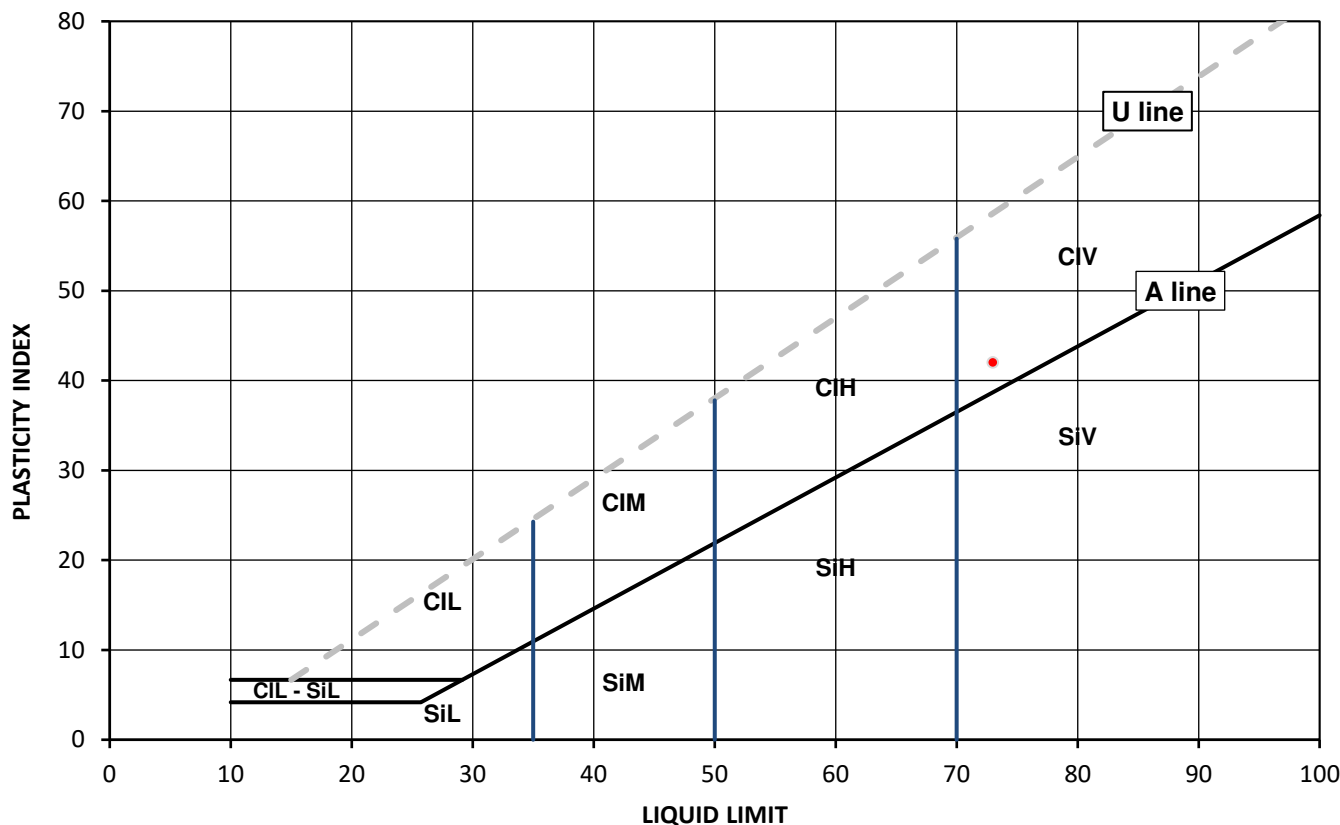
As Received Water Content [W] %	Liquid Limit [WL] %	Plastic Limit [Wp] %	Plasticity Index [Ip] %	% Passing 425µm BS Test Sieve
36	73	31	42	100

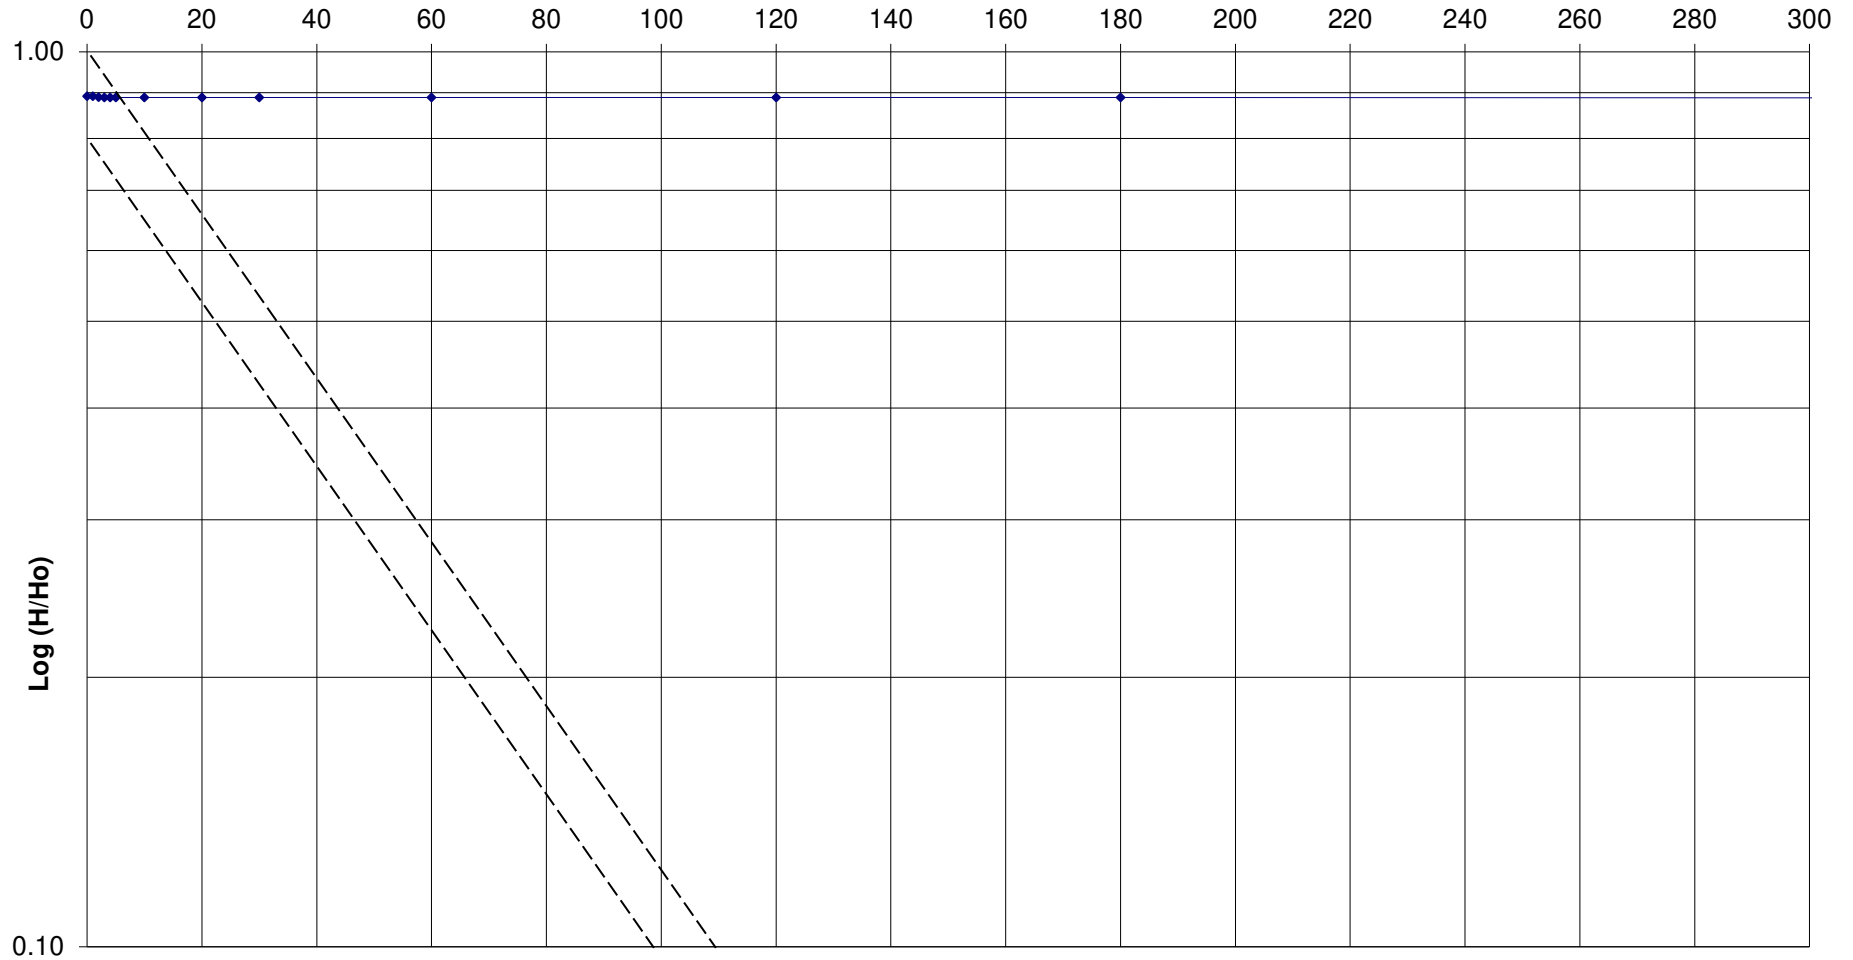
Loss Ratio for WS1

—◆— Loss Ratio (H/Ho)

Infiltration was insufficient to enable calculation of permeability/infiltration rate. Based on the findings, it is considered unlikely that the use of soakaway drainage will be feasible at the site.
