Standard Contract for Goods and/or Services - Order Form

1) National Nature Reserve (NNR) Heritage at Risk Project

2) Paston Great Barn National Nature Reserve (NNR)

3) Scope

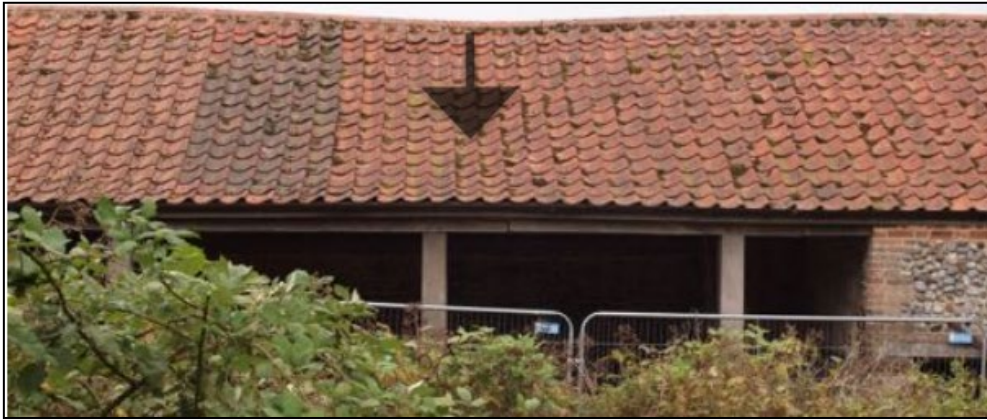
The roof of the South Range Barn has a depression about mid-length where the structure below has failed. The connection between the truss and wall plate has broken and the wall plate has spread outwards and the truss has fallen down. The roof is relying on the short connection joints of the wall plate to prevent further spreading and collapse.

Figure 3: South Range Barn, showing collapsing roof (Photo: Nicholas Warns Architects).

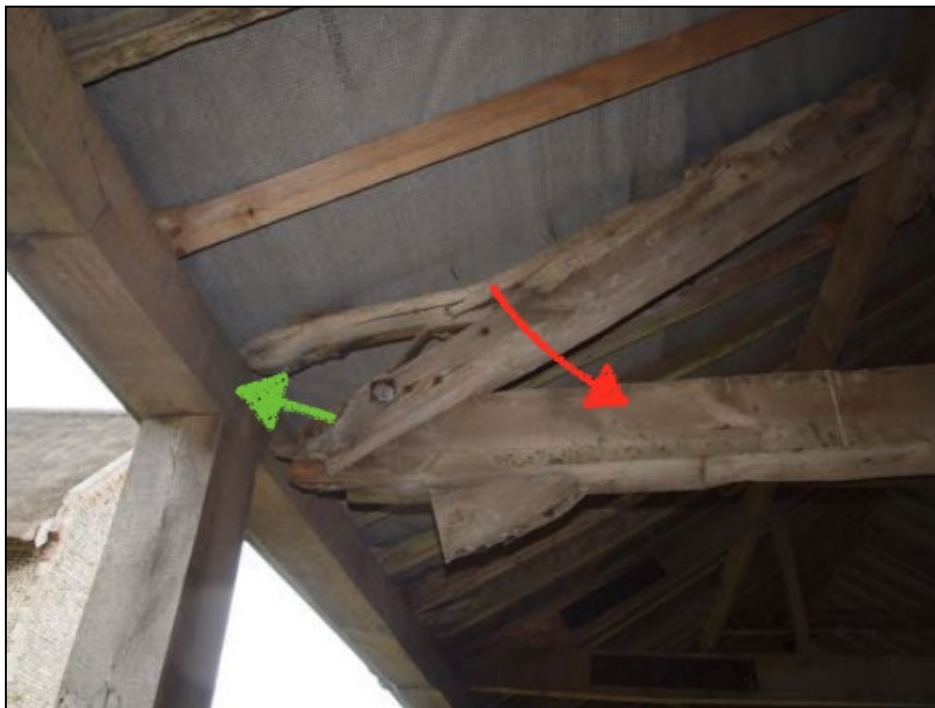
Internally, the truss has disconnected from the wall-plate and fallen down, the wall-plate has been pushed outwards by the falling roof slope and the support post has moved and twisted and may pop out, which would lead to major collapse.

Figure 4: The roof truss has disconnected with the wall-plate and the roof has partially collapsed. Red arrow: Movement of the truss downwards. Green arrow: Movement of the wall-plate outwards (Photo: Nicholas Warns Architects).

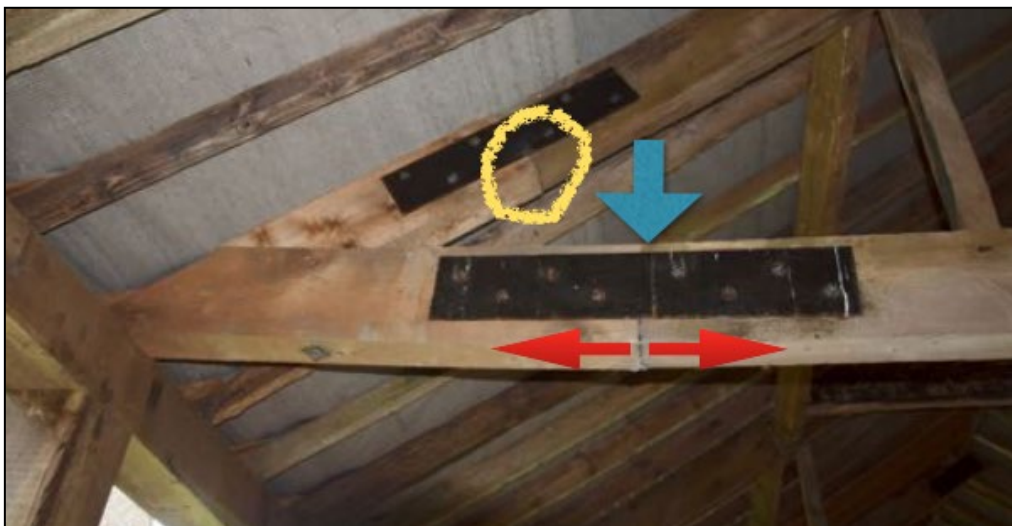
Inspection of the internal roof shows that the trusses are bending and the connection between the trusses and support posts is weak, subsequently all the trusses appear to be sagging, and the repair plates are ineffective, and the tie beams are bending. Also, the principal truss rafters are bending and other support posts appear to show movement.

Figure 5: The repair plates are ineffective, and the tie beams are bending. Also, the principal truss rafters are bending (Photo: Nicholas Warns Architects).

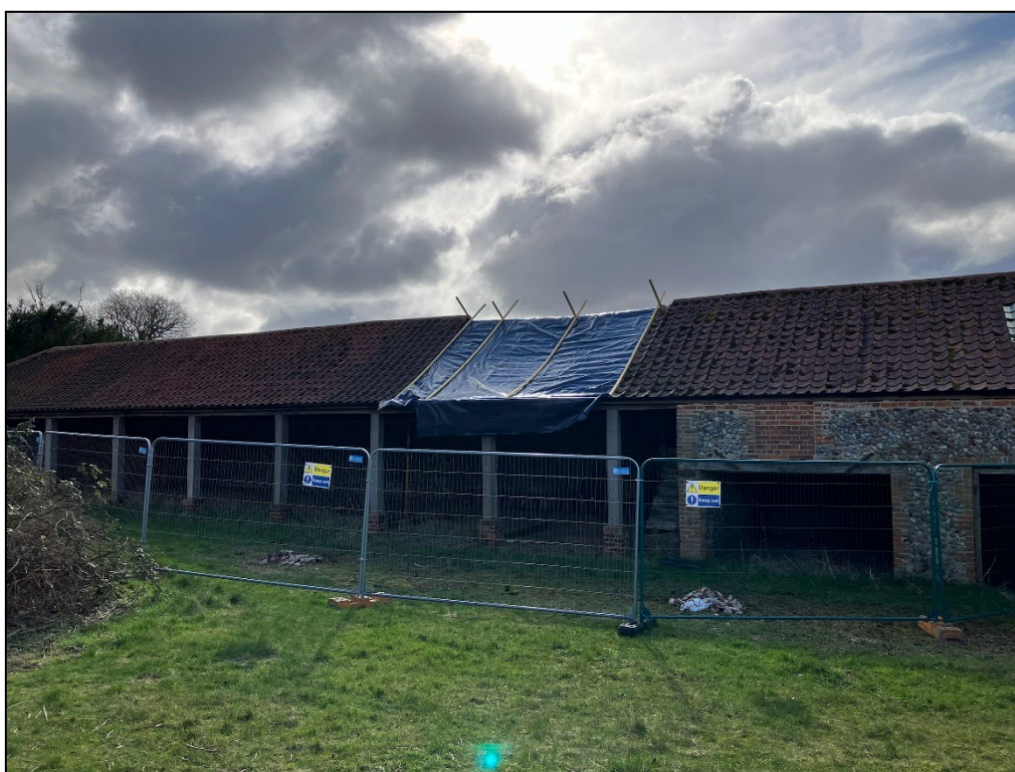
The section of roof with the failed truss has been propped and stabilised to prevent further damage and the roof tiles have been removed from the two associated bays to reduce the roof loading and a temporary covering employed. Additionally, the public footpath adjacent to the South Range Barn has been temporarily rerouted.

Figure 6: Temporary stabilisation and roof covering, and exclusion of public footpath from the South Range Barn (Photo: Natural England/ Howard Jones).
