SURVEY

Drawing:  
Existing Monument Elevations  
C78

Job Title:  
**Heritage Restoration of Falmouth's  
Ponsharden Cemeteries**

Job No: **J20-077** Dwg No: **1006** Rev: **A**

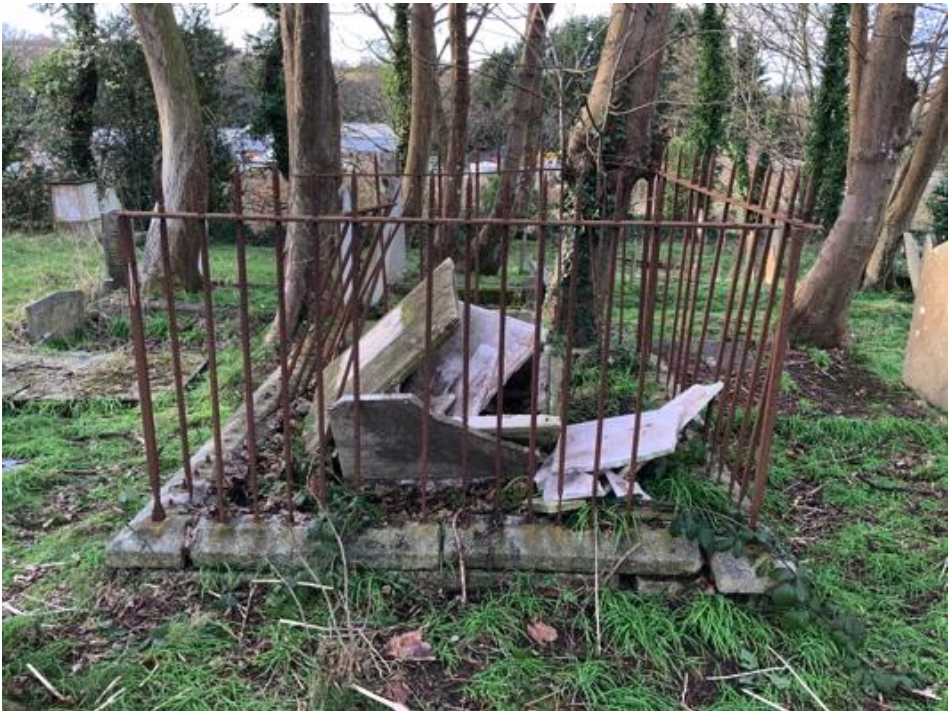
The tomb and railings have suffered further damage since the original survey and drawings were created. The photographs show its condition as at the end of January 2021, whilst the drawings show its condition in March 2020.

The main differences are that the south railings and gate have been pushed further against the monument, the stone lid has been dislodged and the top cap has come off and is lying within the railings. The south panel of the tomb has suffered the loss of the top section where previously it was only fractured. The east panel has been dislodged and there has been additional fracture damage to the panels. The additional repairs required have been included in the repair drawings and the Proforma Condition and Repairs Schedule.

Existing 25mm thick marble top panels previously taken down and stored within tomb and leant against railings. Panels are broken into approximately 25 pieces of varying sizes, but all are believed to survive. 100 x 100mm square section limestone corner pieces to upper section are stored within tomb or are on floor inside railings. Assume that three corner posts are broken into two pieces.
