# Wakefield College ASBESTOS REFURBISHMENT & DEMOLITION SURVEY INSPECTION REPORT

## A Block Wakefield

Survey Date: 18 February 2013

Job Number: W13-00415

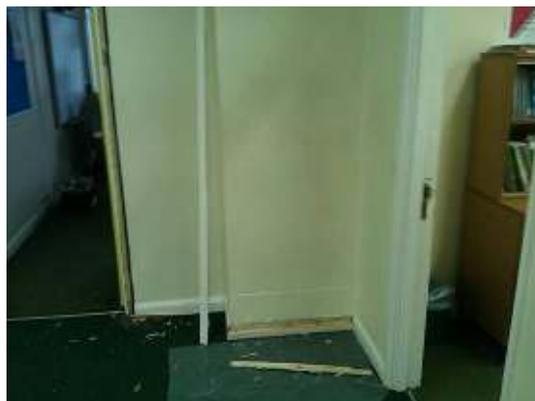
#### 7.2.1 A417, 4th Floor Corridor, Face Boarding to Riser R1 Outside Room A408, Insulating Board

<b>Sample Number</b>	1	<b>Condition</b>	N/A
<b>Extent</b>	2m x 1m x 10mm	<b>Surface Treatment</b>	Painted
<b>Debris Present</b>	No	<b>HSE Licensable Material</b>	N/A
<b>Asbestos Type</b>	No Asbestos Detected

**Recommendations** No asbestos was detected in this sample

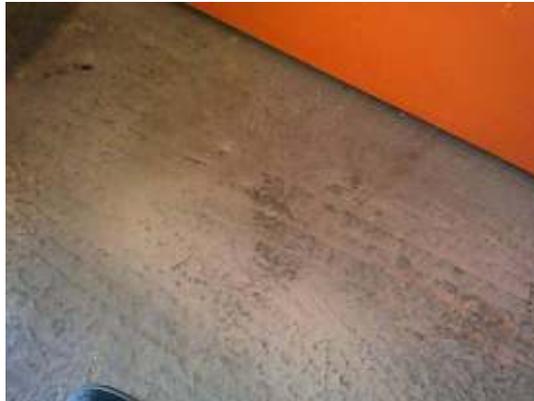
### 7.2.15 LM1, Lift Motor Room, Floor Adhesive Residue, Bitumen

<b>Sample Number</b>	15	<b>Condition</b>	N/A
<b>Extent</b>	2mx 2m x 10mm	<b>Surface Treatment</b>	Bitumen Bonded
<b>Debris Present</b>	No	<b>HSE Licensable Material</b>	N/A
<b>Asbestos Type</b>	No Asbestos Detected

**Recommendations** No asbestos was detected in this sample

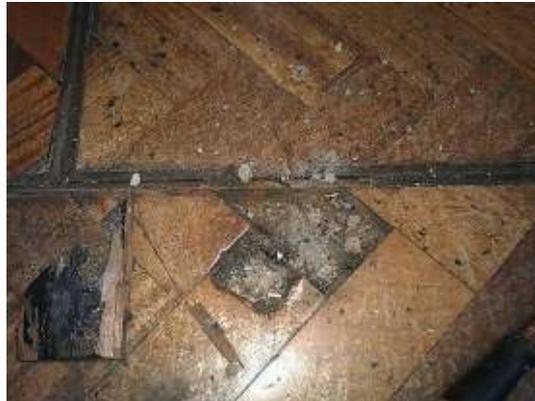
### 7.2.16 A306, 3rd Floor Lab, Floor Adhesive Under Timber, Bitumen

<b>Sample Number</b>	16	<b>Condition</b>	N/A
<b>Extent</b>	10m x 10m x 5mm	<b>Surface Treatment</b>	Bitumen Bonded
<b>Debris Present</b>	No	<b>HSE Licensable Material</b>	N/A
<b>Asbestos Type</b>	No Asbestos Detected

**Recommendations** No asbestos was detected in this sample

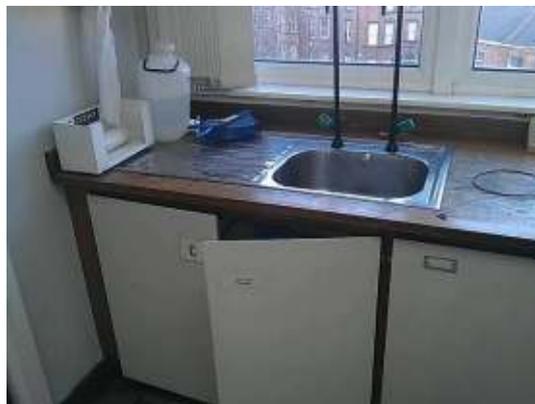
### 7.2.19 Room A306, 3rd Floor Lab, Damper Pad to Stainless Steel, Bitumen

<b>Sample Number</b>	19	<b>Condition</b>	N/A
<b>Extent</b>	200mm x 200mm x 5mm	<b>Surface Treatment</b>	Bitumen Bonded
<b>Debris Present</b>	No	<b>HSE Licensable Material</b>	N/A
<b>Asbestos Type</b>	No Asbestos Detected

**Recommendations** No asbestos was detected in this sample

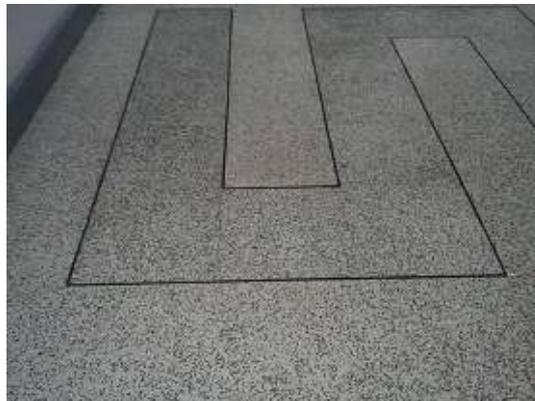
### 7.2.24 ST2, GF Lobby of Stairwell, Marble Floor Expansion Joint, Bitumen

<b>Sample Number</b>	24	<b>Condition</b>	N/A
<b>Extent</b>	100m x 5mm x 5mm	<b>Surface Treatment</b>	Bitumen Bonded
<b>Debris Present</b>	No	<b>HSE Licensable Material</b>	N/A
<b>Asbestos Type</b>	No Asbestos Detected

**Comments** Joint to marble edge of floor all the way up stairwell ST2

**Recommendations** No asbestos was detected in this sample

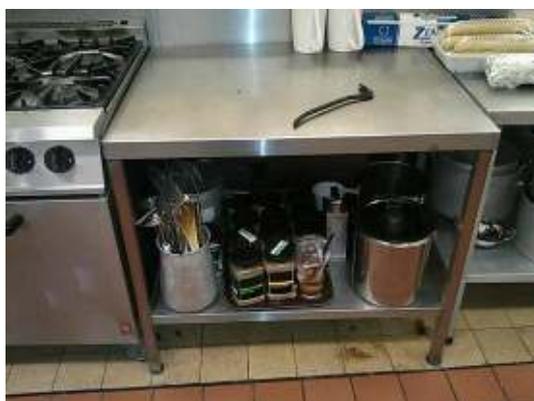
### 7.2.25 K1, GF Kitchen, Damper Pads to Prep Tables, Bitumen

<b>Sample Number</b>	25	<b>Condition</b>	Low damage
<b>Extent</b>	1m x 0.2m x 5mm	<b>Surface Treatment</b>	Bitumen Bonded
<b>Debris Present</b>	No	<b>HSE Licensable Material</b>	<b>No</b>
<b>Asbestos Type</b>	<b>Chrysotile</b>

**Recommendations** This material is defined as Non-Licensable and if it is to be removed, it should be done using an HSE licensed removal contractor or by employees who are sufficiently trained and following the guidance in the HSE Asbestos Essentials Task Manual (HSG 210). The recent update in the Control of Asbestos Regulations (2012) requires work on some non-licensed asbestos containing materials to be notified to the appropriate authority and this should be established prior to any removal works.

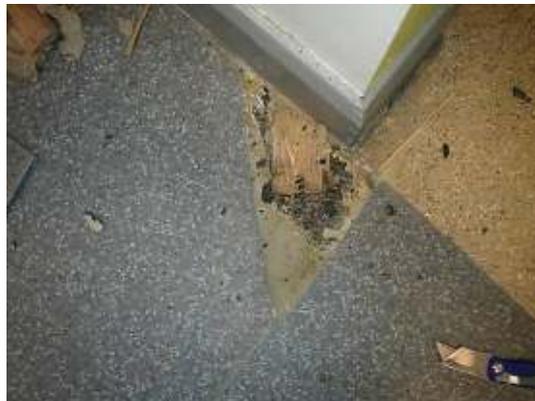
### 7.2.28 FC1, GF Food Court, Floor Under Modern Vinyl, Bitumen Rock Ash Felt

<b>Sample Number</b>	29	<b>Condition</b>	N/A
<b>Extent</b>	40m x 40m x 10mm	<b>Surface Treatment</b>	Bitumen Bonded
<b>Debris Present</b>	No	<b>HSE Licensable Material</b>	N/A
<b>Asbestos Type</b>	No Asbestos Detected

**Recommendations** No asbestos was detected in this sample

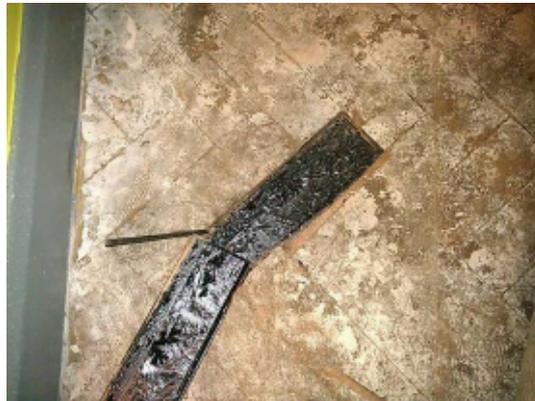
### 7.2.29 FC1, GF Food Court, Floor Under Modern Vinyl, Bitumen Adhesive Under Timber Floor

<b>Sample Number</b>	30	<b>Condition</b>	N/A
<b>Extent</b>	40m x 40m x 10mm	<b>Surface Treatment</b>	Bitumen Bonded
<b>Debris Present</b>	No	<b>HSE Licensable Material</b>	N/A
<b>Asbestos Type</b>	No Asbestos Detected

**Recommendations** No asbestos was detected in this sample

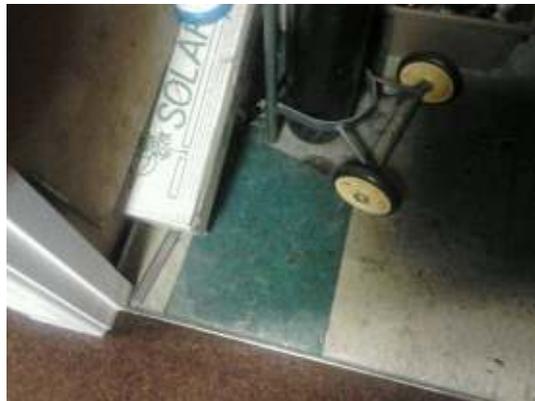
### 7.2.31 Room R1, 3rd Floor Riser/Cupboard, Teal Floor Tiles, Vinyl

<b>Sample Number</b>	32	<b>Condition</b>	N/A
<b>Extent</b>	0.5x1m	<b>Surface Treatment</b>	Composite Material
<b>Debris Present</b>	No	<b>HSE Licensable Material</b>	N/A
<b>Asbestos Type</b>	No Asbestos Detected

**Recommendations** No asbestos was detected in this sample

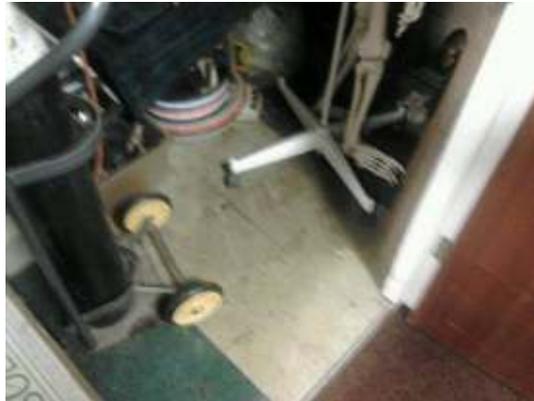
### 7.2.32 Room R1, 3rd Floor Riser/Cupboard, Floor Tiles, Vinyl

<b>Sample Number</b>	33	<b>Condition</b>	N/A
<b>Extent</b>	1x1m	<b>Surface Treatment</b>	Composite Material
<b>Debris Present</b>	No	<b>HSE Licensable Material</b>	N/A
<b>Asbestos Type</b>	No Asbestos Detected

**Recommendations** No asbestos was detected in this sample

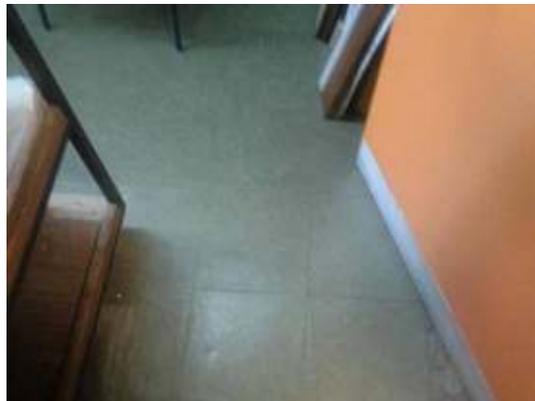
### 7.2.34 Room A309, 3rd Floor Prep Room, Dark Green Floor Tiles, Vinyl

<b>Sample Number</b>	35	<b>Condition</b>	N/A
<b>Extent</b>	2x5m	<b>Surface Treatment</b>	Composite Material
<b>Debris Present</b>	No	<b>HSE Licensable Material</b>	N/A
<b>Asbestos Type</b>	No Asbestos Detected

**Recommendations** No asbestos was detected in this sample

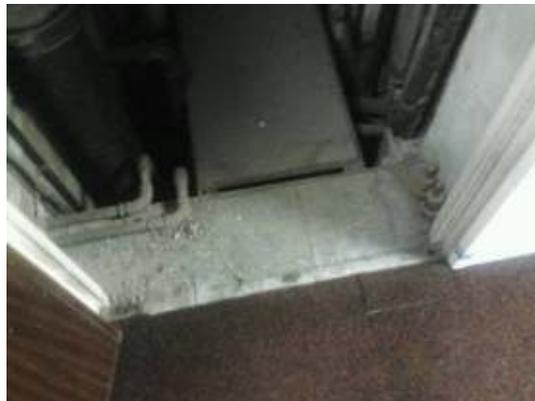
### 7.2.35 Room R2, 3rd Floor Riser, Floor Tiles, Vinyl

<b>Sample Number</b>	36	<b>Condition</b>	N/A
<b>Extent</b>	1x0.25m	<b>Surface Treatment</b>	Composite Material
<b>Debris Present</b>	No	<b>HSE Licensable Material</b>	N/A
<b>Asbestos Type</b>	No Asbestos Detected

**Recommendations** No asbestos was detected in this sample

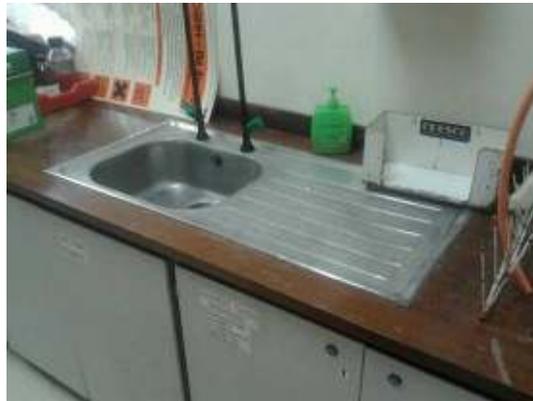
### 7.2.38 Rooms A301, 302, 303, 304, 3rd Floor Labs, Damper Pads Beneath Sinks, Bitumen Felt

<b>Sample Number</b>	39	<b>Condition</b>	N/A
<b>Extent</b>	2 no.	<b>Surface Treatment</b>	Composite Material
<b>Debris Present</b>	No	<b>HSE Licensable Material</b>	N/A
<b>Asbestos Type</b>	No Asbestos Detected

**Recommendations** No asbestos was detected in this sample

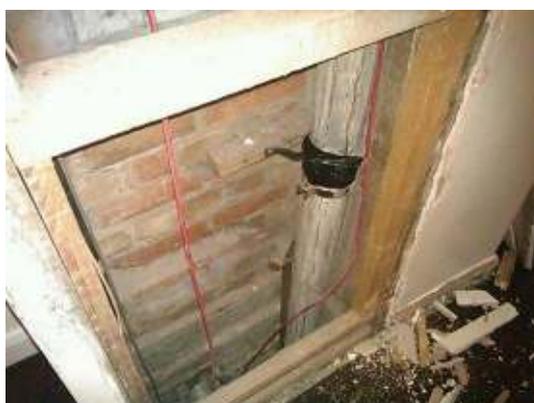
### 7.2.45 Room R7, Service Riser, Flue Pipe, Cement

<b>Sample Number</b>	46	<b>Condition</b>	Medium damage
<b>Extent</b>	15m x 100mm x 5mm	<b>Surface Treatment</b>	Unsealed
<b>Debris Present</b>	No	<b>HSE Licensable Material</b>	<b>No</b>
<b>Asbestos Type</b>	Amosite / Chrysotile

**Recommendations** This material is defined as Non-Licensable and if it is to be removed, it should be done using an HSE licensed removal contractor or by employees who are sufficiently trained and following the guidance in the HSE Asbestos Essentials Task Manual (HSG 210). The recent update in the Control of Asbestos Regulations (2012) requires work on some non-licensed asbestos containing materials to be notified to the appropriate authority and this should be established prior to any removal works.

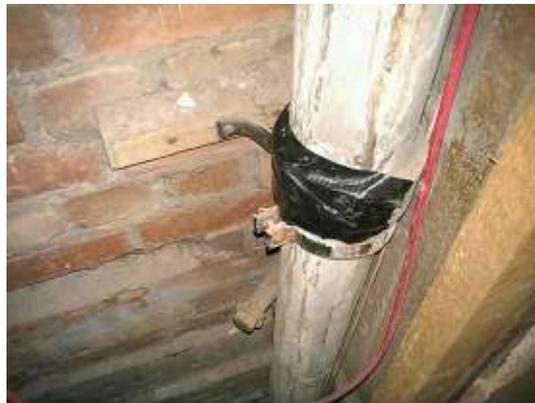
### 7.2.46 Room R7, Service Riser, Flue Pipe Joint Seal, Cement

<b>Sample Number</b>	47	<b>Condition</b>	Medium damage
<b>Extent</b>	1m x 10mm x 5mm	<b>Surface Treatment</b>	Unsealed
<b>Debris Present</b>	No	<b>HSE Licensable Material</b>	<b>No</b>
<b>Asbestos Type</b>	Amosite / Chrysotile

There are several joints throughout the length of pipe.

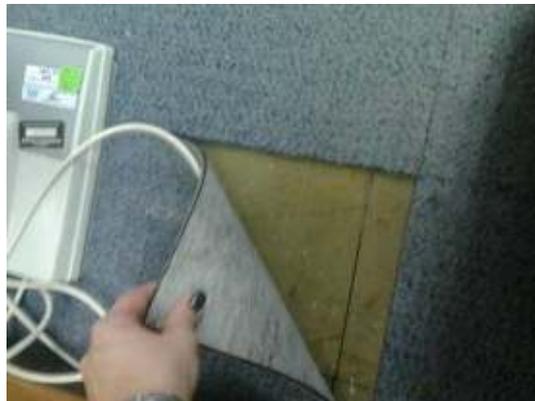
### 7.2.47 Room A218, 2nd Floor Office, Floor Tiles, Vinyl

<b>Sample Number</b>	48	<b>Condition</b>	Good
<b>Extent</b>	6x6m	<b>Surface Treatment</b>	Composite Material
<b>Debris Present</b>	No	<b>HSE Licensable Material</b>	<b>No</b>
<b>Asbestos Type</b>	Chrysotile

**Recommendations** No asbestos was detected in this sample

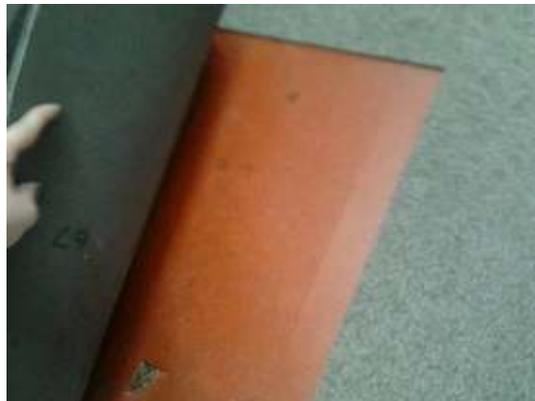
### 7.2.48 Room A210, 2nd Floor Office, Red Floor Tiles, Vinyl

<b>Sample Number</b>	49	<b>Condition</b>	N/A
<b>Extent</b>	3x3m	<b>Surface Treatment</b>	Composite Material
<b>Debris Present</b>	No	<b>HSE Licensable Material</b>	N/A
<b>Asbestos Type</b>	No Asbestos Detected

**Recommendations** No asbestos was detected in this sample

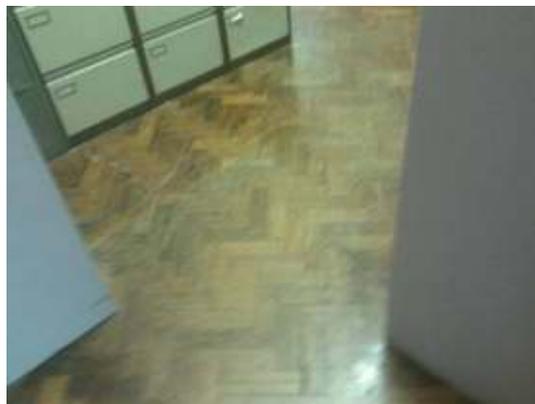
### 7.2.49 Rooms A201-204, 2nd Floor Staff Rooms & Class rooms, Bitumen adhesive to parquet flooring, Bitumen

<b>Sample Number</b>	50	<b>Condition</b>	N/A
<b>Extent</b>	6x50m	<b>Surface Treatment</b>	Bitumen Bonded
<b>Debris Present</b>	No	<b>HSE Licensable Material</b>	N/A
<b>Asbestos Type</b>	No Asbestos Detected

**Recommendations** No asbestos was detected in this sample

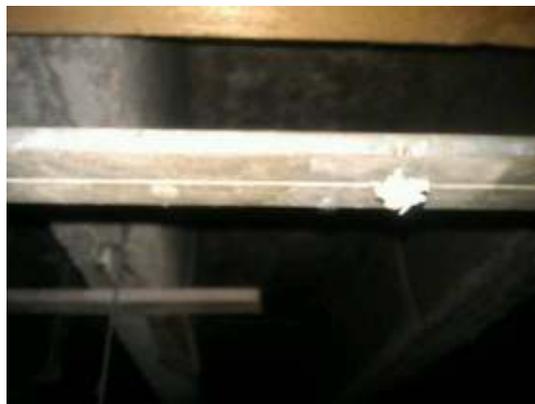
### 7.2.50 CV1, Ceiling Void Above GF Reception and offices, Debris, Insulating Board

<b>Sample Number</b>	51	<b>Condition</b>	High damage
<b>Extent</b>	40m x 20m x 5mm	<b>Surface Treatment</b>	Unsealed
<b>Debris Present</b>	Yes	<b>HSE Licensable Material</b>	<b>Yes</b>
<b>Asbestos Type</b>	Amosite / Chrysotile

There are several amounts of debris remaining within the ceiling void remaining from the previous ceiling boarding and is widespread throughout the full void area.

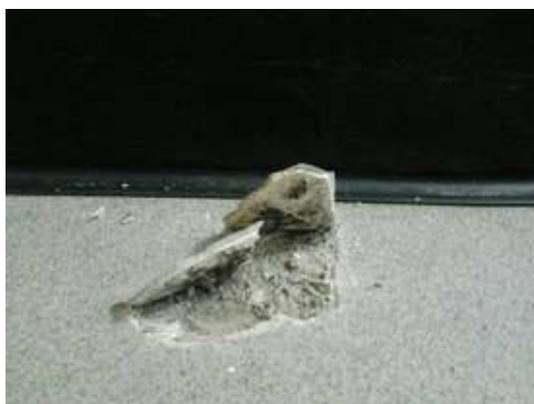
### 7.2.54 Room 2h, 2g, 2j, GF Toilets, Bitumen adhesive under lino, Bitumen

<b>Sample Number</b>	55	<b>Condition</b>	Good
<b>Extent</b>	4x5m	<b>Surface Treatment</b>	Bitumen Bonded
<b>Debris Present</b>	No	<b>HSE Licensable Material</b>	<b>No</b>
<b>Asbestos Type</b>	<b>Chrysotile</b>

**Comments** Composite from the 3 rooms

**Recommendations** This material is defined as Non-Licensable and if it is to be removed, it should be done using an HSE licensed removal contractor or by employees who are sufficiently trained and following the guidance in the HSE Asbestos Essentials Task Manual (HSG 210). The recent update in the Control of Asbestos Regulations (2012) requires work on some non-licensed asbestos containing materials to be notified to the appropriate authority and this should be established prior to any removal works.

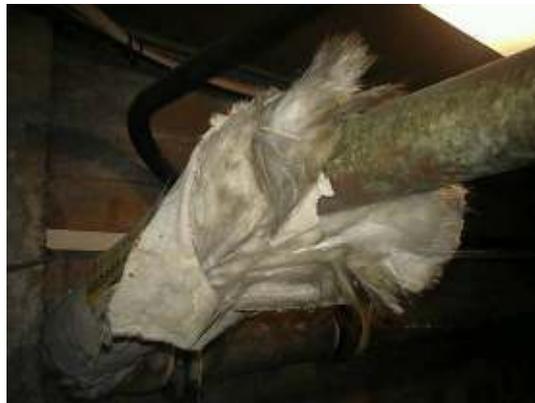
### 7.2.56 R4, GF-4th Floor Service Riser, Pipe Insulation Lining, Paper

<b>Sample Number</b>	57	<b>Condition</b>	High damage
<b>Extent</b>	50m x 2m x 5mm	<b>Surface Treatment</b>	Unsealed
<b>Debris Present</b>	Yes	<b>HSE Licensable Material</b>	<b>Yes</b>
<b>Asbestos Type</b>	Chrysotile

**Recommendations** This material is defined as Licensable and Notifiable and if it is to be removed, it should only be done using an HSE Licensed removal contractor.

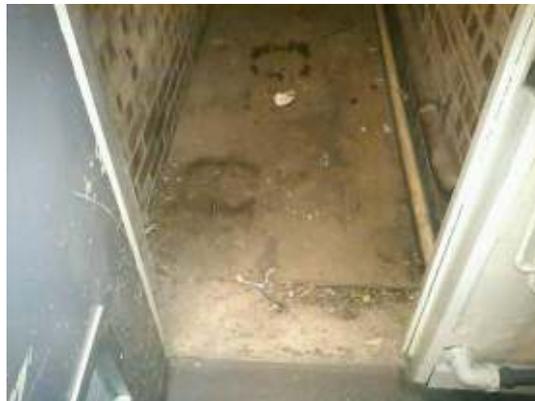
### 7.2.57 R4, GF-4th Floor Service Riser, Pipe Insulation Lining Debris, Paper

<b>Sample Number</b>	58	<b>Condition</b>	High damage
<b>Extent</b>	50m x 2m x 5mm	<b>Surface Treatment</b>	Unsealed
<b>Debris Present</b>	Yes	<b>HSE Licensable Material</b>	<b>Yes</b>
<b>Asbestos Type</b>	Chrysotile

**Recommendations** This material is defined as Licensable and Notifiable and if it is to be removed, it should only be done using an HSE Licensed removal contractor.

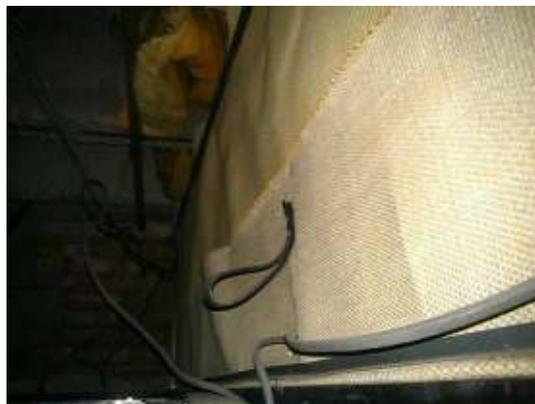
### 7.2.58 A230, 2nd Floor Corridor Ceiling Void, Fire Break Above Stairwell Double Doors, Textile

<b>Sample Number</b>	59	<b>Condition</b>	Medium damage
<b>Extent</b>	4m x 1m x 10mm	<b>Surface Treatment</b>	Unsealed
<b>Debris Present</b>	No	<b>HSE Licensable Material</b>	<b>Yes</b>
<b>Asbestos Type</b>	Chrysotile

**Recommendations** This material is defined as Licensable and Notifiable and if it is to be removed, it should only be done using an HSE Licensed removal contractor.

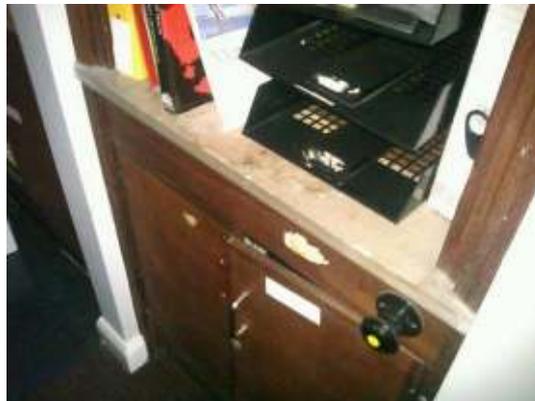
### 7.2.60 Room A205, 2nd Floor Office, Bottom Shelf to Fume Cupboard F1, Cement

<b>Sample Number</b>	61	<b>Condition</b>	Low damage
<b>Extent</b>	1m x 1m x 20mm	<b>Surface Treatment</b>	Sealed
<b>Debris Present</b>	No	<b>HSE Licensable Material</b>	<b>No</b>
<b>Asbestos Type</b>	<b>Chrysotile</b>

**Recommendations** This material is defined as Non-Licensable and if it is to be removed, it should be done using an HSE licensed removal contractor or by employees who are sufficiently trained and following the guidance in the HSE Asbestos Essentials Task Manual (HSG 210). The recent update in the Control of Asbestos Regulations (2012) requires work on some non-licensed asbestos containing materials to be notified to the appropriate authority and this should be established prior to any removal works.

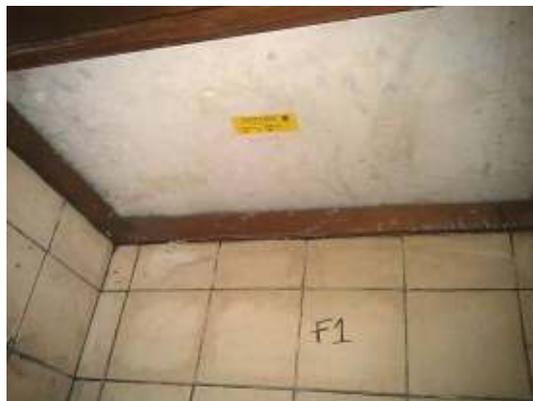
### 7.2.61 Room A205, 2nd Floor Office, Top Shelf to Fume Cupboard F1, Insulating Board

<b>Sample Number</b>	62	<b>Condition</b>	Low damage
<b>Extent</b>	1m x 1m x 20mm	<b>Surface Treatment</b>	Unsealed
<b>Debris Present</b>	No	<b>HSE Licensable Material</b>	<b>Yes</b>
<b>Asbestos Type</b>	Amosite / Chrysotile

**Recommendations** This material is defined as Licensable and Notifiable and if it is to be removed, it should only be done using an HSE Licensed removal contractor.

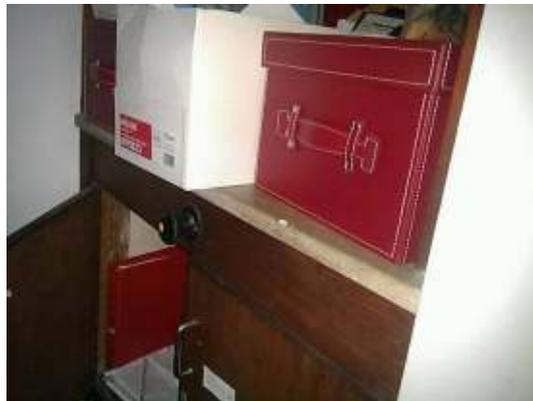
### 7.2.62 Room A205, 2nd Floor Office, Bottom Shelf to Fume Cupboard F2, Cement

<b>Sample Number</b>	63	<b>Condition</b>	Low damage
<b>Extent</b>	1m x 1m x 20mm	<b>Surface Treatment</b>	Sealed
<b>Debris Present</b>	No	<b>HSE Licensable Material</b>	No
<b>Asbestos Type</b>	Chrysotile

**Recommendations** This material is defined as Non-Licensable and if it is to be removed, it should be done using an HSE licensed removal contractor or by employees who are sufficiently trained and following the guidance in the HSE Asbestos Essentials Task Manual (HSG 210). The recent update in the Control of Asbestos Regulations (2012) requires work on some non-licensed asbestos containing materials to be notified to the appropriate authority and this should be established prior to any removal works.

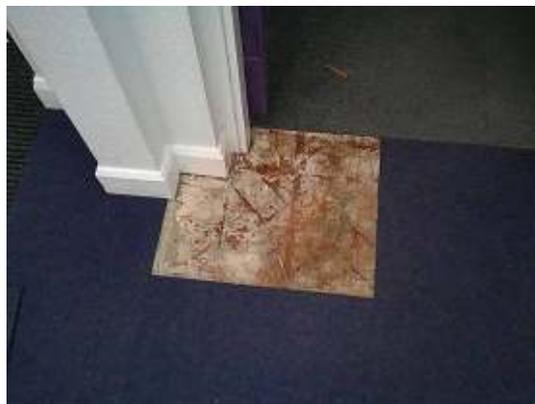
### 7.2.66 Room A150a, 1st Floor Lift Lobby Corridor, Floor Under Carpets & Timber, Bitumen Adhesive

<b>Sample Number</b>	67	<b>Condition</b>	N/A
<b>Extent</b>	5m x 5m x 5mm	<b>Surface Treatment</b>	Bitumen Bonded
<b>Debris Present</b>	No	<b>HSE Licensable Material</b>	N/A
<b>Asbestos Type</b>	No Asbestos Detected

**Recommendations** No asbestos was detected in this sample

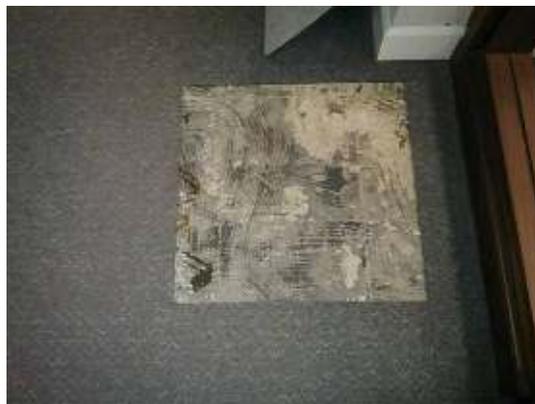
### 7.2.67 Room A160-A162, 1st Floor Offices, Floor Under Carpets & Timber, Blue Floor Tiles

<b>Sample Number</b>	68	<b>Condition</b>	Low damage
<b>Extent</b>	10m x 5m x 5mm	<b>Surface Treatment</b>	Bitumen Bonded
<b>Debris Present</b>	No	<b>HSE Licensable Material</b>	<b>No</b>
<b>Asbestos Type</b>	<b>Chrysotile</b>

**Recommendations** This material is defined as Non-Licensable and if it is to be removed, it should be done using an HSE licensed removal contractor or by employees who are sufficiently trained and following the guidance in the HSE Asbestos Essentials Task Manual (HSG 210). The recent update in the Control of Asbestos Regulations (2012) requires work on some non-licensed asbestos containing materials to be notified to the appropriate authority and this should be established prior to any removal works.

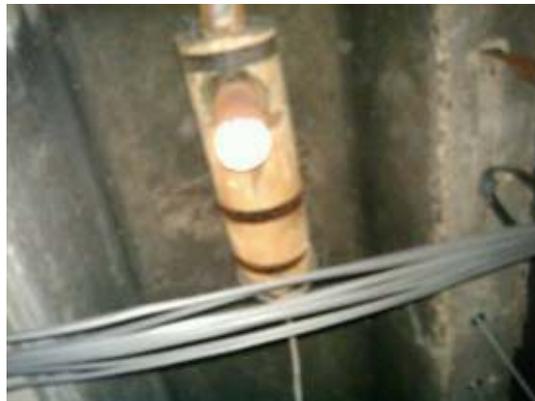
### 7.2.68 Room A150a, 1st Floor Corridor Ceiling Void, Pipe Insulation Lining, Paper

<b>Sample Number</b>	69	<b>Condition</b>	Medium damage
<b>Extent</b>	20m x 3m x 5mm	<b>Surface Treatment</b>	Unsealed
<b>Debris Present</b>	No	<b>HSE Licensable Material</b>	<b>Yes</b>
<b>Asbestos Type</b>	Chrysotile

**Recommendations** This material is defined as Licensable and Notifiable and if it is to be removed, it should only be done using an HSE Licensed removal contractor.

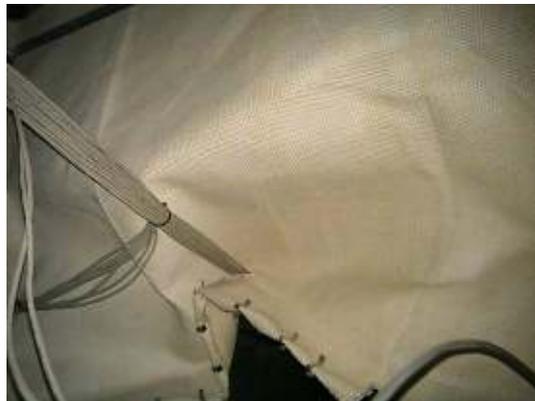
### 7.2.69 Room A150a & A150, 1st Floor Ceiling Voids, Fire Blankets, Textile

<b>Sample Number</b>	70	<b>Condition</b>	Medium damage
<b>Extent</b>	4m x 1m x 5mm	<b>Surface Treatment</b>	Unsealed
<b>Debris Present</b>	No	<b>HSE Licensable Material</b>	<b>Yes</b>
<b>Asbestos Type</b>	Chrysotile

**Recommendations** This material is defined as Licensable and Notifiable and if it is to be removed, it should only be done using an HSE Licensed removal contractor.

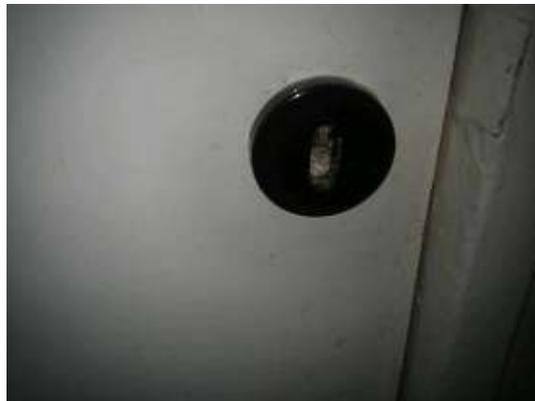
### 7.2.72 Room R6, GF Service Riser Entrance Door, Door Lining, Insulating Board

<b>Sample Number</b>	73	<b>Condition</b>	N/A
<b>Extent</b>	2m x 1m x 10mm	<b>Surface Treatment</b>	Sealed
<b>Debris Present</b>	No	<b>HSE Licensable Material</b>	N/A
<b>Asbestos Type</b>	No Asbestos Detected

**Recommendations** No asbestos was detected in this sample

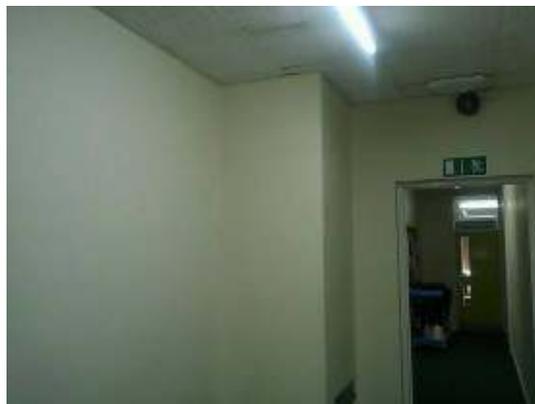
### 7.2.73 A417, 4th Floor Corridor, Face Boarding to Riser R2 Outside Room A406, Insulating Board

<b>Sample Number</b>	As 1	<b>Condition</b>	N/A
<b>Extent</b>	2m x 1m x 10mm	<b>Surface Treatment</b>	Painted
<b>Debris Present</b>	No	<b>HSE Licensable Material</b>	N/A
<b>Asbestos Type</b>	Material visually identical to referenced sample.

**Recommendations** No asbestos was detected in this sample

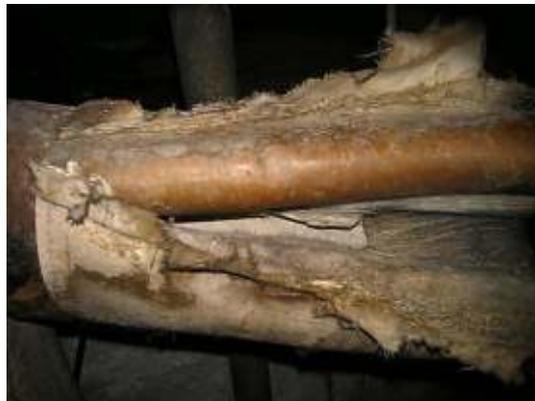
### 7.2.74 R4, Service Riser Next To Lift Shaft, Lining to Pipe Insulation, Paper

<b>Sample Number</b>	As 10	<b>Condition</b>	High damage
<b>Extent</b>	100m x 1m x 5mm	<b>Surface Treatment</b>	Unsealed
<b>Debris Present</b>	No	<b>HSE Licensable Material</b>	<b>Yes</b>
<b>Asbestos Type</b>	<b>Strongly Presumed to contain Chrysotile</b>

**Recommendations** This material is defined as Licensable and Notifiable and if it is to be removed, it should only be done using an HSE Licensed removal contractor.

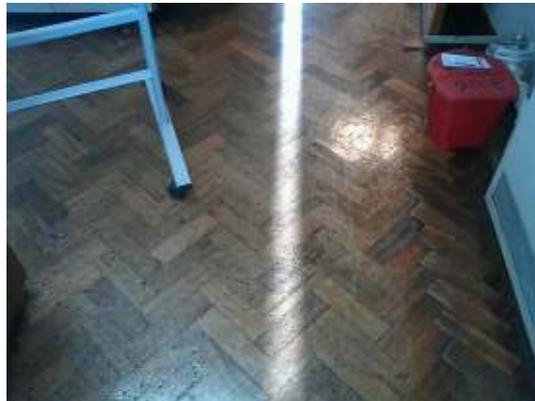
### 7.2.75 Rooms A303, A304 & A304, 3rd Floor Labs, Floor Adhesive Under Timber, Bitumen

<b>Sample Number</b>	As 16	<b>Condition</b>	N/A
<b>Extent</b>	30m x 10m x 5mm	<b>Surface Treatment</b>	Bitumen Bonded
<b>Debris Present</b>	No	<b>HSE Licensable Material</b>	N/A
<b>Asbestos Type</b>	Material visually identical to referenced sample.

**Recommendations** No asbestos was detected in this sample

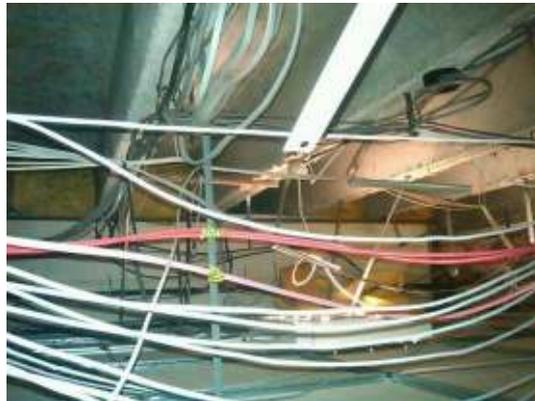
### 7.2.76 Room A330, 3rd Floor Corridor Ceiling Void, Fire Blanket Above Double Doors to Stairwell ST2, Textile

<b>Sample Number</b>	As 37	<b>Condition</b>	Medium damage
<b>Extent</b>	3M X 1M X 5MM	<b>Surface Treatment</b>	Unsealed
<b>Debris Present</b>	No	<b>HSE Licensable Material</b>	<b>Yes</b>
<b>Asbestos Type</b>	<b>Strongly Presumed to contain Chrysotile</b>

**Recommendations** This material is defined as Licensable and Notifiable and if it is to be removed, it should only be done using an HSE Licensed removal contractor.

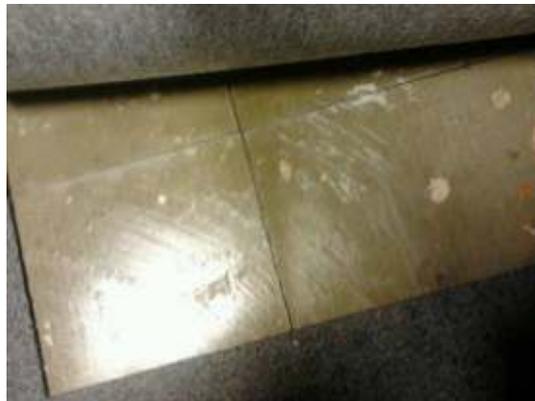
### 7.2.77 Room A214a, 2nd Floor Kitchen/Store, Floor Tiles, Vinyl

<b>Sample Number</b>	As 48	<b>Condition</b>	Good
<b>Extent</b>	2x3m	<b>Surface Treatment</b>	Composite Material
<b>Debris Present</b>	No	<b>HSE Licensable Material</b>	<b>No</b>
<b>Asbestos Type</b>	<b>Strongly Presumed to contain Chrysotile</b>

**Recommendations** This material is defined as Non-Licensable and if it is to be removed, it should be done using an HSE licensed removal contractor or by employees who are sufficiently trained and following the guidance in the HSE Asbestos Essentials Task Manual (HSG 210). The recent update in the Control of Asbestos Regulations (2012) requires work on some non-licensed asbestos containing materials to be notified to the appropriate authority and this should be established prior to any removal works.

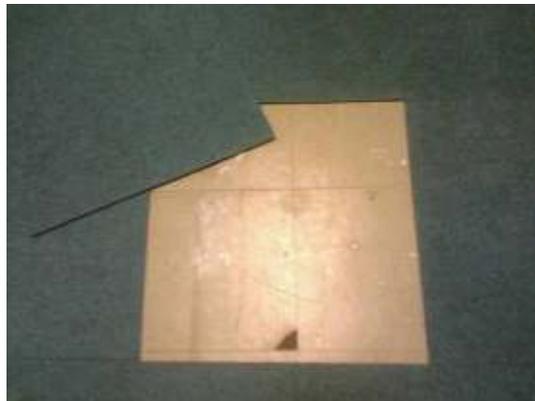
### 7.2.78 Room A215, 2nd Floor Meeting Room, Floor Tiles, Vinyl

<b>Sample Number</b>	As 48	<b>Condition</b>	Good
<b>Extent</b>	2x3.5m	<b>Surface Treatment</b>	Composite Material
<b>Debris Present</b>	No	<b>HSE Licensable Material</b>	<b>No</b>
<b>Asbestos Type</b>	<b>Strongly Presumed to contain Chrysotile</b>

**Recommendations** This material is defined as Non-Licensable and if it is to be removed, it should be done using an HSE licensed removal contractor or by employees who are sufficiently trained and following the guidance in the HSE Asbestos Essentials Task Manual (HSG 210). The recent update in the Control of Asbestos Regulations (2012) requires work on some non-licensed asbestos containing materials to be notified to the appropriate authority and this should be established prior to any removal works.

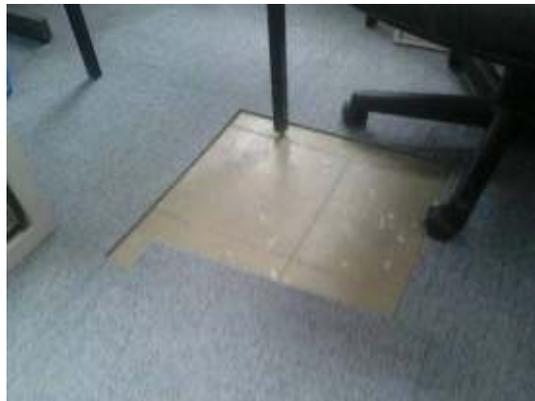
### 7.2.80 Room A213, 2nd Floor Server Room, Floor Tiles, Vinyl

<b>Sample Number</b>	As 48	<b>Condition</b>	Good
<b>Extent</b>	2x3m	<b>Surface Treatment</b>	Composite Material
<b>Debris Present</b>	No	<b>HSE Licensable Material</b>	<b>No</b>
<b>Asbestos Type</b>	<b>Strongly Presumed to contain Chrysotile</b>

**Recommendations** This material is defined as Non-Licensable and if it is to be removed, it should be done using an HSE licensed removal contractor or by employees who are sufficiently trained and following the guidance in the HSE Asbestos Essentials Task Manual (HSG 210). The recent update in the Control of Asbestos Regulations (2012) requires work on some non-licensed asbestos containing materials to be notified to the appropriate authority and this should be established prior to any removal works.

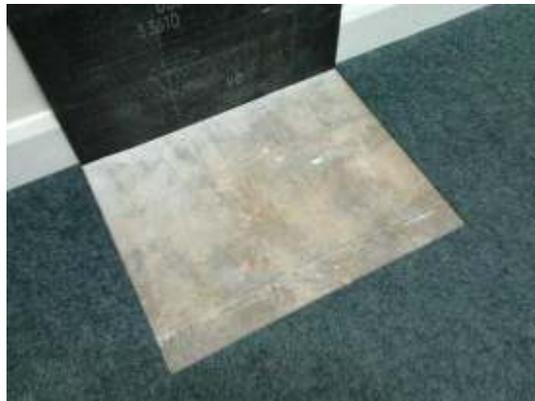
### 7.2.81 Room C2a, GF Finance Office, Grey Floor Tiles, Vinyl

<b>Sample Number</b>	As 52	<b>Condition</b>	Good
<b>Extent</b>	5x9m <sup>2</sup>	<b>Surface Treatment</b>	Composite Material
<b>Debris Present</b>	No	<b>HSE Licensable Material</b>	<b>No</b>
<b>Asbestos Type</b>	<b>Strongly Presumed to contain Chrysotile</b>

**Recommendations** This material is defined as Non-Licensable and if it is to be removed, it should be done using an HSE licensed removal contractor or by employees who are sufficiently trained and following the guidance in the HSE Asbestos Essentials Task Manual (HSG 210). The recent update in the Control of Asbestos Regulations (2012) requires work on some non-licensed asbestos containing materials to be notified to the appropriate authority and this should be established prior to any removal works.

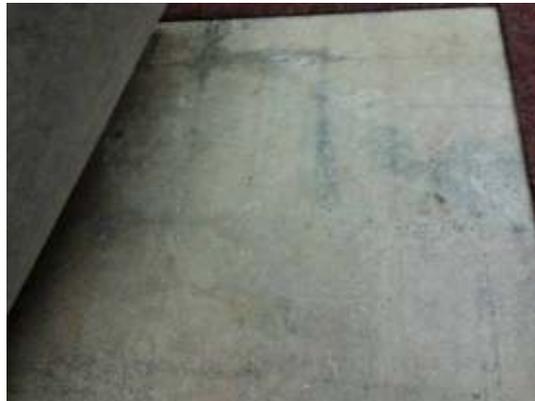
### 7.2.82 Room 001 & 001a, GF Principal Office, Bitumen adhesive to Parquet floor, Bitumen

<b>Sample Number</b>	As 56	<b>Condition</b>	N/A
<b>Extent</b>	12x6m	<b>Surface Treatment</b>	Bitumen Bonded
<b>Debris Present</b>	No	<b>HSE Licensable Material</b>	N/A
<b>Asbestos Type</b>	Material visually identical to referenced sample.

**Comments** Under carpets

**Recommendations** No asbestos was detected in this sample

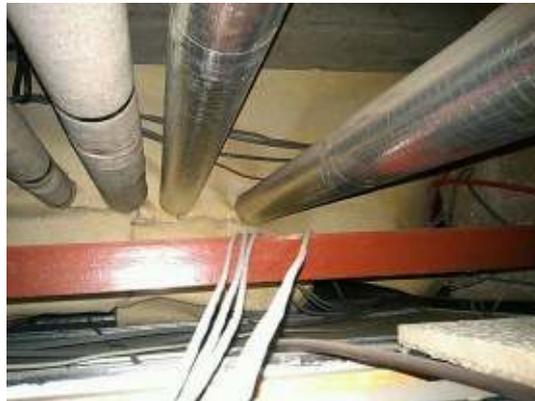
### 7.2.83 A230, 2nd Floor Corridor Ceiling Void, Fire Break Above Corridor Double Doors, Textile

<b>Sample Number</b>	As 59	<b>Condition</b>	Medium damage
<b>Extent</b>	4m x 1m x 10mm	<b>Surface Treatment</b>	Unsealed
<b>Debris Present</b>	No	<b>HSE Licensable Material</b>	<b>Yes</b>
<b>Asbestos Type</b>	<b>Strongly Presumed to contain Chrysotile</b>

**Recommendations** This material is defined as Licensable and Notifiable and if it is to be removed, it should only be done using an HSE Licensed removal contractor.

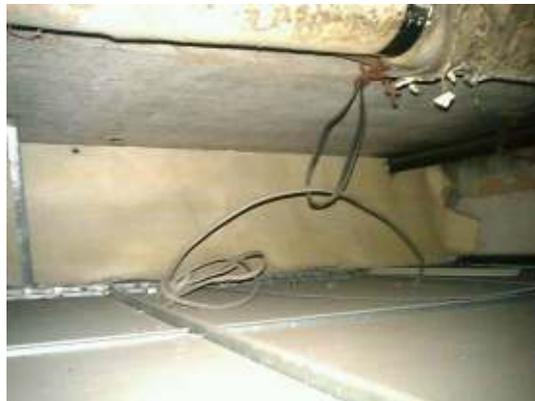
### 7.2.84 Room A205, 2nd Floor Office, Fire Blanket Above Ceiling, Textile

<b>Sample Number</b>	As 59	<b>Condition</b>	Medium damage
<b>Extent</b>	4m x 1m x 5mm	<b>Surface Treatment</b>	Unsealed
<b>Debris Present</b>	No	<b>HSE Licensable Material</b>	<b>Yes</b>
<b>Asbestos Type</b>	<b>Strongly Presumed to contain Chrysotile</b>

**Recommendations** This material is defined as Licensable and Notifiable and if it is to be removed, it should only be done using an HSE Licensed removal contractor.

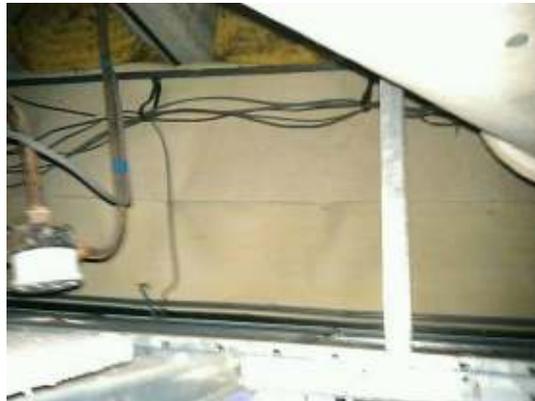
### 7.2.85 A230, 2nd Floor Corridor Ceiling Void, Fire Break Above Far End Stairwell Double Doors, Textile

<b>Sample Number</b>	As 59	<b>Condition</b>	Medium damage
<b>Extent</b>	4m x 1m x 10mm	<b>Surface Treatment</b>	Unsealed
<b>Debris Present</b>	No	<b>HSE Licensable Material</b>	<b>Yes</b>
<b>Asbestos Type</b>	<b>Strongly Presumed to contain Chrysotile</b>

**Recommendations** This material is defined as Licensable and Notifiable and if it is to be removed, it should only be done using an HSE Licensed removal contractor.

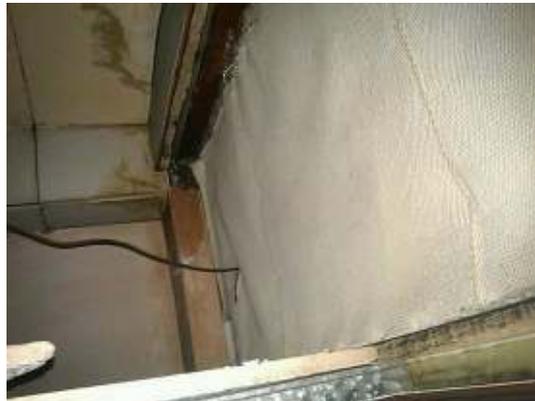
### 7.2.86 Room A417, 4th Floor Corridor, Fire Break Above Middle Mains Double Doors to Stairs ST1, Textile

<b>Sample Number</b>	As 6	<b>Condition</b>	Medium damage
<b>Extent</b>	4M X 1M X 5MM	<b>Surface Treatment</b>	Unsealed
<b>Debris Present</b>	No	<b>HSE Licensable Material</b>	<b>Yes</b>
<b>Asbestos Type</b>	<b>Strongly Presumed to contain Chrysotile</b>

**Recommendations** This material is defined as Licensable and Notifiable and if it is to be removed, it should only be done using an HSE Licensed removal contractor.

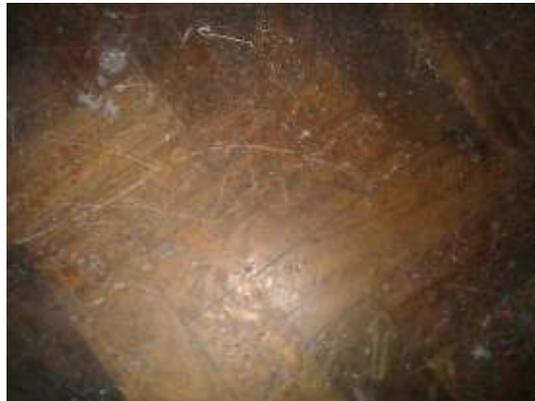
### 7.2.87 Room A117, 1st Floor Classroom, Floor Under Carpets & Timber, Bitumen Adhesive

<b>Sample Number</b>	As 67	<b>Condition</b>	N/A
<b>Extent</b>	30m x 5m x 5mm	<b>Surface Treatment</b>	Bitumen Bonded
<b>Debris Present</b>	No	<b>HSE Licensable Material</b>	N/A
<b>Asbestos Type</b>	Material visually identical to referenced sample.

**Recommendations** No asbestos was detected in this sample

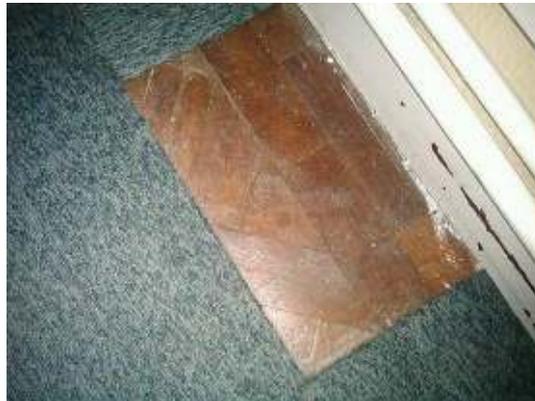
### 7.2.88 Room A101a, A102,A102a,A103, 1st Floor Classrooms, Floor Under Carpets & Timber, Bitumen Adhesive

<b>Sample Number</b>	As 67	<b>Condition</b>	N/A
<b>Extent</b>	30m x 5m x 5mm	<b>Surface Treatment</b>	Bitumen Bonded
<b>Debris Present</b>	No	<b>HSE Licensable Material</b>	N/A
<b>Asbestos Type</b>	Material visually identical to referenced sample.

**Recommendations** No asbestos was detected in this sample

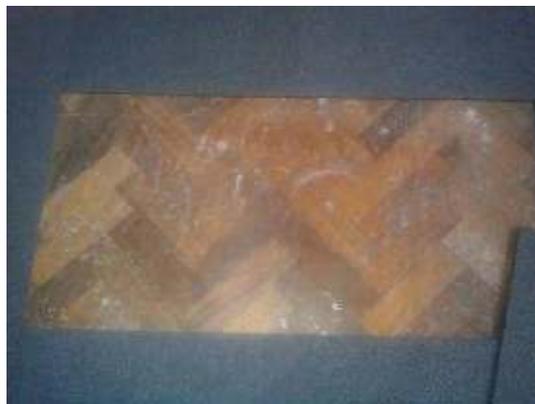
### 7.2.89 Room A116, 1st Floor Classroom, Floor Under Carpets & Timber, Bitumen Adhesive

<b>Sample Number</b>	As 67	<b>Condition</b>	N/A
<b>Extent</b>	30m x 5m x 5mm	<b>Surface Treatment</b>	Bitumen Bonded
<b>Debris Present</b>	No	<b>HSE Licensable Material</b>	N/A
<b>Asbestos Type</b>	Material visually identical to referenced sample.

**Recommendations** No asbestos was detected in this sample

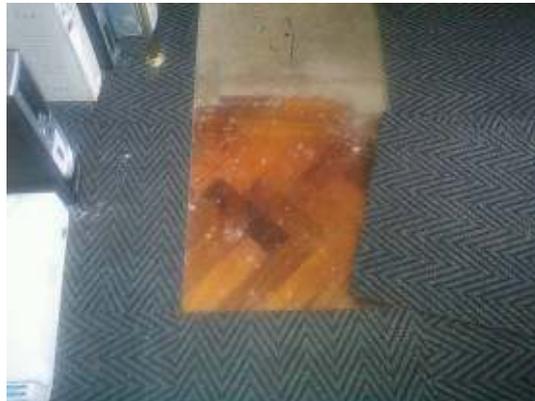
### 7.2.90 Room A116a, 1st Floor Server Room, Floor Under Carpets & Timber, Bitumen Adhesive

<b>Sample Number</b>	As 67	<b>Condition</b>	N/A
<b>Extent</b>	30m x 5m x 5mm	<b>Surface Treatment</b>	Bitumen Bonded
<b>Debris Present</b>	No	<b>HSE Licensable Material</b>	N/A
<b>Asbestos Type</b>	Material visually identical to referenced sample.

**Recommendations** No asbestos was detected in this sample

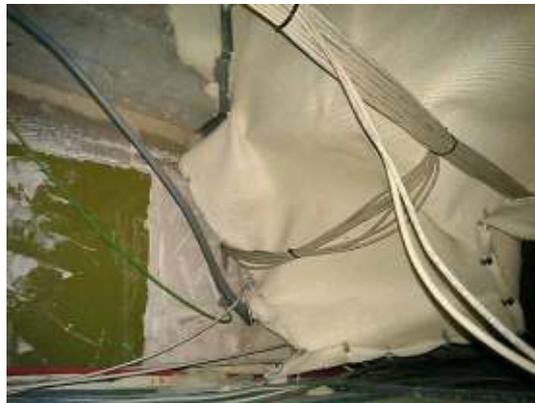
### 7.2.91 Room A150, 1st Floor Ceiling Voids, Fire Blankets in Ceil, Textile

<b>Sample Number</b>	As 70	<b>Condition</b>	Medium damage
<b>Extent</b>	4m x 1m x 5mm	<b>Surface Treatment</b>	Unsealed
<b>Debris Present</b>	No	<b>HSE Licensable Material</b>	<b>Yes</b>
<b>Asbestos Type</b>	<b>Strongly Presumed to contain Chrysotile</b>

**Recommendations** This material is defined as Licensable and Notifiable and if it is to be removed, it should only be done using an HSE Licensed removal contractor.

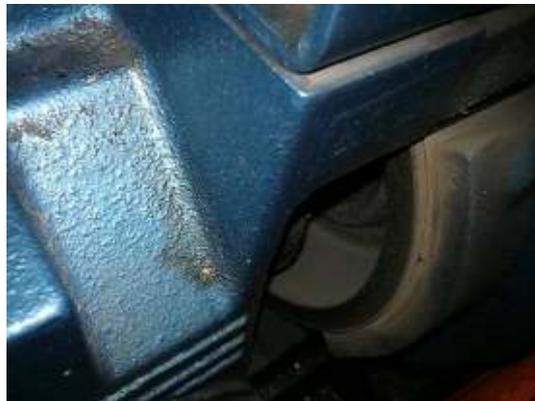
### 7.2.92 LM1, Lift Motor Room, Brake Pads On Lift Motor, Cement

<b>Sample Number</b>	SP 1	<b>Condition</b>	Low damage
<b>Extent</b>	200mx 200m x 10mm	<b>Surface Treatment</b>	Sealed
<b>Debris Present</b>	No	<b>HSE Licensable Material</b>	<b>No</b>
<b>Asbestos Type</b>	<b>Strongly Presumed to contain Chrysotile</b>

**Recommendations** This material is defined as Non-Licensable and if it is to be removed, it should be done using an HSE licensed removal contractor or by employees who are sufficiently trained and following the guidance in the HSE Asbestos Essentials Task Manual (HSG 210). The recent update in the Control of Asbestos Regulations (2012) requires work on some non-licensed asbestos containing materials to be notified to the appropriate authority and this should be established prior to any removal works.
