## Annual Inspection

West Swindon Parish Council

Middleleaze

Inspection Ref: 524050

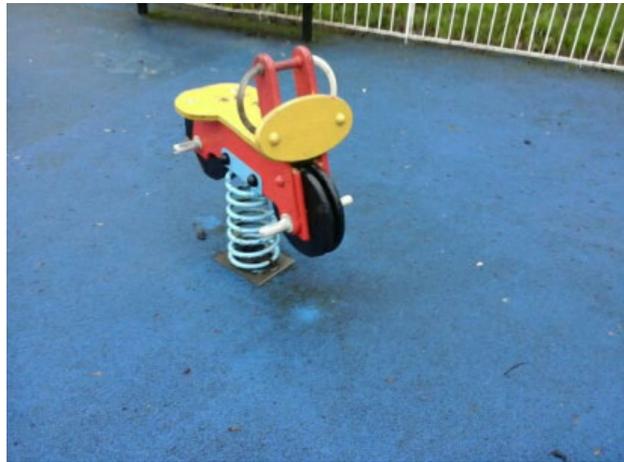
**Item:** Rocking Equipment - Spring Bike  
**Manufacturer:** Kompan Ltd  
**Surface Type:** Wet Pour  
**Equipment Compliance:** No  
**Surface Area Compliance:** Yes  
**Ref/Part Number:**  
**Total Findings:** 5

The end of handgrips and/or footrests have a cross section of less than 15cm<sup>2</sup> and fail to meet the requirements of BS EN 1176:2008 Part 6 - This is a relatively low risk failure and no remedial action is recommended

The paintwork on this item has been damaged or worn exposing the metal underneath which is rusting - Treat any rusting components and repaint

The end caps are missing on the Handgrips/Footrests - Replace missing end caps

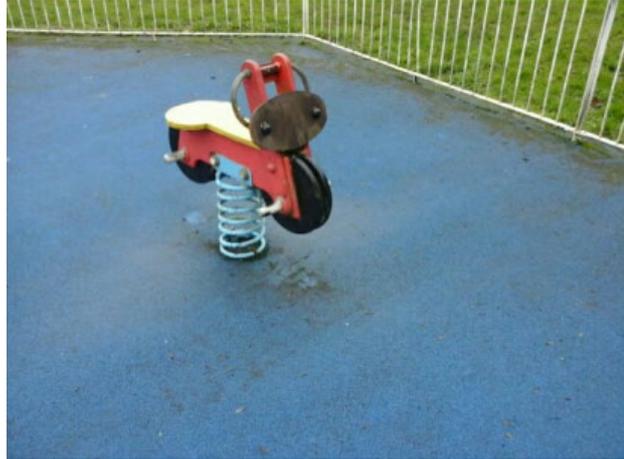
**Item:** Rocking Equipment - Spring Bike  
**Manufacturer:** Kompan Ltd  
**Surface Type:** Wet Pour  
**Equipment Compliance:** No  
**Surface Area Compliance:** Yes  
**Ref/Part Number:**  
**Total Findings:** 3

The paintwork on this item has been damaged or worn exposing the metal underneath which is rusting - Treat any rusting components and repaint

The end of handgrips and/or footrests have a cross section of less than 15cm<sup>2</sup> and fail to meet the requirements of BS EN 1176:2008 Part 6 - This is a relatively low risk failure and no remedial action is recommended

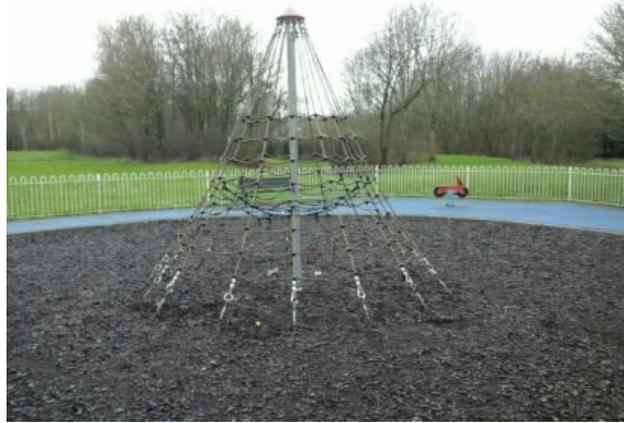
**Item:** Rotor Play - Cone Climber  
**Manufacturer:** Huck Nets (UK) Ltd  
**Surface Type:** Bark Mulch  
**Equipment Compliance:** Yes  
**Surface Area Compliance:** Yes  
**Ref/Part Number:**  
**Total Findings:** 2

The level of loose fill surfacing has fallen significantly below the minimum 200mm recommended by BS EN 1176 Part 1 - Top up loose fill surfacing to recommended levels.

The ropes/nets are worn/damaged in places - Monitor for any further deterioration and repair or replace as required

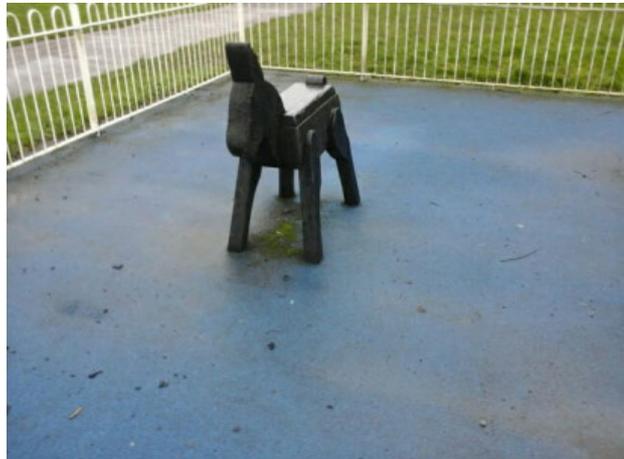
**Item:** Other - Wooden Animal  
**Manufacturer:** S M P (Playgrounds Ltd)  
**Surface Type:** Wet Pour  
**Equipment Compliance:** Yes  
**Surface Area Compliance:** Yes  
**Ref/Part Number:**  
**Total Findings:** 2

There is some evidence of rot in the timber - Monitor for any further deterioration and replace as required

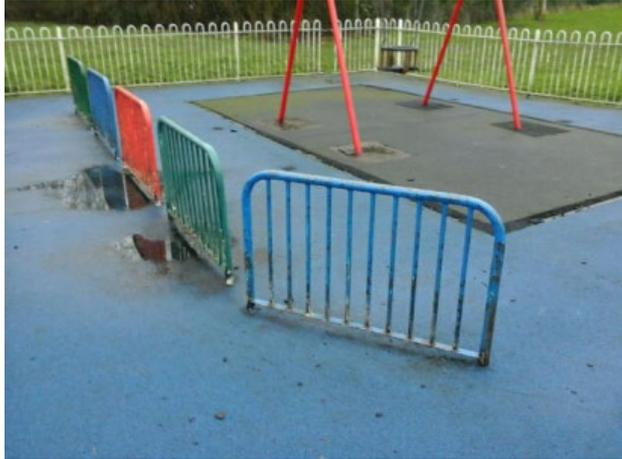
**Item:** Swings - Swing Barrier  
**Manufacturer:** Owner/Operator  
**Surface Type:** N/A  
**Equipment Compliance:** N/A  
**Surface Area Compliance:** N/A  
**Ref/Part Number:**  
**Total Findings:** 1

The paintwork on this item has been damaged or worn exposing the metal underneath which is rusting - Treat any rusting components and repaint

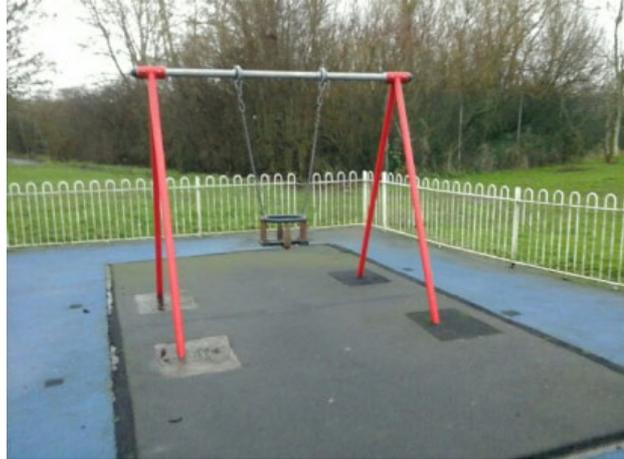
**Item:** Swings - 1 Bay 1 Seat (Cradle) - Type 1  
**Manufacturer:** Not Identified  
**Surface Type:** Wet Pour  
**Equipment Compliance:** No  
**Surface Area Compliance:** No  
**Ref/Part Number:**  
**Total Findings:** 5

The resin/concrete pads form hard objects within the impact area of the equipment in contravention of the requirements of BS EN 1176 Part 1 - Reinstate with appropriate safer surfacing

The surfacing width under each seat is less than 1.75 metres and fails the requirements of BS EN 1176 Part 2 - the concrete patches form hard objects in the impact area - Monitor use

The seat is severely damaged and requires replacing - Replace damaged seat

There is some notable evidence of chain wear - Monitor for any further deterioration and replace when 40% worn

The chain openings are in excess of the 8.6mm as recommended by BS EN 1176 - Monitor use

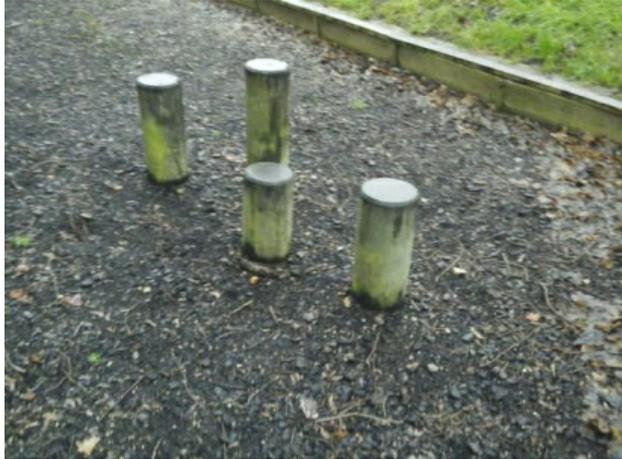
**Item:** Activity Equipment - Stepping Stones  
**Manufacturer:** Playdale Playgrounds Ltd  
**Surface Type:** Bark Mulch  
**Equipment Compliance:** No  
**Surface Area Compliance:** Yes  
**Ref/Part Number:**  
**Total Findings:** 2

There is some evidence of rot in the timber - Monitor for any further deterioration and replace as required

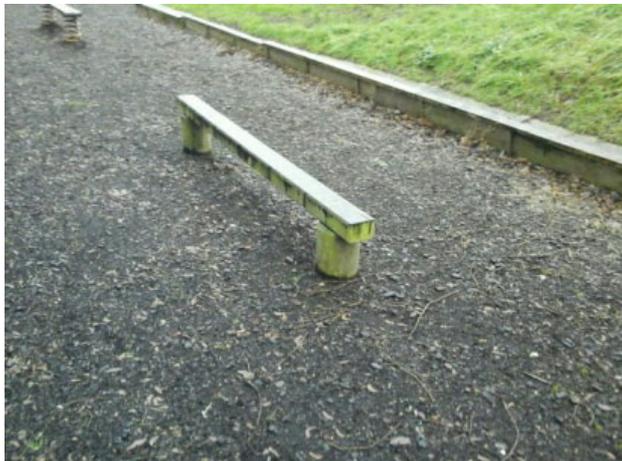
**Item:** Activity Equipment - Balance Beam  
**Manufacturer:** Playdale Playgrounds Ltd  
**Surface Type:** Bark Mulch  
**Equipment Compliance:** Yes  
**Surface Area Compliance:** Yes  
**Ref/Part Number:**  
**Total Findings:** 1

There is some evidence of rot in the timber - Monitor for any further deterioration and replace as required

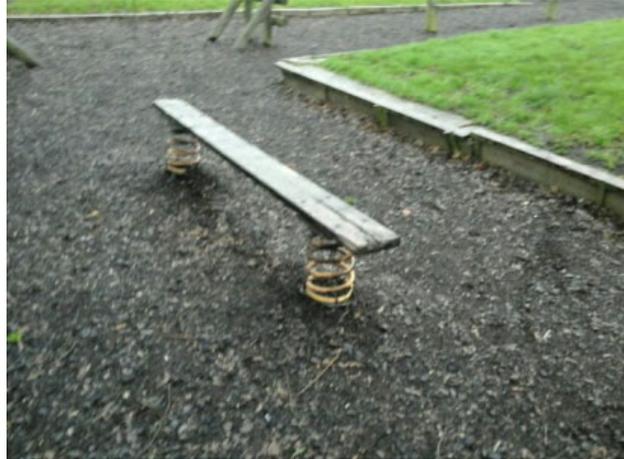
**Item:** Activity Equipment - Spring Balance Beam  
**Manufacturer:** Playdale Playgrounds Ltd  
**Surface Type:** Bark Mulch  
**Equipment Compliance:** Yes  
**Surface Area Compliance:** Yes  
**Ref/Part Number:**  
**Total Findings:** 3

There is some evidence of rot in the timber - Monitor for any further deterioration and replace as required

The paintwork on the spring has been damaged or worn exposing the metal underneath which is rusting - Treat any rusting components and repaint

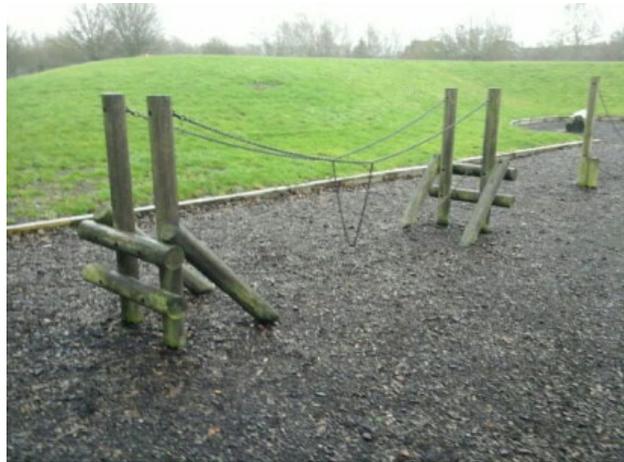
**Item:** Activity Equipment - Burma Bridge  
**Manufacturer:** Playdale Playgrounds Ltd  
**Surface Type:** Bark Mulch  
**Equipment Compliance:** No  
**Surface Area Compliance:** Yes  
**Ref/Part Number:**  
**Total Findings:** 6

There is some evidence of rot in the timber - Monitor for any further deterioration and replace as required

There are areas or parts of angled timber supports x2 on the structure that have rotted - Replace all affected timbers

There is some chain and eye bolt wear - Monitor for any further deterioration and replace when 40% worn

The timber has a number of air cracks apparent, the splits will have penetrated the preservative applied to the timber and allow water ingress to the unprotected areas - Monitor for any deterioration (rot) and replace as required

The chain openings are in excess of the 8.6mm as recommended by BS EN 1176 - Monitor use and replace with compliant chains during next maintenance cycle.

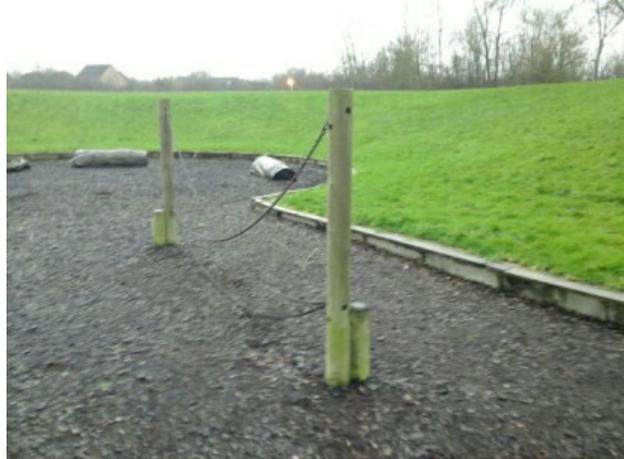
**Item:** Activity Equipment - Chain Traverse  
**Manufacturer:** Playdale Playgrounds Ltd  
**Surface Type:** Bark Mulch  
**Equipment Compliance:** No  
**Surface Area Compliance:** Yes  
**Ref/Part Number:**  
**Total Findings:** 7

A number of eye bolt fixing(s) have worked loose - Secure all loose fixings

There is some evidence of rot in the timber - Monitor for any further deterioration and replace as required

There is some chain and connecting link wear - Monitor for any further deterioration and replace when 40% worn

The timber has a number of air cracks apparent, the splits will have penetrated the preservative applied to the timber and allow water ingress to the unprotected areas - Monitor for any deterioration (rot) and replace as required

The chain openings are in excess of the 8.6mm as recommended by BS EN 1176 - Monitor use

There is/are finger entrapment/s in the posts and the item fails to meet the requirements of BS EN 1176:2008 Part 1 4.2.7.6 Entrapment of fingers - Monitor use

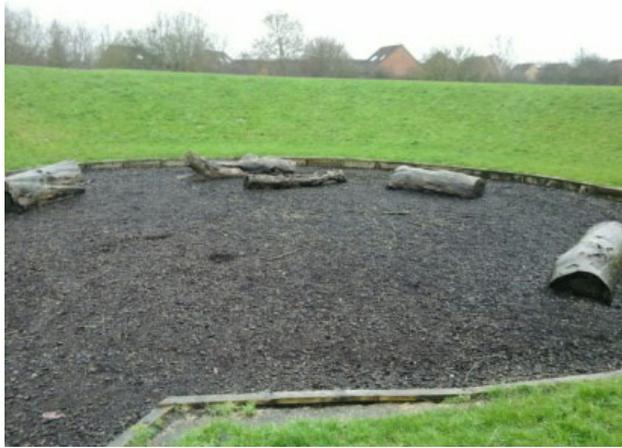
**Item:** Other - Fallen Tree  
**Manufacturer:** Not Identified  
**Surface Type:** Bark Mulch  
**Equipment Compliance:** N/A  
**Surface Area Compliance:** N/A  
**Ref/Part Number:**  
**Total Findings:** 3

Fungus or algae was found on the logs - Remove fungi or algae from the logs

There is some evidence of rot in the timber - Monitor for any further deterioration and replace as required

There are areas or parts of a log that have rotted extensively - Recommend removal of log

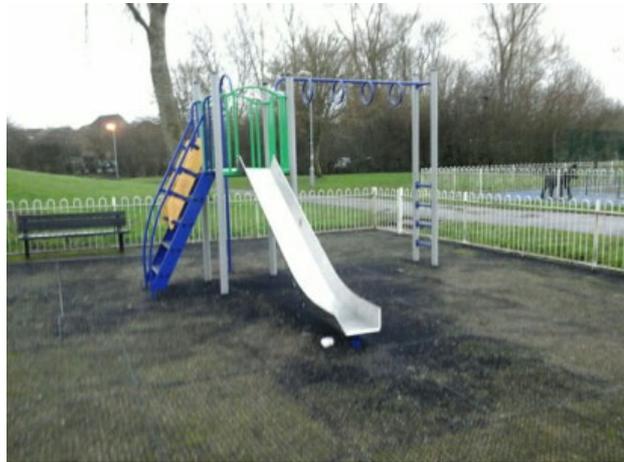
**Item:** Activity Equipment - Multi Play (Junior)  
**Manufacturer:** Not Identified  
**Surface Type:** Grass Matrix Tiles  
**Equipment Compliance:** Yes  
**Surface Area Compliance:** Yes  
**Ref/Part Number:**  
**Total Findings:** 3

The grass mats are silted up and the soil is compacted; this may have an effect on the impact absorbing properties of the surface - Lift and relay mats or test impact absorbing properties to ensure the correct surface qualities are maintained for the equipment

The resin patch repair to the surfacing forms a hard object within the impact area of the equipment in contravention of the requirements of BS EN 1176 Part 1 - Remove resin and repair surfacing using an appropriate medium

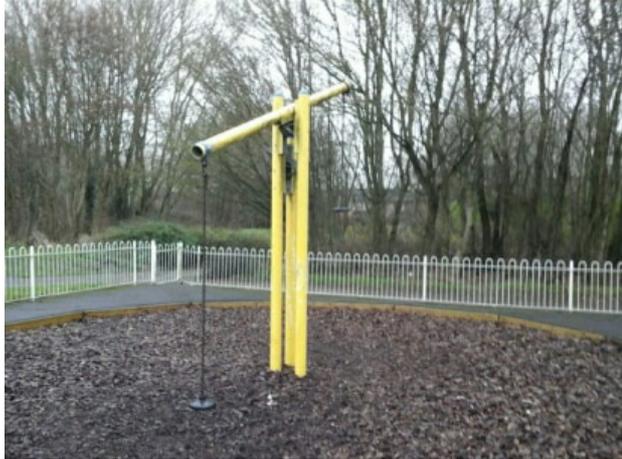
**Item:** Rocking Equipment - Overhead See Saw  
**Manufacturer:** Not Identified  
**Surface Type:** Bark Mulch  
**Equipment Compliance:** No  
**Surface Area Compliance:** Yes  
**Ref/Part Number:**  
**Total Findings:** 5

There are post caps missing from the item - Replace missing post caps

The rubber buffers are worn - Replace the buffers

The chain on one seat was wrapped around the cross bar at the time of inspection and the inspector has been unable to fully assess their condition - Unwrap chain from the crossbar and check for any broken or worn links etc.

The item has missing component(s) - Consider replacing missing components

The chain openings are in excess of 8.6mm as recommended by BS EN 1176 - Monitor use and replace with compliant chains during next maintenance cycle

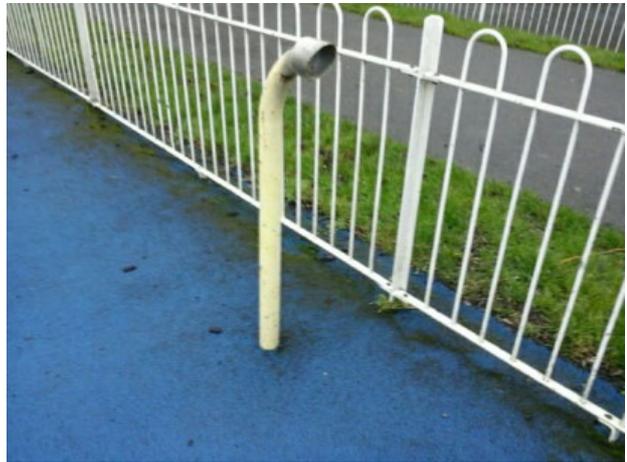
**Item:** Other - Talk Tubes  
**Manufacturer:** Not Identified  
**Surface Type:** Wet Pour  
**Equipment Compliance:** Yes  
**Surface Area Compliance:** N/A  
**Ref/Part Number:**  
**Total Findings:** 1

The paintwork on this item has been damaged or worn exposing the metal underneath which is rusting - Treat any rusting components and repaint

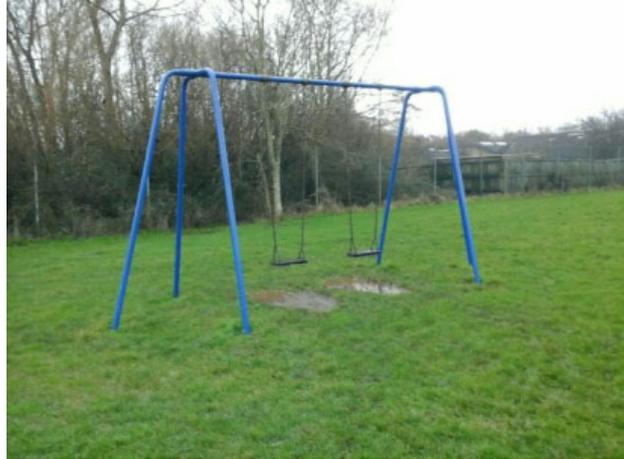
**Item:** Swings - 1 Bay 2 Seat (Flat)  
**Manufacturer:** Not Identified  
**Surface Type:** Grass Matrix Tiles  
**Equipment Compliance:** No  
**Surface Area Compliance:** Yes  
**Ref/Part Number:**  
**Total Findings:** 5

Fixing Pins have been installed in the impact areas of the grass mats - Remove pins from impact areas

The seat is severely damaged and requires replacing - Replace damaged seat

The swing seat connectors are loose - Tighten to secure

There is some chain wear - Monitor for any further deterioration and replace when 40% worn

The chain openings are in excess of the 8.6mm as recommended by BS EN 1176 - Monitor use and replace with compliant chains during next maintenance cycle.

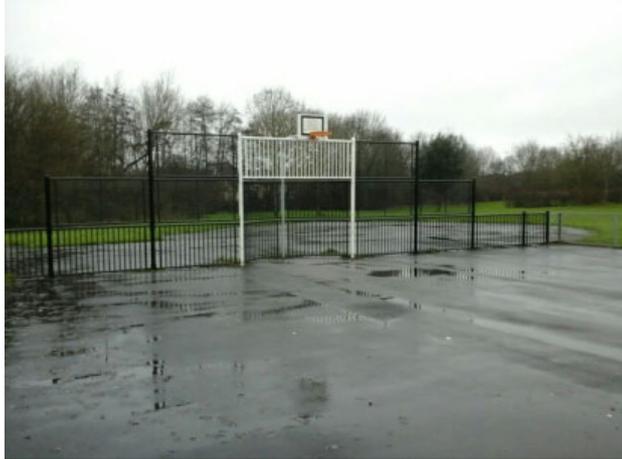
**Item:** Multi Use Games Area - Multi Use Games Area (MUGA)  
**Manufacturer:** Unknown  
**Surface Type:** Bitmac  
**Equipment Compliance:** No  
**Surface Area Compliance:** N/A  
**Ref/Part Number:**  
**Total Findings:** 5

A clearly visible sign should be provided in a prominent position with the wording as detailed BS EN 15312- the equipment is not intended for children less than 3 years old- the warning Do not climb on the framework or nets- the warning Do not hang on the ring (if provided)- the warning Do not wear rings or other jewellery- name and telephone number of the administrator- number to call in case of accident - Provide signage to BS EN 15312

There is/are finger entrapments in the framework due to missing inserts and the item fails to meet the requirements of BS EN 15312 Clause 4.4.2.2 Entrapment of fingers - Replace missing inserts to remove entrapments

The item fails to meet the requirements of BS EN 15312 4.4.2.1 head and neck entrapment between the framework - Monitor use

The nets are damaged - Remove net remnants

There is or are fixings missing on the item - Replace all missing fixings

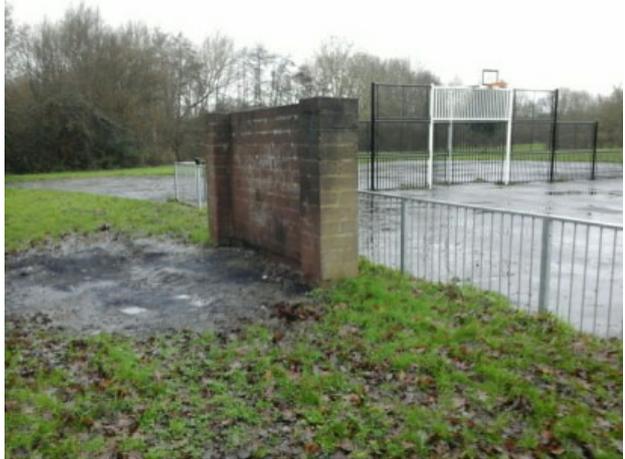
**Item:** Multi Use Games Area - Target Wall  
**Manufacturer:** Not Identified  
**Surface Type:** Grass  
**Equipment Compliance:** N/A  
**Surface Area Compliance:** N/A  
**Ref/Part Number:**  
**Total Findings:** 1

There is some graffiti present on site - Remove the graffiti

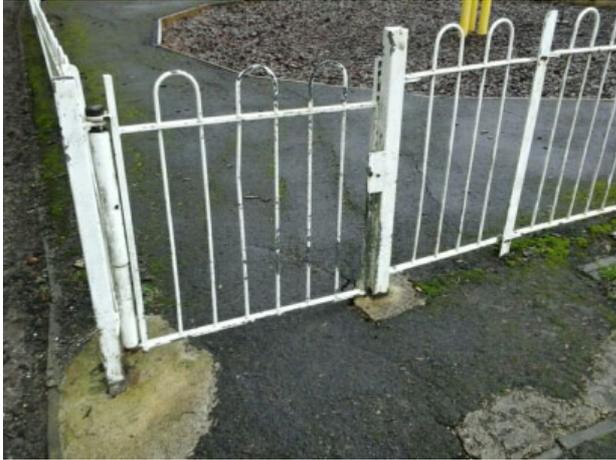
**Item:** Ancillary Items - Gate - Self Closing  
**Manufacturer:** Owner/Operator

**Finding:** There is some minor damage to the gate

**Action:** Monitor for any further deterioration and repair as required

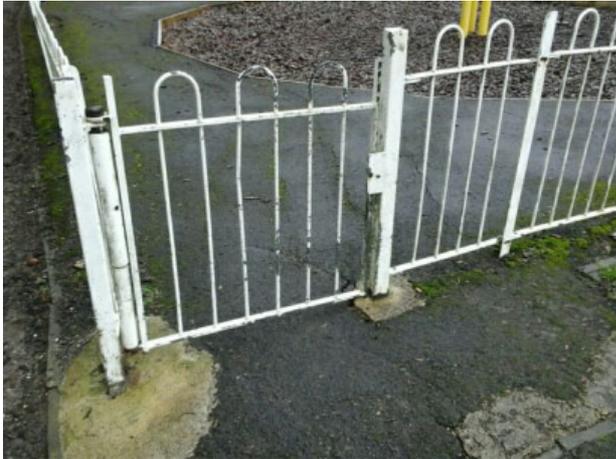
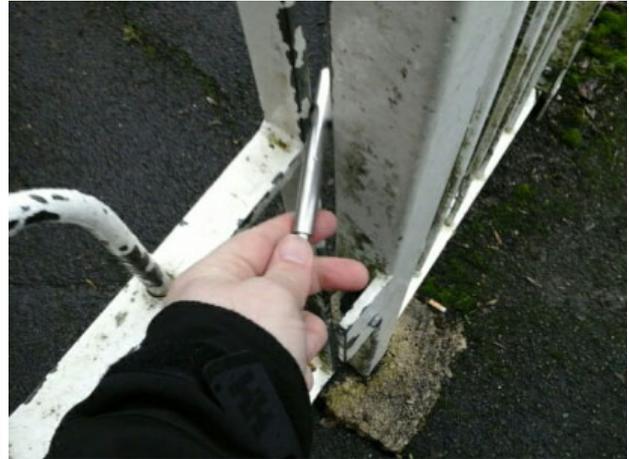
**Item:** Ancillary Items - Gate - Self Closing  
**Manufacturer:** Owner/Operator

**Finding:** The opening between the gate and the post is less than 12mm and could trap users fingers

**Action:** Adjust gate to ensure a 12mm opening all around

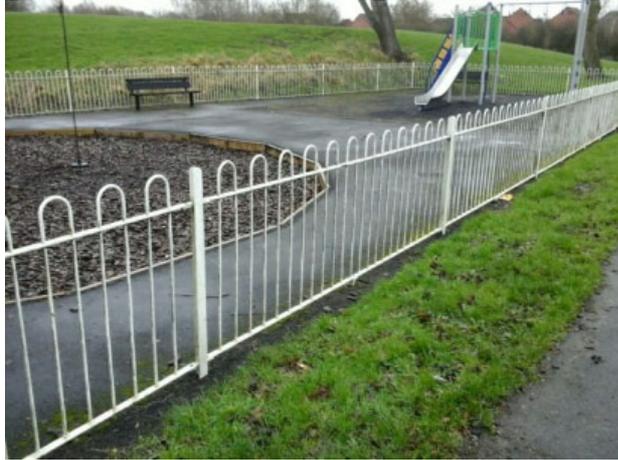
**Item:** Ancillary Items - Fence - Bow Top  
**Manufacturer:** Owner/Operator

**Finding:** The fence is damaged in places

**Action:** Repair or replace all affected sections

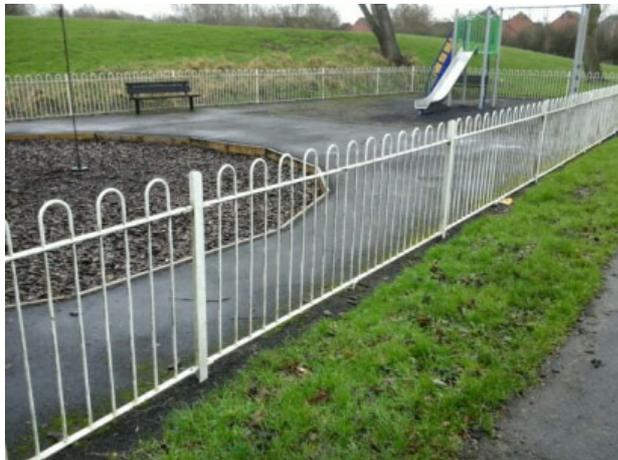
**Item:** Ancillary Items - Fence - Bow Top  
**Manufacturer:** Owner/Operator

**Finding:** A number of fixings have worked loose around the fencing

**Action:** Secure all loose fixings

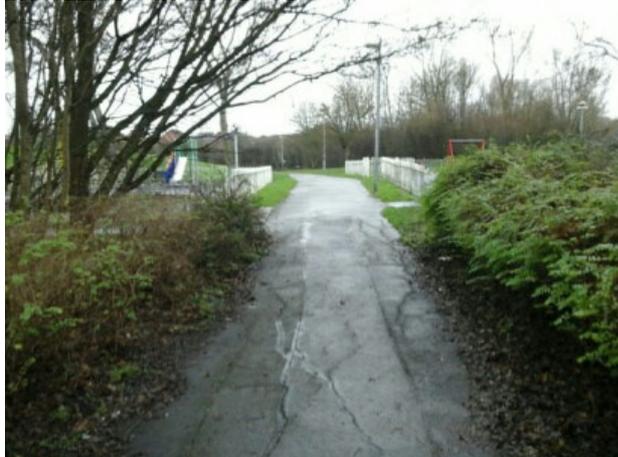
**Item:** Ancillary Items - Site General  
**Manufacturer:** Owner/Operator

**Finding:** The tarmac surfacing is showing signs of wear / damage

**Action:** Monitor for any further deterioration and repair as required

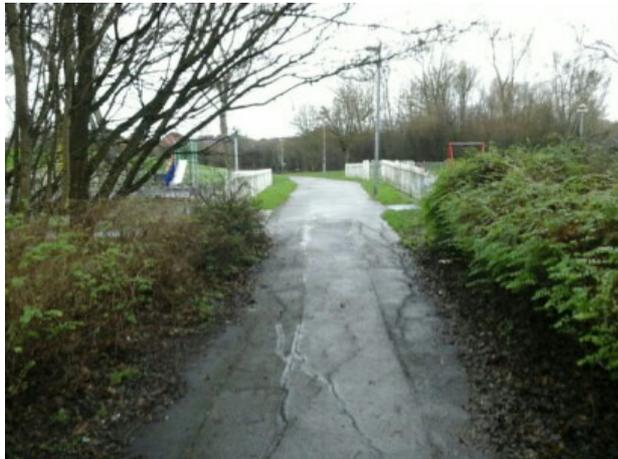
**Item:** Ancillary Items - Site General  
**Manufacturer:** Owner/Operator

**Finding:** There are gaps opening between the wet pour surfacing and the edging surround or between the joints in the surfacing

**Action:** Monitor for any further deterioration and repair as required

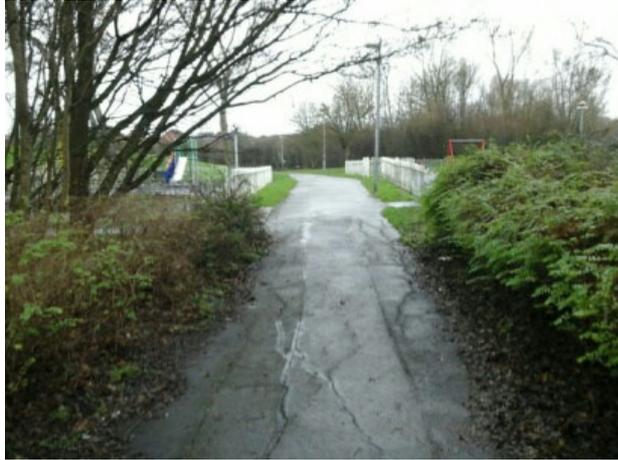
**Item:** Ancillary Items - Site General  
**Manufacturer:** Owner/Operator

**Finding:** There is algae or moss growth on the wet pour surfacing resulting in slippery conditions

**Action:** Clean and treat appropriately

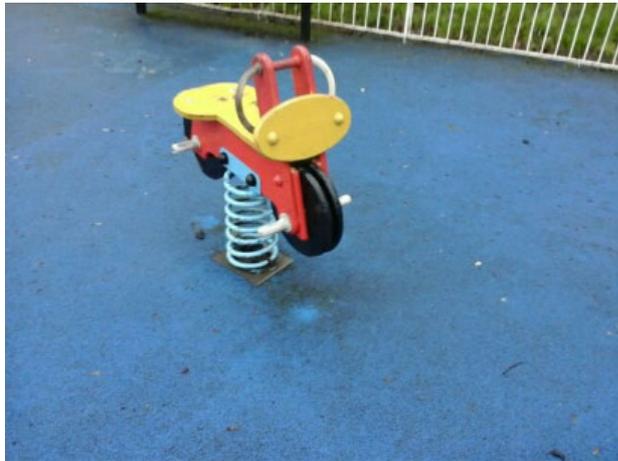
**Item:** Rocking Equipment - Spring Bike  
**Manufacturer:** Kompan Ltd

**Finding:** The end of handgrips and/or footrests have a cross section of less than 15cm<sup>2</sup> and fail to meet the requirements of BS EN 1176:2008 Part 6

**Action:** This is a relatively low risk failure and no remedial action is recommended

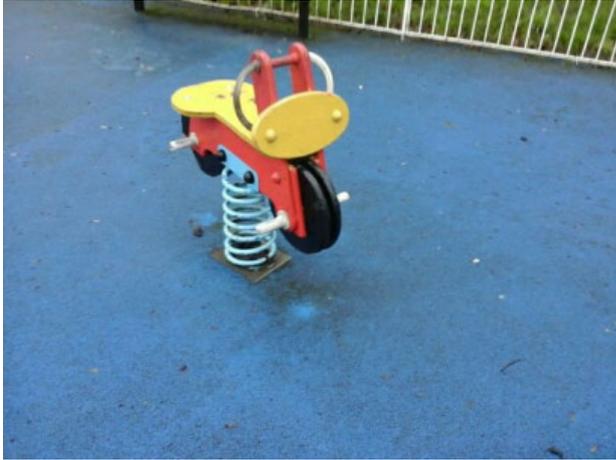
**Item:** Rocking Equipment - Spring Bike  
**Manufacturer:** Kompan Ltd

**Finding:** The paintwork on this item has been damaged or worn exposing the metal underneath which is rusting

**Action:** Treat any rusting components and repaint

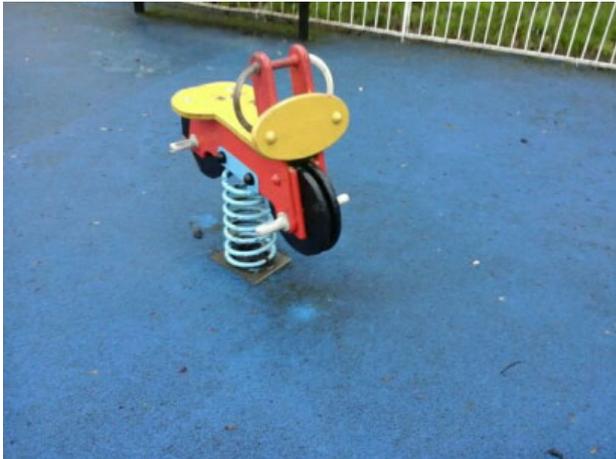
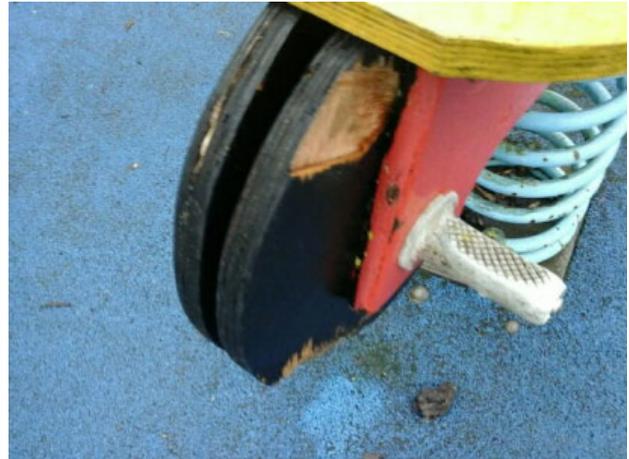
**Item:** Rocking Equipment - Spring Bike  
**Manufacturer:** Kompan Ltd

**Finding:** The plywood has delaminated in some places **Action:** Remove all rough or splintered edges.

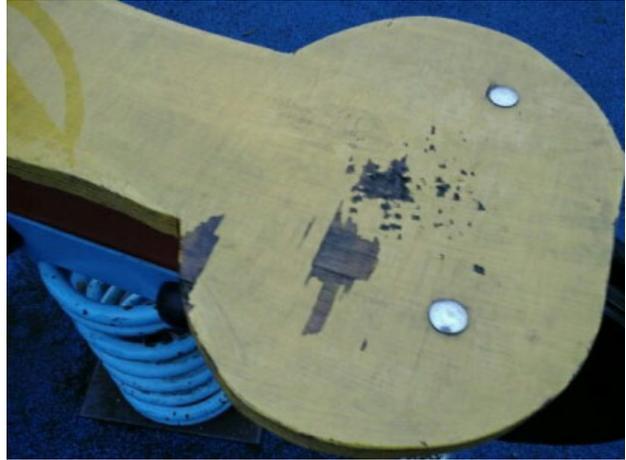
**Item:** Rocking Equipment - Spring Bike  
**Manufacturer:** Kompan Ltd

**Finding:** Parts of the timber are rough or splintered

**Action:** Remove all rough or sharp edges

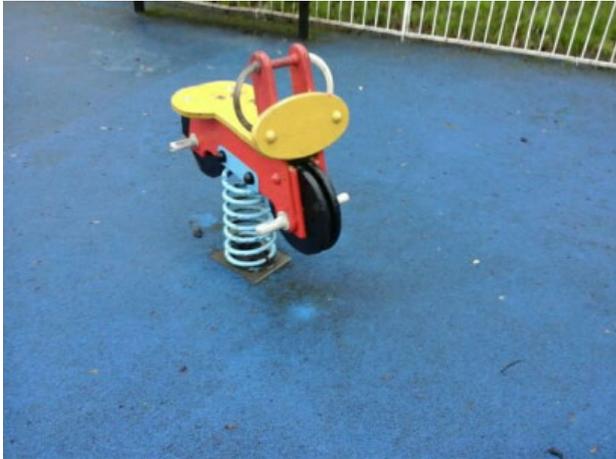
**Item:** Rocking Equipment - Spring Bike  
**Manufacturer:** Kompan Ltd

**Finding:** The end caps are missing on the Handgrips/Footrests

**Action:** Replace missing end caps

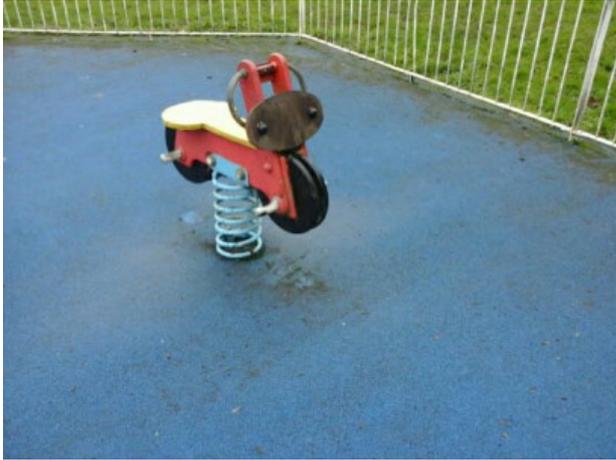
**Item:** Rocking Equipment - Spring Bike  
**Manufacturer:** Kompan Ltd

**Finding:** The paintwork on this item has been damaged or worn exposing the metal underneath which is rusting

**Action:** Treat any rusting components and repaint

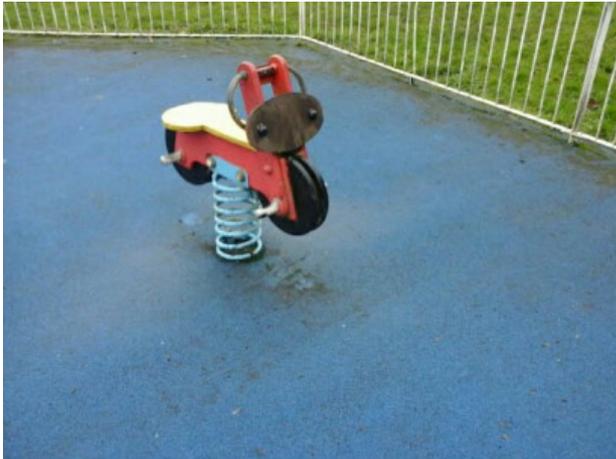
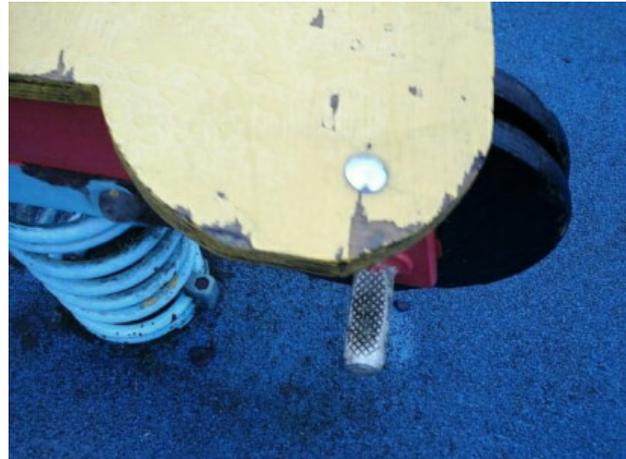
**Item:** Rocking Equipment - Spring Bike  
**Manufacturer:** Kompan Ltd

**Finding:** Parts of the timber are rough or splintered

**Action:** Remove all rough or sharp edges

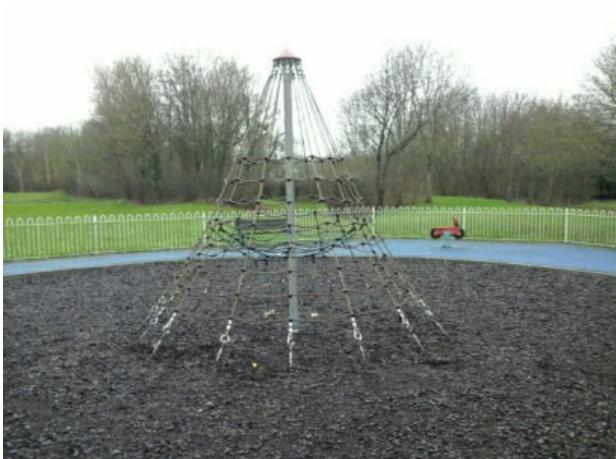
**Item:** Rotor Play - Cone Climber  
**Manufacturer:** Huck Nets (UK) Ltd

**Finding:** The level of loose fill surfacing has fallen significantly below the minimum 200mm recommended by BS EN 1176 Part 1

**Action:** Top up loose fill surfacing to recommended levels.

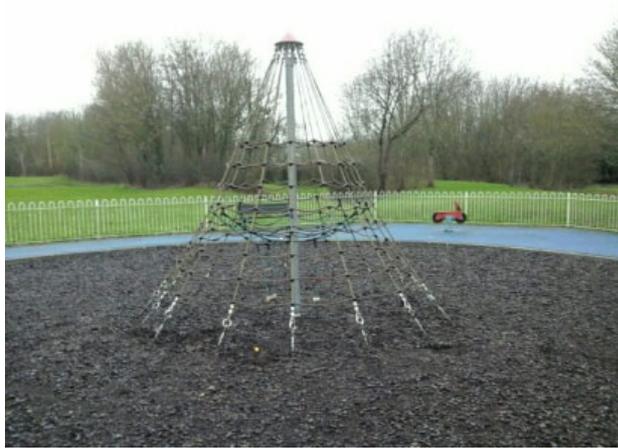
**Item:** Rotor Play - Cone Climber  
**Manufacturer:** Huck Nets (UK) Ltd

**Finding:** The ropes/nets are worn/damaged in places

**Action:** Monitor for any further deterioration and repair or replace as required

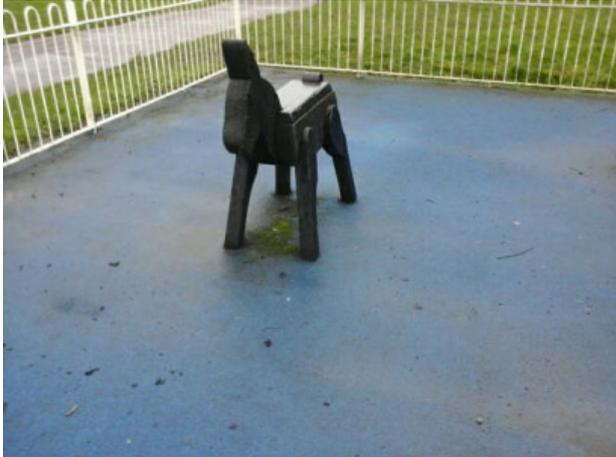
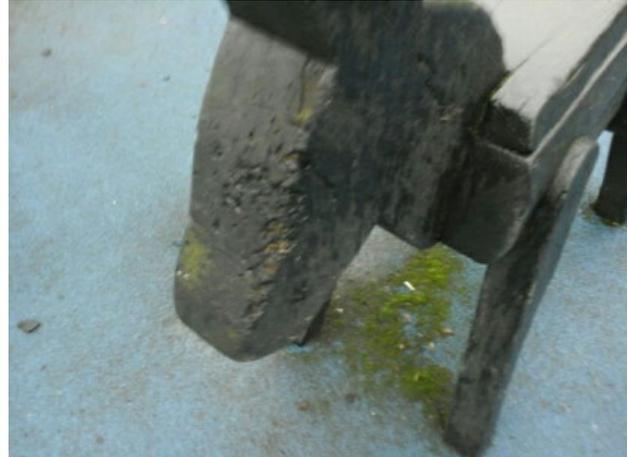
**Item:** Other - Wooden Animal  
**Manufacturer:** S M P (Playgrounds Ltd)

**Finding:** Parts of the timber are rough or splintered

**Action:** Remove all rough or sharp edges

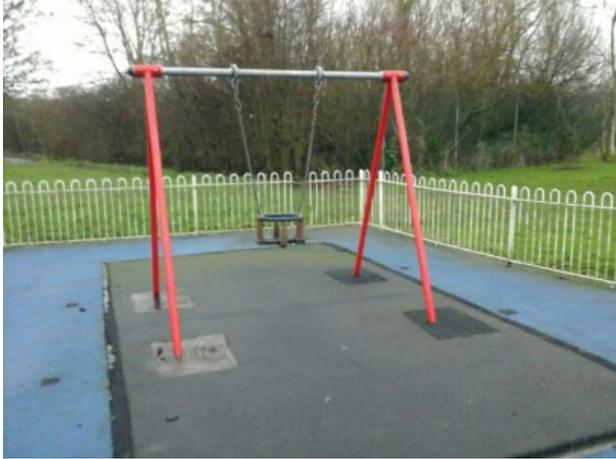
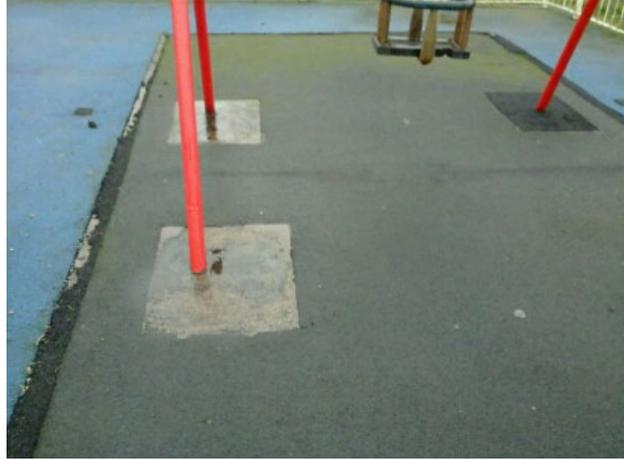
**Finding:** The resin/concrete pads form hard objects within the impact area of the equipment in contravention of the requirements of BS EN 1176 Part 1

**Action:** Reinstate with appropriate safer surfacing

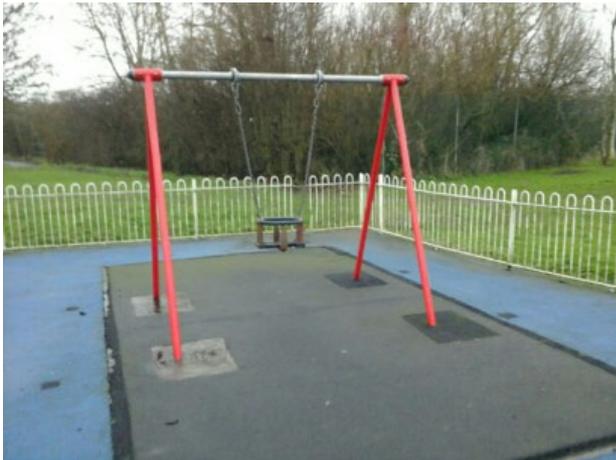
**Finding:** The surfacing width under each seat is less than 1.75 metres and fails the requirements of BS EN 1176 Part 2 - the concrete patches form hard objects in the impact area

**Action:** Monitor use

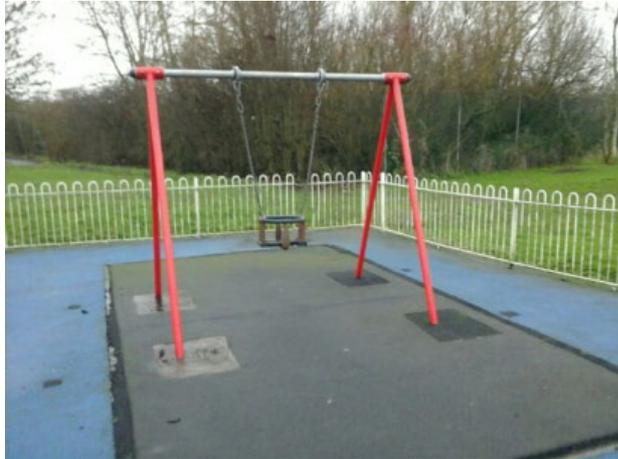
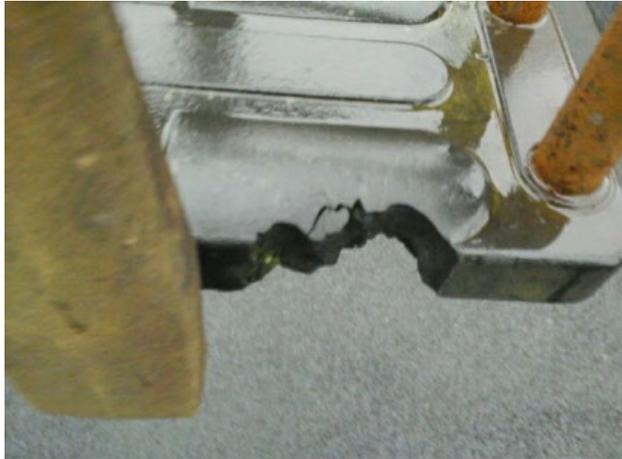
**Item:** Swings - 1 Bay 1 Seat (Cradle) - Type 1 **Risk Level:** L - Low Risk

**Finding:** The seat is severely damaged and requires replacing **Action:** Replace damaged seat

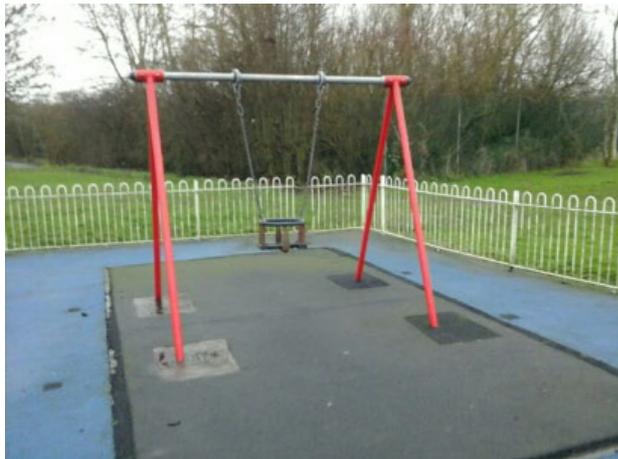
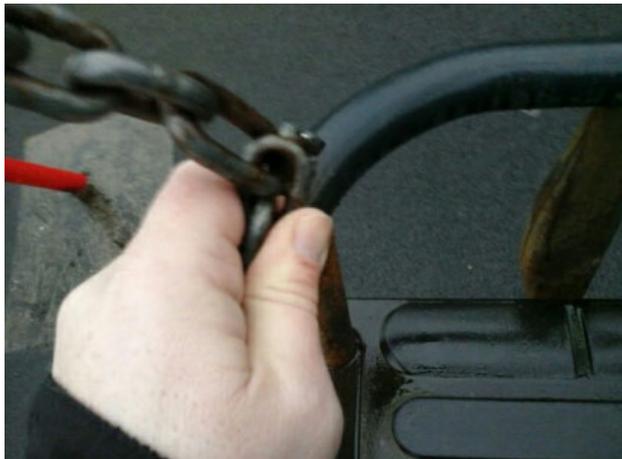
**Item:** Swings - 1 Bay 1 Seat (Cradle) - Type 1 **Risk Level:** L - Low Risk

**Finding:** There is some notable evidence of chain wear **Action:** Monitor for any further deterioration and replace when 40% worn

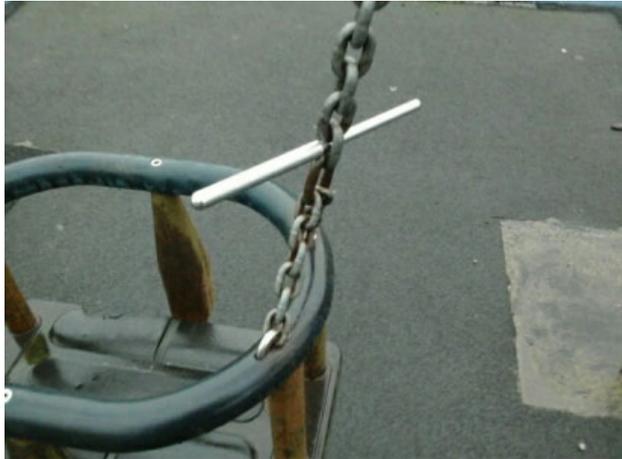
**Item:** Swings - 1 Bay 1 Seat (Cradle) - Type 1 **Risk Level:** V - Very Low Risk

**Finding:** The chain openings are in excess of the 8.6mm as recommended by BS EN 1176

**Action:** Monitor use

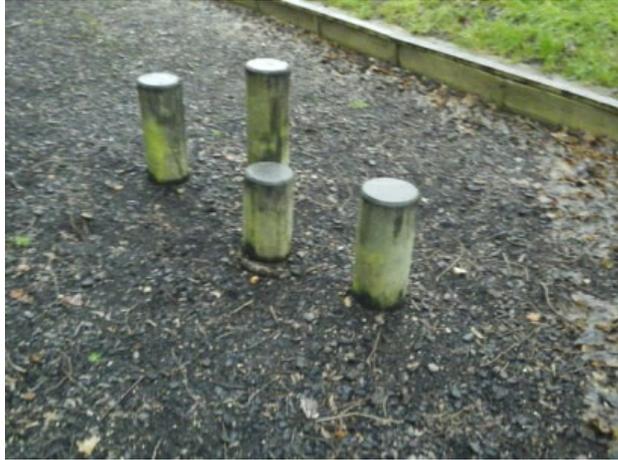
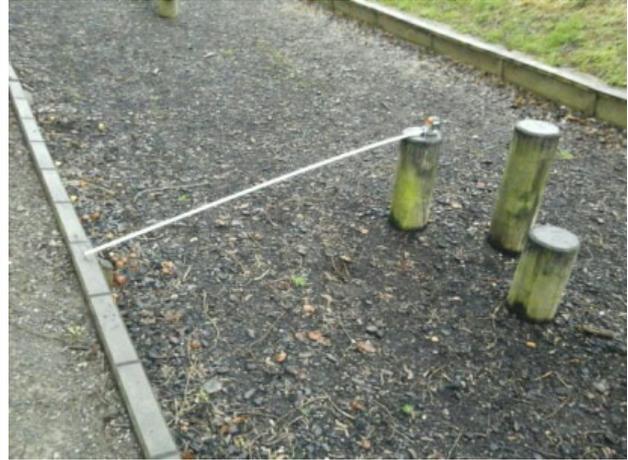
**Item:** Activity Equipment - Stepping Stones  
**Manufacturer:** Playdale Playgrounds Ltd

**Finding:** The timber edging forms a hard object within the falling space of the equipment in contravention of the requirements of BS EN 1176 Part 1

**Action:** Monitor use

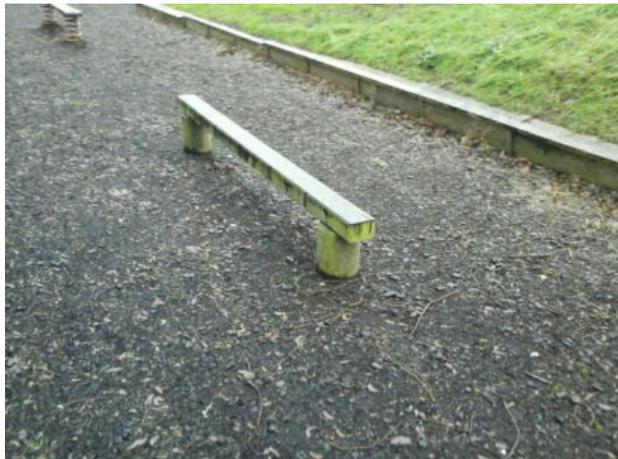
**Item:** Activity Equipment - Balance Beam  
**Manufacturer:** Playdale Playgrounds Ltd

**Finding:** There is some evidence of rot in the timber

**Action:** Monitor for any further deterioration and replace as required

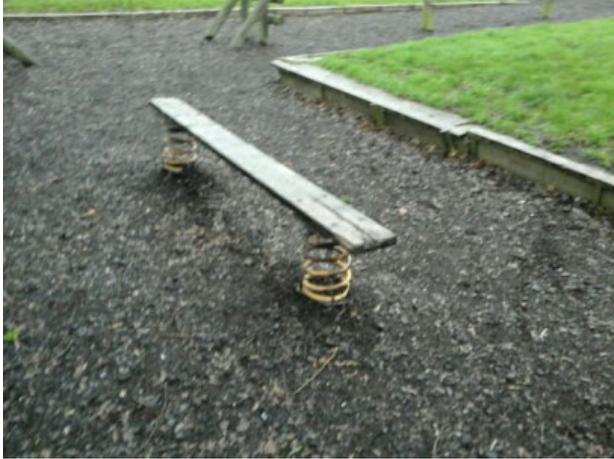
**Finding:** There is some evidence of rot in the timber

**Action:** Monitor for any further deterioration and replace as required

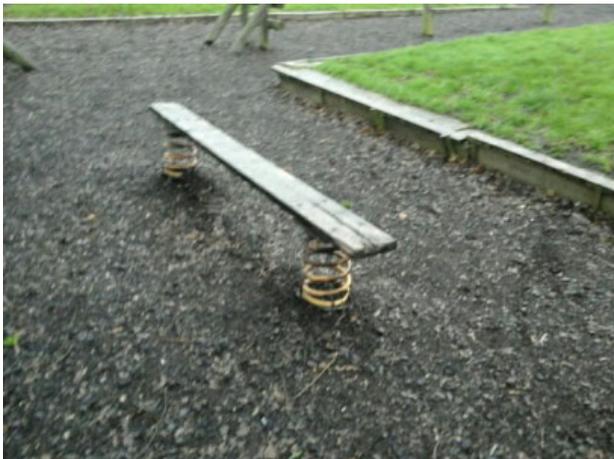
**Finding:** The paintwork on the spring has been damaged or worn exposing the metal underneath which is rusting

**Action:** Treat any rusting components and repaint

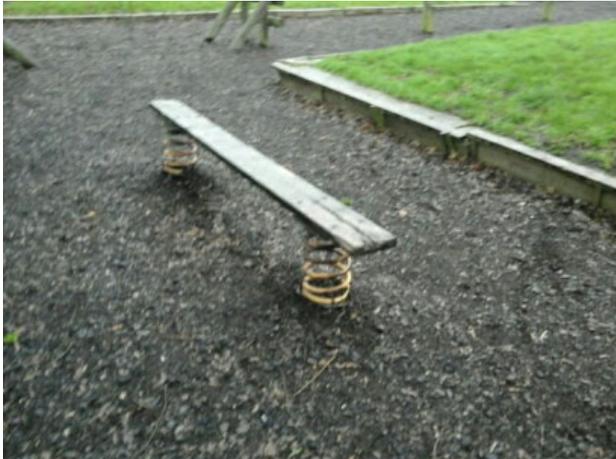
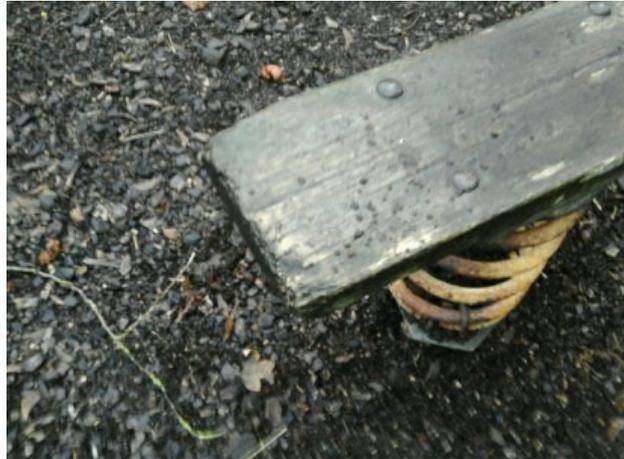
**Finding:** Parts of the timber are rough or splintered

**Action:** Remove all rough or sharp edges

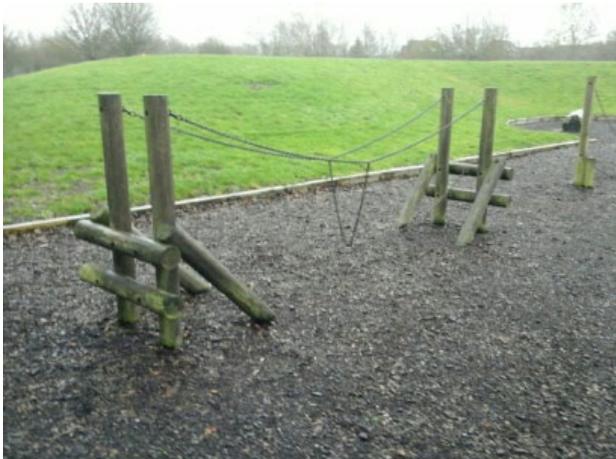
**Finding:** There is some evidence of rot in the timber

**Action:** Monitor for any further deterioration and replace as required

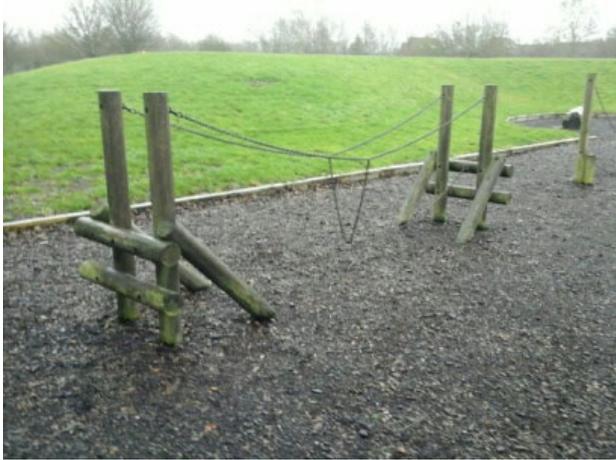
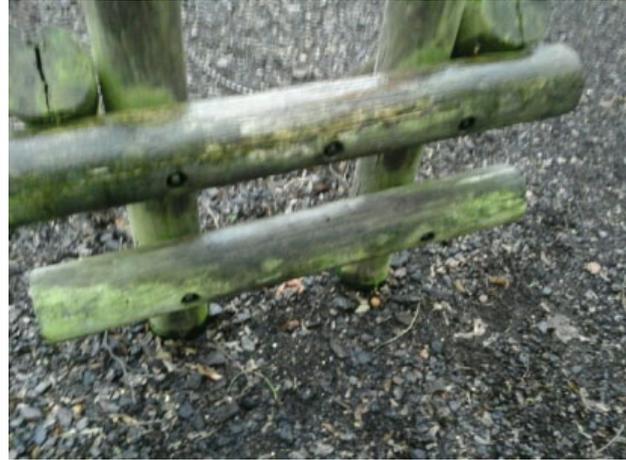
**Item:** Activity Equipment - Burma Bridge  
**Manufacturer:** Playdale Playgrounds Ltd

**Finding:** There is algae or moss on the surface of the equipment

**Action:** Clean and treat appropriately

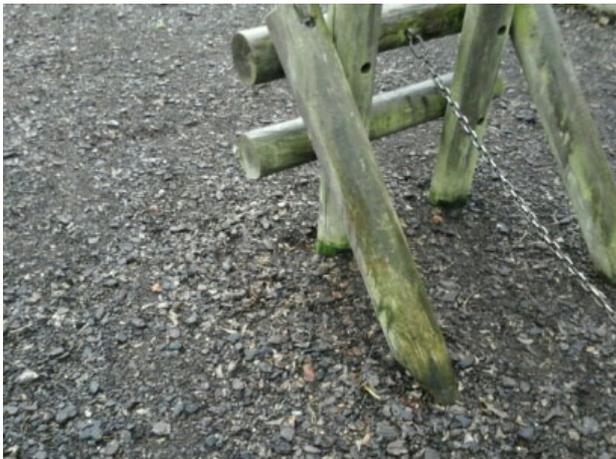
**Item:** Activity Equipment - Burma Bridge  
**Manufacturer:** Playdale Playgrounds Ltd

**Finding:** There are areas or parts of angled timber supports x2 on the structure that have rotted

**Action:** Replace all affected timbers

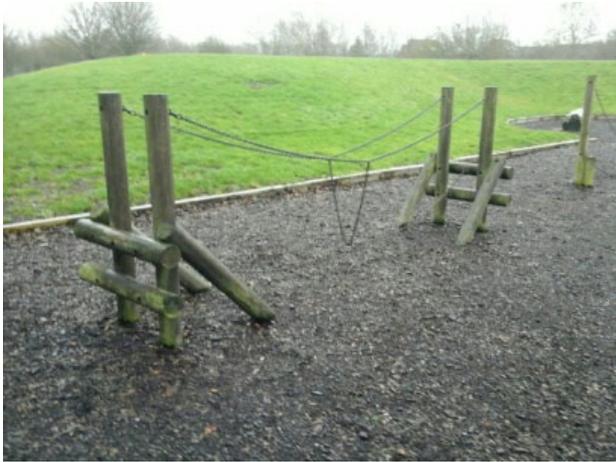
**Item:** Activity Equipment - Burma Bridge  
**Manufacturer:** Playdale Playgrounds Ltd

**Finding:** The timber has a number of air cracks apparent, the splits will have penetrated the preservative applied to the timber and allow water ingress to the unprotected areas

**Action:** Monitor for any deterioration (rot) and replace as required

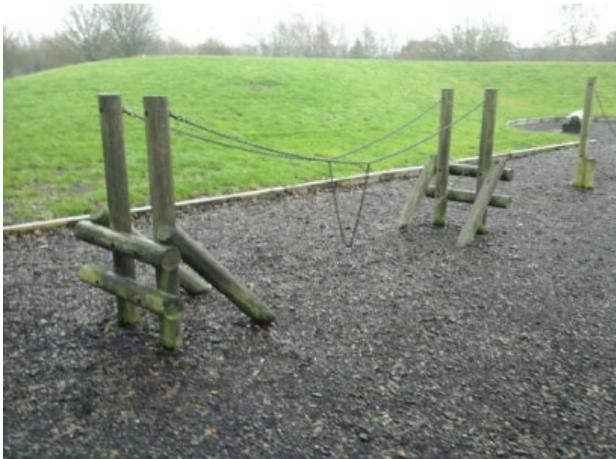
**Item:** Activity Equipment - Burma Bridge  
**Manufacturer:** Playdale Playgrounds Ltd

**Finding:** The chain openings are in excess of the 8.6mm as recommended by BS EN 1176

**Action:** Monitor use and replace with compliant chains during next maintenance cycle.

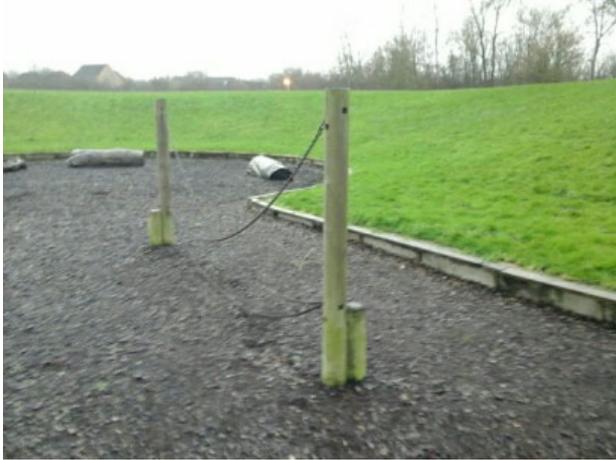
**Item:** Activity Equipment - Chain Traverse  
**Manufacturer:** Playdale Playgrounds Ltd

**Finding:** A number of eye bolt fixing(s) have worked loose

**Action:** Secure all loose fixings

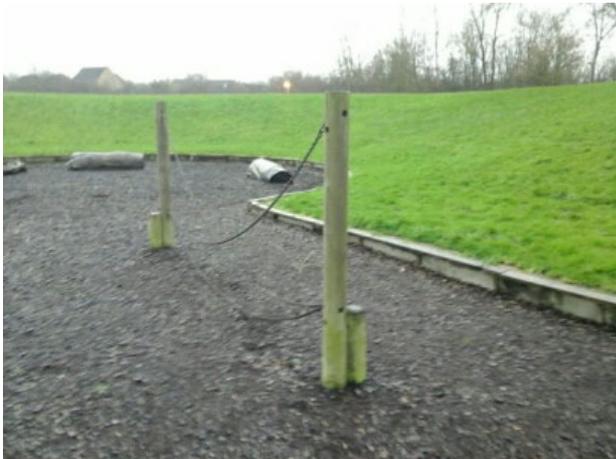
**Item:** Activity Equipment - Chain Traverse  
**Manufacturer:** Playdale Playgrounds Ltd

**Finding:** There is some evidence of rot in the timber

**Action:** Monitor for any further deterioration and replace as required
