## Annual Inspection

West Swindon Parish Council

Middleleaze

Inspection Ref: 524050

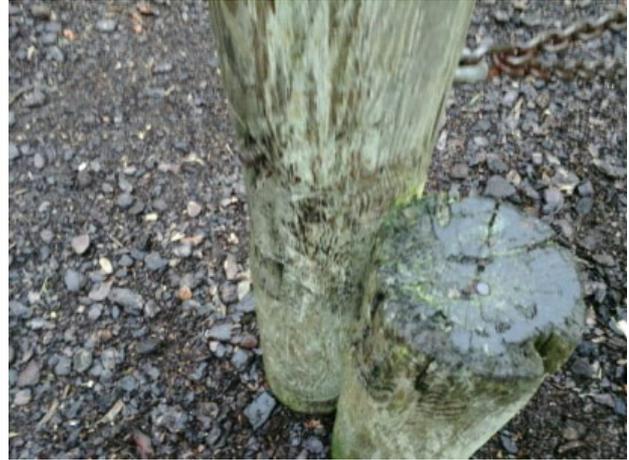
**Item:** Activity Equipment - Chain Traverse  
**Manufacturer:** Playdale Playgrounds Ltd

**Finding:** Parts of the timber are rough or splintered

**Action:** Remove all rough or sharp edges

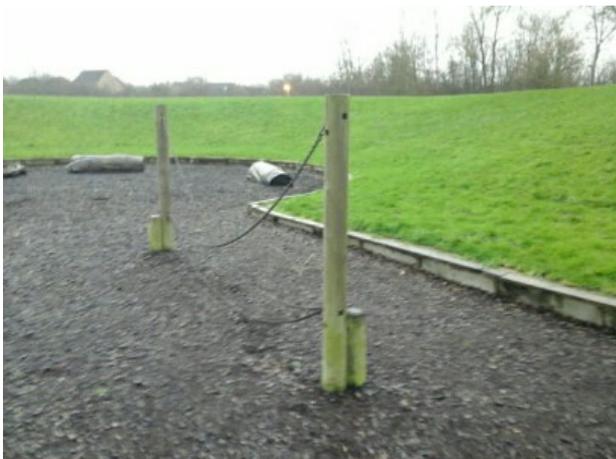
**Item:** Activity Equipment - Chain Traverse  
**Manufacturer:** Playdale Playgrounds Ltd

**Finding:** The chain openings are in excess of the 8.6mm as recommended by BS EN 1176

**Action:** Monitor use

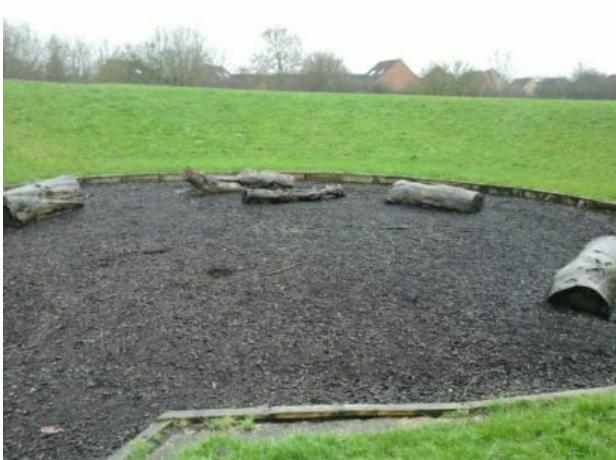
**Item:** Other - Fallen Tree  
**Manufacturer:** Not Identified

Fungus or algae was found on the logs - Remove fungi or algae from the logs

**Finding:** Fungus or algae was found on the logs

**Action:** Remove fungi or algae from the logs

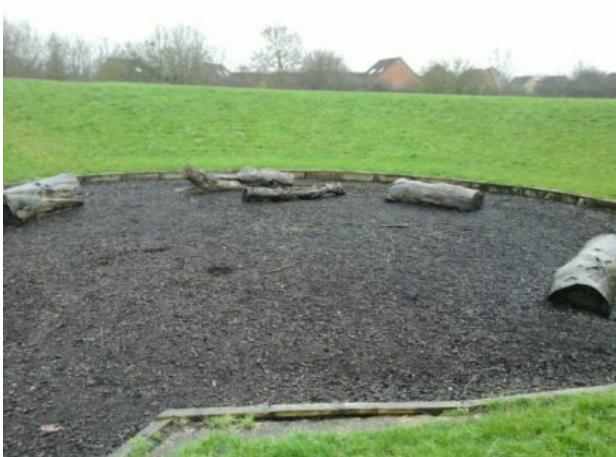
**Item:** Other - Fallen Tree  
**Manufacturer:** Not Identified

**Finding:** There is some evidence of rot in the timber

**Action:** Monitor for any further deterioration and replace as required

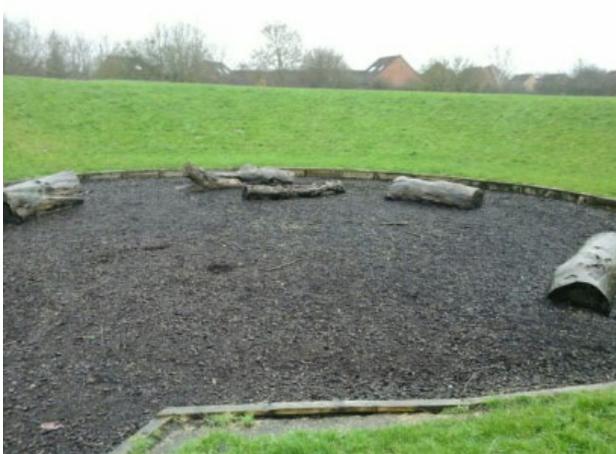
**Item:** Other - Fallen Tree  
**Manufacturer:** Not Identified

There are areas or parts of a log that have rotted extensively - Recommend removal of log

**Finding:** There are areas or parts of a log that have rotted extensively

**Action:** Recommend removal of log

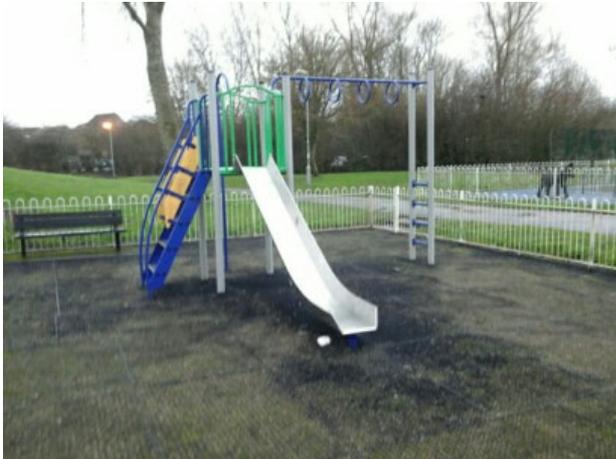
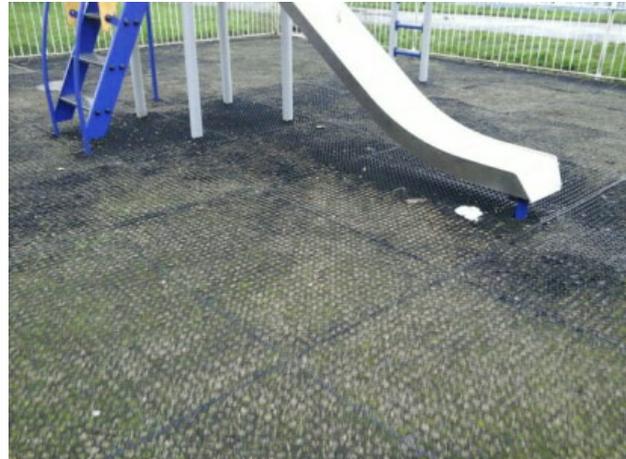
**Item:** Activity Equipment - Multi Play (Junior)  
**Manufacturer:** Not Identified

**Finding:** The grass mats are silted up and the soil is compacted; this may have an effect on the impact absorbing properties of the surface

**Action:** Lift and relay mats or test impact absorbing properties to ensure the correct surface qualities are maintained for the equipment

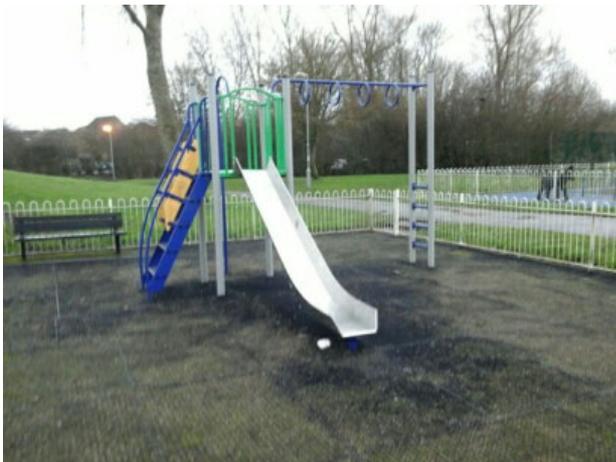
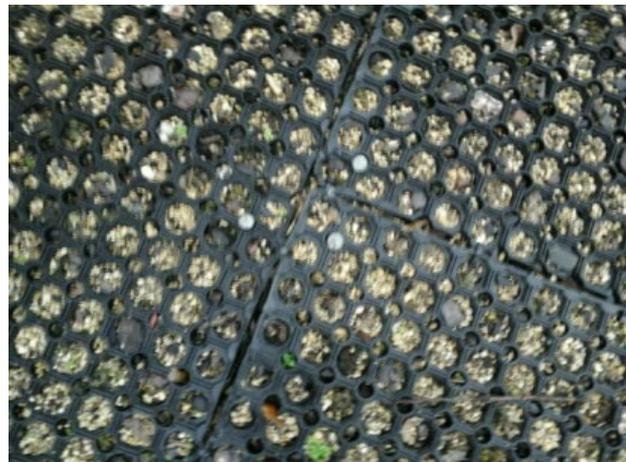
**Item:** Activity Equipment - Multi Play (Junior)  
**Manufacturer:** Not Identified

**Finding:** Fixing Pins have been installed in the impact areas of the grass mats

**Action:** Remove pins from impact areas

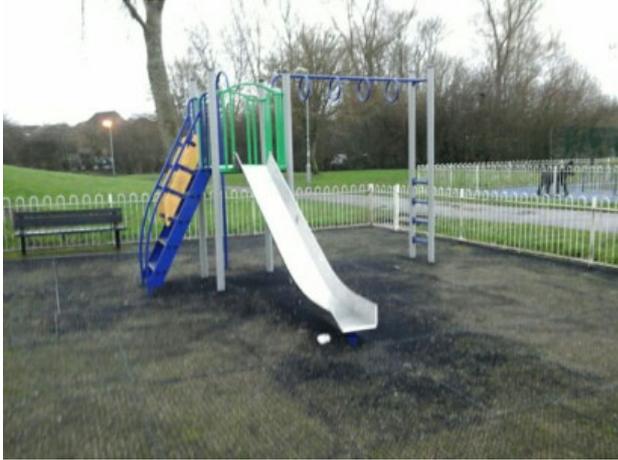
**Item:** Activity Equipment - Multi Play (Junior)  
**Manufacturer:** Not Identified

The resin patch repair to the surfacing forms a hard object within the impact area of the equipment in contravention of the requirements of BS EN 1176 Part 1 - Remove resin and repair surfacing using an appropriate medium

**Finding:** The resin patch repair to the surfacing forms a hard object within the impact area of the equipment in contravention of the requirements of BS EN 1176 Part 1

**Action:** Remove resin and repair surfacing using an appropriate medium

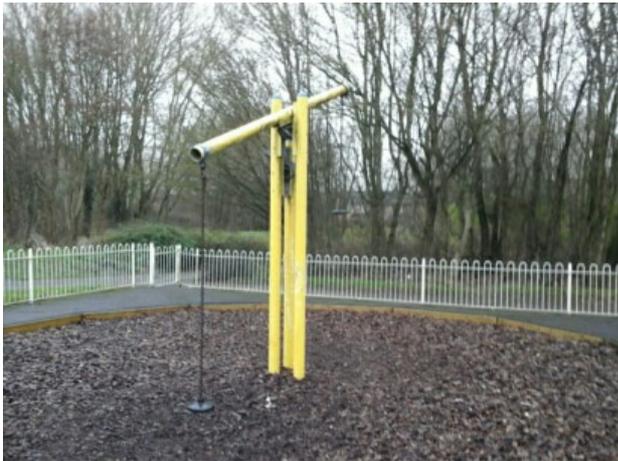
**Item:** Rocking Equipment - Overhead See Saw  
**Manufacturer:** Not Identified

There are post caps missing from the item - Replace missing post caps

**Finding:** There are post caps missing from the item

**Action:** Replace missing post caps

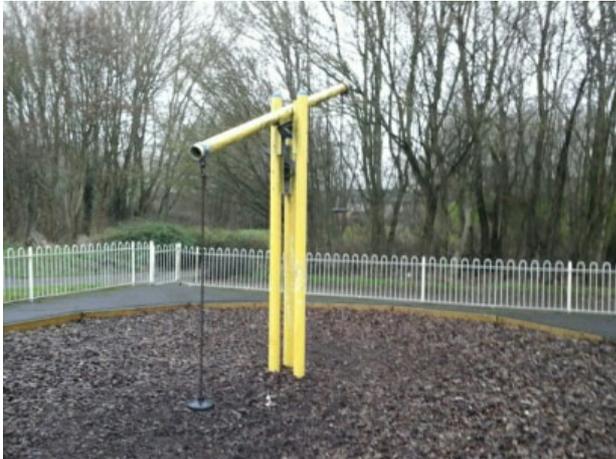
The rubber buffers are worn - Replace the buffers

**Finding:** The rubber buffers are worn

**Action:** Replace the buffers

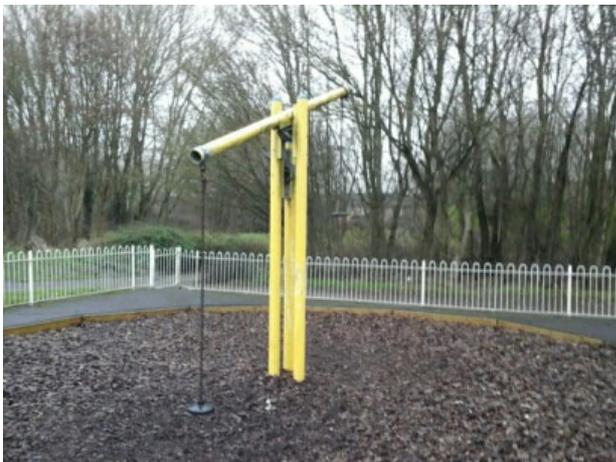
The chain on one seat was wrapped around the cross bar at the time of inspection and the inspector has been unable to fully assess their condition - Unwrap chain from the crossbar and check for any broken or worn links etc.

**Finding:** The chain on one seat was wrapped around the cross bar at the time of inspection and the inspector has been unable to fully assess their condition

**Action:** Unwrap chain from the crossbar and check for any broken or worn links etc.

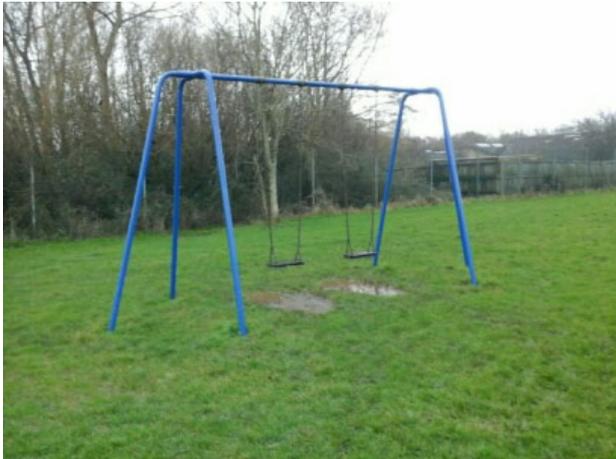
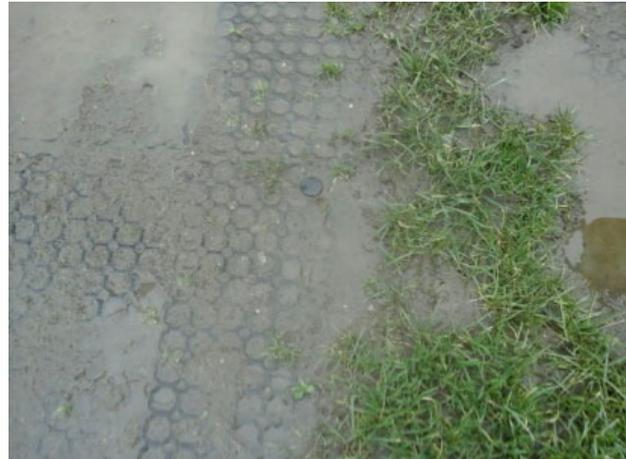
**Item:** Swings - 1 Bay 2 Seat (Flat)  
**Manufacturer:** Not Identified

**Risk Level:** L - Low Risk  
**Surface:** Grass Matrix Tiles

**Finding:** Fixing Pins have been installed in the impact areas of the grass mats

**Action:** Remove pins from impact areas

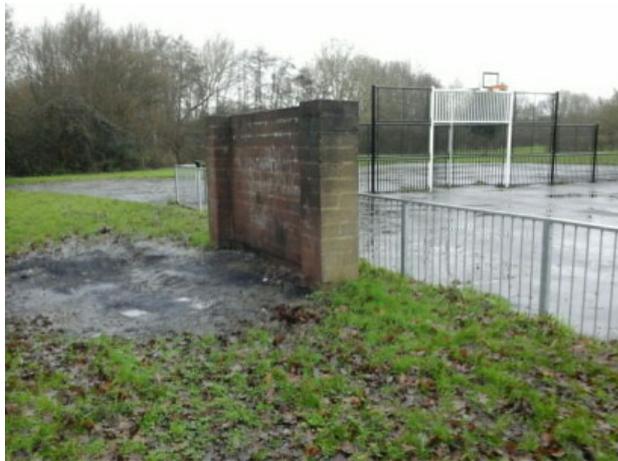
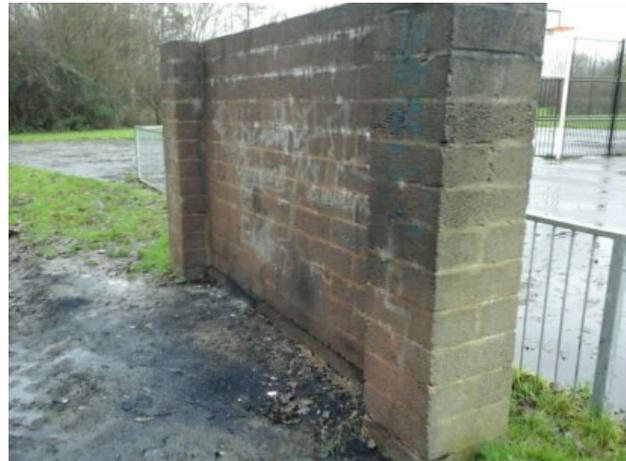
**Finding:** There is some graffiti present on site

**Action:** Remove the graffiti
