# Kennington Park Skatebowl London, SE11 4BE

Structural Engineering Development Outlines Report

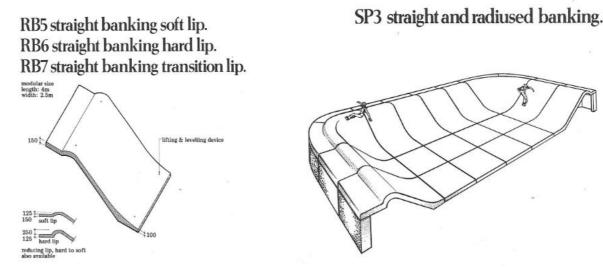
Figure 3 - Left: Typical precast banked unit from Radical Banking catalogue Right: Typical sectional arrangement using banked units on wall sections with flat panel bottom pieces (note; Kennington is larger in arrangement)

The general construction of the skatebowl is that of a precast ferrocement system of units supported on concrete bearing pads. These are part of the modular 'Radical Banking' system by The Great Outdoors Skatepark Company Limited. This organisation was spearheaded by the Skatepark designer and architect Lorne Edwards, with construction of Kennington Bowl taking place in 1978. The park consists of the RB6 hard lipped 'Banked' sections seated on perimeter wall units at their higher end, with the 'flat-bottom' of the skatebowl formed of the RB1 'standard flat sections' (Figure 3). Typical system elements are outlined in further detail in the Radical Banking System's design catalogue.

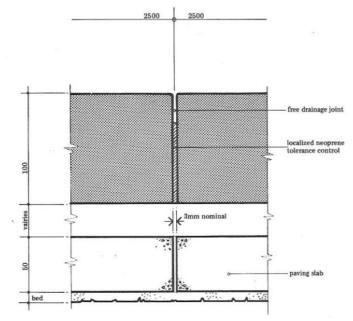
Figure 5 - Jointing detail between PC units from Radical Banking Catalogue

The skatepark has seen noticeable movement over the years since its construction, with the gaps between the precast elements varying considerably in horizontal and vertical distance. Thus, the rideability of the skatepark deteriorated as these gaps became untraversable for skateboard and rollerblade wheels. The original jointing detail is that of a neoprene gasket strip with a nominal gap of 3mm provided (Figure 5 -Jointing detail between PC units). Whilst the park pre-dates the current British Standard for skatepark construction joints, the original 3mm horizontal gap is within the acceptable construction joint deviation in BS EN14974:2010.

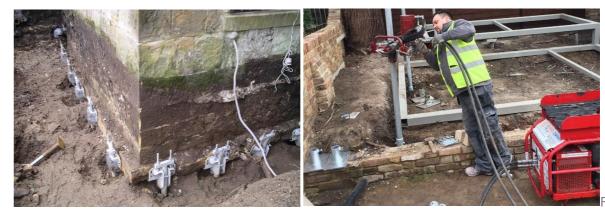
left: Screw-pile underpinning installed onto subsiding masonry to external corner of residential property Right: Typical manual installation of helical screw-pile installation

would form a new founding level, with the edges of these units jacked into positions removing the deviation between units. The advantage of using screw-piles is that these can be founded to a level not adversely affected by the near-surface ground movement; screw-piles being partially threaded, in that the shank area with the helical screw is located below the region of anticipated ground movement (trees and frost-heave). Whilst traditional mass or strip footings in a hit-and-miss underpinning sequence can also be considered, the required depths along with the likelihood of tree roots under the skatepark could prove an issue when excavating for footings. A screw-pile solution can also be installed by hand-held means.

Once the external banked members are re-positioned then the new flat-bottom slab can be installed in-situ with support off the same screw-pile foundations.
