## ***ASBESTOS SURVEY REPORT***

***REPORT ID NO: AAS101105DXT-D***

***SITE NAME: Yew Tree Court***

***CLIENT: Broxstowe Council***

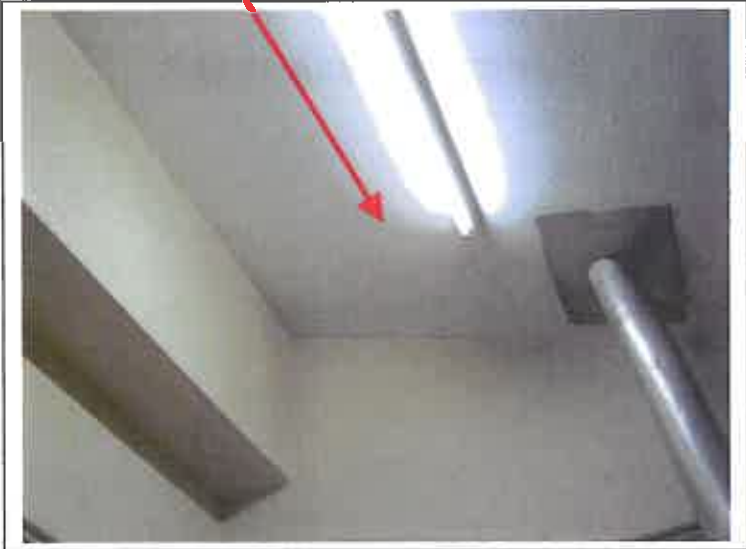
<b>Condition</b>	<b>Surface Treatment</b>
Good (0) <input checked="" type="checkbox"/> Fair (1) <input type="checkbox"/> Poor (4) <input type="checkbox"/> Debris (6) <input type="checkbox"/>	Sealed (0) <input checked="" type="checkbox"/> Poor (2) <input type="checkbox"/> Bare (4) <input type="checkbox"/>

<b>Accessibility</b>	<b>Risk Band</b>
Low (0) <input checked="" type="checkbox"/> Medium (1) <input type="checkbox"/> High (2) <input type="checkbox"/>	18 points or more (A) <input type="checkbox"/> 14-17 points (B) <input type="checkbox"/>
	9-13 points (C) <input type="checkbox"/> 1-8 points (D) <input checked="" type="checkbox"/> 0 points (E) <input type="checkbox"/>
