TARGETED PRE-REFURBISHMENT SURVEY

APEX HOUSE
3 EMBASSY DRIVE
EDGBASTON
BIRMINGHAM
B15 1TR

15.06.2016

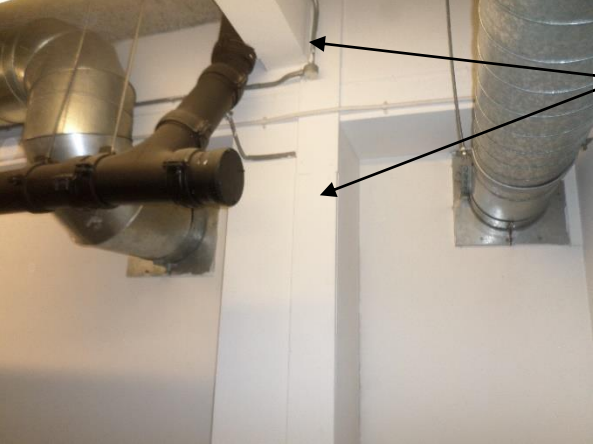
| ITEM | Sample Number | Exterior/ Interior | Level | Location/ Room | Position | Quantity (Approx) |
|---|---|---|---|---|---|---|
| 00 | 001 | Interior | Basement | Lift lobby | Wall | 6m ² |

| ITEM | Sample Number | Exterior/ Interior | Level | Location/ Room | Position | Quantity (Approx) |
|---|---|---|---|---|---|---|
| | | | | Insulating board (non-asbestos) | | |

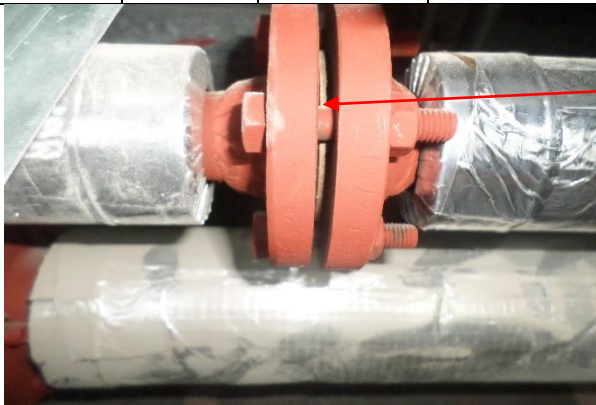
| ITEM | Sample Number | Exterior/ Interior | Level | Location/ Room | Position | Quantity (Approx) |
|---|---|--|---|--|---|---|
| 01 | 007 | Interior | Ground | Offices | Pipework above ceiling tiles | Throughout |

The gaskets to the pipework were sampled on the ground and first floor, with both being proven to be asbestos containing materials. Any gaskets should now be treated as asbestos. It is not suspected that any of these gaskets are to be disturbed as part of the renovation works, therefore they should be labelled as asbestos. If any of the pipework is to be renewed, then these gaskets must be removed under controlled asbestos removal conditions and disposed of as asbestos waste.

| ITEM | Sample Number | Exterior/ Interior | Level | Location/ Room | Position | Quantity (Approx) |
|---|---|--|---|--|---|---|
| | | | | Compressed asbestos fibre gaskets | | |

If pipework is to be renewed to any of the floors, then the gaskets should be removed under controlled asbestos removal conditions and disposed of as asbestos waste.

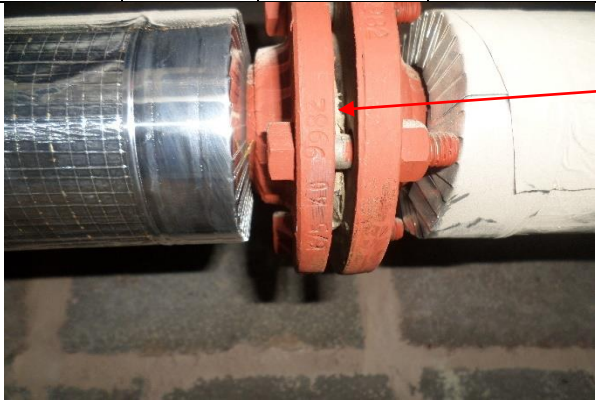
| ITEM | Sample Number | Exterior/ Interior | Level | Location/ Room | Position | Quantity (Approx) |
|---|---|--|---|--|---|---|
| 01 | 007 | Interior | Ground | Offices | Pipework above ceiling tiles | Throughout |

| ITEM | Sample Number | Exterior/ Interior | Level | Location/ Room | Position | Quantity (Approx) |
|---|---|--|---|--|---|---|
| | | | | Compressed asbestos fibre gaskets | | |

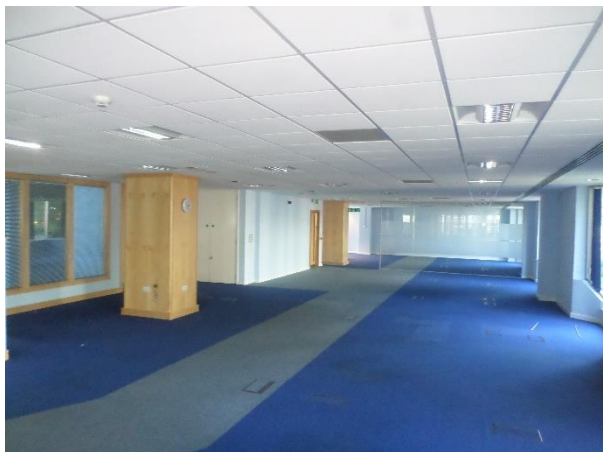
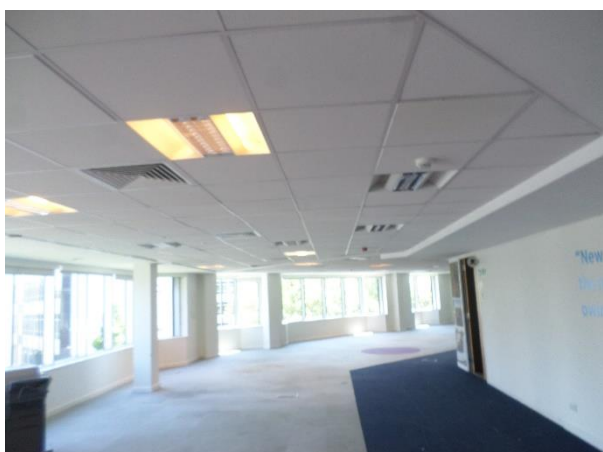
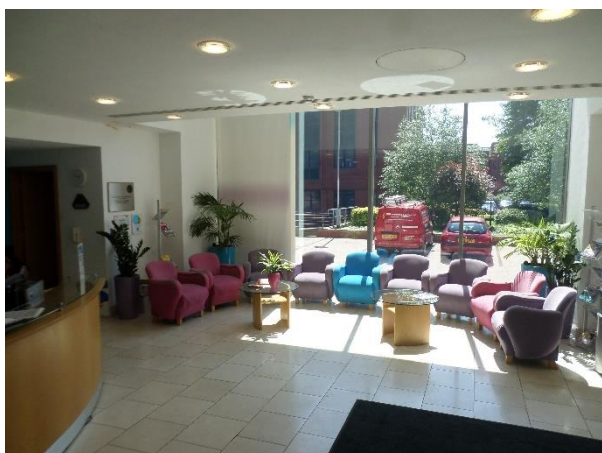
After surveying all assessable areas to the basement/carpark, ground and first floor, there was eight samples of suspect items taken. After analytical testing two of the eight samples were proven to be asbestos containing materials. These being identical items, with both being gaskets the too pipework flanges. On the ground and first floor office areas there are modern style ceiling tiles in the majority of the rooms, either being made up of plasterboard or MMMF board. Above the ceiling tiles there are concrete ceilings then MMMF blanket insulation (firebreaks), plasterboard, MMMF pipe insulation to all pipework and ducting throughout both floors. There is a raised metal access flooring covered with carpet tiles on the majority both floors, with the kitchens and toilets having vinyl floor coverings. The majority of the walls are block or brick built with there being some plasterboard partition walls. There are several timber and plasterboard boxing's which are concealing plastic and metal pipework and the structural concrete columns. To both floors there is a lift lobby area and toilets which have both been included in this survey, with no suspect materials being found. All risers have been checked on both the ground and first floor, all being visually similar. There are vast amounts of pipework and ducting's all being insulated with MMMF insulation. Any gaskets are to be treated as samples 007 & 008, which have been proven to be compressed asbestos fibre gaskets. The reception area has plasterboard ceilings, brick/block walls and ceramic floor tiles. The reception area could not be as intrusively checked as it is a live area with consent human traffic passing through.
