Asbestos Refurbishment & Demolition Survey Report

**Willett Hill Depot
Lydeard St Lawrence
Taunton
Somerset
TA4 3QB**

Report Status:		ISSUED 23 May 2017	
Report Reference:		9492	
Name		Signature	Date
Surveyor:	Henry Parkin & No Assistant surveyor

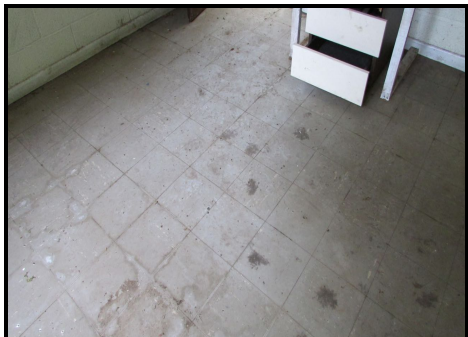
Sample No.	007	Building (Floor)	Willett Hill Depot (Ground Floor)	Comments

Room Area	Office C	Description of Location	Floor tile		
Product Description	No ACMs	Asbestos Type	Not Applicable		
Approx Quantity	N/A	HSE Notifiable	N/A
